Weston High School

WESTON SCHOOLS FACILITIES FEASIBILITY STUDY

WESTON HIGH SCHOOL - FACILITY CONDITIONS ANALYSIS

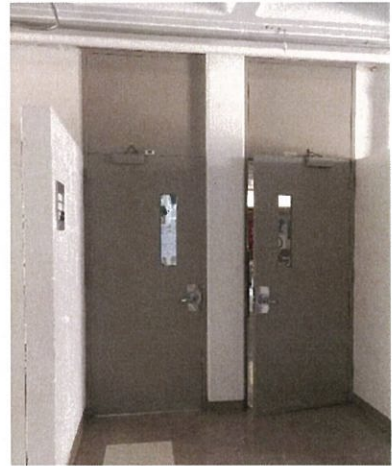
Figure 5: Original classroom doors without required push pull clearance

Many ADA accessibility and code issues were noted at this facility. This is a common occurrence given the age of the building and its renovations. These items should be included in the long term capital plan. Many of the doors within the original structure do not have the required push and pull clearances. All of the courtyards do not appear to meet the required egress as dictated by the code. All of the required grab bars do not exist in any of the handicap restrooms as they are all missing the vertical grab bar. Some gang toilet rooms are missing a handicap stall all together. As previously mentioned, in addition to these toilet rooms other ADA noncompliance items there is also the noncompliant casework.

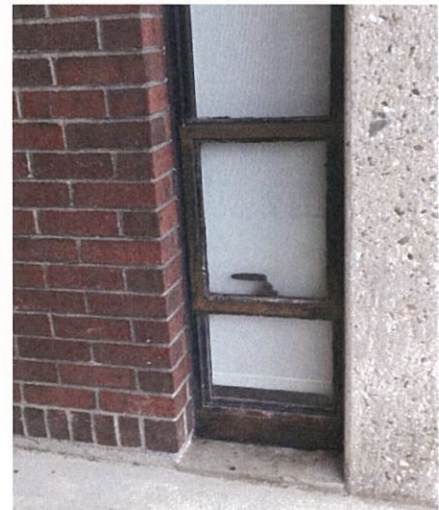
Figure 8: Original Window condition

When evaluating the energy efficiency of a building, it is known that nearly 25–40% of all heat energy is lost through windows. The new additions have received new double-glazed aluminum frame windows. They appear to be in good condition. However, many of the old windows are still in place today. These older steel windows with a single pane of glass are not efficient at all. Many go all the way to the floor. There are also clearstory windows throughout the school too. Many of these windows are deteriorating and should be replaced with new energy efficient systems. The exterior doors seemed to have all be replaced. A few utility doors may still be existing from the original construction and should be replaced. There are a variety of roofs at this school. Ballast roofs are on the additions and a variety of EPDM roofs are on the existing building. The ballast roof appears to be in good shape. The roof was believed to be replaced in 2000 so it is approaching the end of its warranty period.

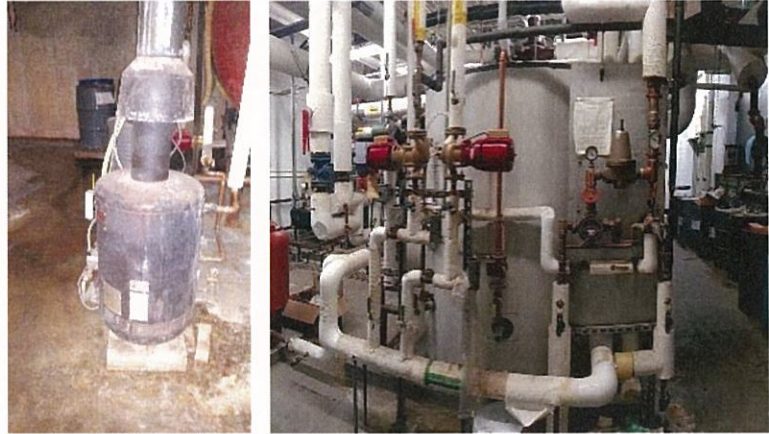
Domestic hot water is produced by two gas-fired water heaters. The first water heater, located in one of the boiler rooms, has an input rating of 199,000 BTUH and feeds two large storage tanks with unknown volumes. The water heater was manufactured in 1985 and is 32 years old. The system should have an average life expectancy of approximately 20-25 years, so this system has reached the end of its useful life. The second water heater, located in the other boiler room, has an input rating of 1,010,000 BTUH and a storage volume of 750 gallons. The system is approximately 12 years old. The system should have an average life expectancy of approximately 20-25 years and remaining life expectancy it about 10 years, however, there is some severe corrosion on some of the piping and this should be repaired/replaced.

To maximize service life, the Water Heater should be regularly serviced per the manufacturer's maintenance recommendations including, but not limited to, draining and flushing, testing relief valve, and inspecting/replacing anode. Refer to manufacturer's O&M literature.

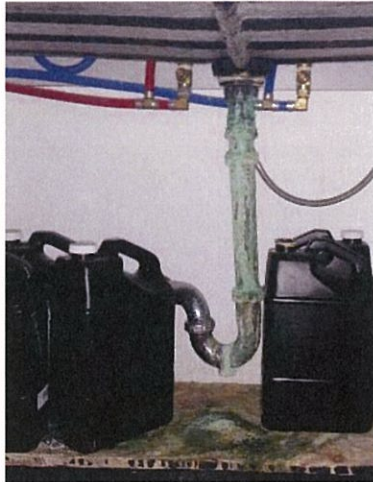
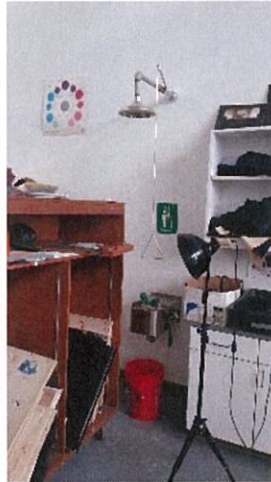
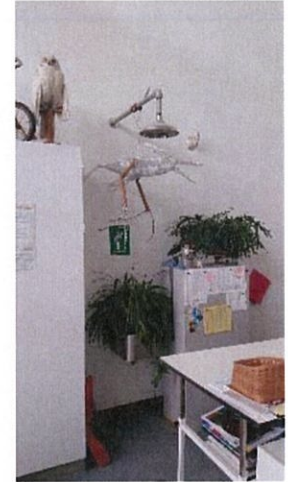
While the overall condition of the fixtures is good, there are a few issues noted during the visit. The drain for the sink in the darkroom has severe corrosion and should be replaced or repaired (See photo below left). Some of the emergency showers that are installed are not accessible or in working order due to items being stored in the area that should be clear for the shower or in one case, the handle for the emergency shower has been removed (See photos below center and right).

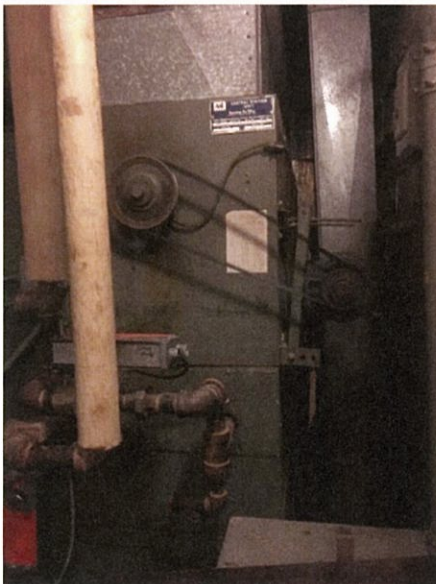
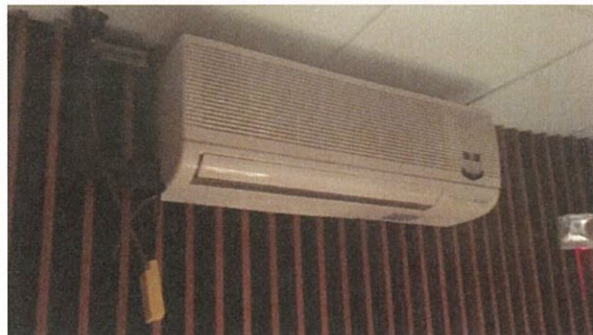
An original 1968 Air Handling Unit serves a portion of C-Wing. The unit is at the end of its useful life and should be budgeted for replacement. The unit is currently running with an exposed drive and no belt guard which is a hazard to personnel.

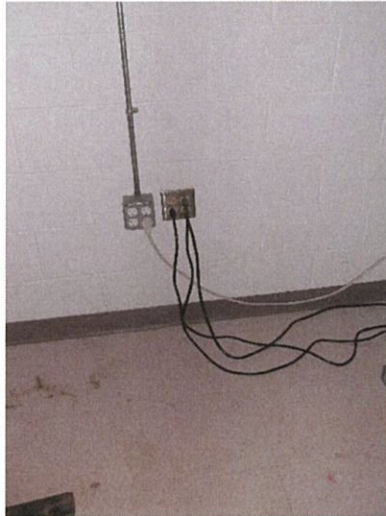
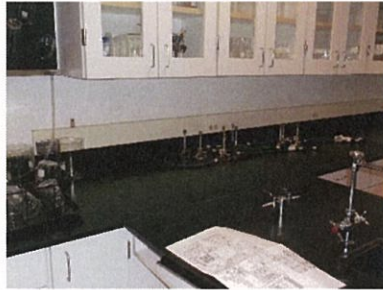
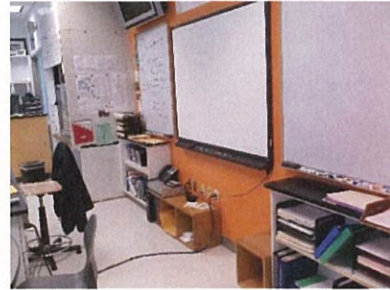
The existing power receptacles throughout the school are mostly recessed mounted duplex and quad receptacles with metal cover plates. There are some surface mounted devices that are fed by either surface mounted conduit or surface mounted raceway (wiremold). The Tech. Woodshop Room has ceiling mounted cord reels with a single receptacle on the end of the retractable cord. The Science Rooms and some other Classrooms have surface mounted dual channel raceway for both power and communication devices. The receptacles for the most part appear to be in good operating condition, there are a few locations that spotted that the devices should be replaced or remounted to the back box.

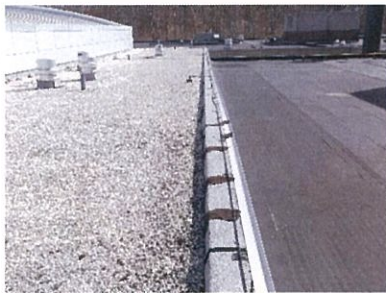
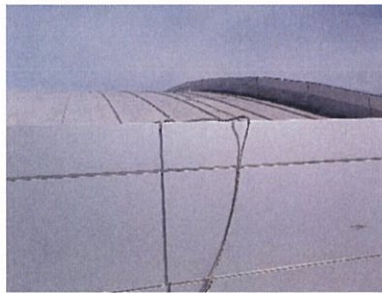
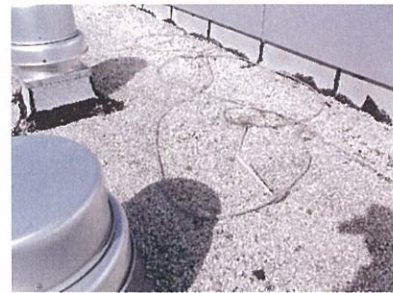
There is a lightning protection system installed on the roof of the building, with air terminals and cables. There is damage to both the air terminals and the cable along the south-east side of the North addition roof. There are cables that are broken apart, air terminals damaged or pull off the roof and a section of cables and terminals just sitting coiled up on the roof.
