Weston Intermediate School

WESTON SCHOOLS - FACILITIES FEASIBILITY STUDY

WESTON INTERMEDIATE SCHOOL - FACILITY CONDITIONS ANALYSIS

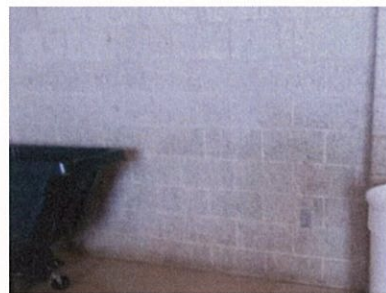
Figure 4: Cafetorium CMU wall

TAG NO.	ASSESSMENT	SYSTEM/ CODE REFERENCE	RANKING	CORRECTIVE ACTION	ESTIMATED COST	REMARKS
INTERIOR CONDITIONS						
A8	Block walls dirty		3	Clean and seal	\$ 6,000	
A9	Sheet flooring in Cafetorium is torn and has large gaps		2	Determine if slab has moisture or movement issues. Replace floor.	\$ 81,180	
A10	Ceiling tiles are stained		3	Replace the ceiling tiles throughout the building	\$ 3,600	
A11	Penetration firestopping is not at all penetrations of boiler room		1	Fire putty around penetrations as needed	\$ 1,500	
A12	Furniture and equipment is located in gymnasium vestibule blocking egress clearance requirements		1	Move furniture	\$ -	
A13	Gym egress is undersized and inadequate. It does not meet code requirements.		1	Add double doors to exterior	\$ 25,000	
A14	VCT is cracked in various areas		2	Replace the floor tiles throughout the building	\$ 8,000	
A15	Window caulk is beginning to wear		3	Recaulk as required	\$ 36,000

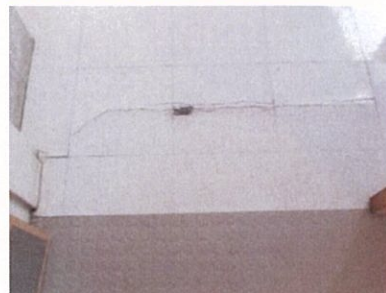
Figure 5: VCT cracking near stair

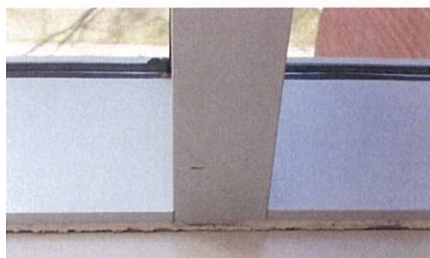
Figure 6: Window caulk cracking

The facility consists of a similar doors, frames and hardware. Most doors are wood doors, some with a glazing opening within the leaf. Hardware are hand levers and panic devices that meet today's code requirements. Frames are painted. Overall the interior doors are in good condition. It is recommended to continue painting frames as required. The interior of the windows are in good condition although caulk is beginning to crack in some locations. Typically caulk should be replaced every 10-15 years.

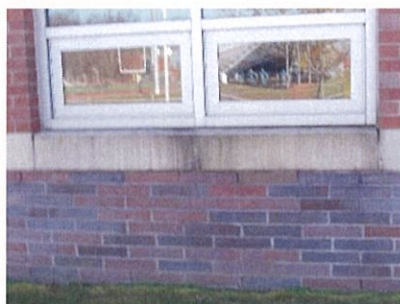
Figure 7: Precast sill

The exterior consists of brick and metal panels. The brick walls of the school are generally in good condition, with areas of settling and spalling. The original building is constructed with brick “veneer” with an airspace, insulation and either concrete masonry back up or metal stud with sheetrock back up. Overall, the mortar is in great condition. Limited areas will need more attention in the years to come such as the parapet. It is slowly beginning to wear. Mildew is forming on the precast sills, most notably on the lower level. These should be washed and sealed to maintain their lifespan. Also small amounts of mildew are building up in various areas on portions of the low wall. It was also noted the parapet wall at the gym is bowing and the metal cap is loose. *This will have further evaluation to determine the cause and remedy*. The base of the building in areas where it meets the concrete sidewalk have areas of caulk deteriorating. These areas should be caulked. It was also noted that control joints are showing early signs of cracking. Overall the masonry appears to be in good condition.

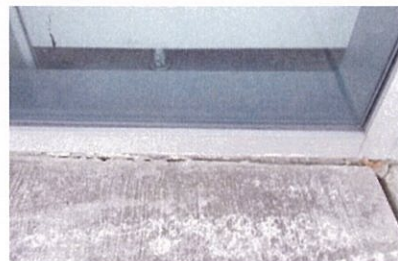
Figure 8: Deteriorating caulk at building base and sidewalk

A3	Areas at base of masonry and parapet are dirty with mildew and vegetation			3			Clean and seal	\$ 8,000	
A4	Caulk where building meets sidewalk caulk is deteriorating			3			Recaulk as required	\$ 2,000	
A5	Caulk and mortar around precast parapet cap and masonry have mildew			3			Recaulk as required	\$ 3,000	
A6	Control joint caulk is showing early signs of wear and cracking			3			Recaulk as required	\$ 5,000	
A7	Knee wall at gymnasium				1		Rebuild parapet, portion of roof and add external gutters - at \$800 per linear foot	\$ 264,000	
EXTERIOR SUBTOTAL									
								\$	298,000

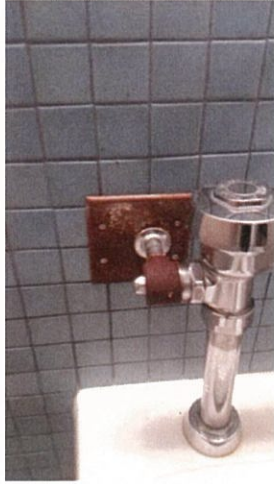
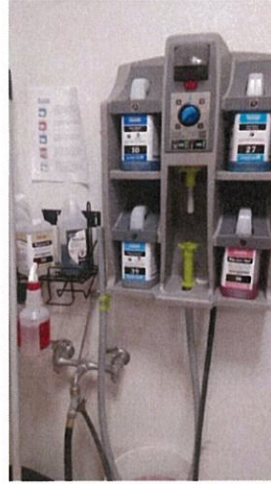
While the overall condition of the fixtures is good, some of the issues noted during the visit are noted below. Some of the chrome trim on the flush valves is severely corroded and should be replaced. The reason for the corrosion is unknown and difficult to determine since it only seems to be effecting certain trim pieces and only on certain valves (See photo below left). A janitor's sink was observed with

hoses connected to the faucet from a chemical feed system without a vacuum breaker to prevent back siphoning in the event of a drop in building water pressure (See photo below right). The condition could result in contamination the domestic water system creating a safety hazard. Recommend installing a vacuum breaker as soon as possible.

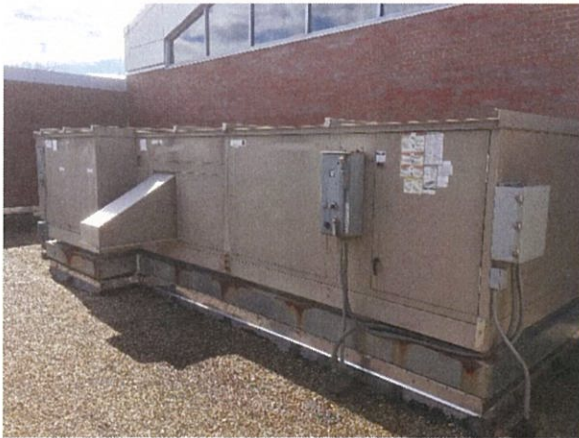
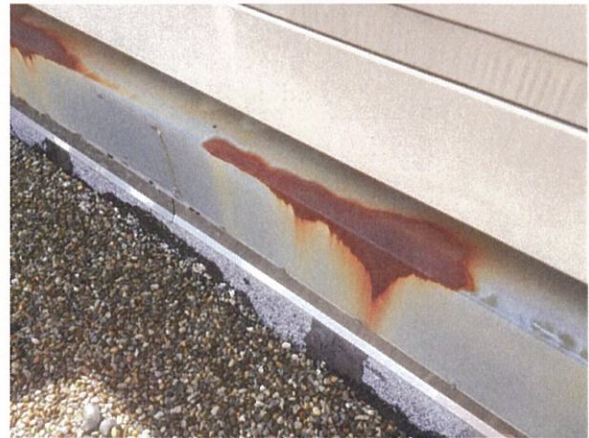
The School is served by seven Rooftop Air Handling Units. The units appear to be in good condition however, there is some visible rust occurring, especially on the roof curbs. The Air Handling Units should receive continued preventative maintenance including regular lubrication, filter and fan belt replacement, and motor and bearing replacement as required. Condensate pans and drains should be cleaned and valves and dampers, including actuators, should be periodically checked for proper operation. Touch-up painting should be done as required.

M7	Air Handling Unit Curbs have multiple rust spots		3	Clean and touchup paint as required.	\$ 2,000	Total cost
M8	Steam Humidifier should receive regular service		3	Provide annual service of steam generator and distribution unit.	\$ 500	Annual Cost

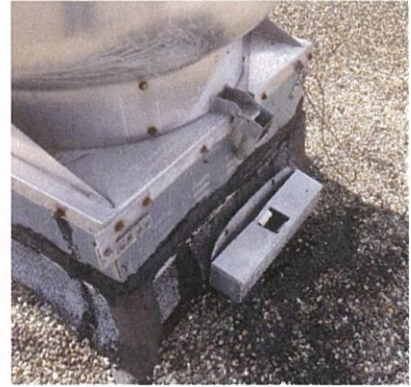
The Grease Exhaust Fan appears to be in serviceable condition but the grease trough has come loose from the fan. Recommend reattaching the grease trough to the fan to prevent the cooking grease from damaging the roof.

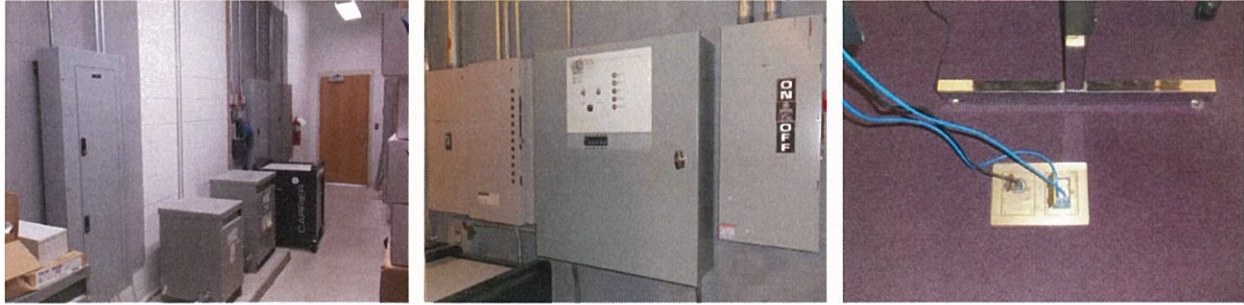
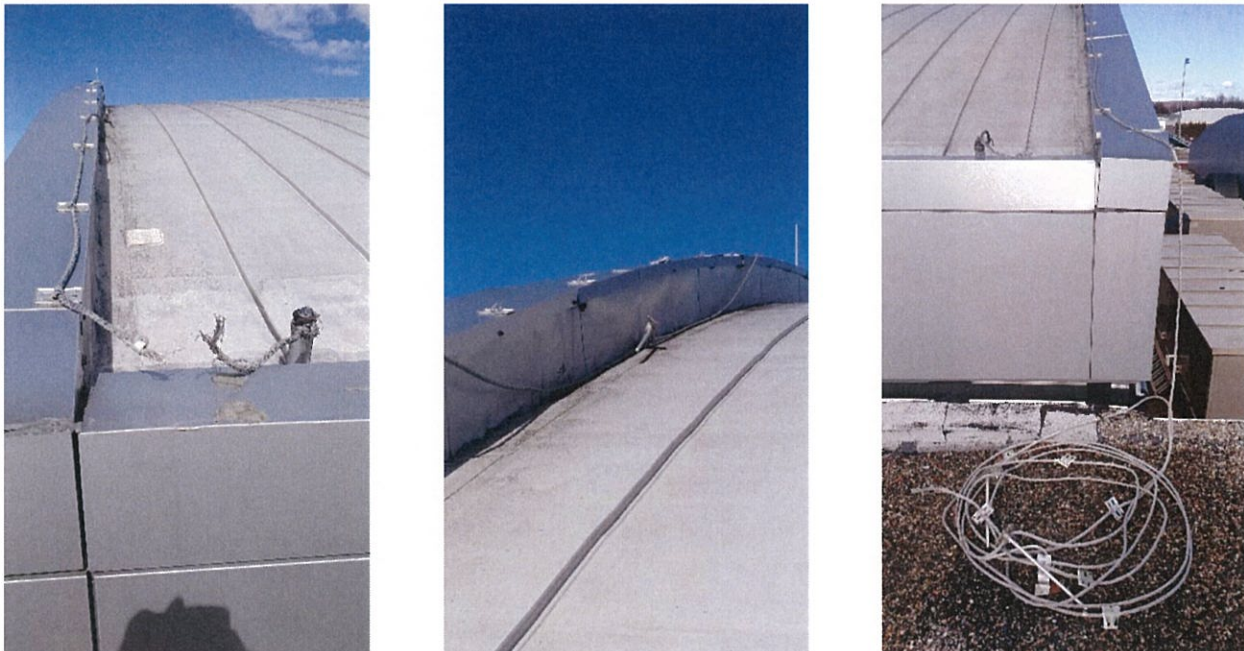
There is a lightning protection system installed on the roof of the building, with air terminals and cables. There is damage to both the air terminals and the cable along the south side of the Gymnasium roof. There are cables that are broken apart, air terminals damaged or pull off the roof and a section of cables and terminals just sitting coiled up on the roof.

E2	It does not appear to be sufficient emergency lighting in the Courtyard for egress to meet the current code		2	Install new LED fixtures to provide current code required light levels for egress	\$5,000.00	
E3	Light levels are low and do not appear to meet egress requirements for the accessible access to the Stage/Platform		2	Replace existing fixtures with new higher output LED fixtures or add new LED fixtures in addition to the existing fixtures	\$5,000.00	
E4	Existing fluorescent, HID & incandescent fixtures throughout the school, appear fully operational but not very efficient		4	Replace all existing fluorescent, HID and incandescent fixtures with new energy efficient LED fixtures.	\$662,712.00	allowance
E5	A portion of the existing lightning protection system is damaged & partially removed		3	Replace damaged wire and reinstall existing lightning rods and cable after wall/parapet has been repaired.	\$2,500.00
