## Weston Middle School

# WESTON SCHOOL FACILITIES FEASIBILITY STUDY

## WESTON MIDDLE SCHOOL - FACILITY CONDITIONS ANALYSIS

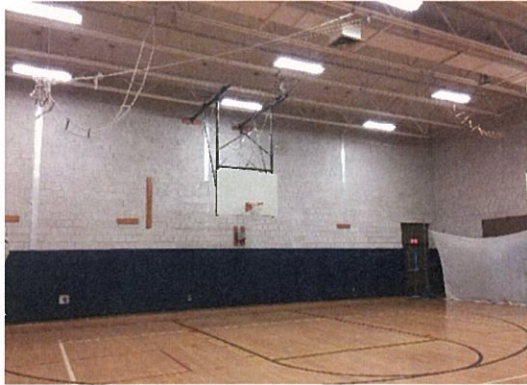
The interior of the building is maintained based on the existing conditions and existing systems. A visual inspection of the walls, floor and ceiling were reviewed during the building walkthrough. The interior walls consist mostly of concrete masonry units (CMU) or block. There are also some areas with sheetrock and paneled walls in between some of the classrooms. Most walls appear to be in fair condition. However, some of the block walls throughout the school have significant vertical cracks. Specifically, with the 8x8 CMU. This most notably occurs in the New Gym where numerous cracks are evident. Metal plates have been added to help remedy this issue. It is recommended to provide further evaluation by a structural engineer.

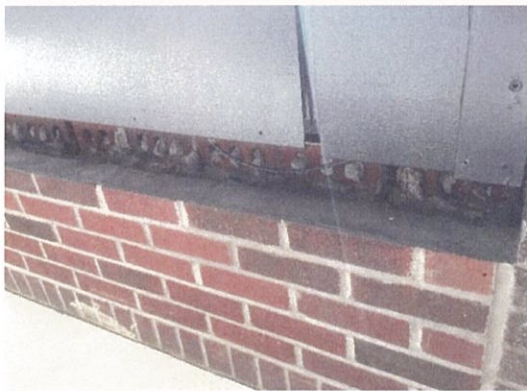
*Figure 5: Below window wall missing brick course*

Secondly, during the window renovations the removal of brick (likely due to PCBs) had taken place. The interior brick under the sills had never been infilled leaving the wall cavity open and unfinished. This is an aesthetically unpleasing look and it negatively impacts the thermal qualities of these walls. This should be infilled with brick or block. Additionally, rubber baseboard throughout the school is in need of replacement, specifically noted at the built out base of the lockers. These bases are also too large for the lockers and could result in a tripping hazard.

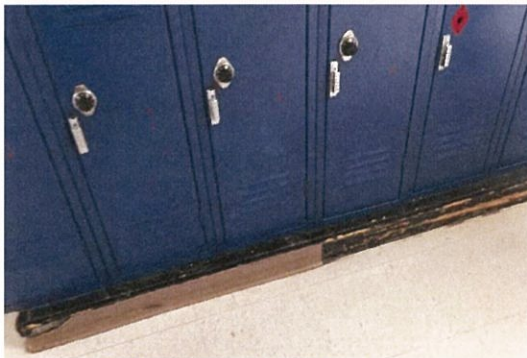
*Figure 4: Locker base and baseboard*

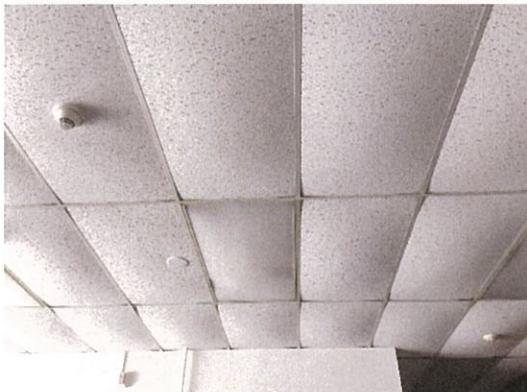
The majority of the ceilings throughout the school are 2x2 or 2x4 dropped acoustical ceilings. There are also some areas with old spline ceilings. The remainder of the building is exposed structure and deck. This occurs in areas such as the gymnasiums, the Media Center, the newly painted decks in the technology rooms, and the original wood at the main entrance and admin spaces. Some corridors are exposed with low ductwork. Most of the acoustical tiles are old and sagging and they should be replaced. Spline ceilings should also be replaced. Some of the exposed ceilings could use a fresh coat of paint and the wood ceilings should be refinished to maintain their lifespan.

*Figure 6: Typical sagging ceiling*

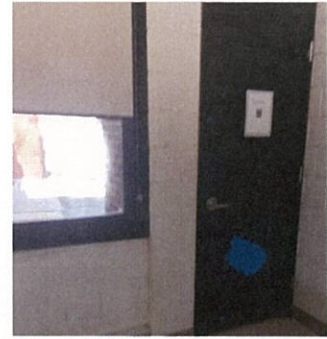
The facility consists of a variety of doors, frames and hardware. Most doors are hollow metal set within hollow metal frames. Many doors contain a glazing opening within the leaf. Many are painted and some are in need of new paint. Door hardware appears to meet code. Most doors have hand levers and panic devices. Frames appear to be in good condition although some have begun to rust, most notably at the pool. Windows were recently replaced and are only a few years old. The interior of the windows appears to be in good condition. Overall the interior doors and windows are in good condition. It is recommended to continue painting doors and frames as needed.

Figure 7: Door peeling paint

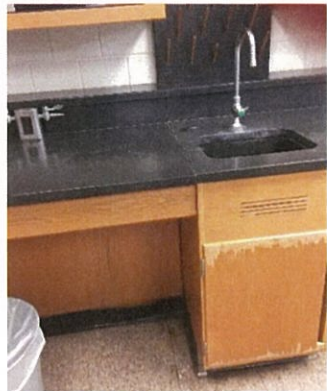
Most casework and built-in shelving appear to be original to the school. Most are dated and nearing the end of their useful life. Some built-in bookcases in classrooms don't even have shelves. Most casework does not have knee spaces. The ones with sinks do not have the required knee space and therefore are not considered accessible. Science and Art classrooms have casework that is very dated, peeling and inefficient. These specific areas need more efficient and usable casework. There are some newer areas with blue plastic laminate casework that does appear to be in good condition. Additionally, lockers throughout the school are in disrepair. Student lockers in corridors are mangled and do not lock properly. Locker rooms are also not in the greatest condition. Lockers and the bases in the corridors should be replaced throughout the school.

Figure 8: Science casework

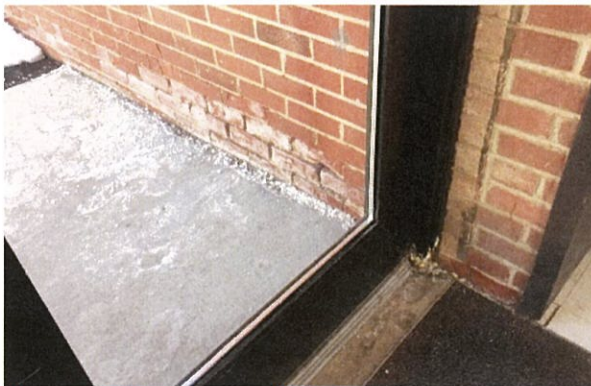
Figure 9: Efflorescence and C10 door

The brick walls of the school are generally in good condition, with some areas of settling and spalling. The original building is constructed with brick "veneer" and concrete masonry unit (CMU) interior or brick interior. The energy efficiency of the original construction is very low, and typical in the 1960s ("pre energy crisis"), and not one that is easily corrected. Overall, the mortar appears to be in fair condition with limited areas in need of repointing. Certain areas are in need of more attention. For instance, the area outside of door C10 had some efflorescence at the base of the wall which is a sign of water infiltration. Additionally, some of the painting at the foundation wall is beginning to wear. Some areas of black paint are peeling and should be fixed and repainted. Overall the masonry appears to be in good condition.

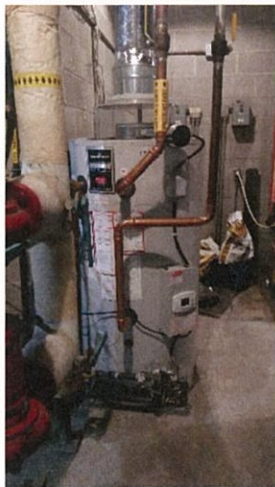
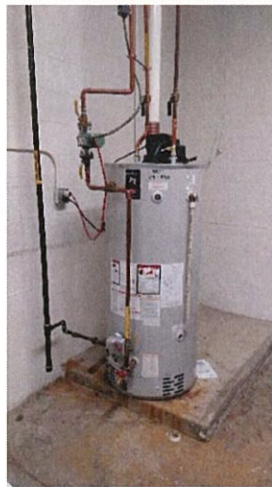
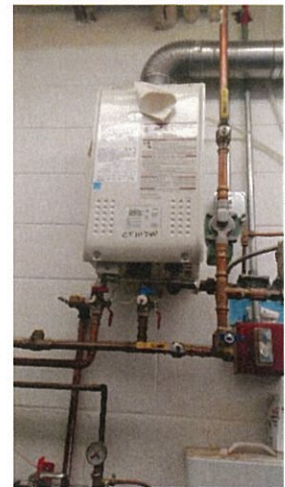
Domestic hot water is produced by three gas-fired water heaters. The first water heater, located in one of the boiler rooms, has an input rating of 450,000 BTUH and a storage volume of 80 gallons. The system is approximately 1-year-old. The system should have an average life expectancy of approximately 20-25 years and remaining life expectancy it about 19-24 years. The second water heater, located in the other boiler room, has an input rating of 76,000 BTUH and a storage volume of 75 gallons. The system is approximately 1-year-old. The system should have an average life expectancy of approximately 20-25 years and remaining life expectancy it about 19-24 years. The third water heater is a tankless water heater located in the office area of the kitchen. This water heater has an input rating of 199,000 BTUH and it appears that the old water heater is being used as a storage tank. The system is approximately 8 years old. The system should have an average life expectancy of approximately 15-20 years and remaining life expectancy it about 7-12 years.

To maximize service life, the Water Heater should be regularly serviced per the manufacturer's maintenance recommendations including, but not limited to, draining and flushing, testing relief valve, and inspecting/replacing anode. Refer to manufacturer's O&M literature.
