Report on Superintendents house bathroom project

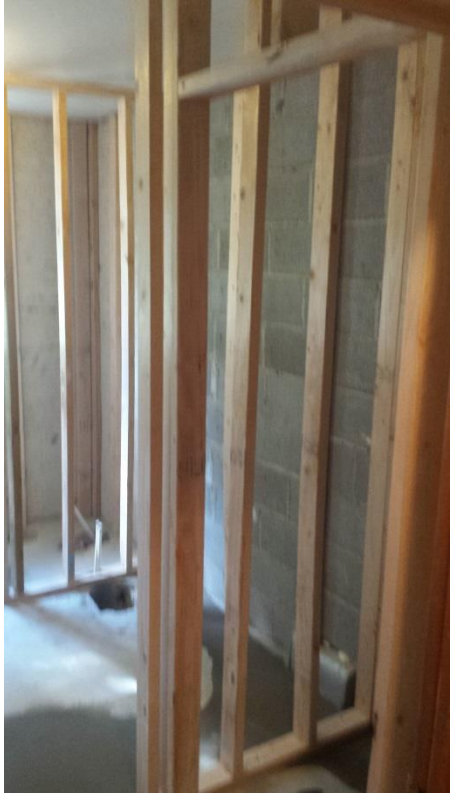
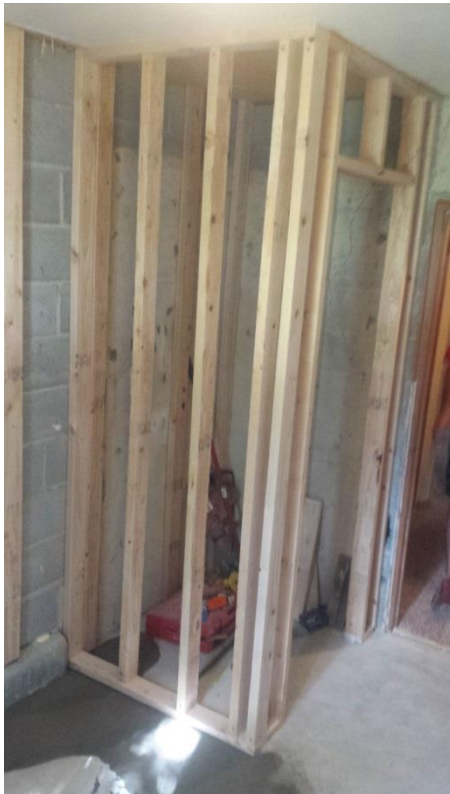
The photo below shows the bathrooms north wall where the shower and toilet used to be located. The contractor has removed all items and began to frame in the new wall and shower area. Upon examination of this work it was noted that the manner in which it was done was not acceptable in that the studs were not set well, they were not square, and there was no header placed above the doorway of the closet, all contrary to standard and acceptable building practices.

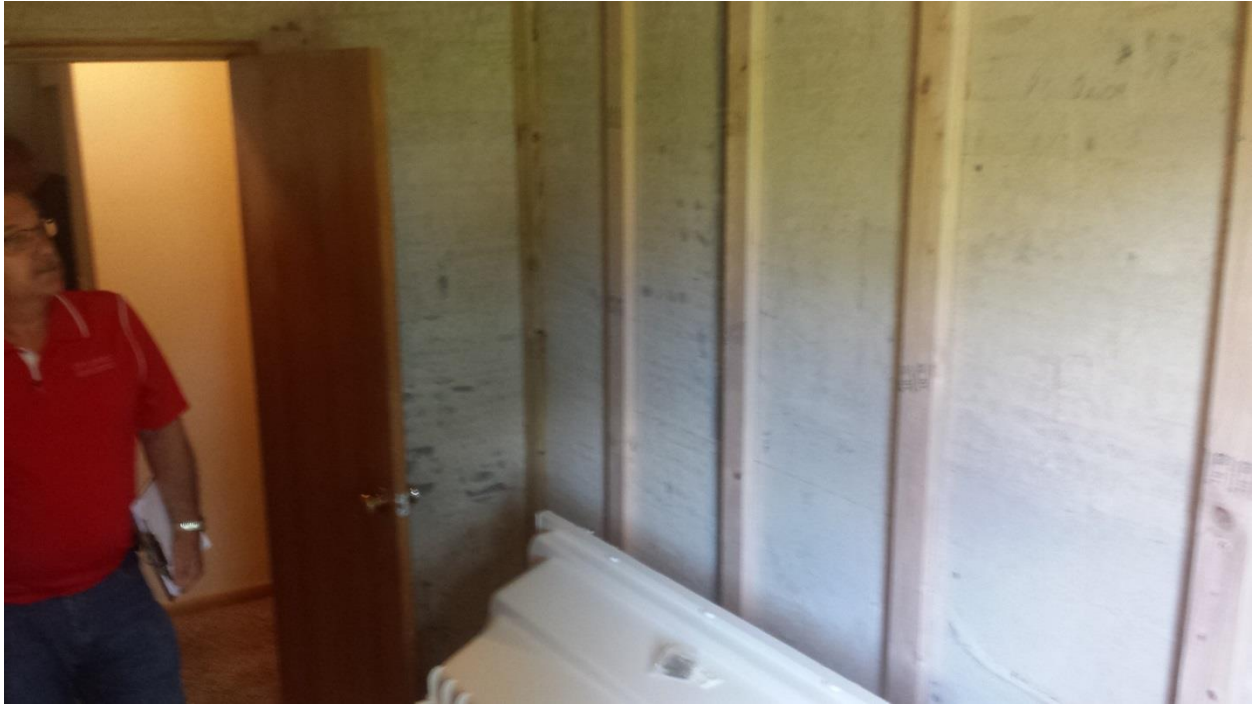
The above photo again shows the lack of a header and the fresh concrete that has been applied over the excavated plumbing.

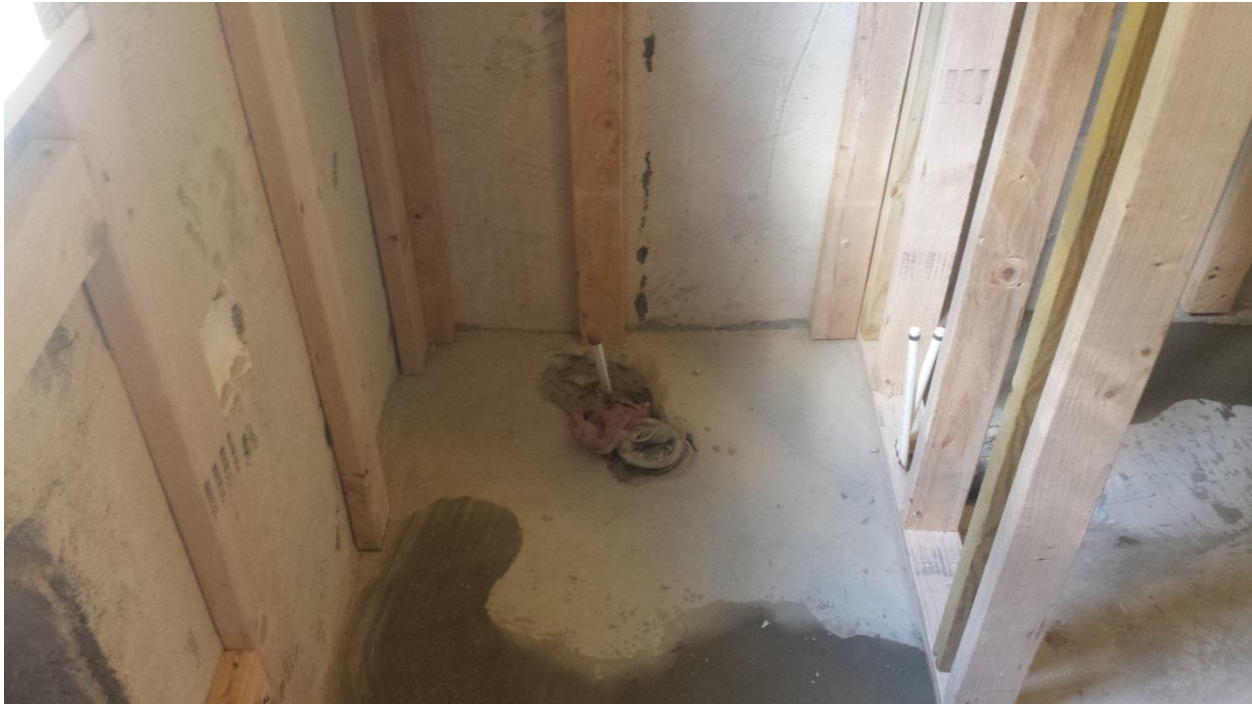
Also noted during the inspection was the lack of furring strips placed on the wall, their attachment, and locations. The above photo shows 2x4's placed flat against the wall to be used for furring strips. There were several areas of this wall that were not square and not prepared properly as should have been done.

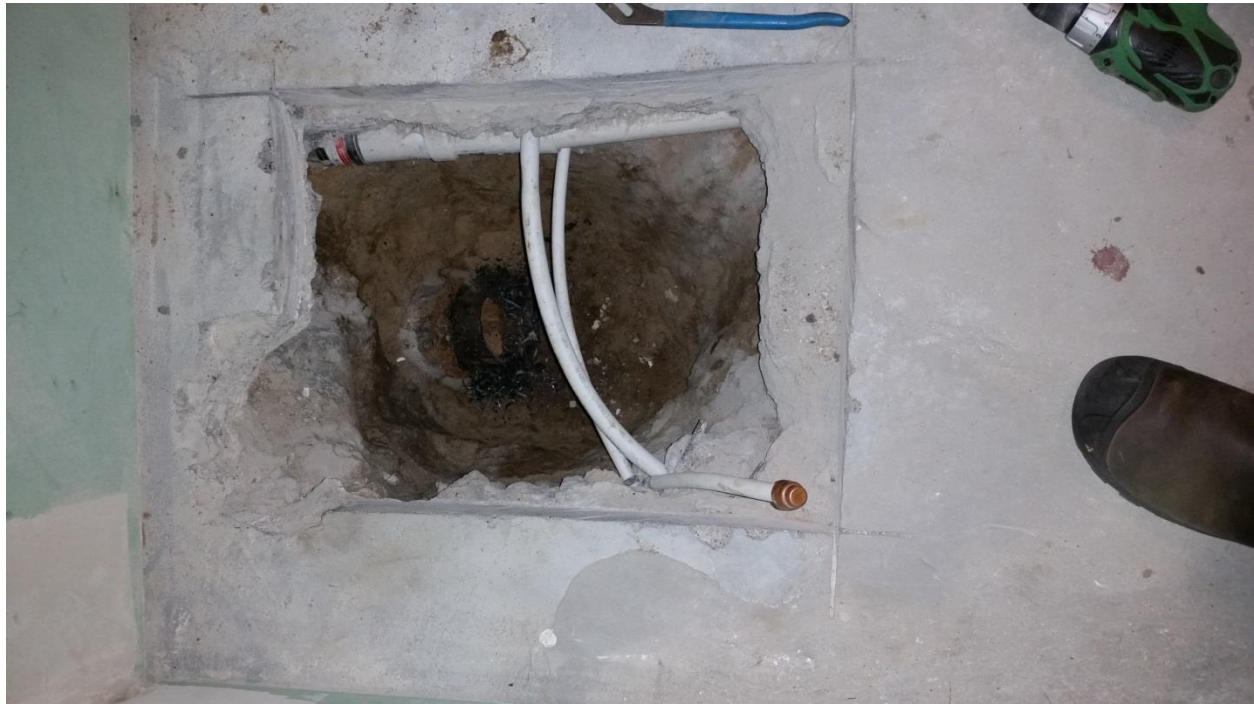
The above photo shows the area where the toilet is to be located. The contractor has placed the water supply line and used the old flange and drain for the toilet. The 2x4's placed against the wall flat in this manner used as furring strips reduce the backset for toilet placement which will cause problems when the toilet is to be set. It will not allow enough space to set the toilet once the wall is finished.

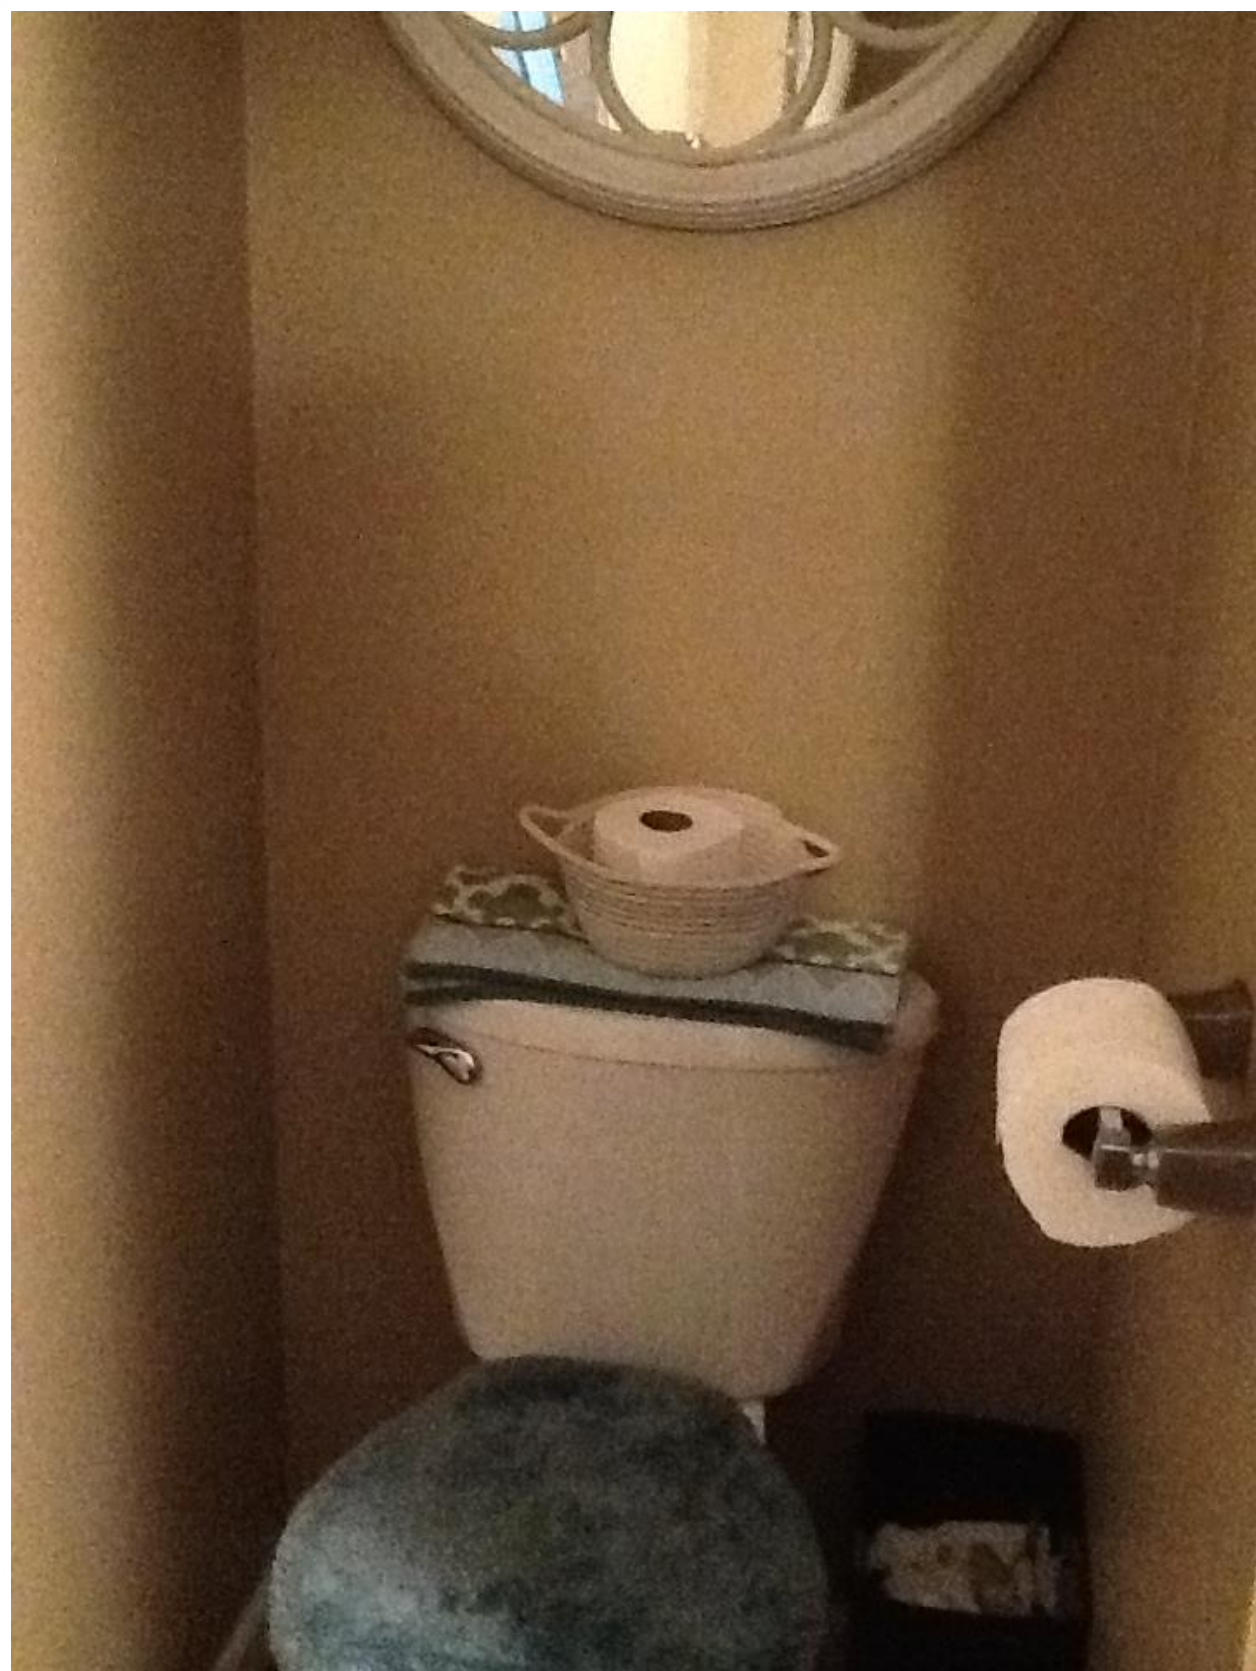
After several weeks of work Bruhl Construction was able to complete the project and finish the bathroom. The below photo shows the mirror, shower, and toilet as finished.
