FLYROCK **CAUSE & PREVENTION**

KURT GLEASON

RMS, LLC

BLASTING INCIDENT REVIEWS

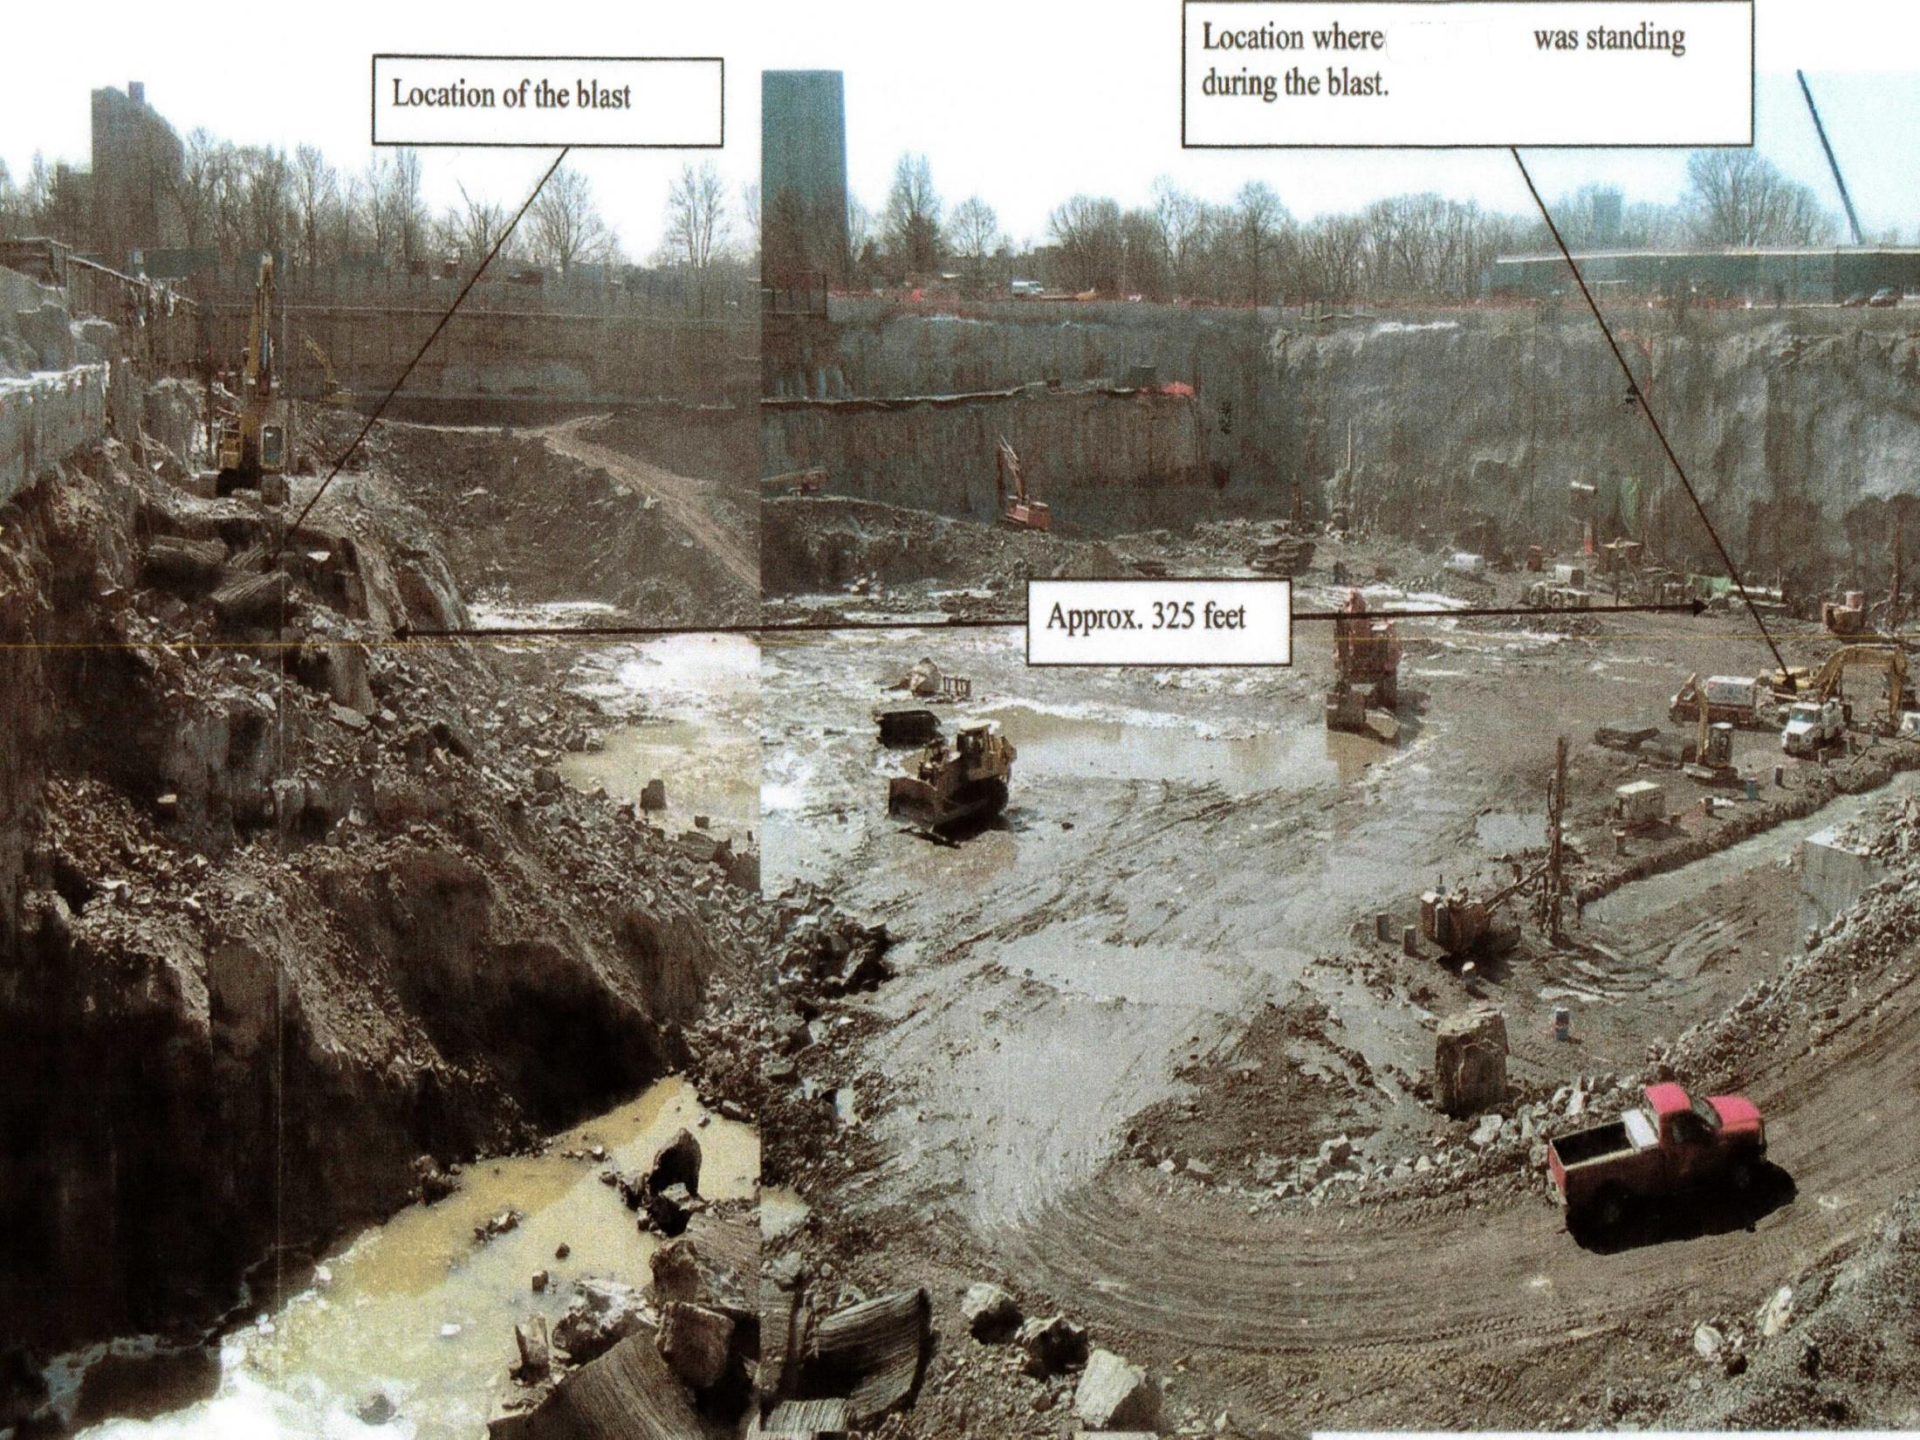
Location of the blast

Location where
during the blast.

was standing

Approx. 325 feet

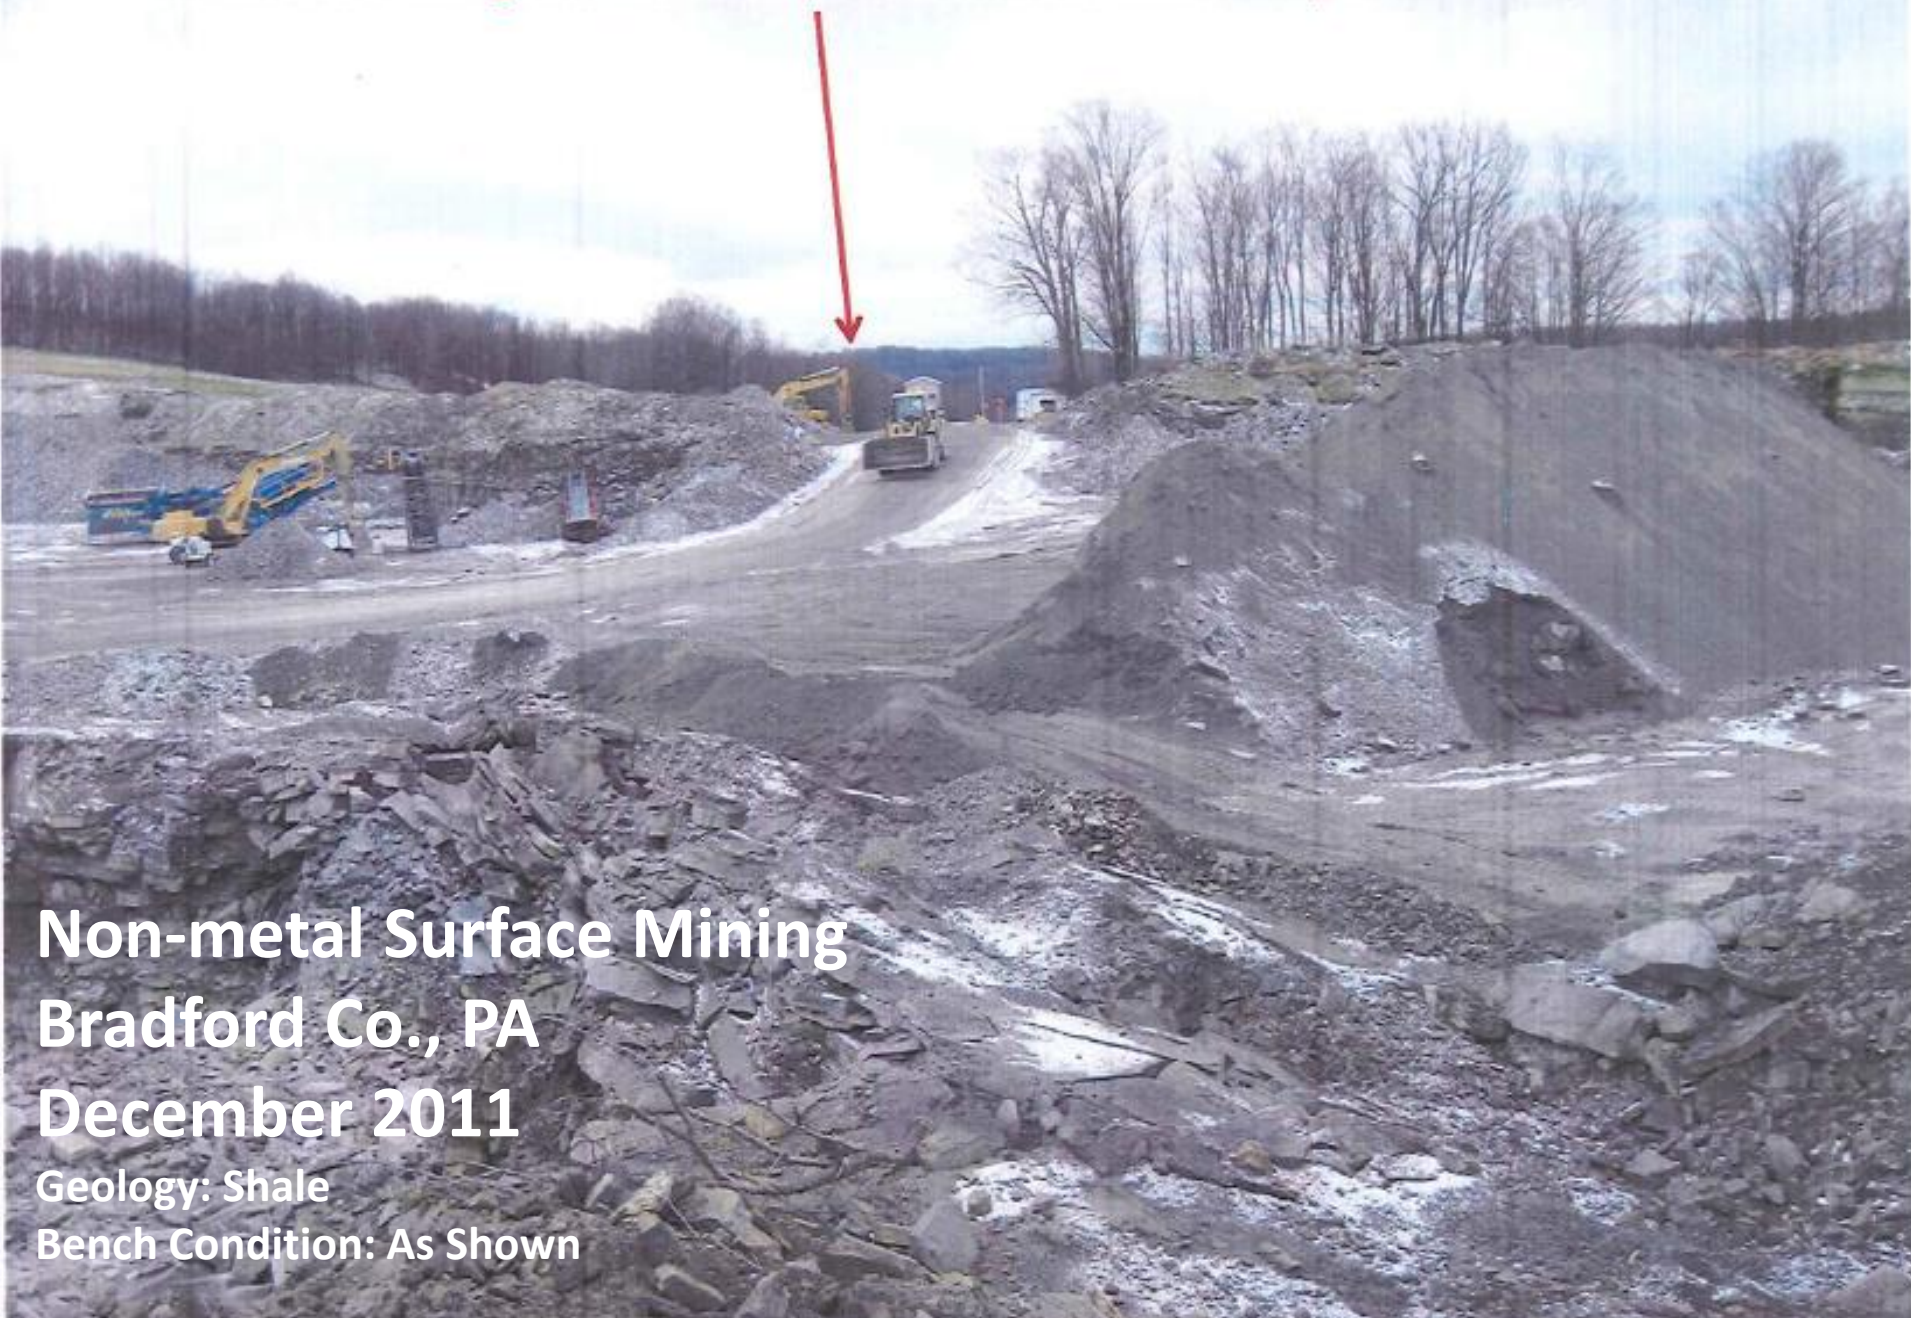
From shot looking at scale house, Excavator Hoe 475 feet by GPS

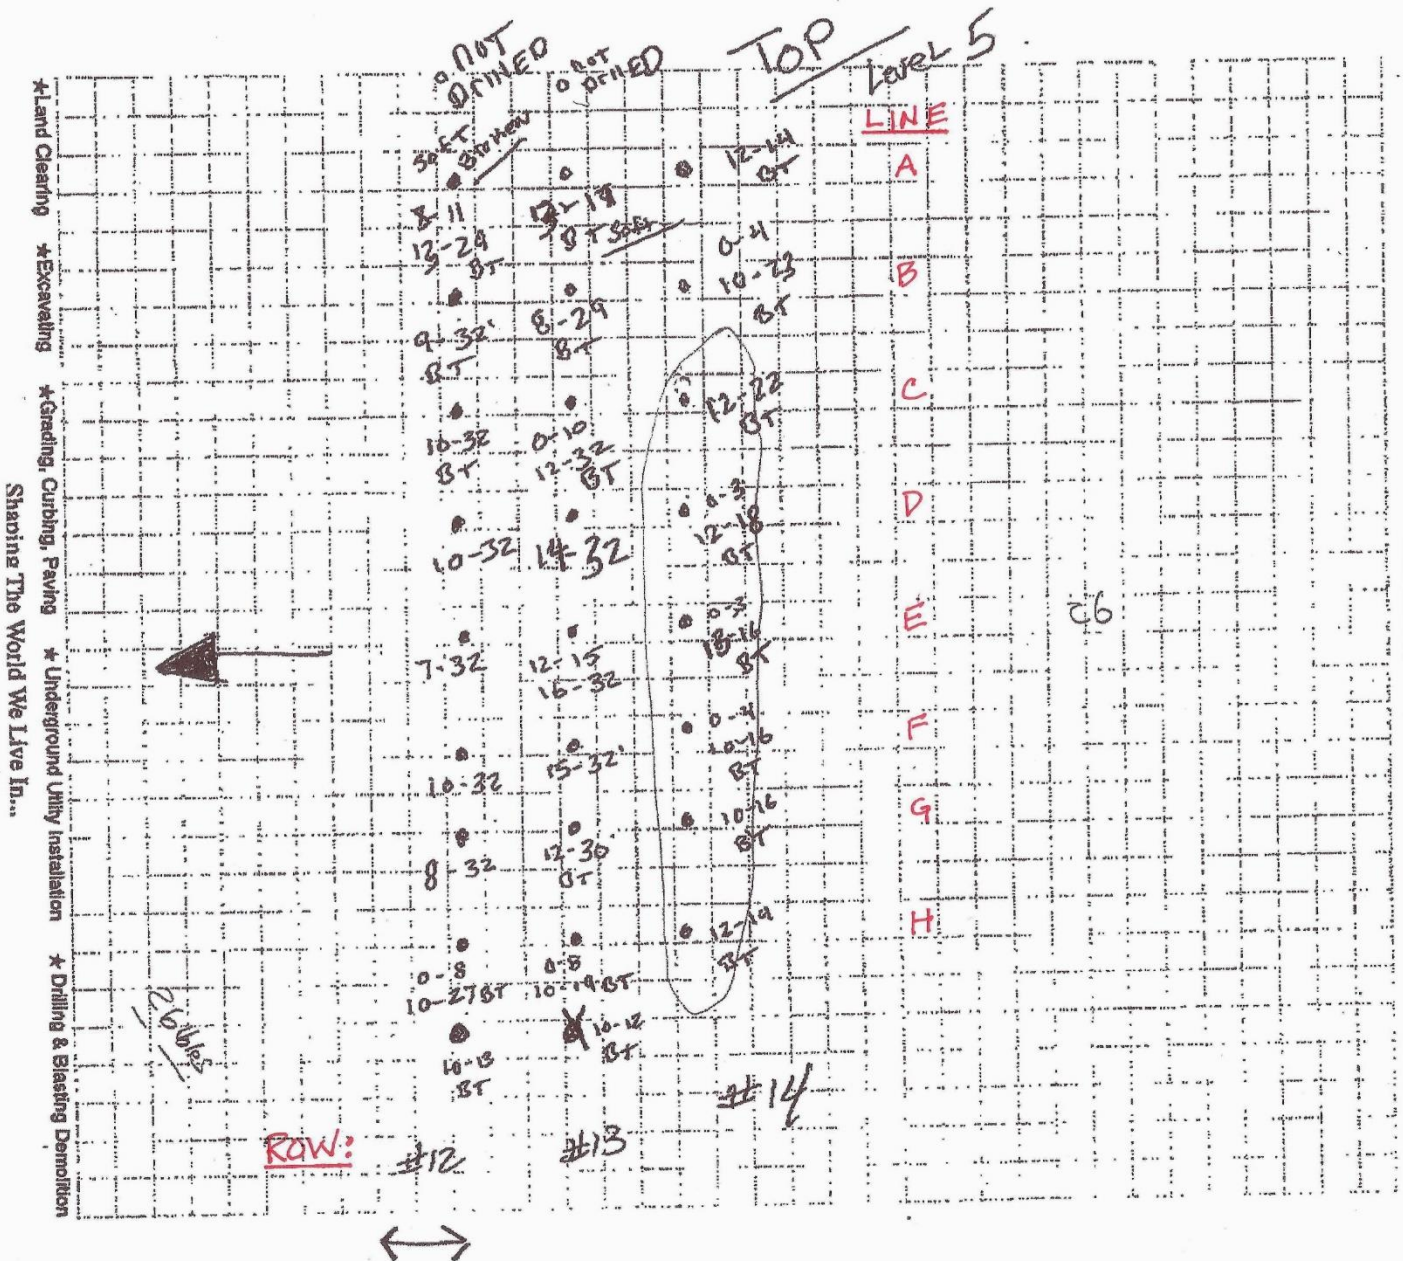
BOREHOLE PROFILE - Row # 14

LOCATION OF ROCK

OVERBURDEN/
MUD SEAM / VOID

BT - BLOW THROUGH

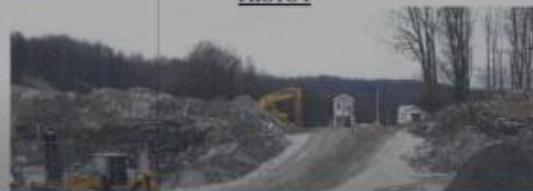
PHOTO 1

The evidence available to DEP indicates that the blast of December 19, 2011 caused flyrock to be ejected from an area near the southern corner of the blast for several reasons. Photo 1 was taken from the area where the flyrock is believed to have been ejected from. The position of the workers who were struck relative to the blast supports my conclusion that the rocks that struck them were ejected from the southern corner of the blast because equipment located in close proximity to the workers was also damaged. The employees that were struck were standing near the John Deere loader shown in Photo 4. Photo 3 shows a service truck that was also in the vicinity of the workers who were struck. Windows in both pieces of equipment were broken by flyrock ejected from the blast.

This flyrock incident could have been prevented if the blaster had not loaded and detonated holes next to an area where rock is known to be incompetent. I recommend that the design for future blasts detonated at this quarry take into consideration how far loaded holes are positioned next to unloaded holes in incompetent rock. I also recommend that the number of rows with respect to burden be limited based on how much open area there is surrounding a blast to ensure horizontal movement, and that the blasts continue to be designed to minimize the

risk of ejection of flyrock vertically. Additionally, I recommend that all employees retreat to a safe distance of at least 1,000 feet from all blasts, and that they do not position themselves near any open or partially open faces.

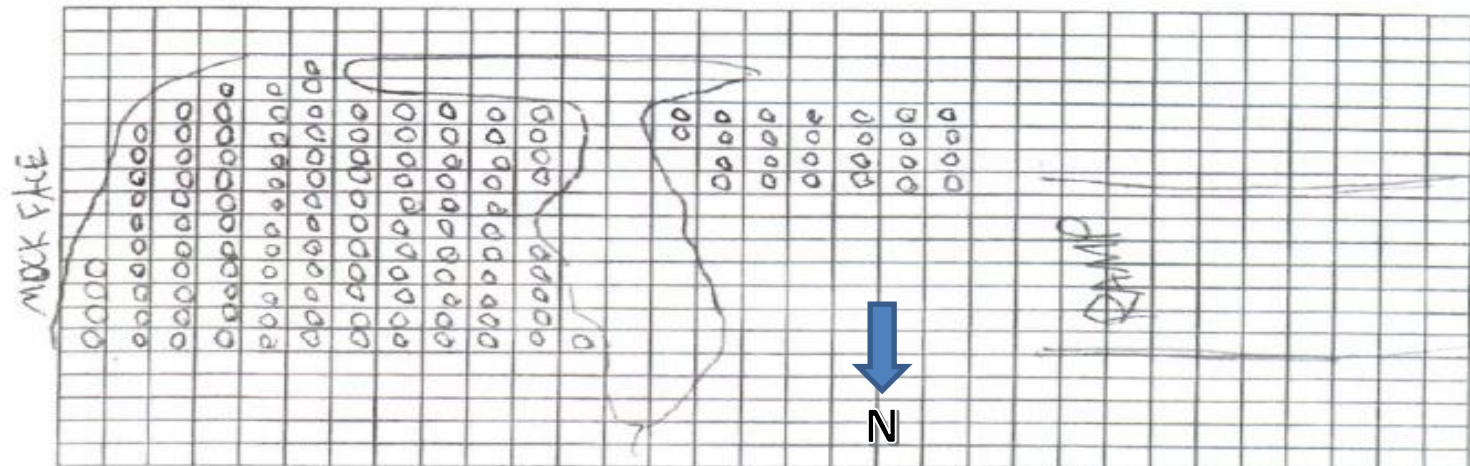
Middle of 5, 6, 7th rows have bad seam that appears to
run between holes, also mud seam in 10, 11, 12 area

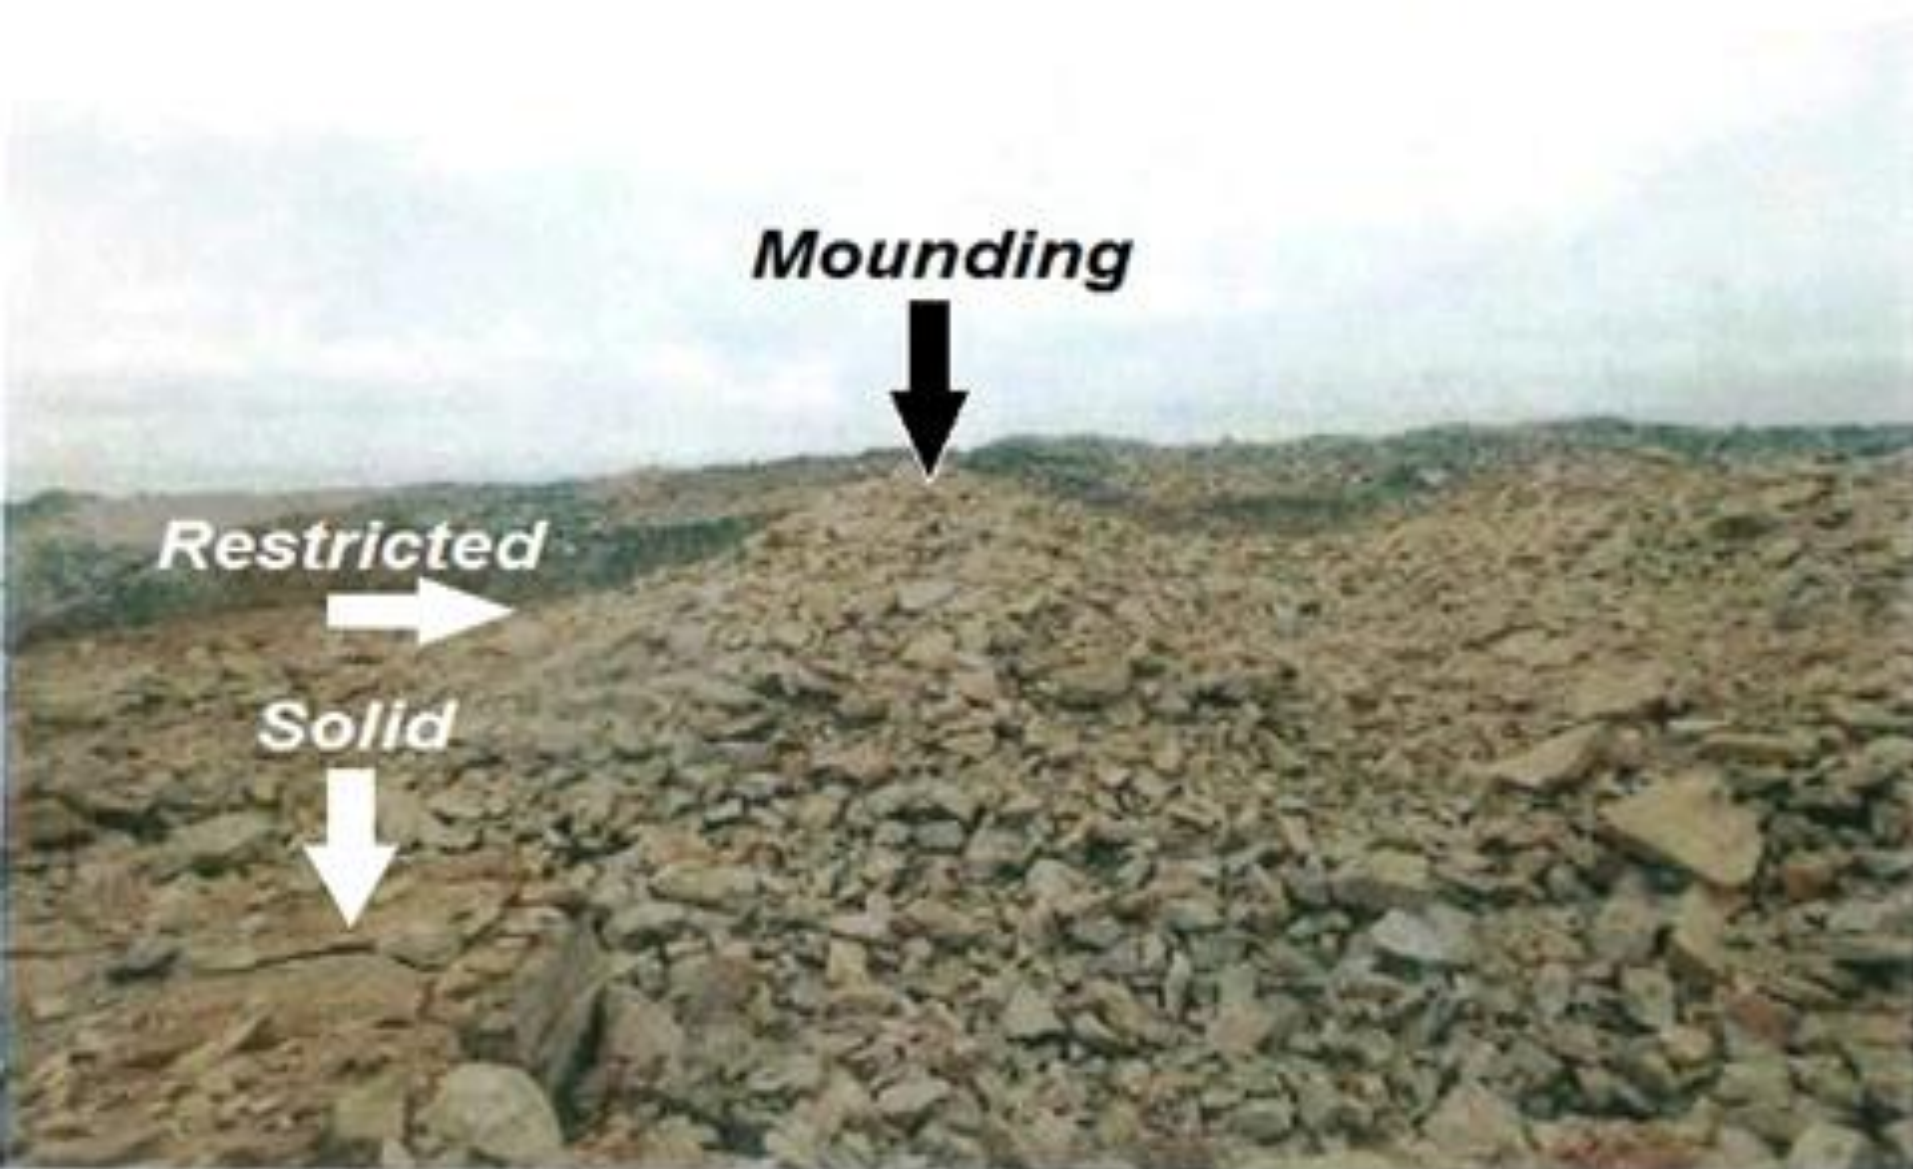
Location/Photo Description: over view of blast looking north to south

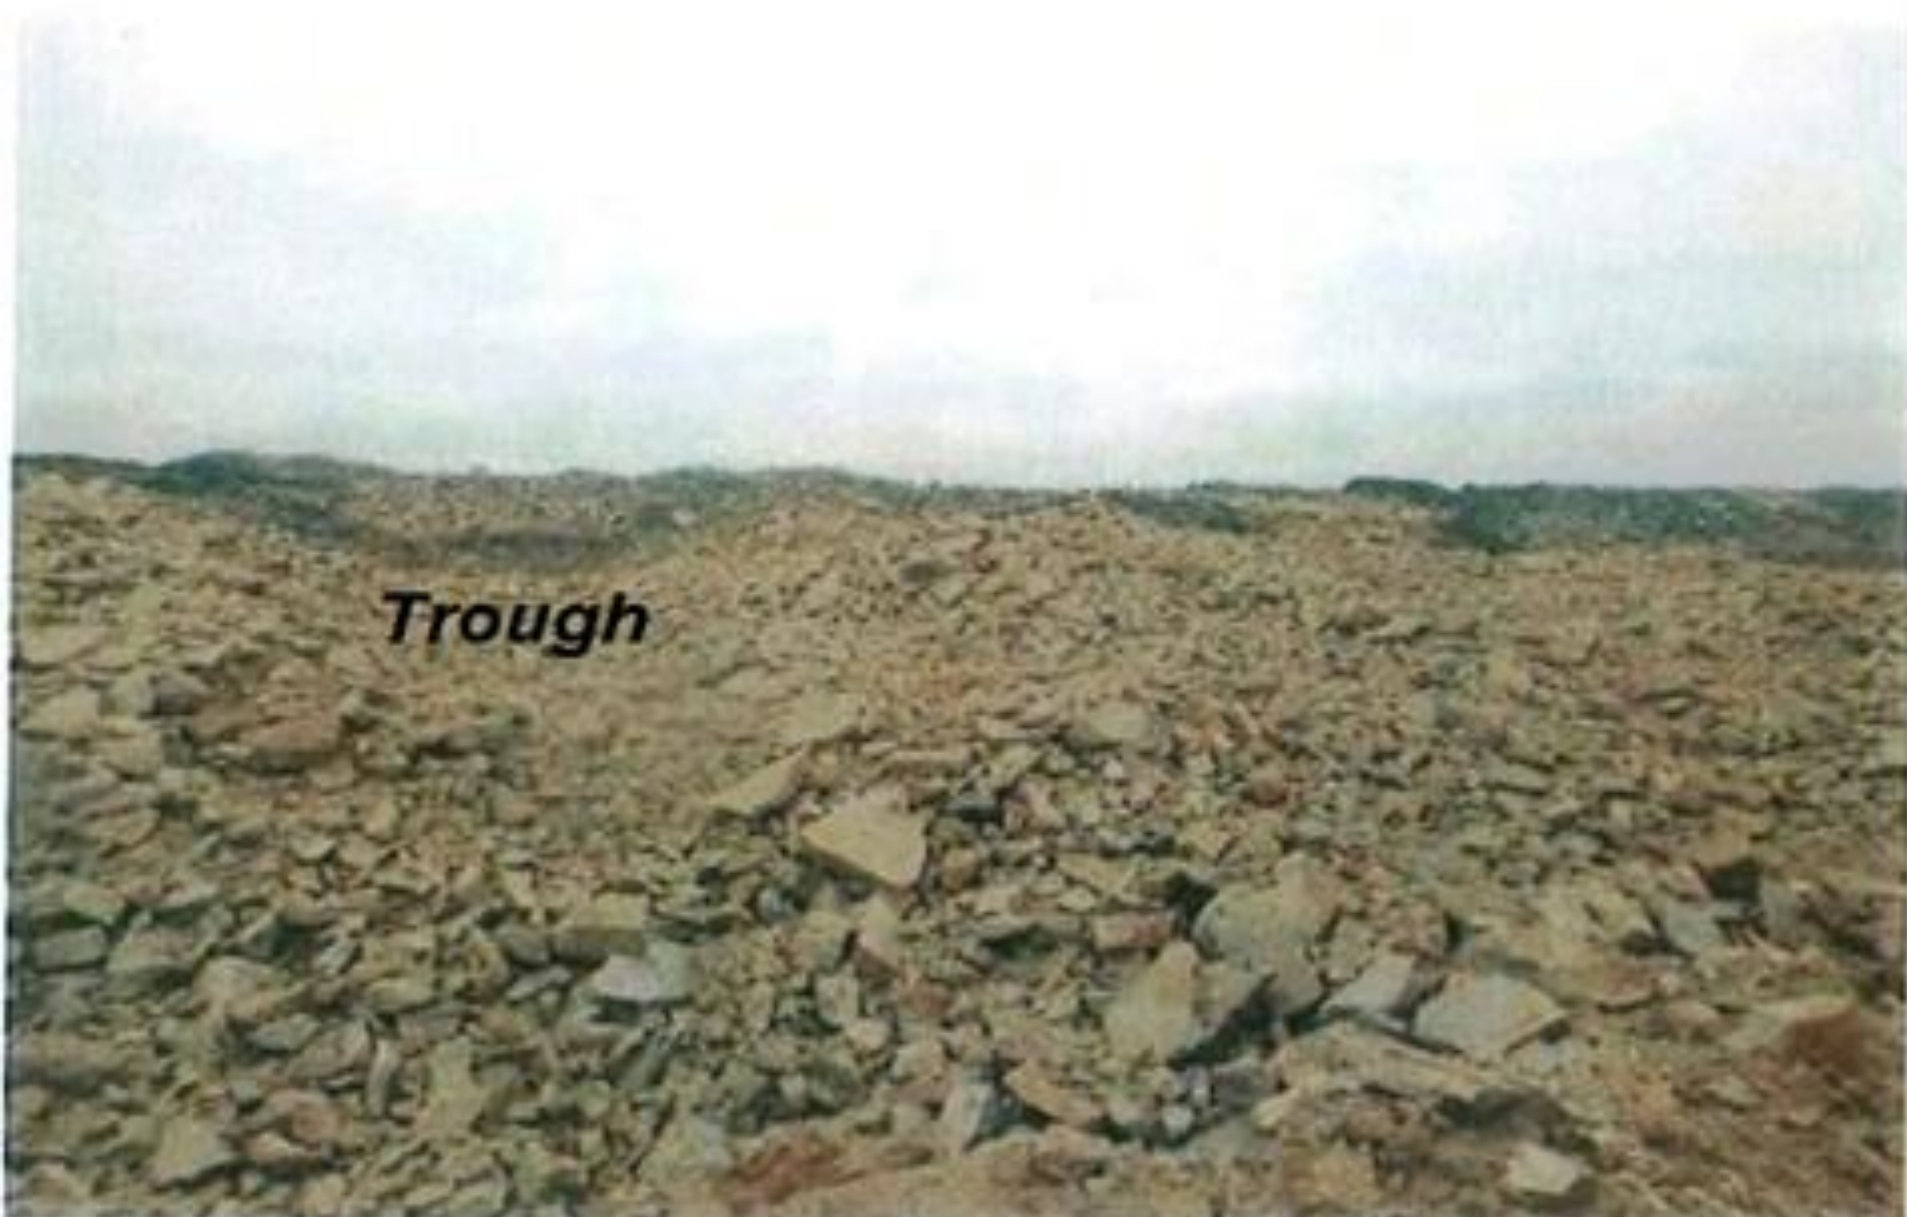
Location/Photo Description: over view of blast looking north to south

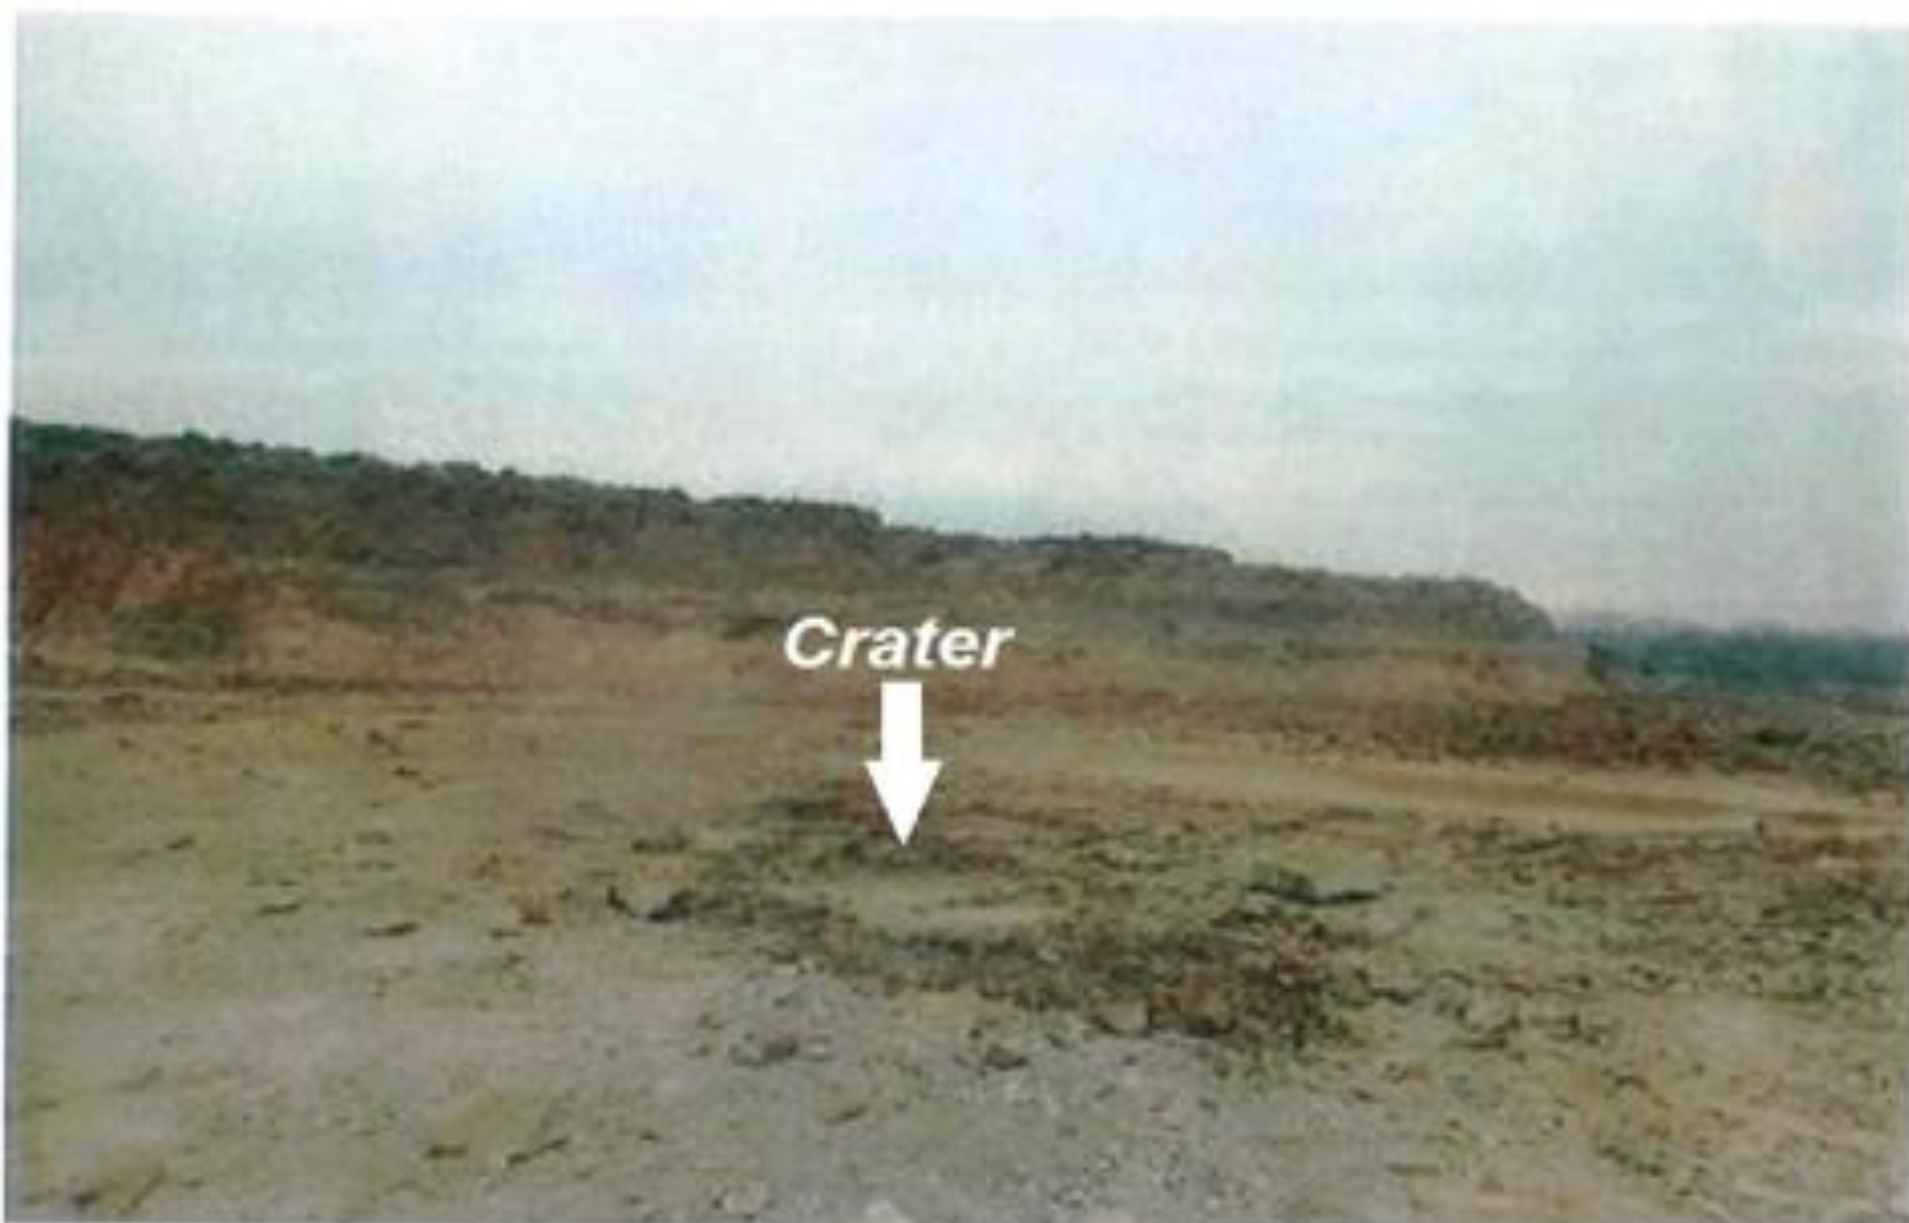
Location/Photo Description: overview of blasted bench looking northeast
