**PRESERVATION STAFF REPORT**  
*for*  
**Determination of Preferably Preserved**

**Site:** 15 MacArthur Street

**Petition:** Applicant seeks to demolish the 1 ½-story wood-framed barn

Re: 15 Macarthur Street - Structural Evaluation of Detached Barn

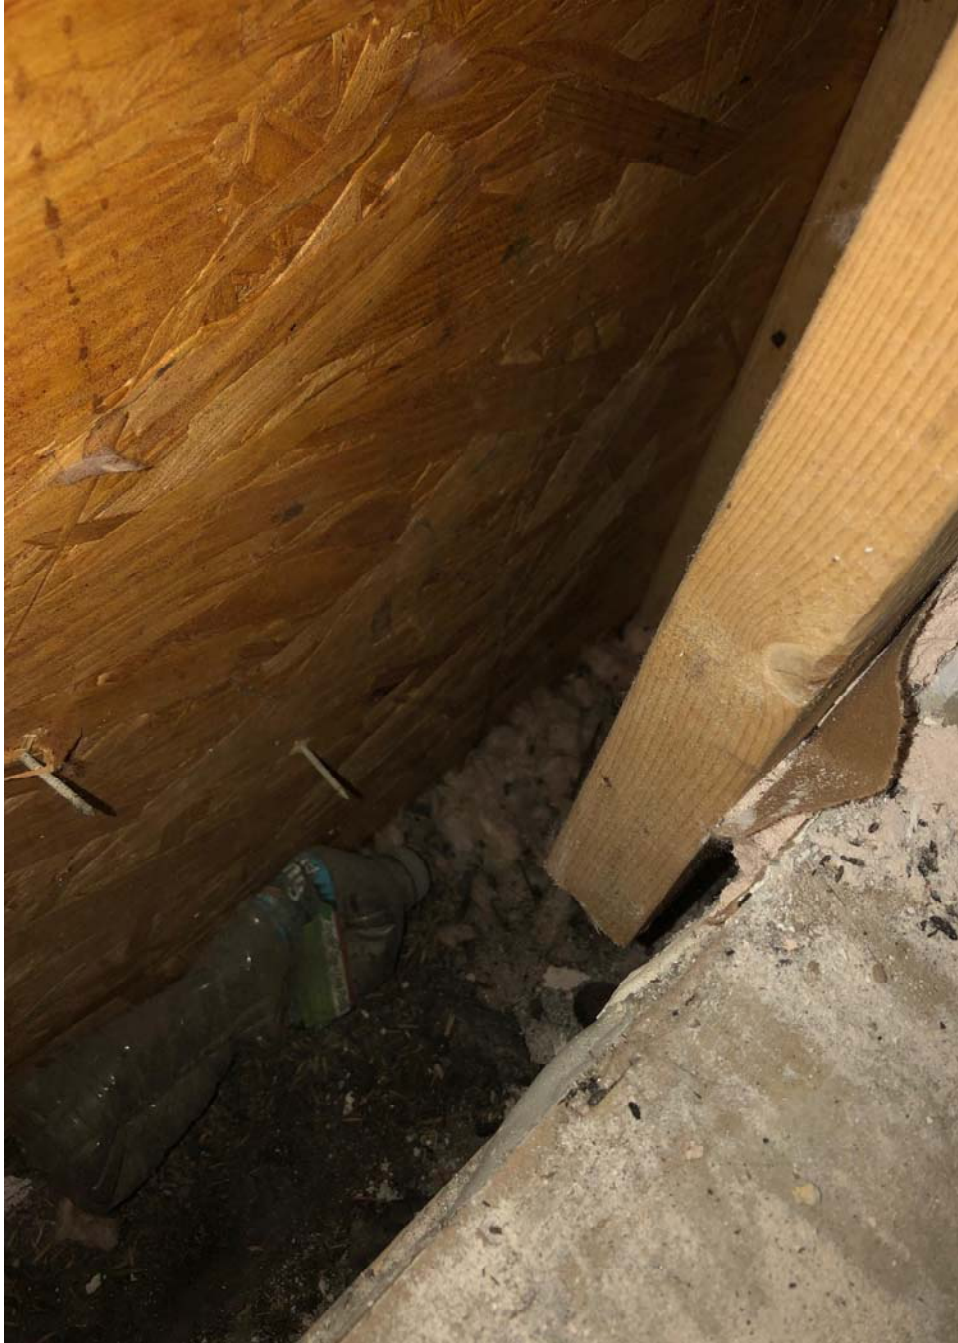
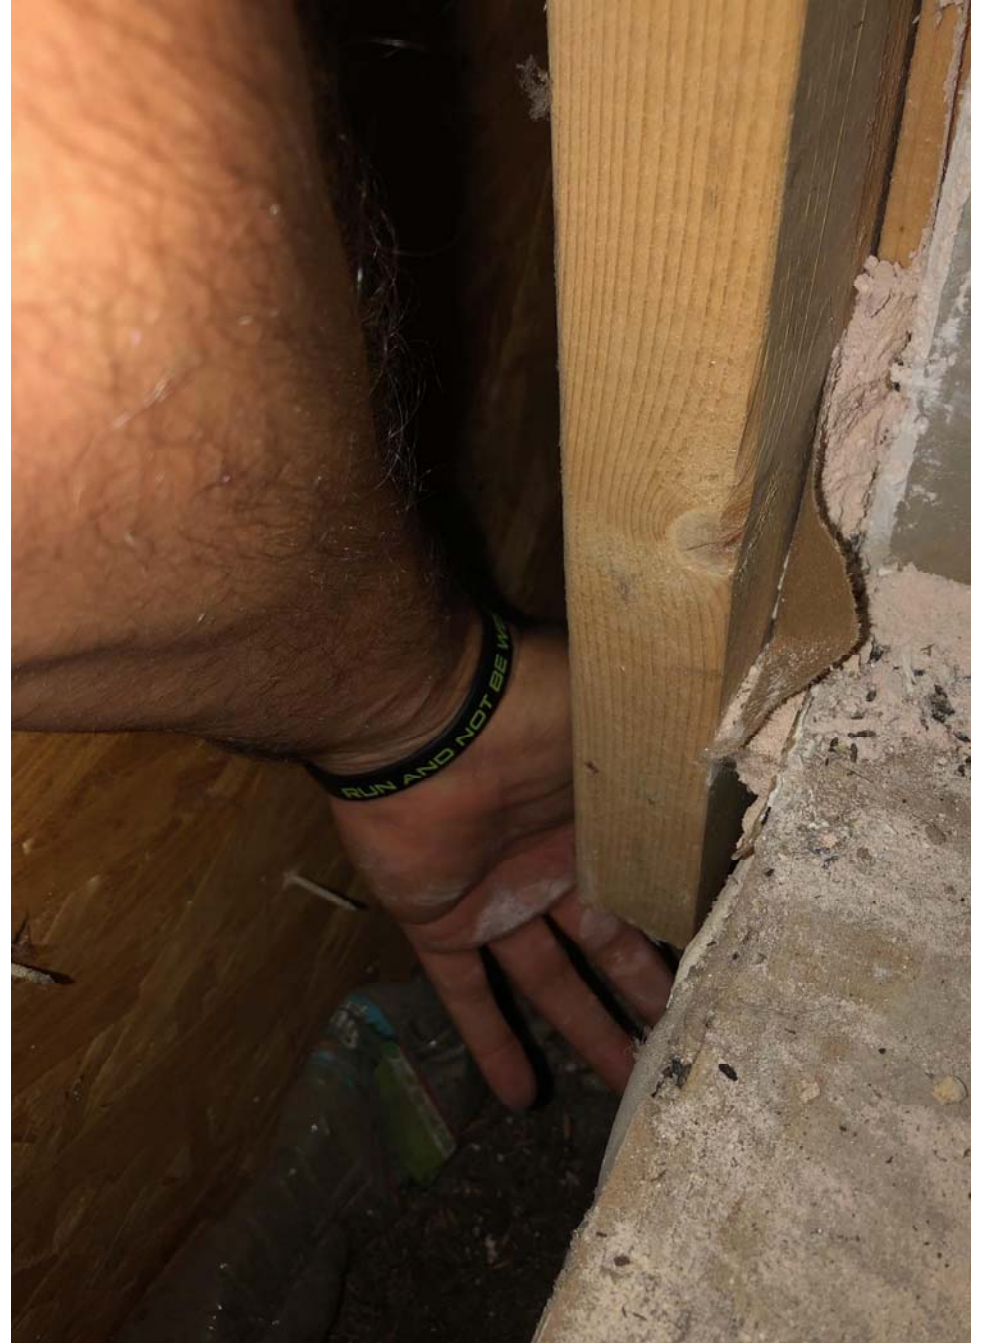
SOMERVILLE 15 MACARTHUR STREET - P1  
SEPTEMBER 26, 2019

DAMAGED STUDS USED FOR REPAIRS ARE FLOATING ABOVE THE BASE - HAND SHOWS AIR SPACE UNDER THE BOTTOM OF STUD  
OSB SHEATHING USED FOR REPAIRS DETACHED FROM THE WALL STUD

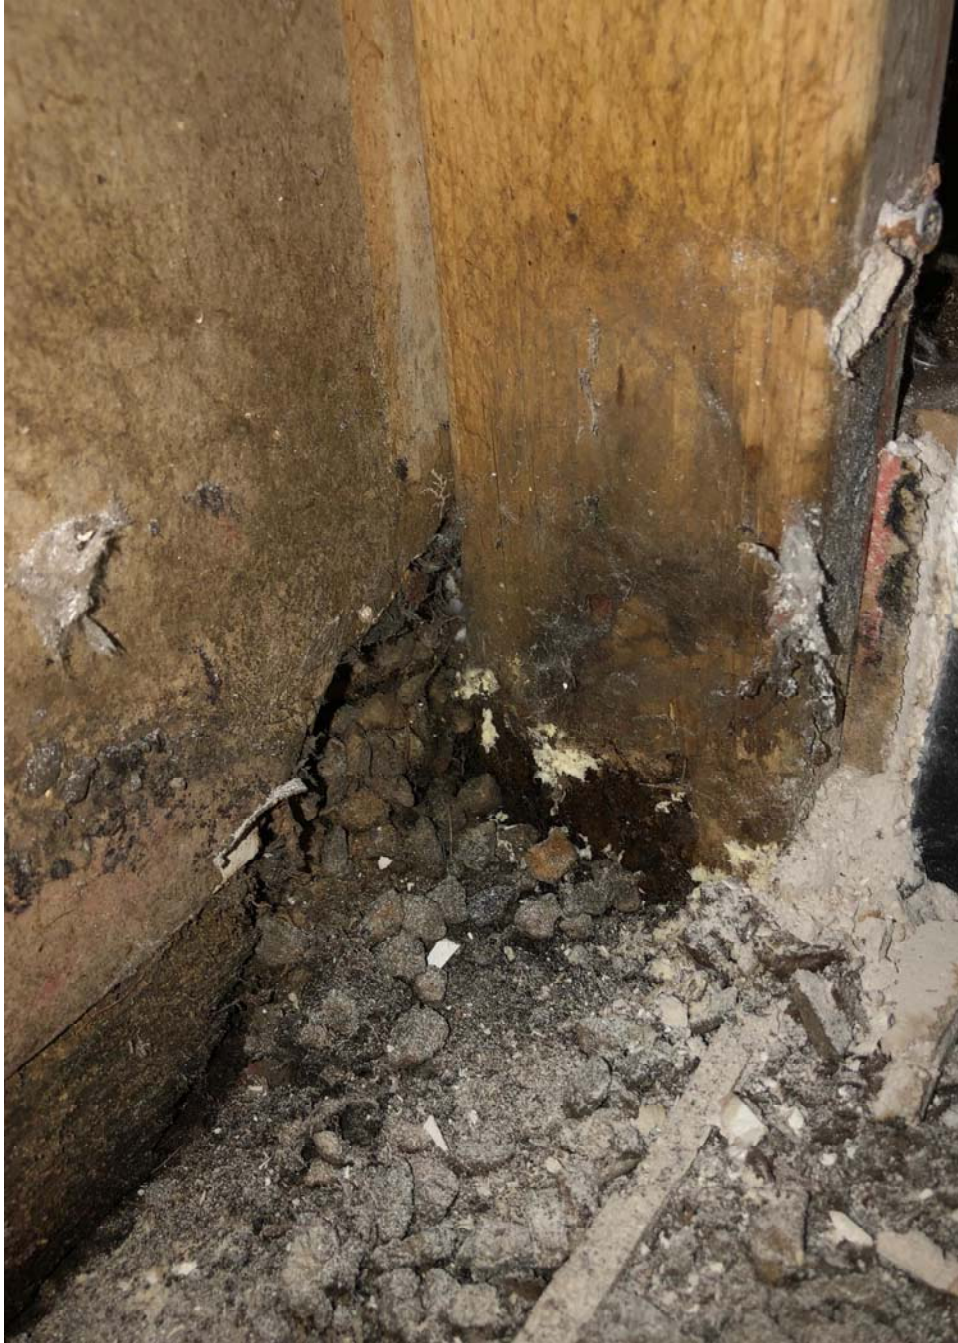
ROT AT BASE OF STUD AND WALL SHEATHING, POOR CONCRETE REPAIRS WITH EXPOSED AGGREGATE OF THE POUR.

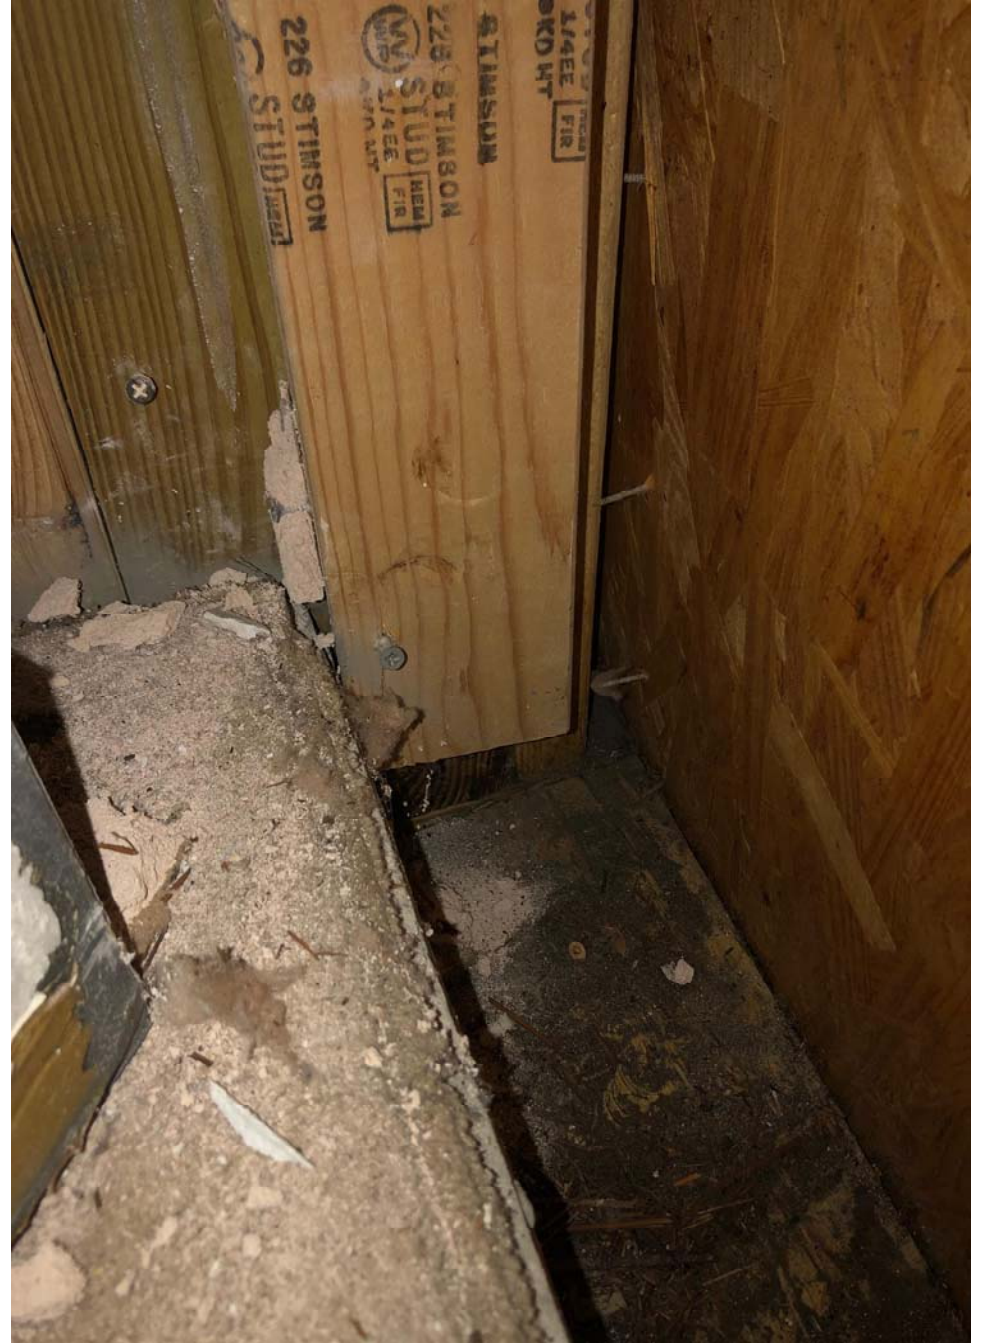
WALL STUDS NOT SUPPORTED AT THE BASE AND DETACHED OSB SHEATHING INDICATE POOR REPAIRS.

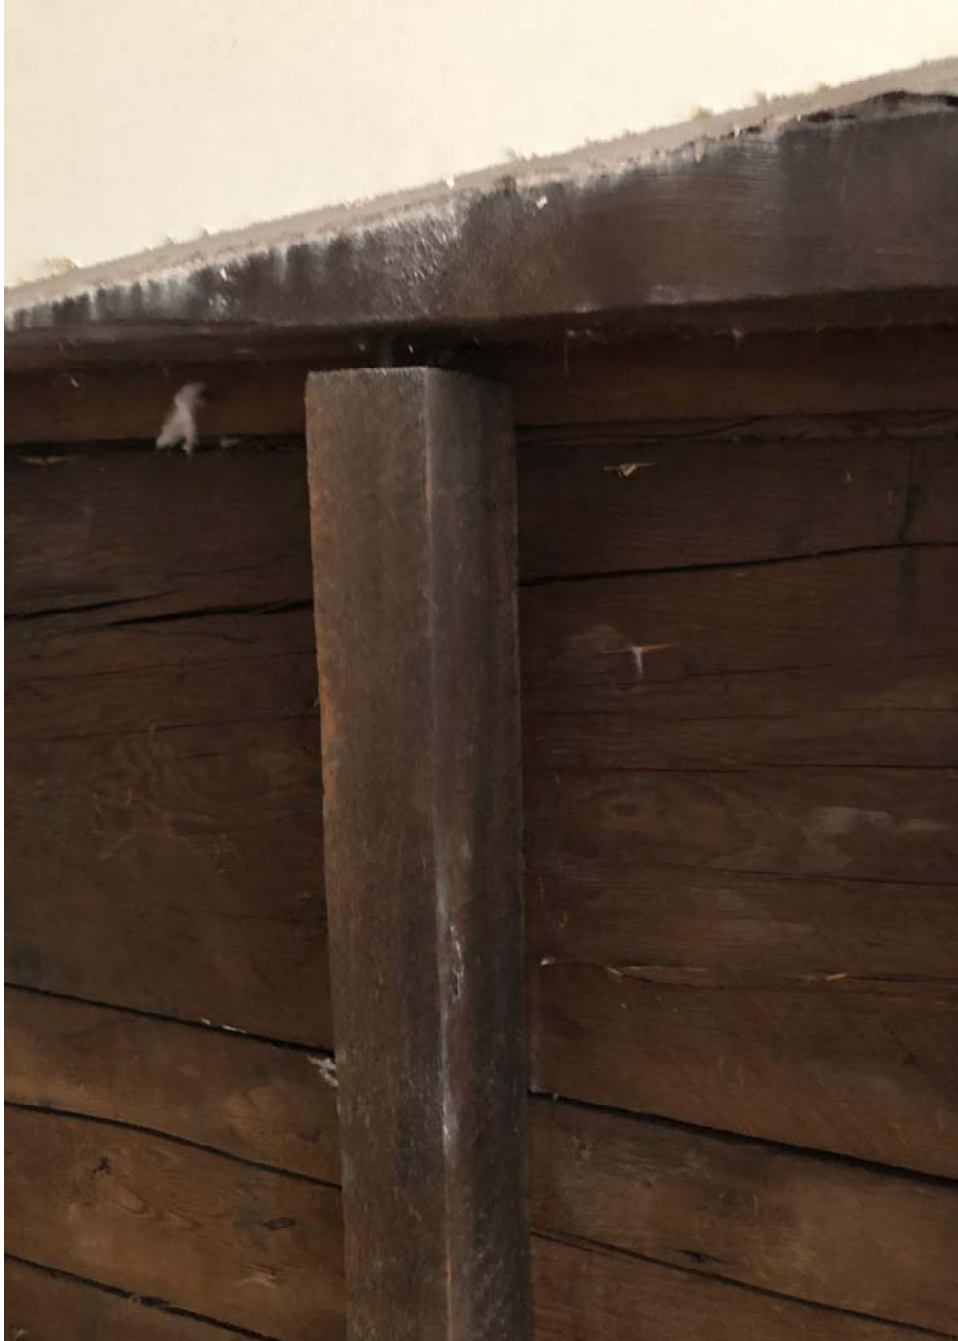
STUDS DETACHED FROM THE ROOF EAVE BEAM AND DRY ROT IN THE WALL SHEATHING BOARDS WITH SEVERAL CHECKS.

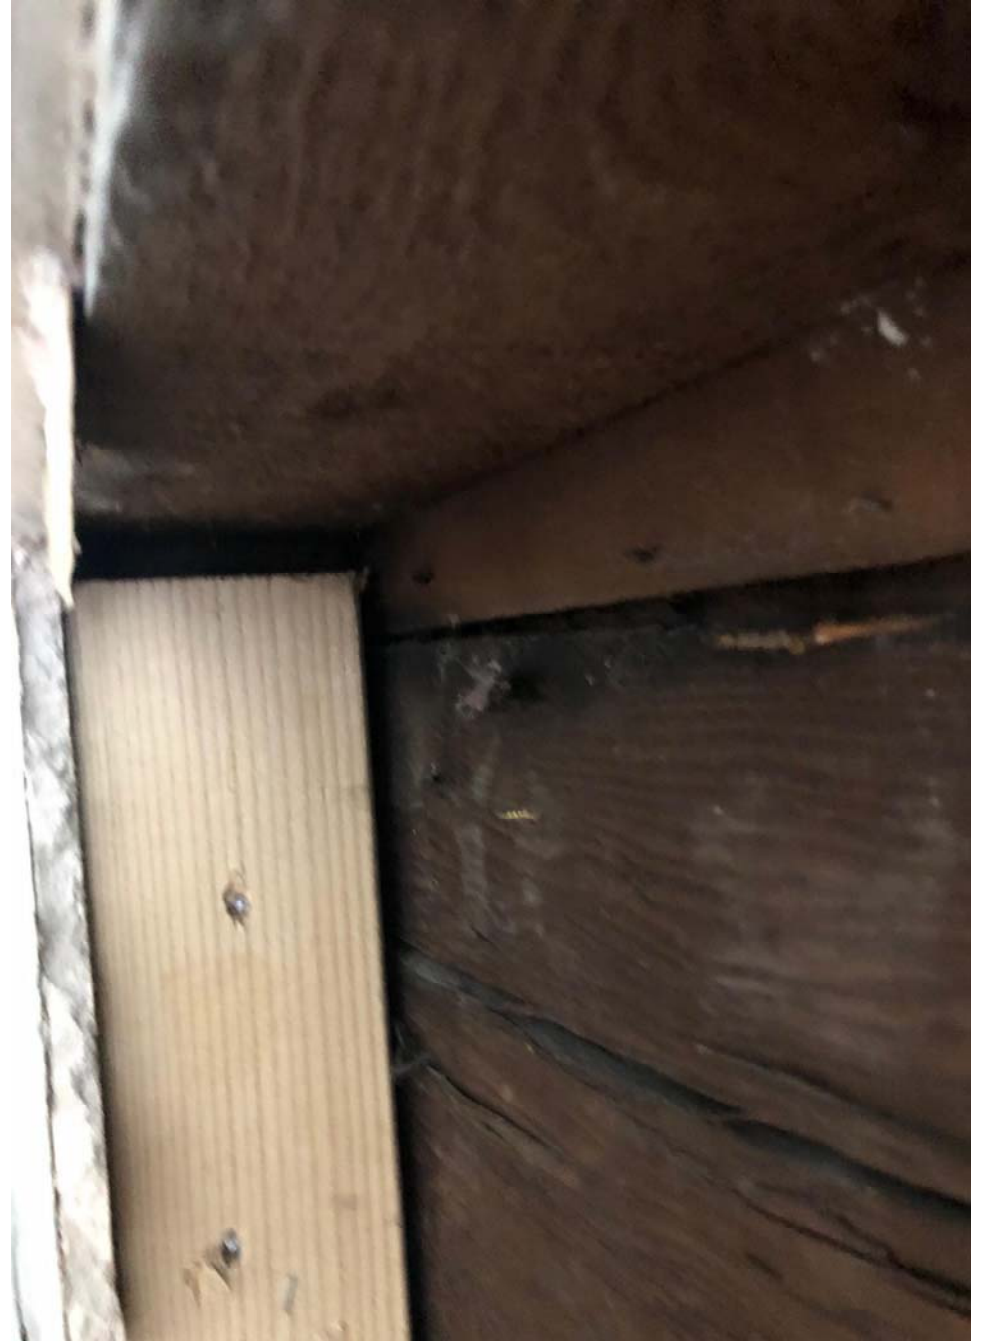
ORIGINAL FINISH REPLACED WITH GYPSUM WALL BOARD

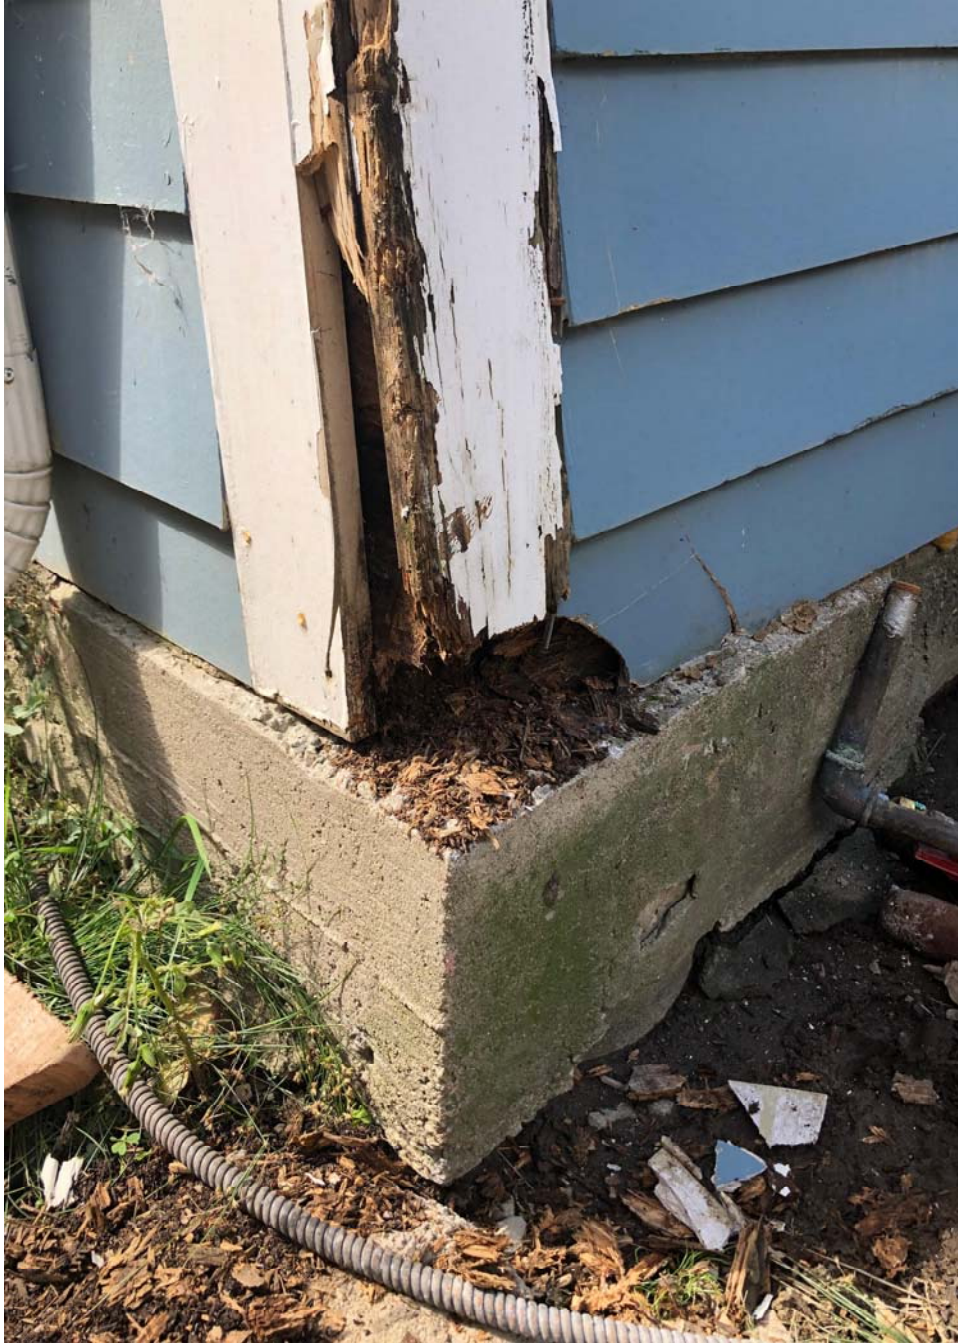
FULLY DAMAGED CORNER POST AND CONCRETE  
BASE FLOATING ABOVE THE GRADE

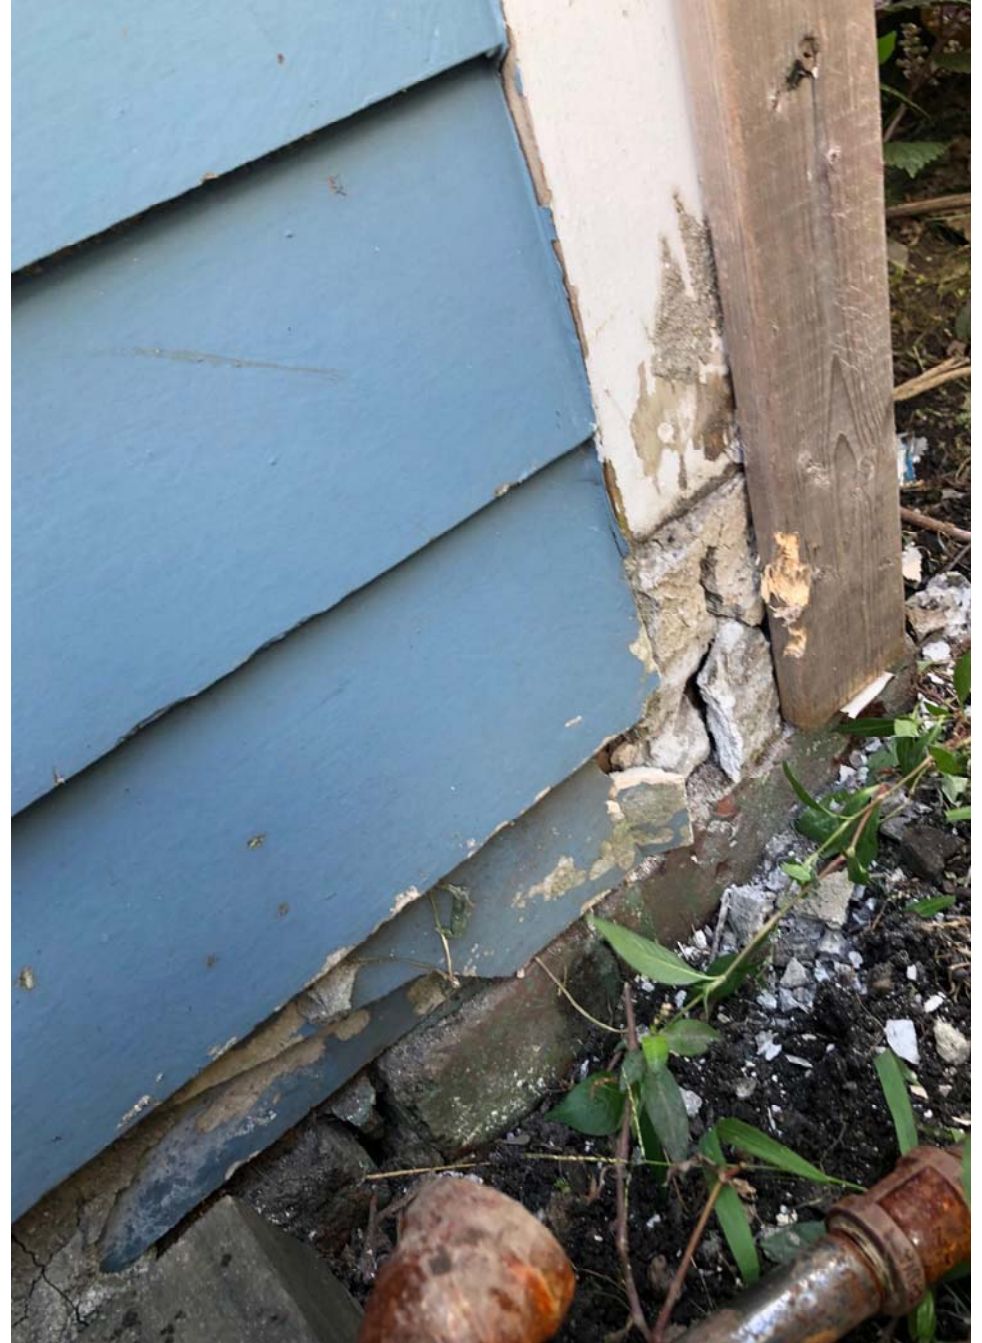
DAMAGED TO OTHER CORNER POST AT BASE AND  
DISINTEGRATED FOUNDATION TOP
