TO: Historic Preservation Commission
FROM: PPZ Staff
SUBJECT: 76 Highland Ave - HP25-000076
Dated: February 27, 2026

WINDOW CONDITION ASSESSMENT and PRESERVATION REPORT

Property Address: 76 Highland Avenue, Somerville, MA

Survey Performed on: 2/2/2026

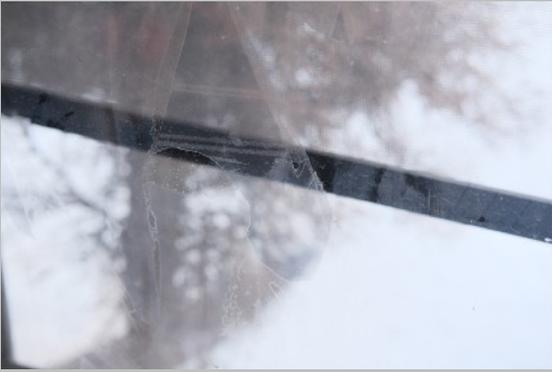
- 1, N, 1 Three upper sash panes replaced with etched glass
- 1, N, 2 Lower sash is missing
- 1, N, 3 Silicone caulking is spread on areas of the glass
- 1, E, 1 Damaged glass

1 E 1 Damaged Glass	1 E 2 Rot - Detached Corners

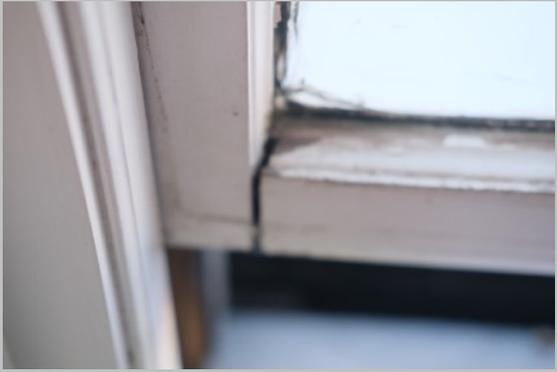
- 1, E, 2 Corners of bottom rail have rot and detached from the stiles
- 1, NW, 1 (Dining Room) Meeting rail of upper sash is rotted
- 1, W, 2 Upper sash meeting rail, sagging and rotted; rotting jambs

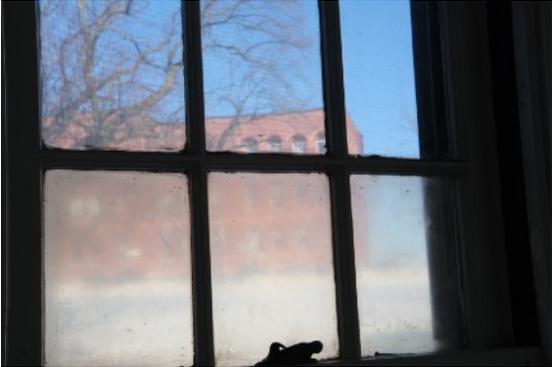
1 N 1 Etched Glass	1 N 2 Missing Lower Sash

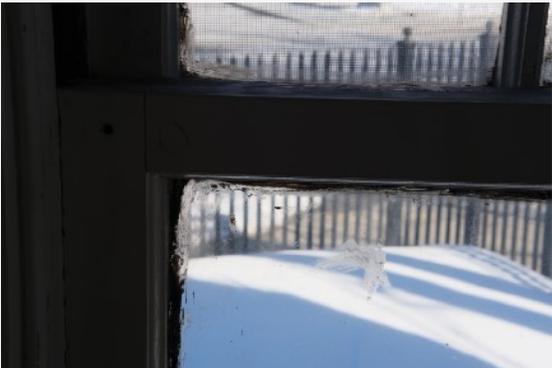
1 N 3 Silicone Caulk on Glass	1 NW 1 (DR) Meeting Rail Rot

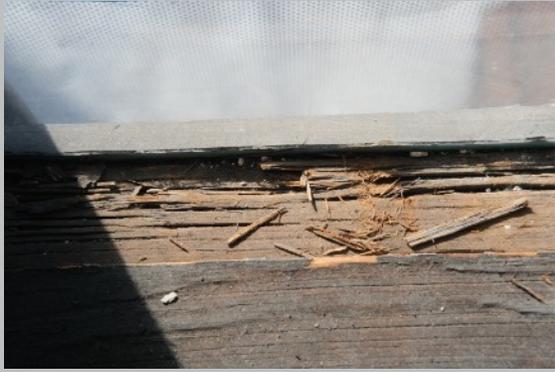
1 NW 1 (DR) Meeting Rail Rot

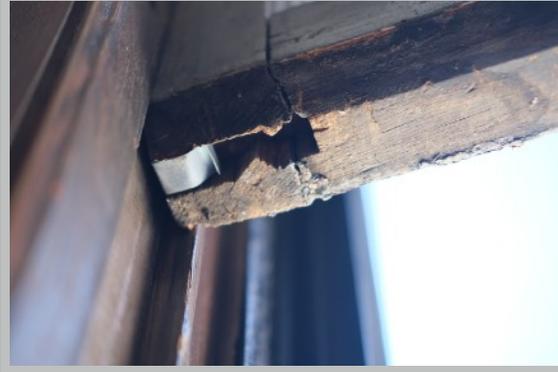
- Pantry** Underside of bottom sash, bottom rail is rotted
- 2, N, 4 Upper sash meeting rail, rotted and separating; lower sash corner rotted and separating; jambs are rotted

1 PANTRY Rotted Separating Corner

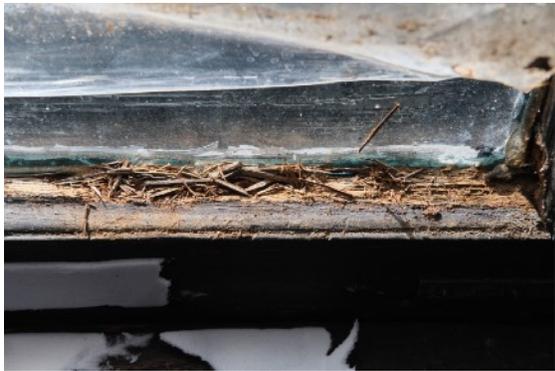
1 W 2 Meeting Rail Rot

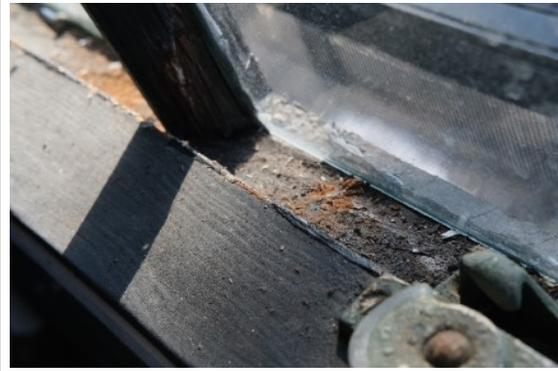
1 W 2 Meeting Rail Sagging

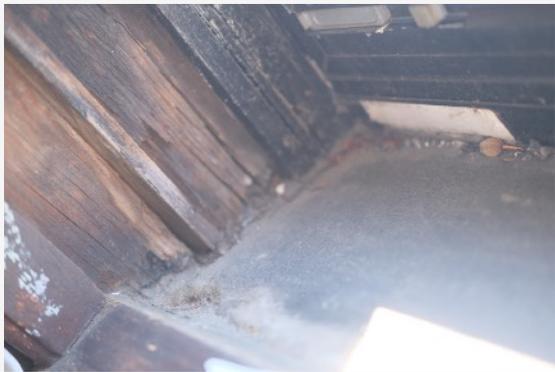
1 W 2 Rotting Jambs

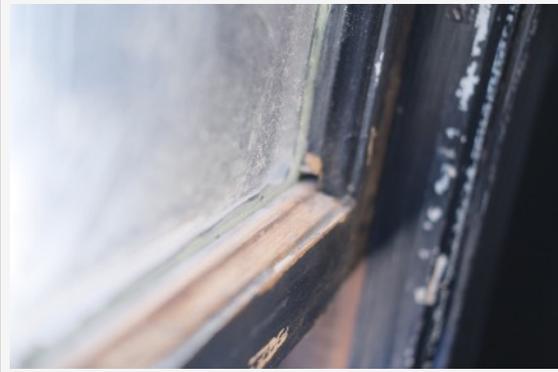
- 2, E, 1 Lower sash, bottom rail, corners rotted and separating
- 2, S, 1 Upper sash meeting rail rotting; lower sash bottom rail corners are rotted and supported by angle irons screwed in rail and stiles

2 E 1 Bottom Rail Sinking

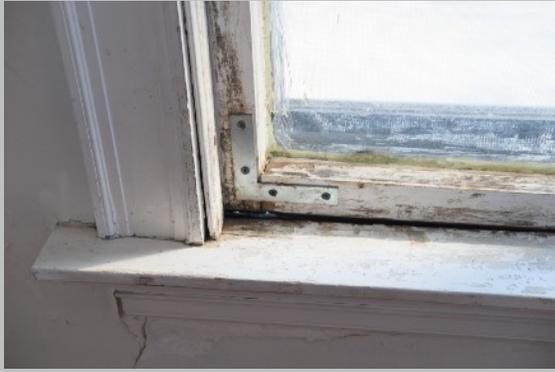
- 2, S, 2 Bottom sash corners rotted and missing material
- 2, E, 1 Upper sash rotted meeting rail; lower sash corners supported by angle irons
- 2, E, 2 Upper sash rotted meeting rail; lower sash corners supported by angle irons

2 E 2 Angle Iron Corners

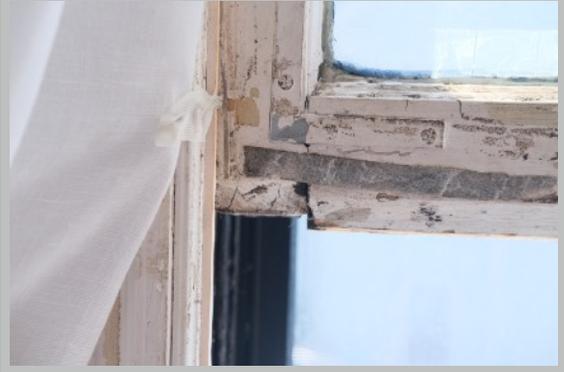
2 N 4 Botom Rail Dropped

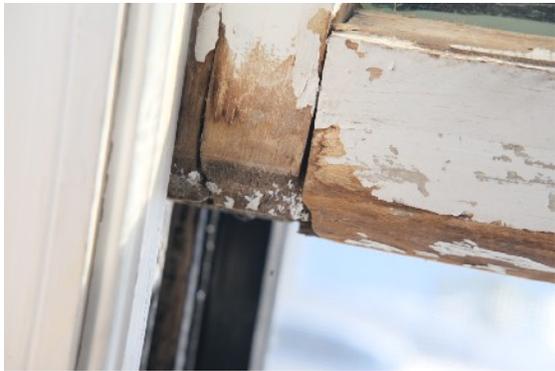
2 N 4 Bottom Rail Rot

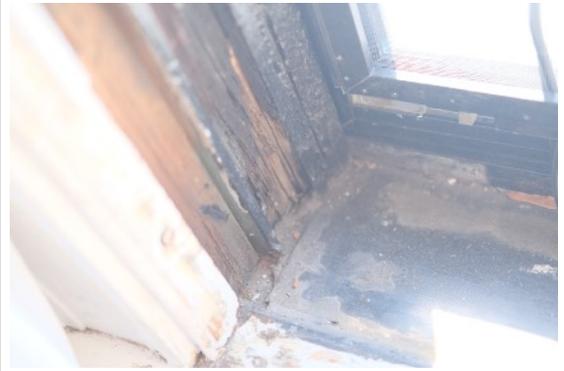
2 N 4 Jamb Rot

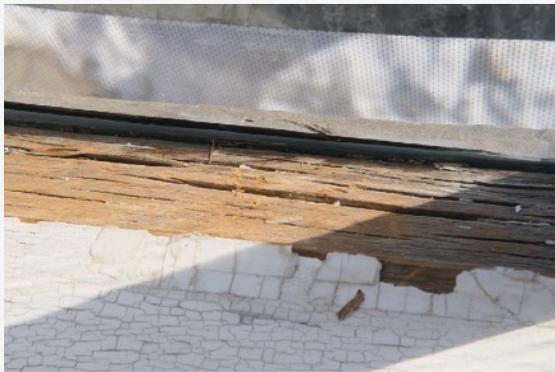
2 N 4 Meeting Rail Rot

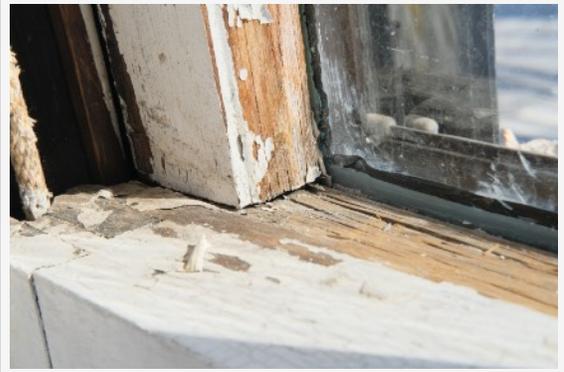
2 N 4 Meeting Rail Separating

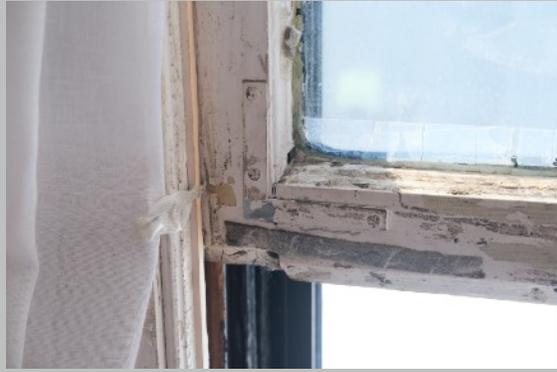
2 S 1 Angle Iron Corner

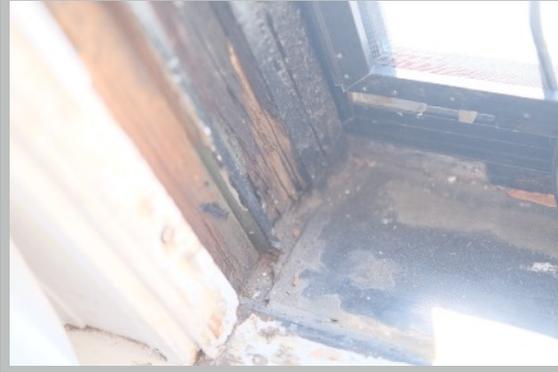
2 S 1 Rotting Jambs

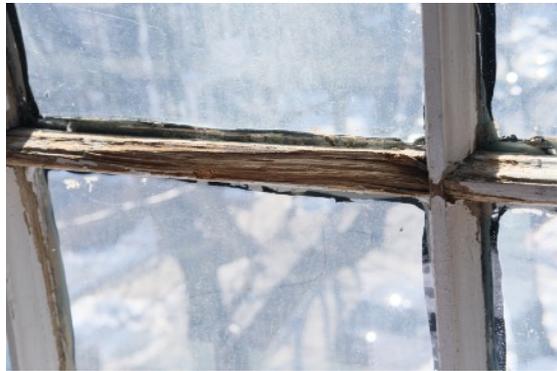
- 3, E, 1 Upper sash,, meeting rail rot and separating; damaged muntins
Lower sash, rotted corners.

3 E 1 Damaged Muntin

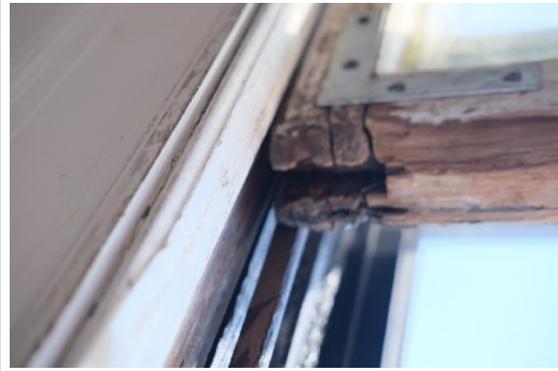
- 3, N, 1 Upper sash, meeting rail is separating (from muntins and stiles)
Lower sash, corners rotted and separating
- 3, N, 2 Upper sash, meeting rail is separating;
Lower sash, corners rotted and separating, secured with angle irons

3 N 1 Lower Sash Corner Rot

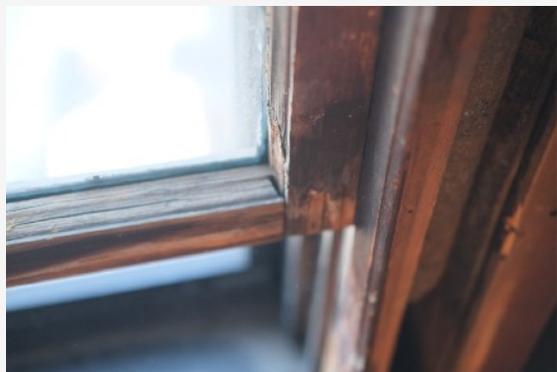
- 3, W, 1 Upper sash rotting meeting rail; rotting jambs
- 3, W, 2 Missing lower sash
- 3, S, 1 Upper sash meeting rail is rotting
- 3, S, 2 Lower sash, bottom corners rot and separating

3 S 2 Bottom Rail Separating

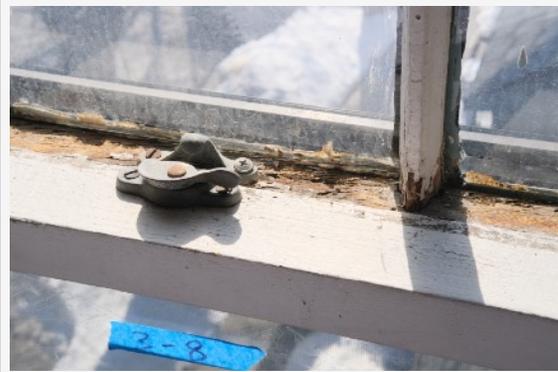
3 W 1 Rotted Meeting Rail
