HISTORIC PRESERVATION COMMISSION

Case #: HPC 2019.085
Date: November 19, 2019

PRESERVATION STAFF REPORT

Site: 33 Warren Avenue

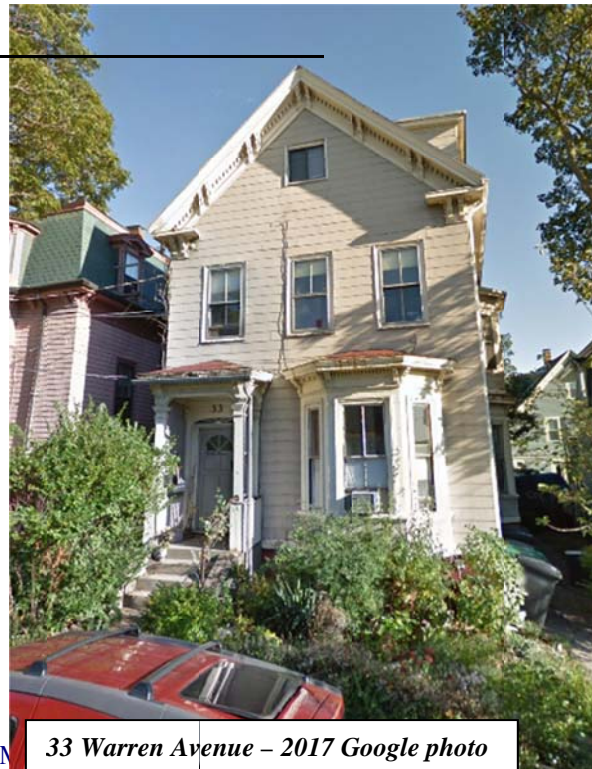
33 Warren Avenue – 2017 Google photo

It is sided with asbestos shingles over the original clapboard. Investigations have shown that the house was clapboard with turned rope wood corner boards as can be seen on several other buildings in the neighborhood. Very little maintenance has been undertaken.

All masonry is in poor condition. The chimney needs to be rebuilt as does the foundation.

The windows in the attic have replaced with aluminum sliders. The remaining windows appear to be the original wood. Several windows have rotted sills. Many of the basement windows are missing and boarded up. A ground floor on the left side bay toward 58 Columbus Avenue has been blinded. This window is minimally visible from Warren Street due to its proximity to the adjacent house on

Columbus Avenue. A second floor window on the opposite bay, second floor is also blinded and much more visible. A highly visible fire escape runs down the back of the building from the attic to the ground. There is a skylight to the front of the chimney visible from uphill Warren Avenue and Columbus Avenue.

Staff Findings: Staff finds that the removal of the asbestos siding and the repair of the historic fabric beneath are in keeping with the HPC Guidelines and recommends granting a Certificate of Appropriateness for that change. A Certificate of Non-Applicability will be issued for the repairs to the original fabric thereby revealed.

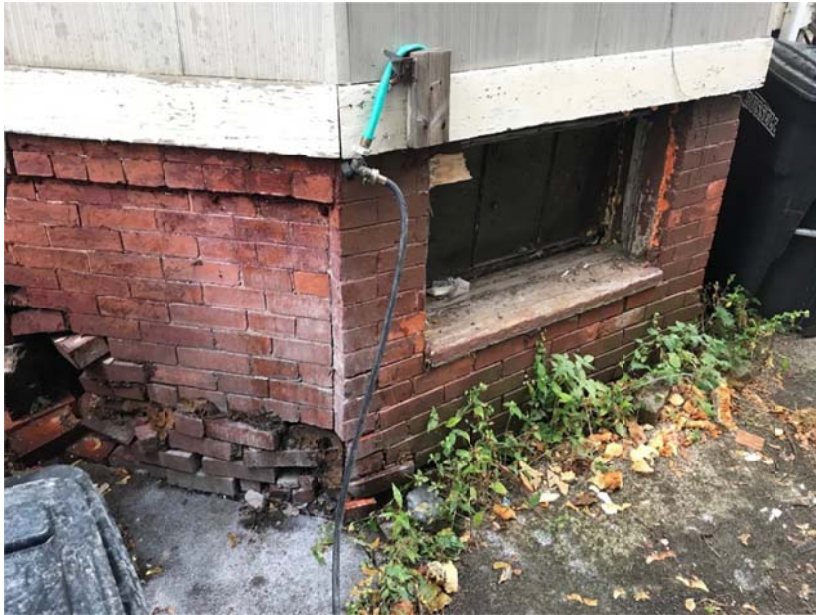
Typical basement window and foundation

A Certificate of Appropriateness should be issued to replace the attic windows with double-hung wood windows to fit the original opening to match the remaining existing double-hung windows; and replacement of the basement windows to match the existing. A Certificate of Non-Applicability may be issued for the repair of the original wood windows.

A Certificate of Non-Applicability shall be issued for the extensive repairs and maintenance in kind including the refurbishment and replacement of the original fabric found under the asbestos siding and the re-pointing of the basement and chimneys. The Applicant may also install new storm windows which are excluded from HPC review.

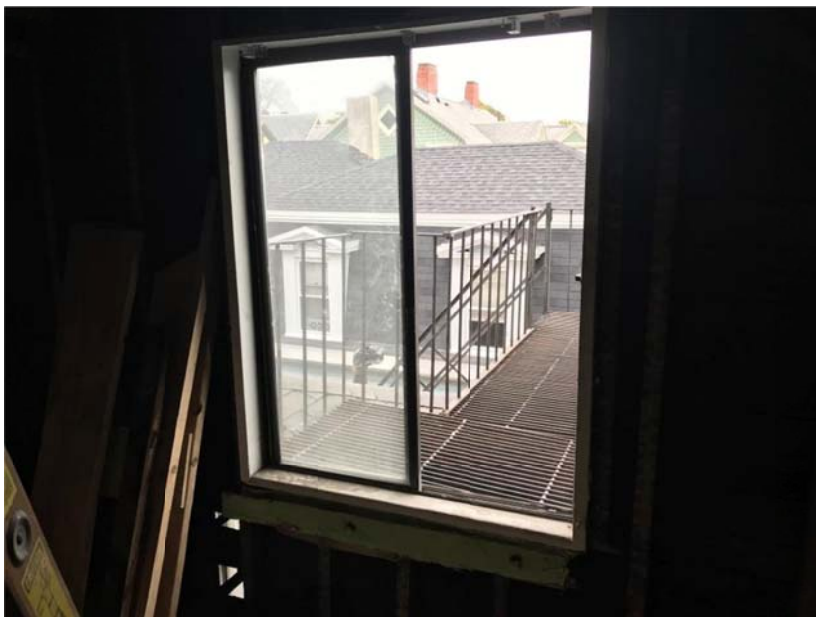
Attic window and fire escape
