Case #: HPC 2019.064
Date: October 15, 2019

PRESERVATION STAFF REPORT
for
Determination of Preferably Preserved

Site: 59 Albion Street Barn

RE: 59 Albion Street Barn – Site Visit Report

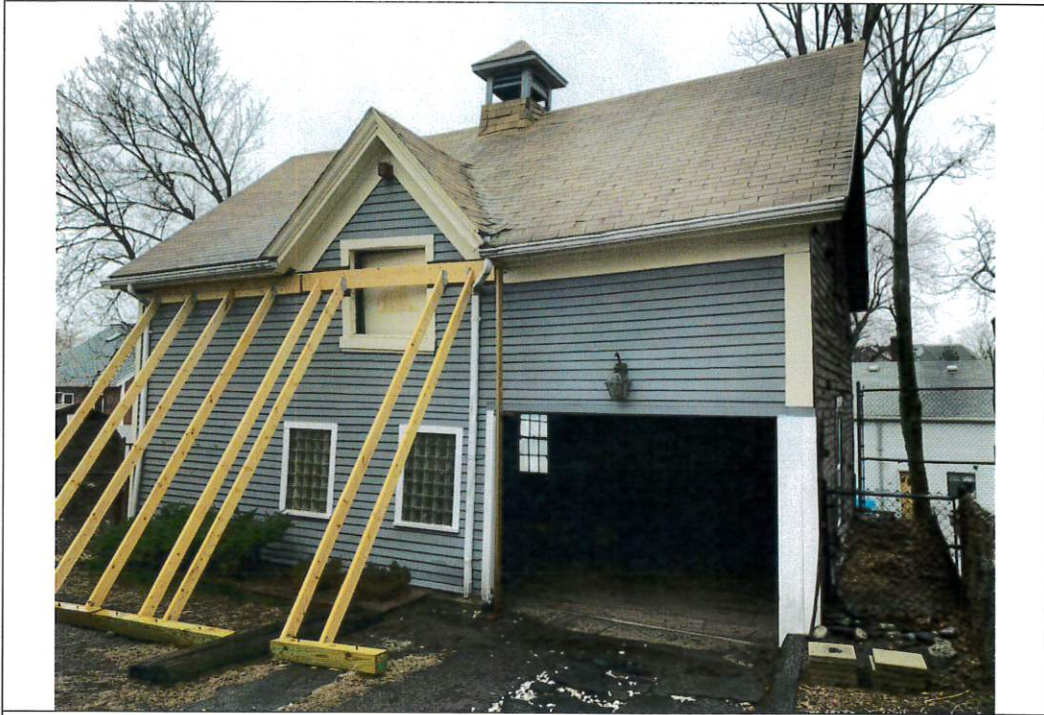
It was raining during our visit, which allowed us to observe several deficiencies with the existing grading around the structure. We noted that the driveway sloped down toward the south (front) elevation of the barn (see **Photo 1**). At the garage door, we noted water flowing into the structure, debris from storm water flows, previous repair and sealant applications at the west jamb of the door, and significant deterioration at the base of the 3 1/2" x 5" wood post at the west jamb (see **Photo 2**). Adjacent to this post, we observed a wall stud had detached from the sill plate and had kicked inward. At the interior side of the front wall, we noted a layer of black and grey-colored coarse stone between the bottom foot of the studs (see **Photo 3**). We observed that the exterior elevation appeared slightly higher than the interior first floor elevation at this location, and noted daylight visible at the bottom of the exterior walls at the southwest corner. We also noted that there were no, or structurally inadequate, window headers above the front elevation windows.

Photograph 1 – South (front) elevation

1. Fix the exterior grading around the structure to reduce water flows toward and into the structure.
2. Remove all retained earth adjacent to the wood-framed exterior walls.
3. Repairs or replacement of the exterior wall framing is anticipated at each wall elevation, due to long-term exposure to moisture. The extent of which is unknown, due to limited exposure of the exterior wall studs. At a minimum, we anticipate widespread damage at the base of all wall studs.
4. Installation of windows headers where they are missing or inadequate. Only the front elevation headers were exposed, but the condition is likely similar at the other elevations.

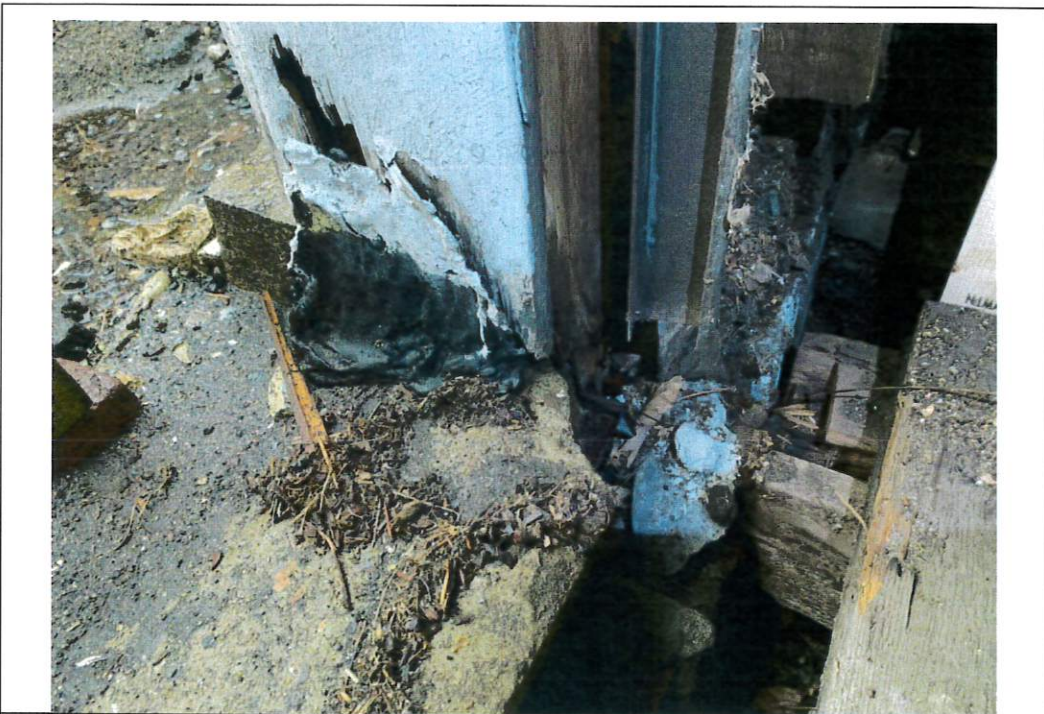
Photograph 2 – View of west jamb of garage door

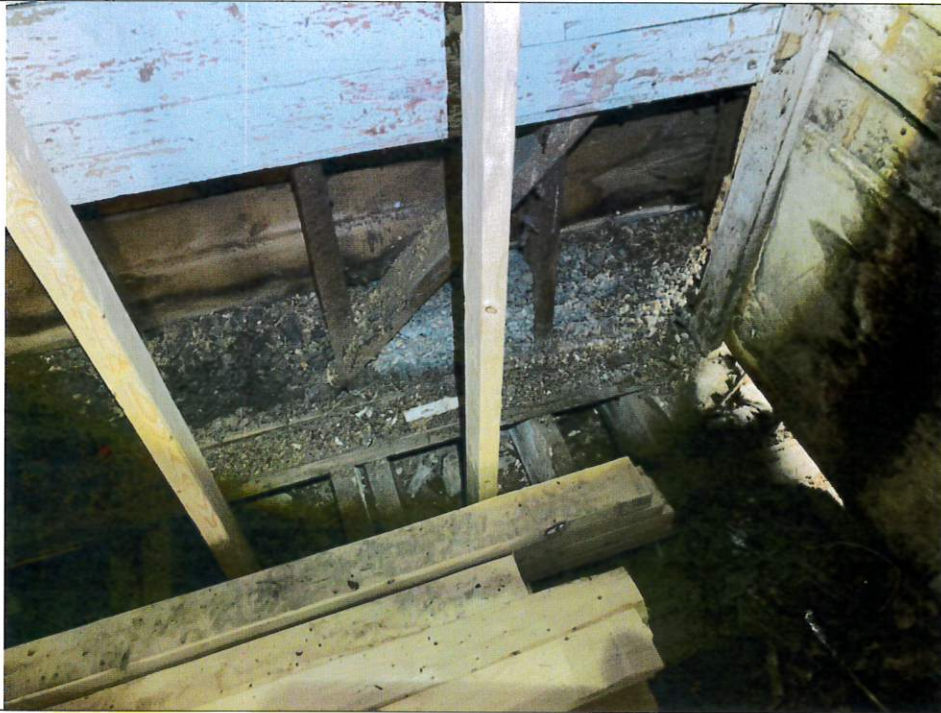
Photograph 3 – View of interior of south exterior wall. Note water staining at wall boards, stone between wall studs, and daylight visible at the southwest corner.

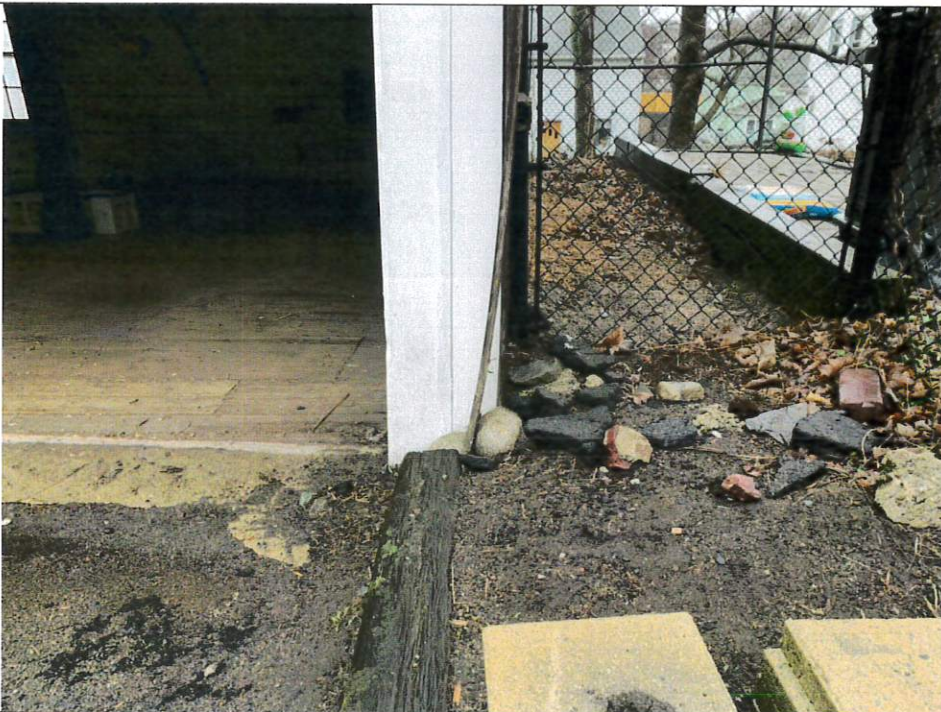
At the east exterior wall, we noted the exterior grade was higher than the interior first floor elevation, which indicates the exterior wood wall is retaining soil. We observed water infiltrating through the exterior wall boards toward the interior of the

Photograph 4 – View of southeast corner. Note exterior grade is higher than the first floor elevation

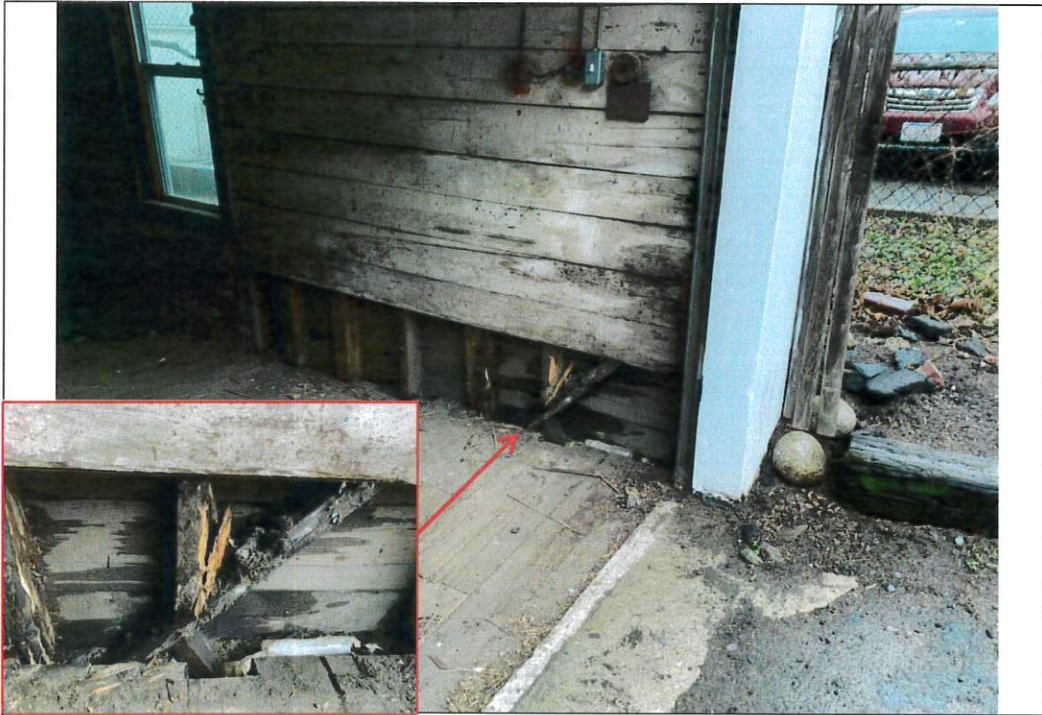
barn (see **Photos 4 & 5**). We also noted significant deterioration of the wall studs and bracing at the south end of the east exterior wall. Not all studs were exposed at the east wall, but based on the staining observed at perimeter floor boards and interior wall boards, water appeared to be infiltrating along this entire elevation.

Photograph 5 – View of interior of east exterior wall. Note water seeping through boards and deterioration of studs and bracing.

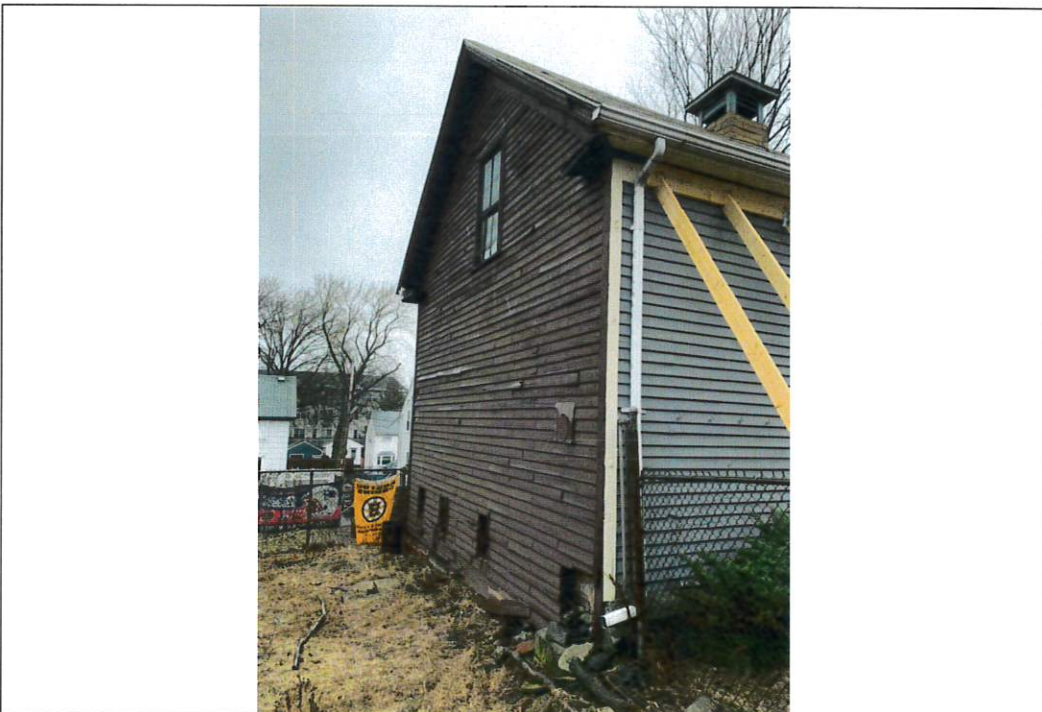
At the west elevation, we noted deteriorated clapboard siding and spalled and deteriorated masonry at the exposed exterior face of the foundation wall (see **Photos 6 & 7**).

Photograph 6 – West exterior elevation

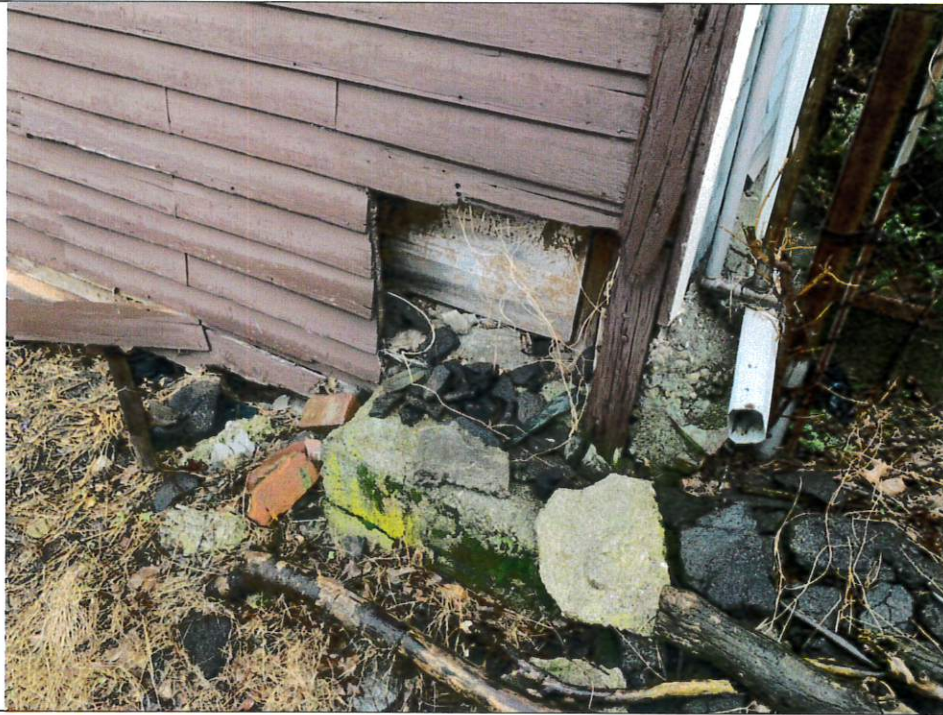
Photograph 7 – Closeup view of southwest corner, note deterioration at the top of foundation wall.

The existing stone and brick foundation walls are in poor condition, with areas of partial collapse and major deterioration to the brick/stone units and mortar joints. Due to the extent of damage observed, the following are a few options that could be implemented:

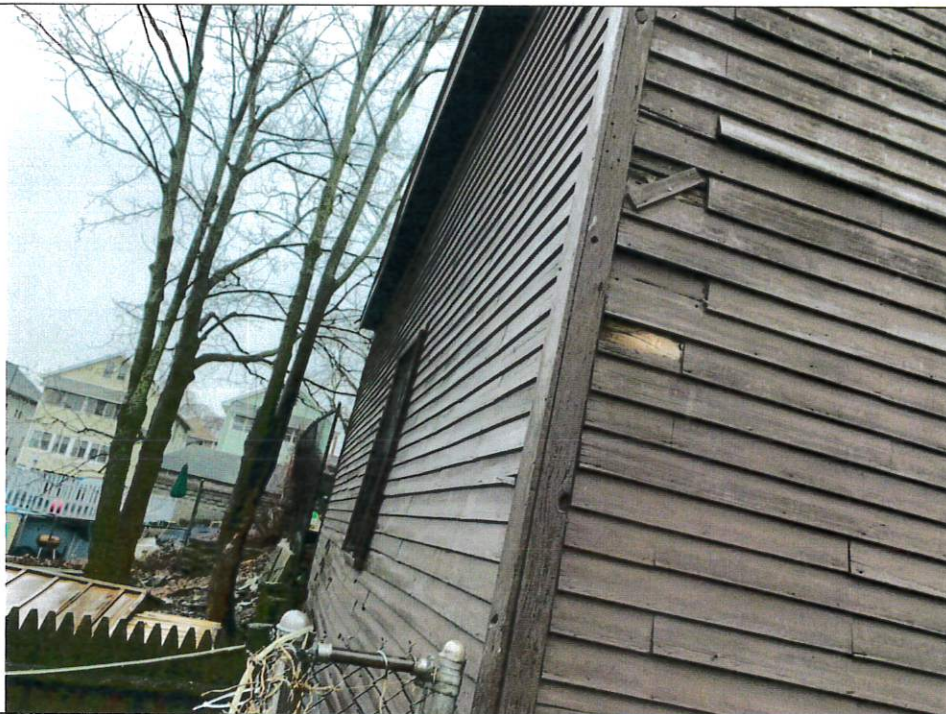
At the north (rear) elevation, we were unable to view the full extents of the elevation, but noted that from the northwest corner the lower portion of the wall appeared to bow outward, while the middle and upper portion appeared to bow inward (see **Photo 8**).

Photograph 8 – View of north (rear) elevation (looking east)

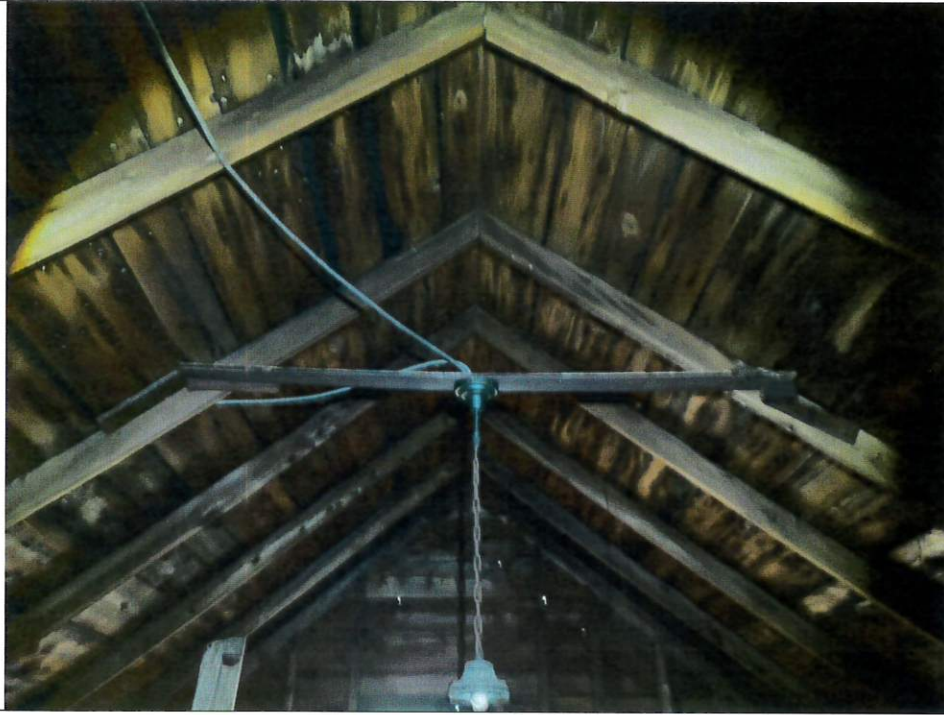
The roof framing consisted of 1x boards supported by 2" x 5" rafters spaced at approximately 30 inches on center (see **Photo 9**). The rafters spanned between the ridge and the front and rear exterior knee walls. At the ridge, the rafters butted against each other, with no ridge board or ridge beam. The top plate elevation of the north and south knee walls approximately 4 feet above the second-floor decking elevation. We noted wide-spread staining at the surfaces of the rafters, and at underside of the exterior and interior roof boards. We did not observe ridge, eave, or gable end ventilation. We also observed what appeared to be recently installed rafter ties and hurricane ties (see **Photo 10**).

Photograph 9 – View of ridge and rafters looking west. Note staining at rafters and underside of roof boards.

1. Provide new roofing, new roof sheathing, and reinforce or replace the existing rafters. The existing roof framing has deteriorated and the rafters are structurally inadequate for the current code-prescribed roof loads. Due to the level of deterioration observed, replacement is likely the only viable option.

2. Provide a ridge board or other mechanism to prevent rafter movement at ridge.
3. Provide a connection between knee wall studs and second floor joists.

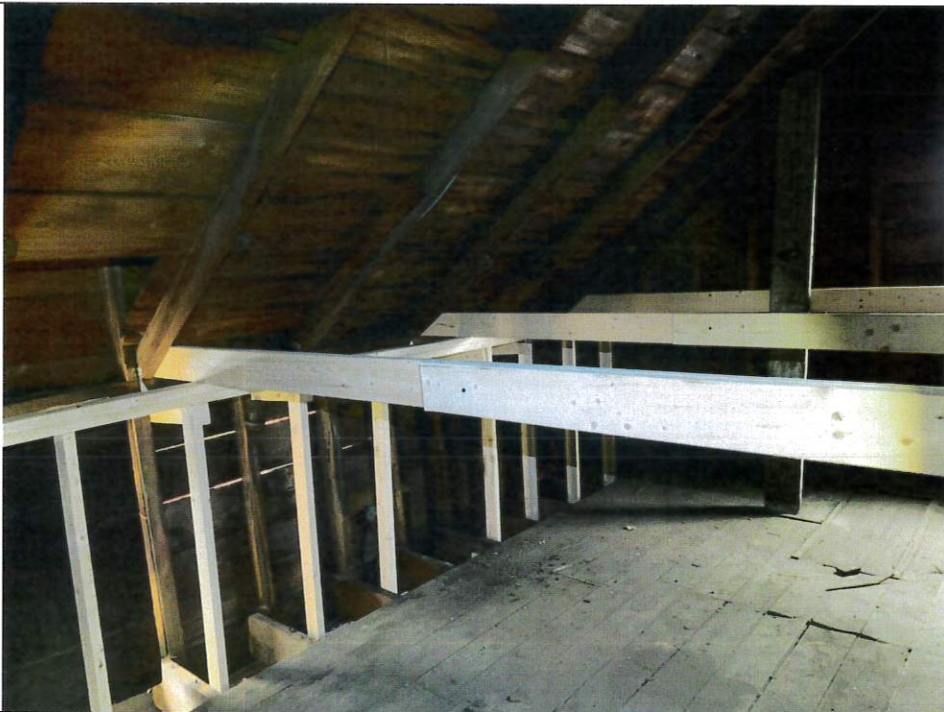
Photograph 10 – View of temporary rafter ties and shoring

4. Create a permanent rafter thrust restraint mechanism. The currently installed temporary rafter ties will dramatically impact any reasonable use of the second floor.

- a. One thrust restraint mechanism would be to add a structural ridge, supported by interior posts. This system could be aligned and integrated with a girder/column system at the floor levels below (see sections below for additional info). Adding a ridge beam does not resolve all the issues at the exterior wall framing,

but it will eliminate the rafter thrust due to gravity loads.

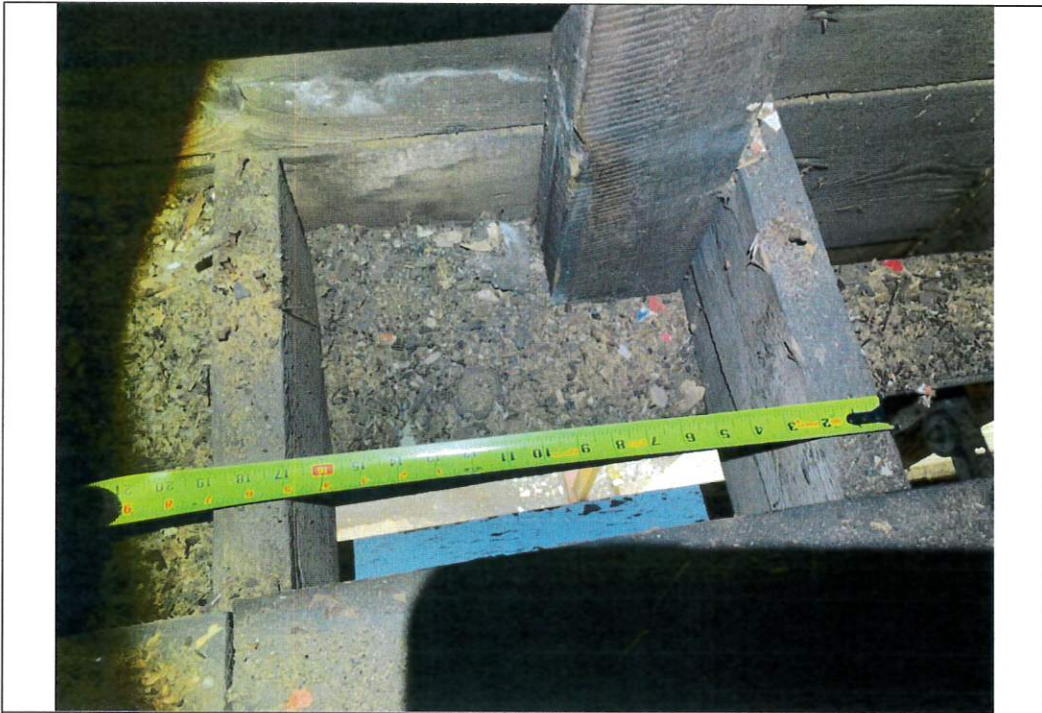
The second-floor framing consisted of 1x boards supported by 2" x 8 1/2" joists spaced at approximately 17 inches on center (see **Photo 11**). The floor joists spanned between the front and rear exterior walls. We observed that the joists were supported by a top plate of the first-floor walls, but noted that not all of the second-floor knee wall studs were adjacent to or attached to the second-floor joists (see **Photo 12**).

Photograph 11 – Close-up view second floor joists at south (front) exterior wall from above

1. Reinforce or replace the second-floor joists. The existing joists span over 20 feet and are inadequate for habitable or uninhabitable attic loading. Sistering of the joists may be an option, but due to the extent of work required at the roof, and exterior walls, replacement may be a more feasible approach.
2. Alternatively, introducing a mid-span girder and interior columns may allow for the majority of the existing joists to be reused. However, further exposure of the joists would be required to ensure additional repairs are not required due to deterioration.

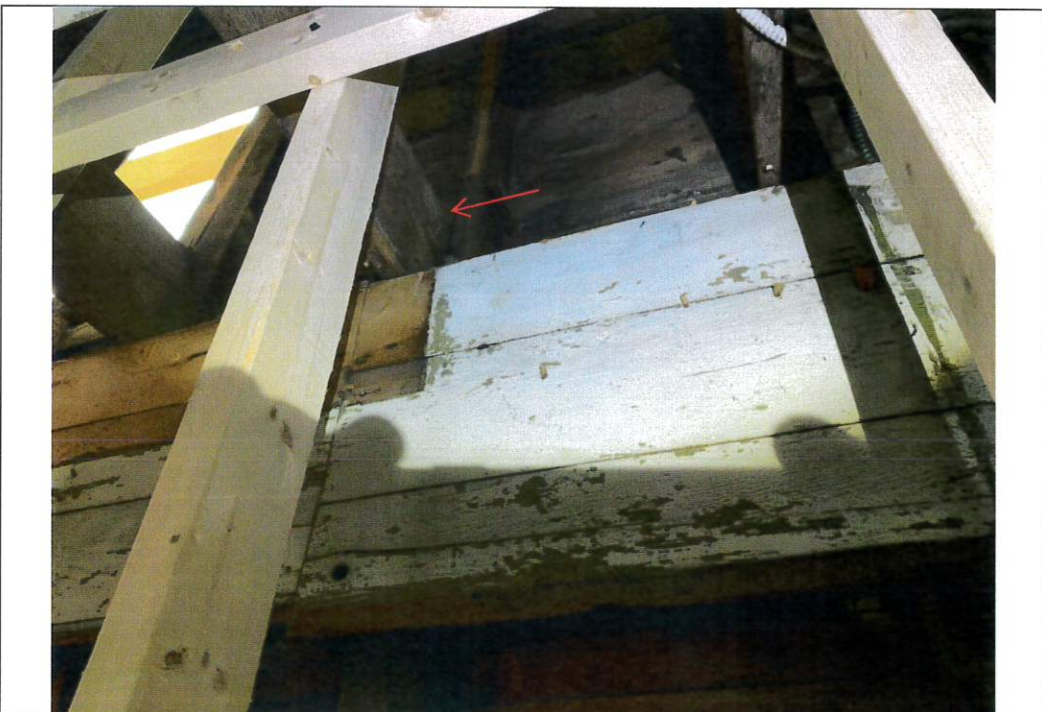
Photograph 12 – Close-up view second floor joists at south (front) exterior wall from below. Note not all second-floor wall studs were attached to the floor joists.

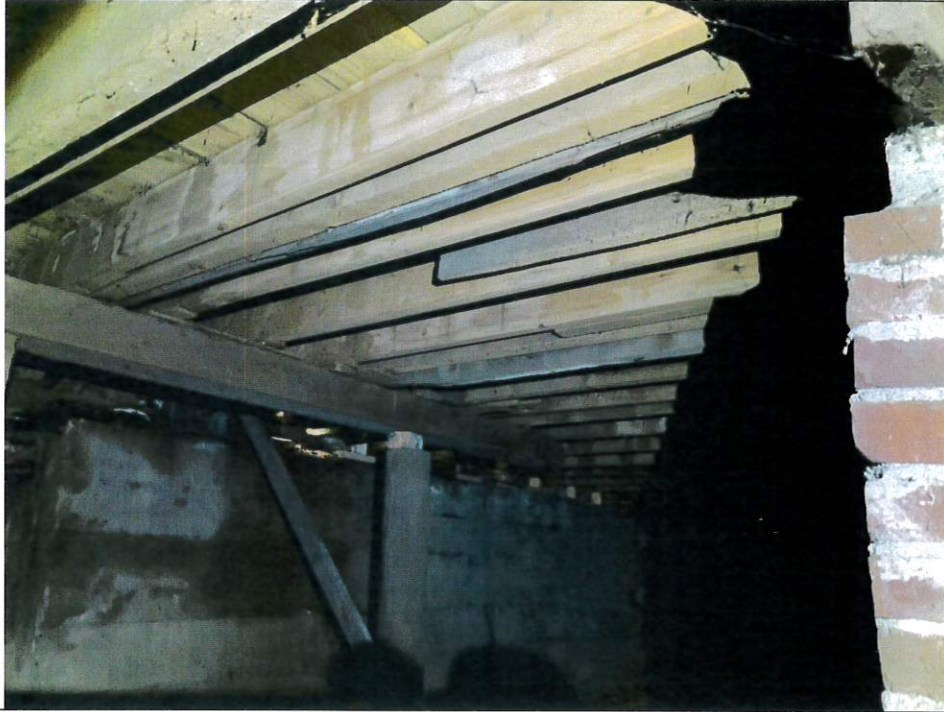
The first-floor framing consisted of 1x boards supported by a variety of joist sizes and spacings. It appeared that the original joists were generally 2" x 8" joists spaced at approximately 18 inches on center (see **Photos 13 & 14**). The first-floor joists were supported by the exterior foundation walls and were lapped over an interior 6" x 6" girder, which was supported by 12" x 12" brick columns. We noted wide-spread staining of the floor joists and girders. Where the joists and girders were supported by foundation walls, the staining was more pronounced and we noted moderate to heavy deterioration, particularly at the south and east foundation walls.

Photograph 13 – View of first floor framing looking southwest

1. Repair or replace the damaged first-floor joists. The existing joists appear to have adequate capacity for the proposed use, but due to deterioration due to long-term moisture exposure, repairs are anticipated. At a minimum, repairs to the joist ends are anticipated at most, if not all, joists. Additional repairs and reinforcing at interior portions of the joists may be required at spot locations.
2. Reinforce or replace the center girder, or add additional interior columns to support the existing one. The existing girder is structurally inadequate for the proposed use. In addition, the east end of the girder has deteriorated and require repairs and proper support at the foundation wall.
3. Replace the deteriorated beam at the garage door threshold, or remove and support the floor joists with a new foundation wall.

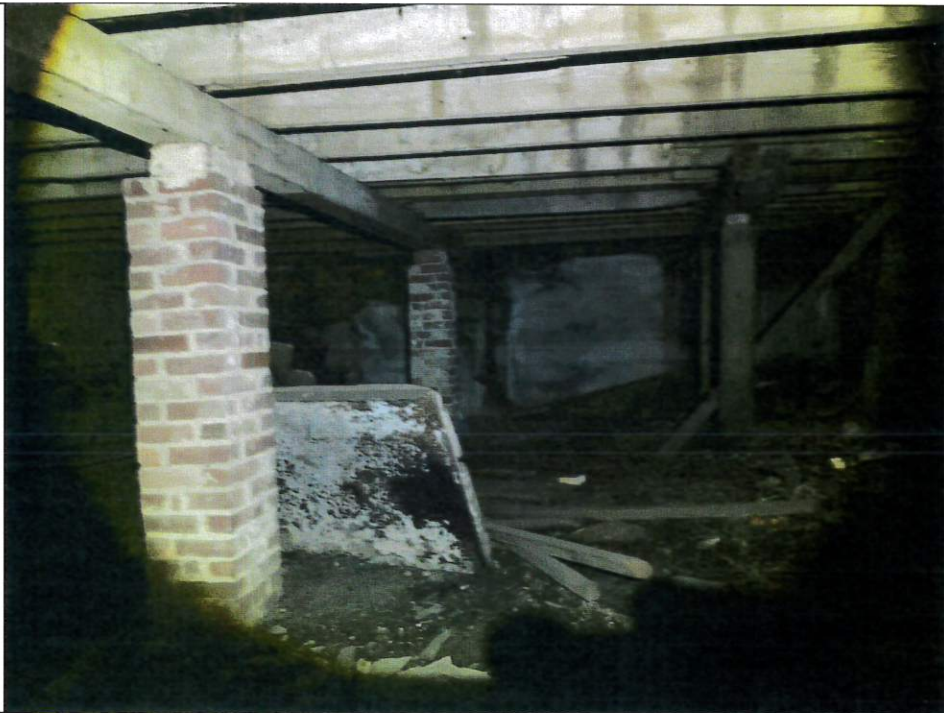
Photograph 14 – View of first floor framing looking east

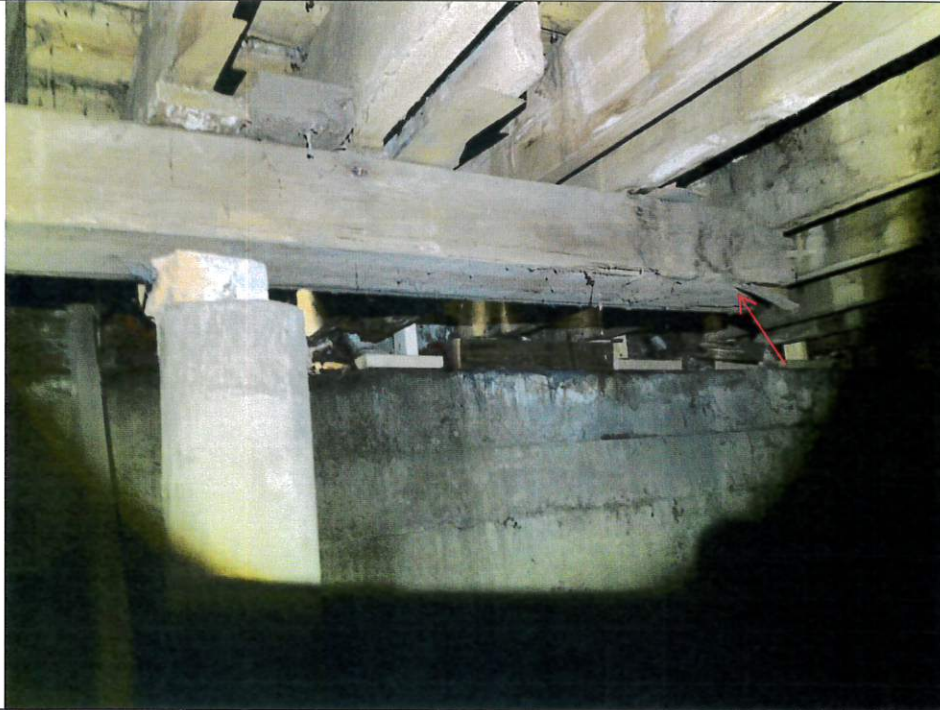
Additional 2x8 joists appear to have been added between the existing joists, particularly at the southeast corner of the barn, adjacent to the garage door. In addition, a 4 3/4" x 8" girder was added at the southwest corner, approximately 3 feet from the front foundation wall. We noted a portion at the west end of the girder had deteriorated and collapsed (see **Photo 15**). The additional joists and girder were likely added to support heavy loading, such as vehicles or heavy storage.

Photograph 15 – View of 4 $\frac{3}{4}$ " x 8" girder near garage door opening. Note staining and collapsed west end of girder

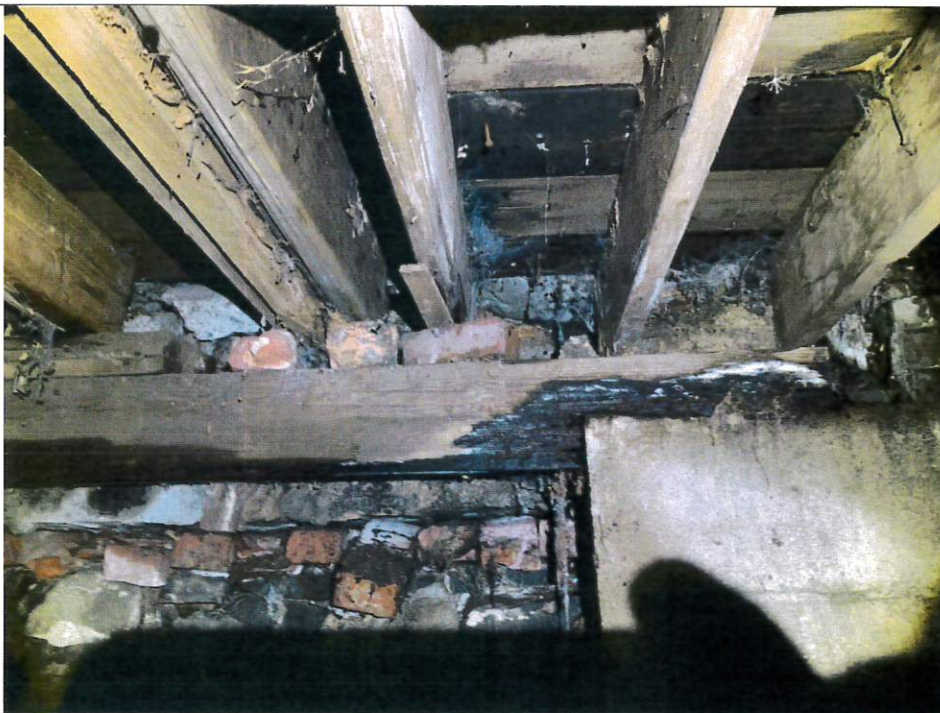
At the threshold of the garage door, we noted a 6-inch deep wood beam that spanned between a cast-in-place concrete wall, at the west jamb of the garage door, and the east exterior wall (see **Photo 16**). We noted the beam was wet (saturated), deteriorated, and had a 3" deep x 12" deep notched end at the concrete wall.

Photograph 16 – View of beam below garage door opening at south (front) elevation

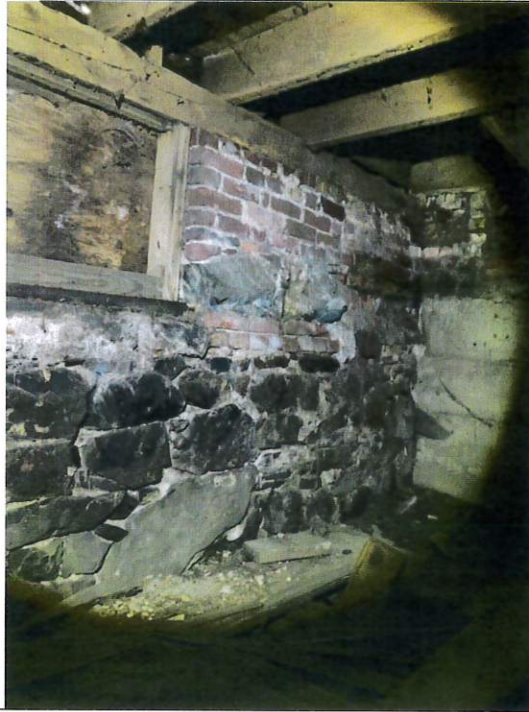
The foundation walls consisted of a mixture of red brick masonry, approximately 12" thick, atop field stone (see **Photo 17**). We noted mortar between the bricks and stone had varying levels of deterioration and erosion. At the front elevation, it appears that a cast-in-place concrete wall was placed at the interior face of the existing foundation wall (see **Photos 18 & 19**). We noted that the cast-in-place wall was not placed at the garage door location. At the east and west foundation walls, we noted areas of cast-in-place concrete or a thick parge coating at portions of the interior face of foundation walls (see **Photos 19 – 21**). At the southwest corner, we noted an area where the base of the stone wall had partially collapsed inward (see **Photo 21**).

Photograph 17 – View of typical foundation wall configuration

1. Remove and replace the existing foundation in its current location with a new cast-in-place foundation wall. This will require partial removal of the existing foundation wall, in pieces, if the superstructure is going to remain in place during the foundation work. Based on the extent of work to the superstructure, it may be more practical to demolish the superstructure.

2. Build a new foundation wall at the inside face of the existing foundation wall. This option will require either new vertical supports for the floor joists and rafters at the exterior wall, such as a new interior bearing wall, or new floor framing at the first floor that can cantilever past the new interior foundation wall and support the framing above. The demand on the exterior walls can be significantly reduced if an interior girder/column line are introduced at midspan of the first floor, second floor, and roof.

3. Demolish and infill the existing basement and build a new frost-protected foundation or conventional foundation wall at the first floor elevation. Since many of the foundation problems stem from moisture intrusion and grading, removal of the basement and existing foundation walls will significantly reduce the moist intrusion challenges into the build.

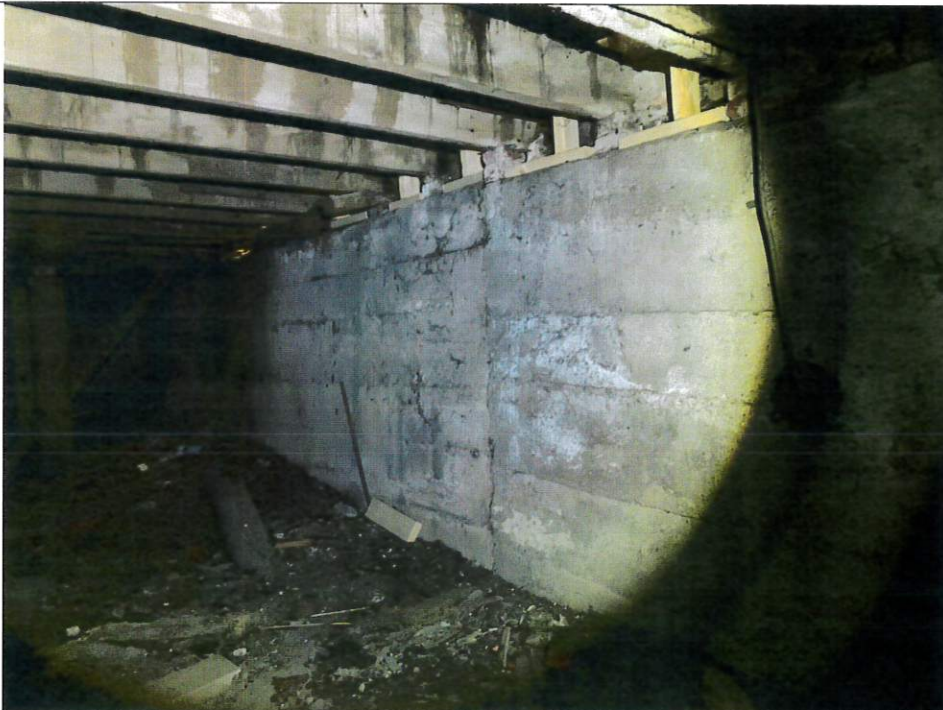
Photograph 18 – View cast-in-place concrete foundation wall at south (front) elevation

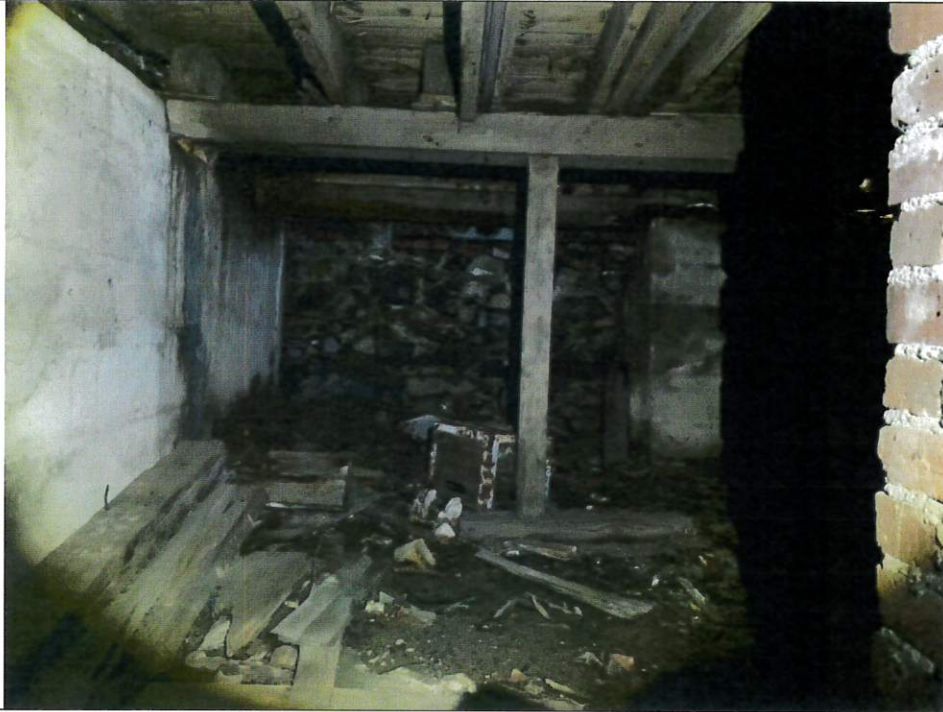
Photograph 19 – View south and east foundation walls. Note cast-in-place wall note located at garage door opening area.

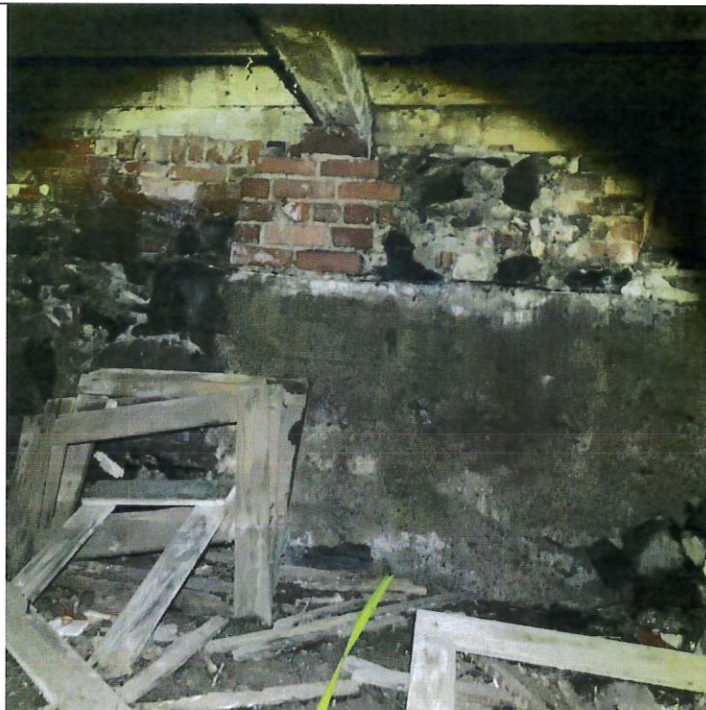
Photograph 20 – View of west exterior wall elevation

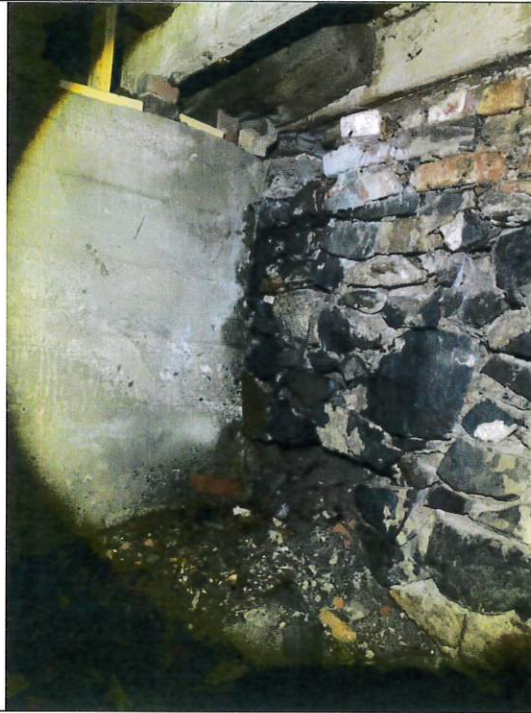
Photograph 21 – View of foundation at southwest corner. Note partially collapsed stone wall at base of the west foundation wall.
