CITY OF SOMERVILLE, MASSACHUSETTS
MAYOR JAKE WILSON
DEPARTMENT of INFRASTRUCTURE & ASSET MANAGEMENT
ENGINEERING DIVISION

SOMERVILLE IDDE INVESTIGATION – PERMIT YEAR 7 CATCHMENT INSPECTION

The purpose of this memorandum is to summarize investigations conducted by the City of Somerville, Massachusetts (City) in support of the MS4 General Permit (Permit) Illicit Discharge Detection and Elimination (IDDE) requirements. This memorandum describes the IDDE activities conducted to locate a suspected illicit connection located in Catchment 7 on Weston Avenue and recommended next steps.

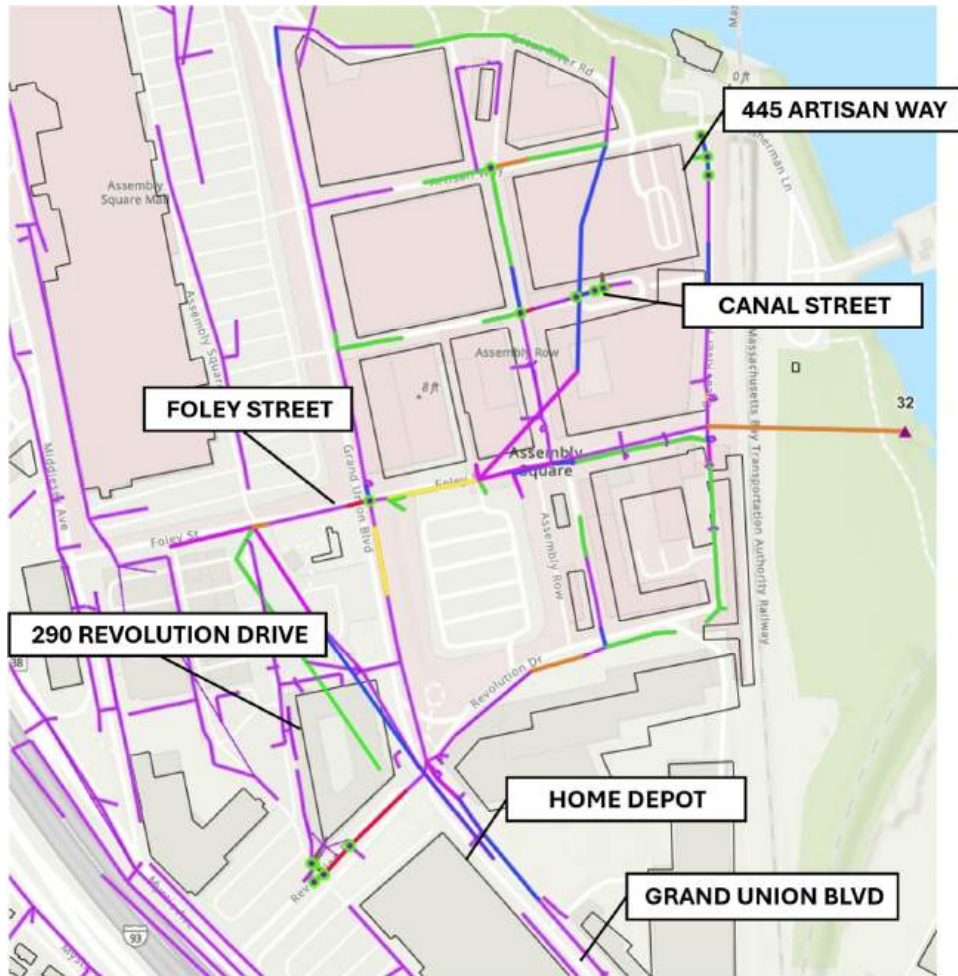
FIGURE 1: CATCHMENT 32 OVERVIEW

Catchment 32 is a highly interconnected catchment that also experiences tidal influence based on the location of the outfall. Due to tidal influence, the drain line has been observed flowing in reverse. For this reason, while there are multiple distinct areas of the catchment, the backflow characteristics make it hard to isolate contamination sources. The main regions within Catchment 32 (Canal Street, Foley Street, Revolution Drive, and Grand Union Boulevard) are shown in Figure 1.

Revolution Drive: Sampling results from December 2020 showed that pipe segment 32-6267 : 32-6265 on Revolution Drive met the likely sewer indicators threshold. The contaminated pipe is located in front of 290 Revolution Drive, which is a newly constructed building. Upstream sampling was completed in June 2023 to determine the source of contamination, and it was determined that contamination began in DMH 32-6425. Investigations from prior permit years near 290 Revolution Drive indicated that flow in DMH 32-6425 was associated with warmer weather, potentially caused by condensate from a HVAC unit discharging into a roof drain. This theory was suggested because all building dye tests were legal and the structure always observed dry during winter months. SDE was able to complete pipe inspections during warmer weather conditions in June 2025. When SDE re-visited this location in June 2025, a sample was taken for human and total bacteroides; however, both test results were non-detect. This indicates that some source of ammonia is getting into the drainage system in this area, but there is no evidence of sewage. There is a

Canal Street: The sampling results from December 2020 showed that pipe segment 32-7001 : 32-6122 on Canal Street met the likely sewer indicators threshold. This segment is located downstream of 445 Artisan Way, which is a large retail/commercial/apartment complex. The pipe segment (32-7000 : 32-6443) had a sewage odor and visual evidence of sewage present during an April 2023 inspection. CCTV was completed on Canal Street in September 2023 of pipes on the eastern side of DMH 31-6122. The CCTV inspections showed an unmapped inlet in DMH 32-6442. The inlet was observed to have waste and toilet paper entering the drainage manhole. The camera went 54.8' into the property of 445 Artisan Way (this property is an apartment complex also known as 450 Canal Street) and could not move around the bend, however more toilet paper was seen coming from that direction. This is a suspected illicit connection from the apartment complex. As mentioned previously, there was also potential waste/visual evidence observed in DMH 32-7000 in April 2023. There could potentially be multiple issues here as this is not in line with the unmapped inlet to 32-6442.

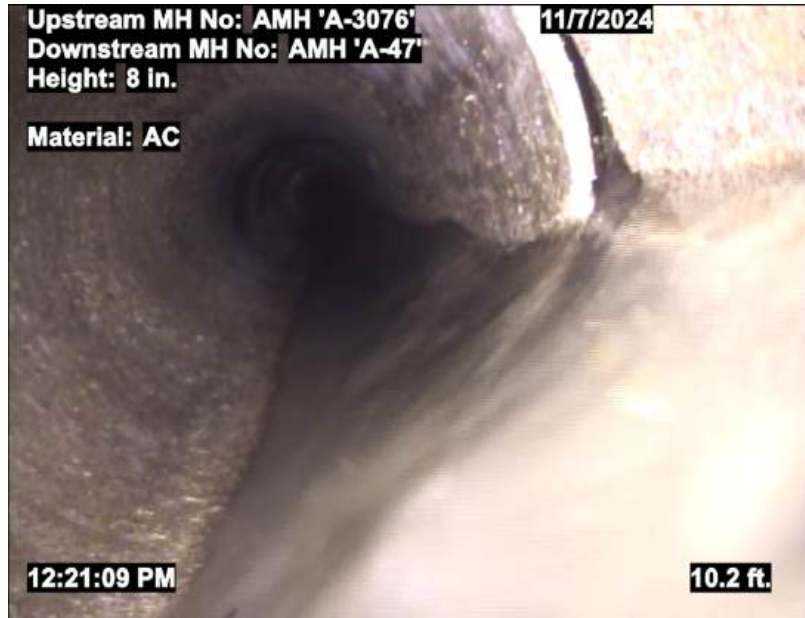
FIGURE 1: JOINT OFFSET IN SANITARY SEWER MAIN A-3076 : A-47

One of the most notable defects was a large offset in the sanitary sewer pipe A-3076 : A-47, where water appears to be exfiltrating out of the sanitary sewer pipe. This is shown in **Figure 1** below.

As described above, A-3076 : A-47 has a high chance for exfiltration and it is clear that water is infiltrating into both storm drain segments on Weston Avenue (7-6459 : 7-5831 and 7-5831 : 7-5829). Therefore, there is a high probability that wastewater is exiting the sanitary sewer system and entering the MS4 drainage system.

It is important to rehabilitate the sanitary sewer and storm drain pipes on Weston Avenue to prevent contamination from entering the drainage system and protect nearby waterbodies. Recommendations for rehabilitation to prevent illicit connections are summarized in the table below. While cured in place pipe (CIPP) lining will address illicit connections, for those segments with documented sags full replacement should be considered to both address illicit connections and reestablish full flow capacity.

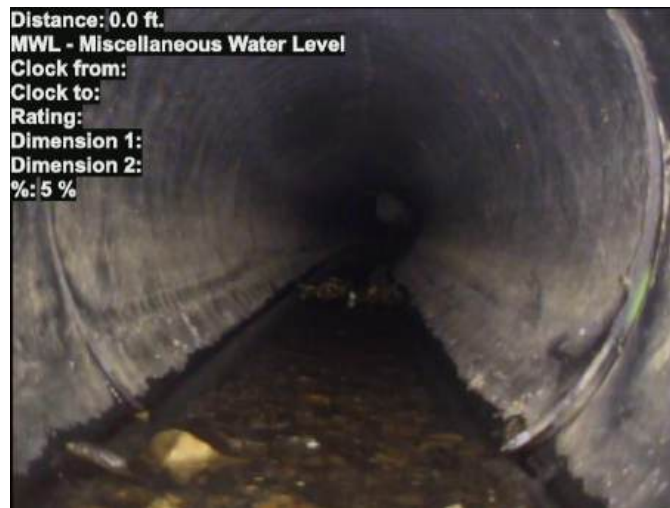
FIGURE 2: STORM DRAIN 7-6459 : 7-5831 (VIEW FROM DMH 7-5831)

The CCTV inspection for 7-6459 : 7-5831 had some signs of infiltration and standing water at the start of the inspection from DMH 7-5831 as shown in **Figure 2** below. The dark stains around the edge of the joint indicate the potential for water to enter the pipe.

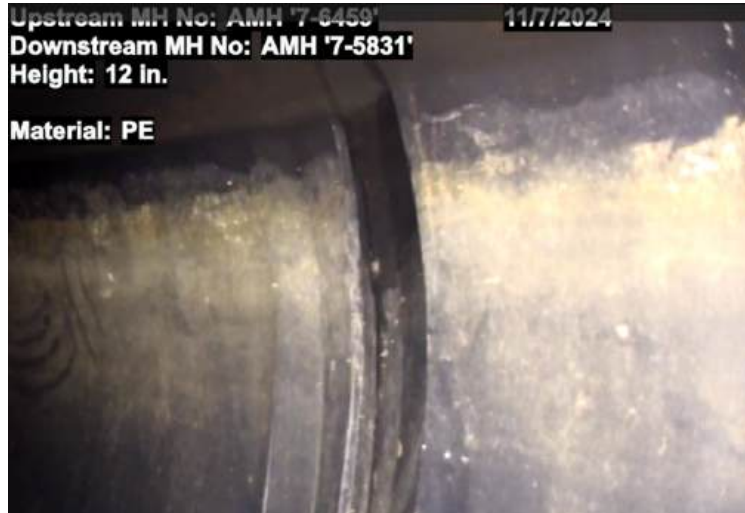
FIGURE 3: JOINT SEPARATION IN STORM DRAIN 7-6459 : 7-5831

The joint approximately 15 feet from DMH 7-5831 also appears to have some separation, as shown in **Figure 3** below.

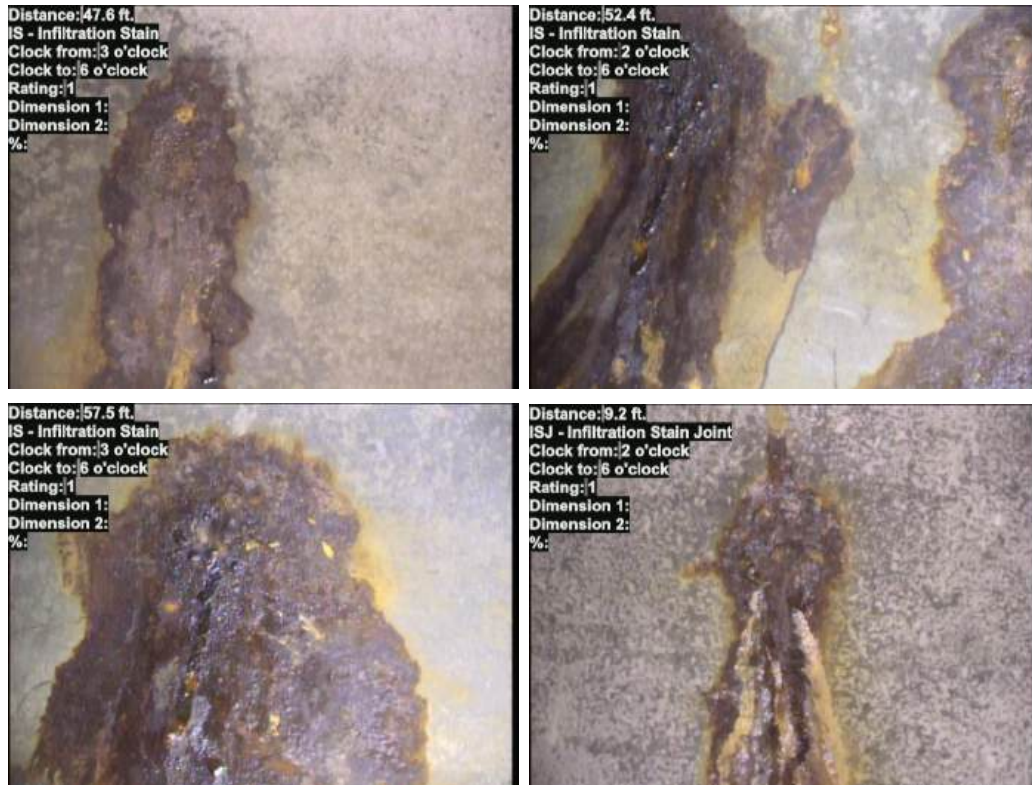
FIGURE 4: INFILTRATION IN STORM DRAIN 7-5831 : 7-5829

CCTV inspections also showed infiltration stains on joints and throughout entire storm drain pipe 7-5831 : 7-5829. This is the furthest downstream storm drain pipe on Weston Avenue, before the pipes tie into Broadway. Photos of infiltration locations are included in **Figure 4** below.

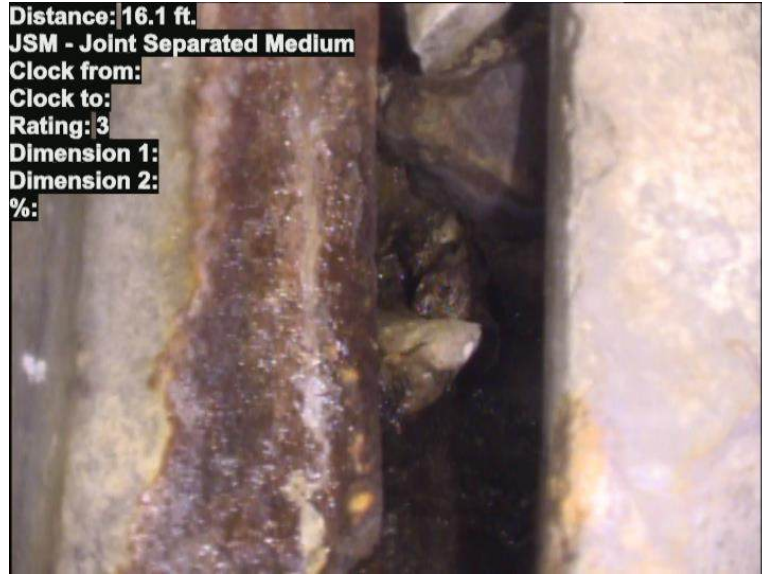
FIGURE 5: JOINT SEPARATION WITH INFILTRATION IN STORM DRAIN 7-5831 : 7-5829

Segment 7-5831 : 7-5829 also was observed to have a separated joint with evidence of infiltration, proving that water is able to infiltrate into the storm drainage system. Since wastewater appears to be exfiltrating out of the sanitary sewer system, it has the capacity to infiltrate into the City's MS4 drainage system. The separated joint with infiltration is shown in **Figure 5** below.

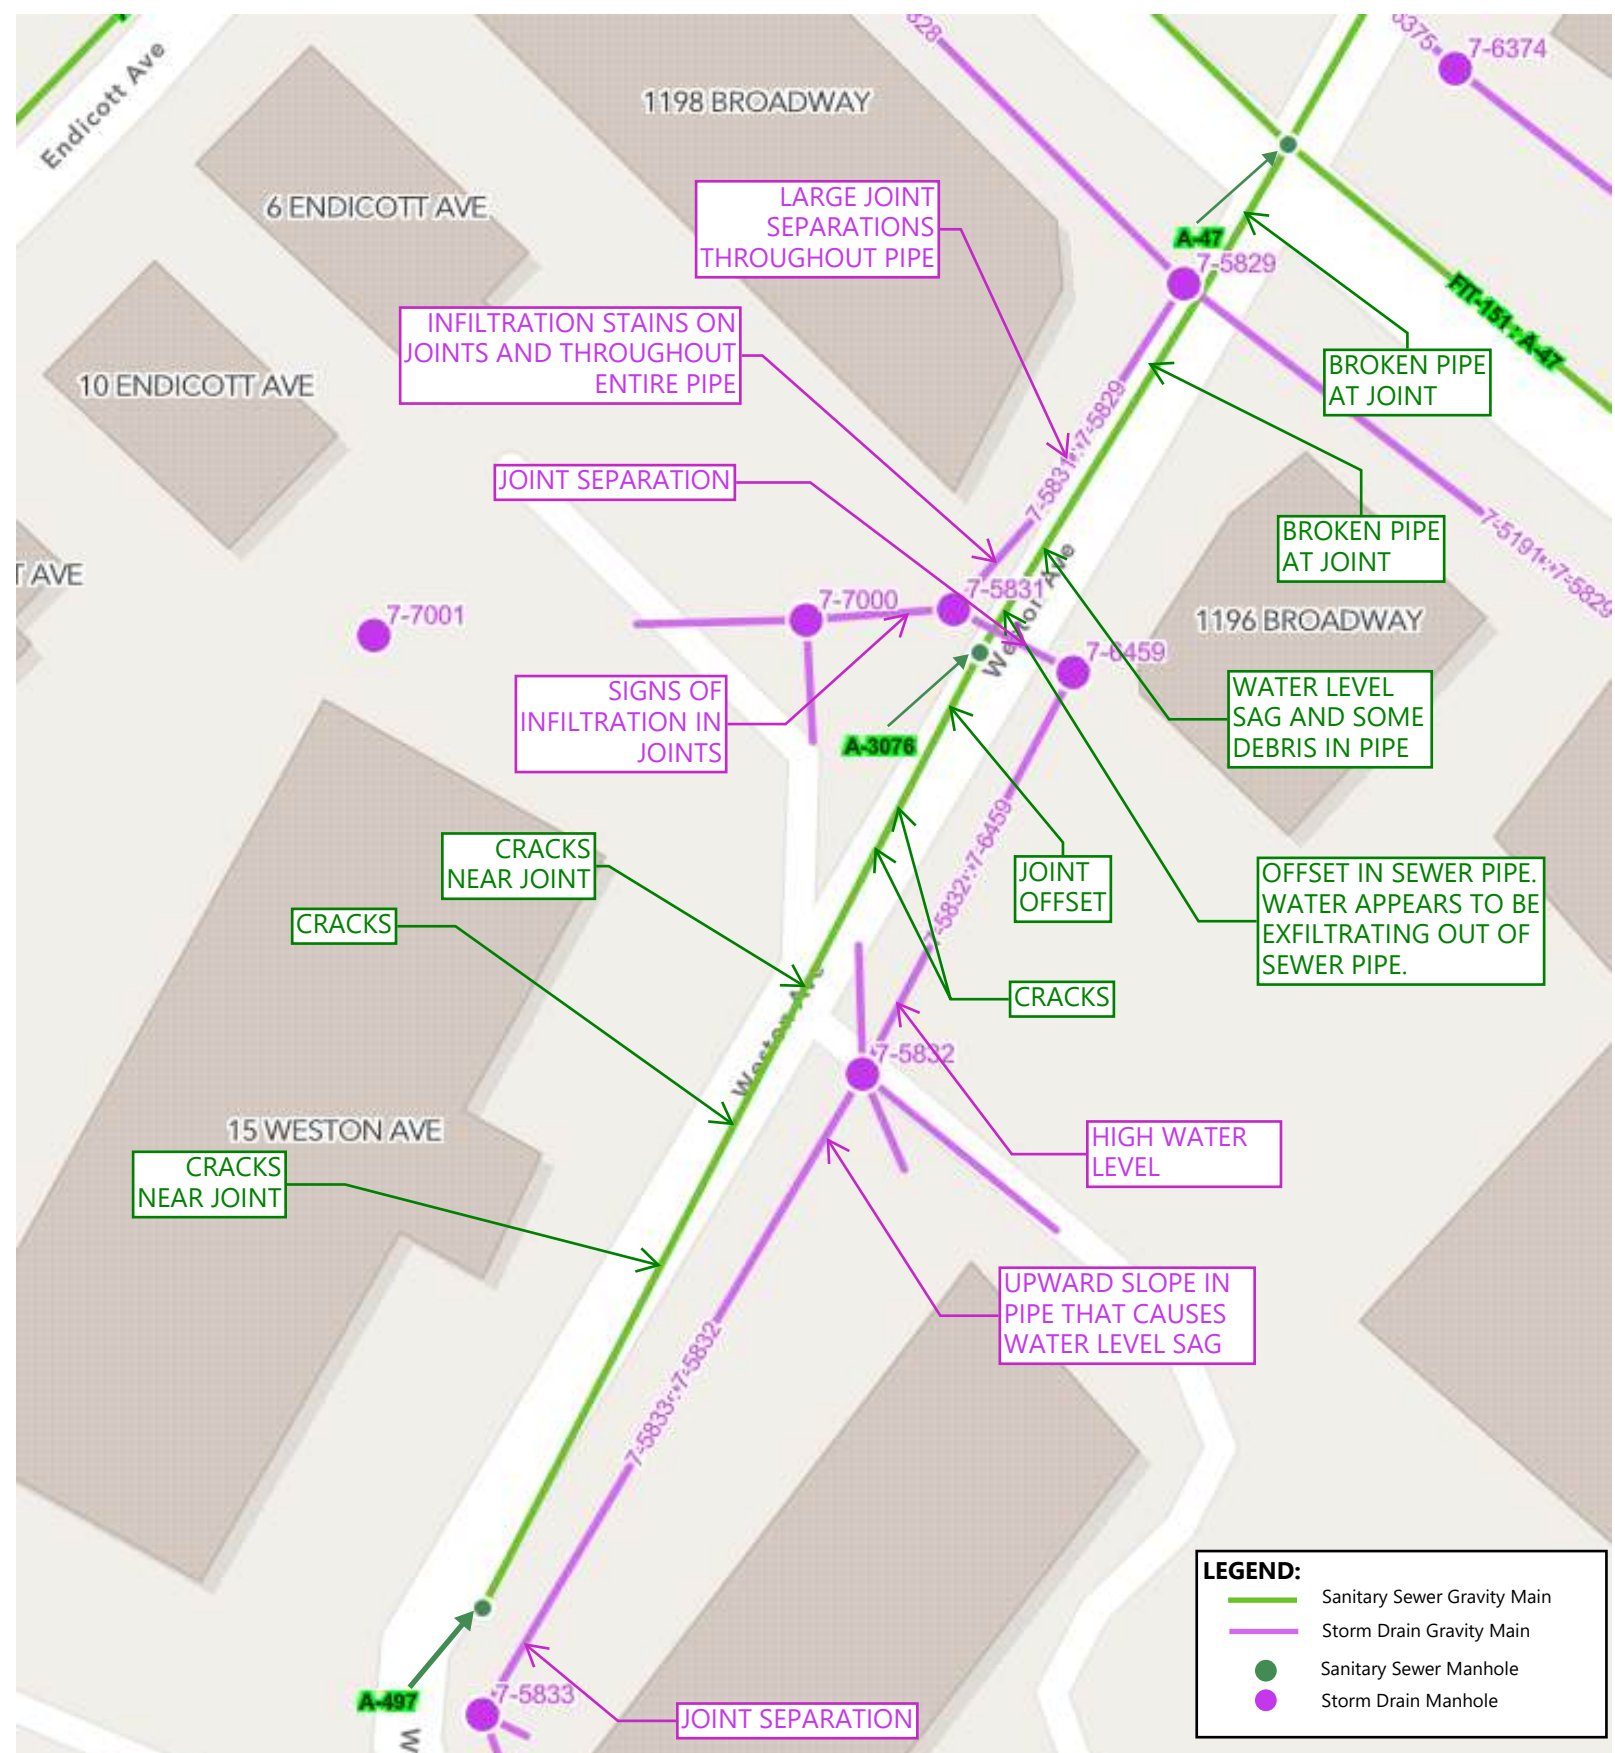
Attachment: Weston Ave CCTV Summary Permit Year 7 Figure

Pipe Segment	System	Diameter (in)	Material	Length (ft)	Notes	Recommendation
7-5833 : 7-5832	Storm	12	HDPE	124	Joint Separation Upward Slope/Water Level Sag	Replace or CIPP
7-5832 : 7-6459	Storm	12	HDPE	76	Water Level Sag	No Action or CIPP
7-6459 : 7-5831	Storm	12	HDPE	24	Joint Separation	Replace or CIPP
7-5831 : 7-5829	Storm	12	VCP	65	Infiltration Stains Joint Separation	Replace or CIPP
A-497 : A-3076	Sanitary	8	VCP	179	Cracks Offset Joint	Replace or CIPP
A-3076 : A-47	Sanitary	8	VCP	98	Broken Pipe at Joints Offset Joint (with exfiltration)	Replace
