INSPECTIONS FOR FALL HAZARDS AT BUILDING INTERIOR AND FACADE

Winter Hill Community Innovation School

3 October 2023

SGH Project 230889

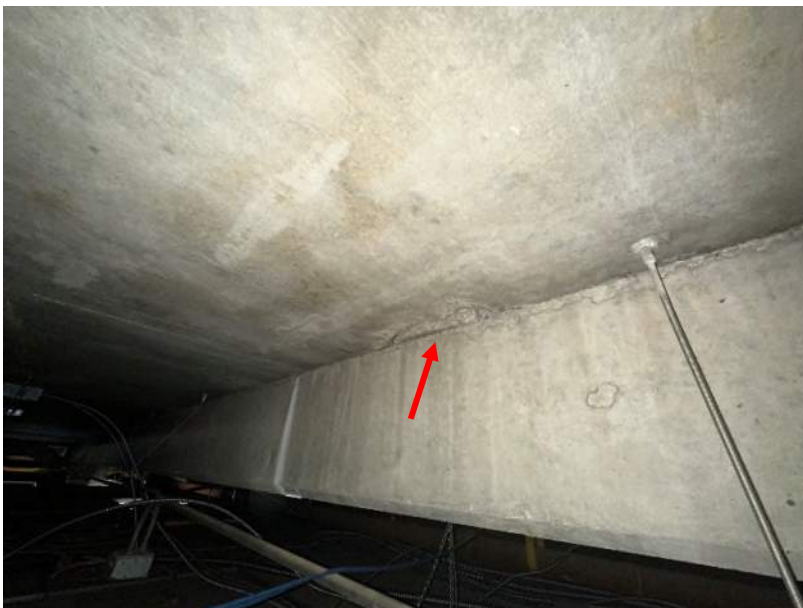
Photo 3

- The structure above the kitchen and cafeteria is in generally good condition.
- There are two locations with cracked concrete representing potential fall hazards, one at the cafeteria and one at the kitchen (Photos 3 and 4). Their size is approximately 3 in. by 6 in. Figure 1 shows the approximate locations of these areas. There is no indication of corrosion-induced damage at these locations.

Cracked concrete at kitchen representing fall hazard.

- Remove concrete identified as a potential fall hazard at the underside of the floors above the kitchen and cafeteria. Removal of unsound concrete at these locations does not compromise the floor's structural integrity and, therefore, does not require immediate repairs.
- Remove grout identified as a potential fall hazard at the top of the partition CMU wall. Removed grout will need to be repaired to restore fire separation between the kitchen and cafeteria. This item requires further verification.

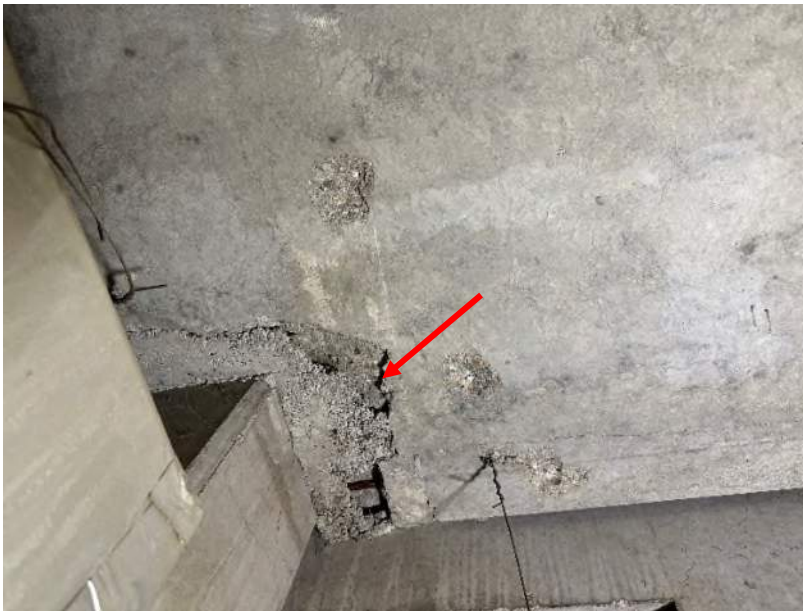
Photo 4

Cracked concrete at cafeteria representing fall hazard.

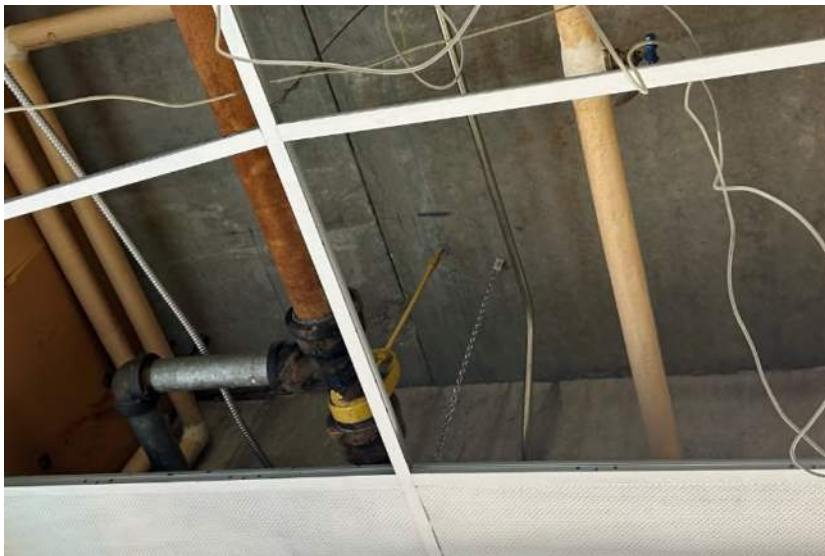
Photo 5

- There are three small areas of unsound concrete above the kitchen (Photo 5). Their size is approximately 6 in. by 6 in. We sounded the adjacent concrete and did not find loose or deteriorated concrete posing a potential fall hazard risk. Figure 1 shows the approximate locations of these areas.

Small area with unsound concrete above the kitchen.

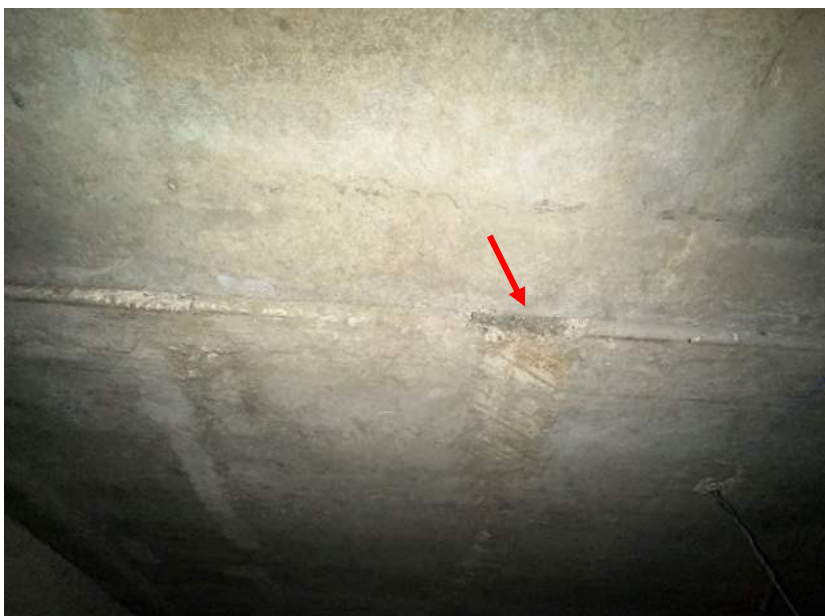
Photo 6

- There are multiple existing spalls in the concrete, typically at the joints between floor planks above the kitchen and cafeteria (Photos 6 and 7). Their sizes vary from 2 in. by 2 in. to 9 in. by 9 in. There is no indication of corrosion-induced damage at these locations. We sounded the adjacent concrete and did not find loose or deteriorated concrete posing a potential fall hazard.

Existing small spall above kitchen.

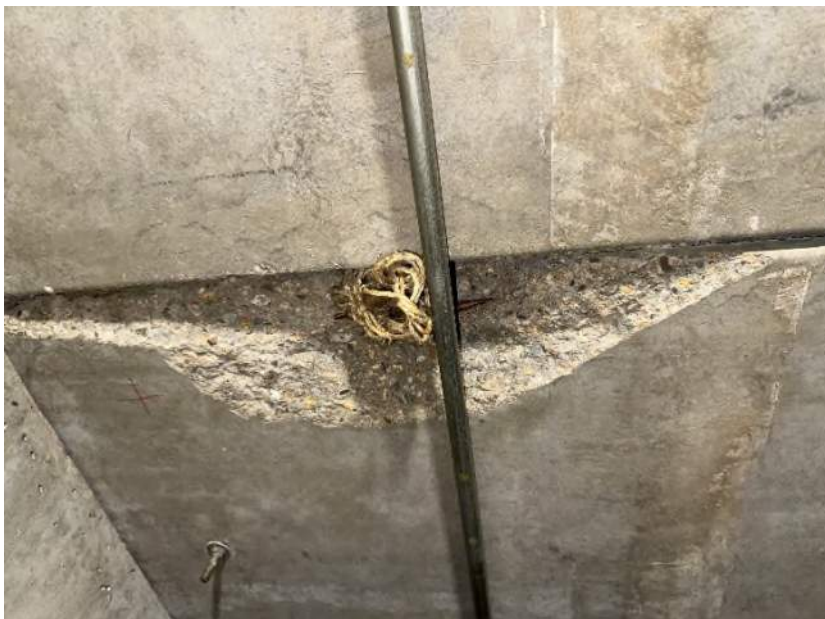
Photo 7

Existing spall above cafeteria.

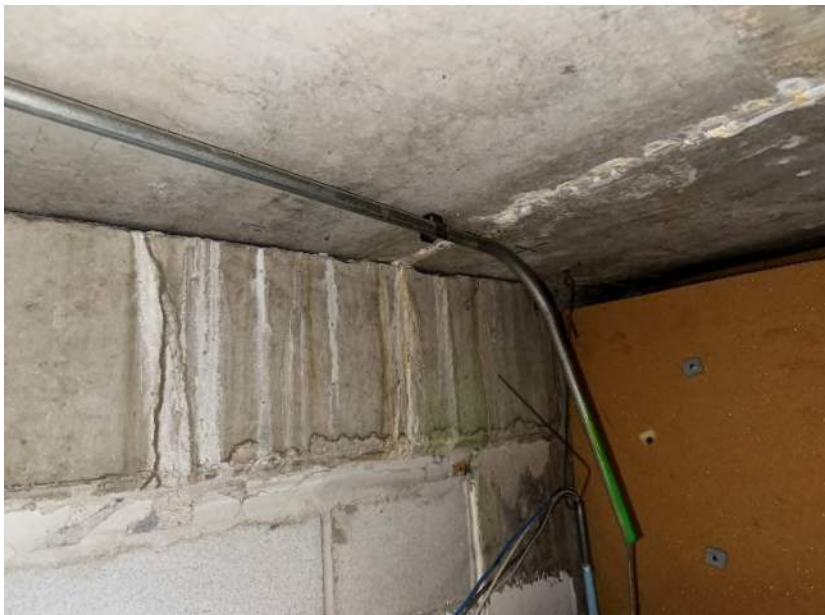
Photo 8

- There is efflorescence at several joints between floor planks and beams within the cafeteria and kitchen (Photo 8). There were no signs of active leakage. We sounded the adjacent concrete and did not find loose or deteriorated concrete posing a potential fall hazard.

Efflorescence at joint between floor planks and beams.

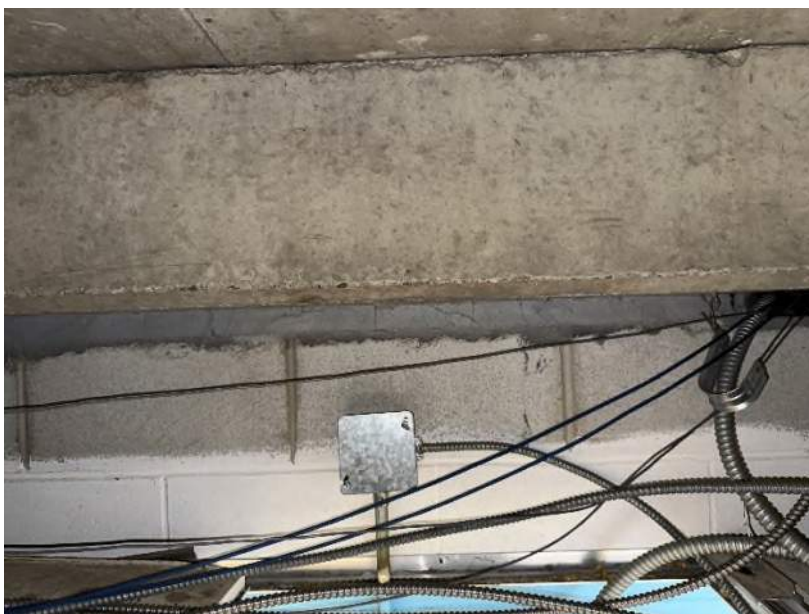
Photo 9

- The grout between the CMU partition wall and beam separating the kitchen and cafeteria is cracked and loose at several locations (Photo 9). The loose grout poses a potential fall hazard.

Cracked and loose grout at top of CMU partition wall representing potential fall hazard.

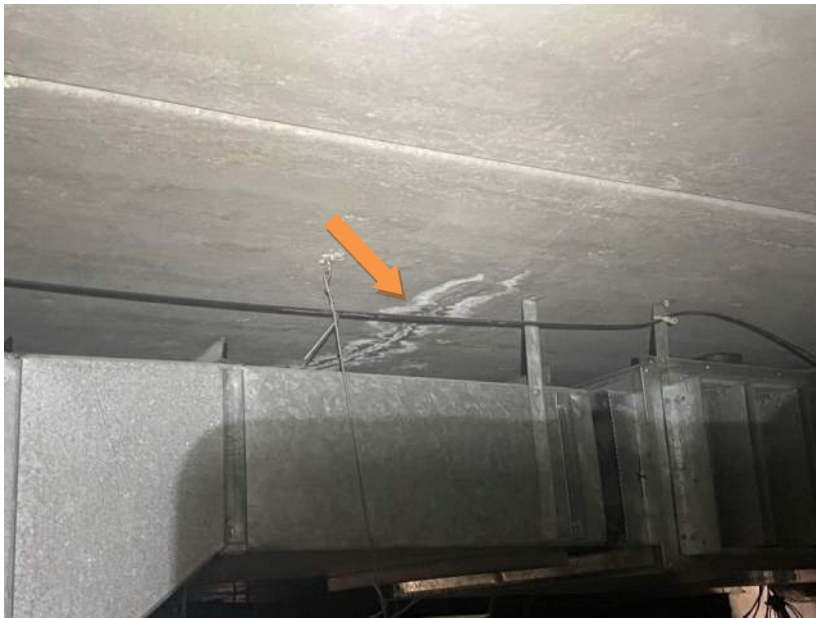
Photo 1

- The underside of the floor and roof structures are generally sound.
- There are small cracks with efflorescence at several locations throughout the underside of the floor and roof (Photo 1). The concrete surrounding these cracks is generally sound.
- There are small spalls, measuring less than 2 in. by 2 in., are at several locations throughout the classrooms, offices, and hallways (Photo 2). The spalls are typically located adjacent to mechanical hangers and appear to be abandoned attachment locations. There are additional spalls at other locations, such as panel joints, beams, and columns. The concrete surrounding the spalls is sound.
- There is heavy corrosion staining along beams, corbels, and mechanical ducts throughout Levels 3 and 4 (Photo 3). No active leaks were observed.

Crack with efflorescence at the underside of the floor.

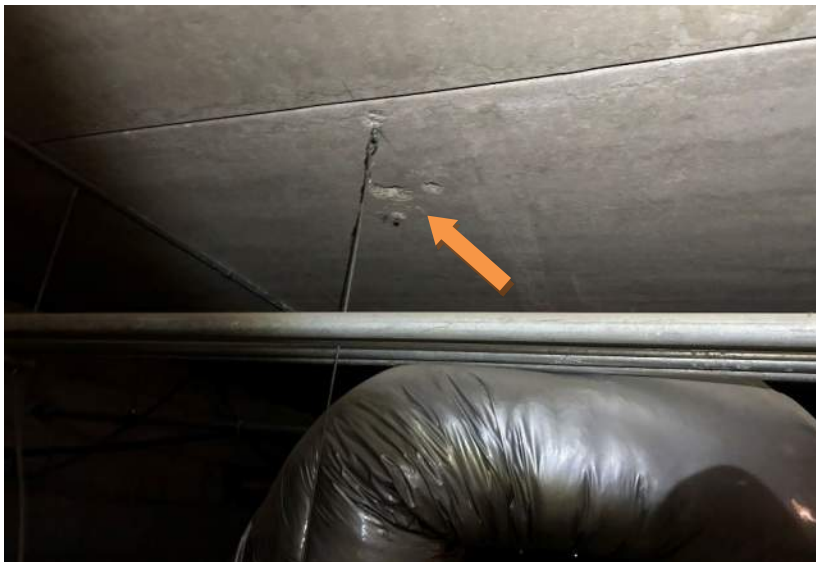
Photo 2

Small spalls adjacent to mechanical hangers.

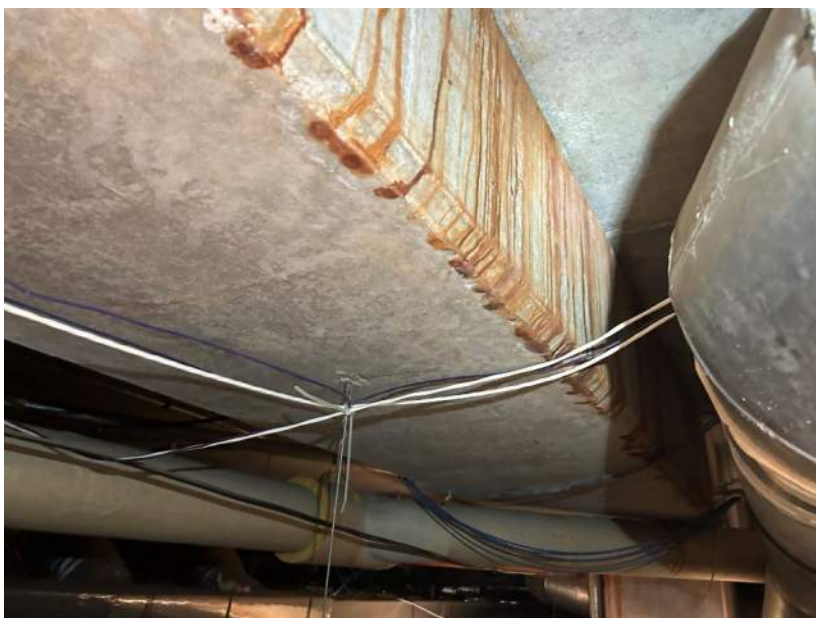
Photo 3

Heavy corrosion staining at underside of roof.

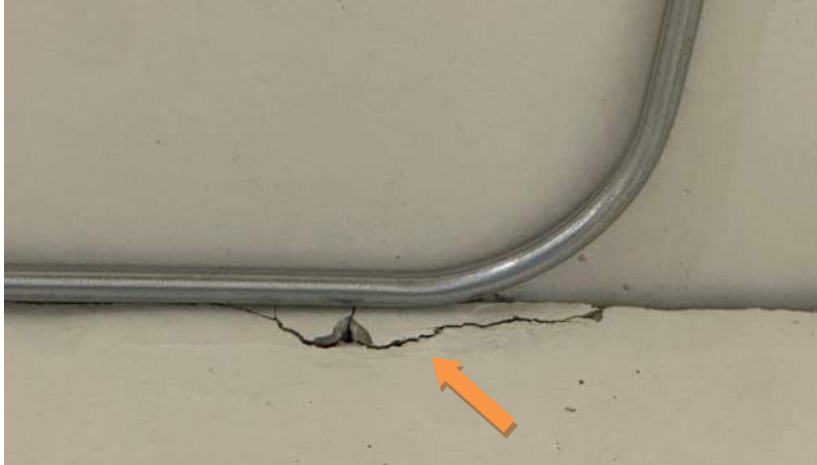
Photo 4

- Classrooms: there are seven potential fall hazards at three classrooms that we inspected, as described below:
 - Two potential fall hazards in Room 105. One potential fall hazard is located along a beam measuring approximately 1 in. by 6 in. (Photo 4). The second potential fall hazard is located at a corbel and measures approximately 3 in. by 3 in.
 - Two potential fall hazards in Storage Room 105. One potential fall hazard is along a panel joint measuring approximately 1 in. by 2 in. The second potential fall hazard is located adjacent to a column and measures 2 in. by 2 in.
 - Three potential fall hazards in Room 106. The three fall hazards are adjacent to columns and measure between 4 in. by 4 in. and 4 in. by 8 in.

Potential fall hazard in Room 105.

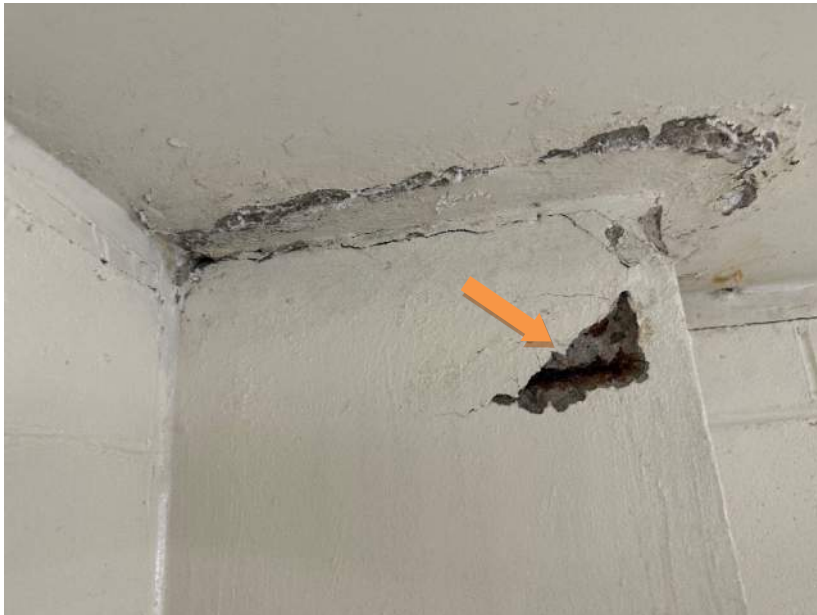
Photo 5

- An existing 4 in. by 12 in. spall is adjacent to a column in Room 106 with exposed and corroded reinforcement (Photo 5).

Existing spall with exposed reinforcement in Room 106.

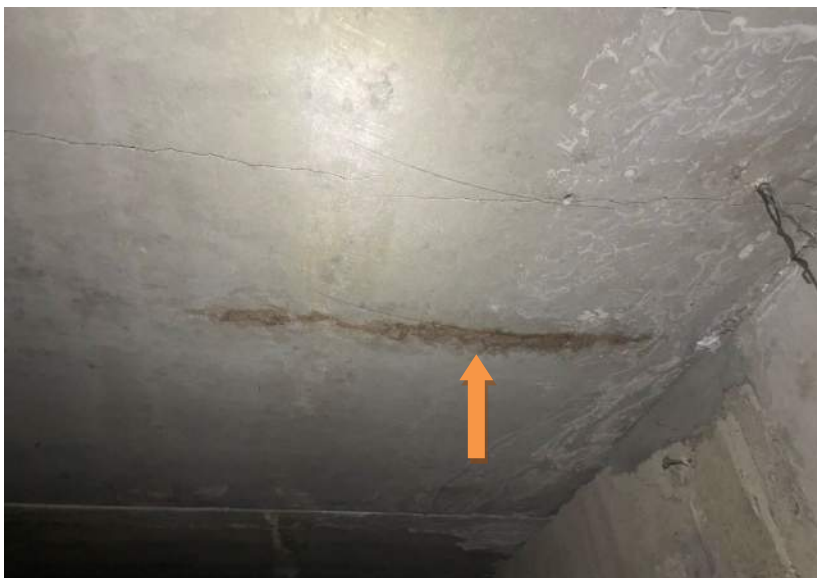
Photo 6

- One area of unsound concrete, measuring less than 1 sq ft, along with a crack showing corrosion staining in Room 216 (Photo 6).
 - Two existing spalls along panel joints and one existing spall at a beam in Room 219, each measuring 2 in. by 2 in.

Unsound concrete at crack with corrosion staining in Room 216.

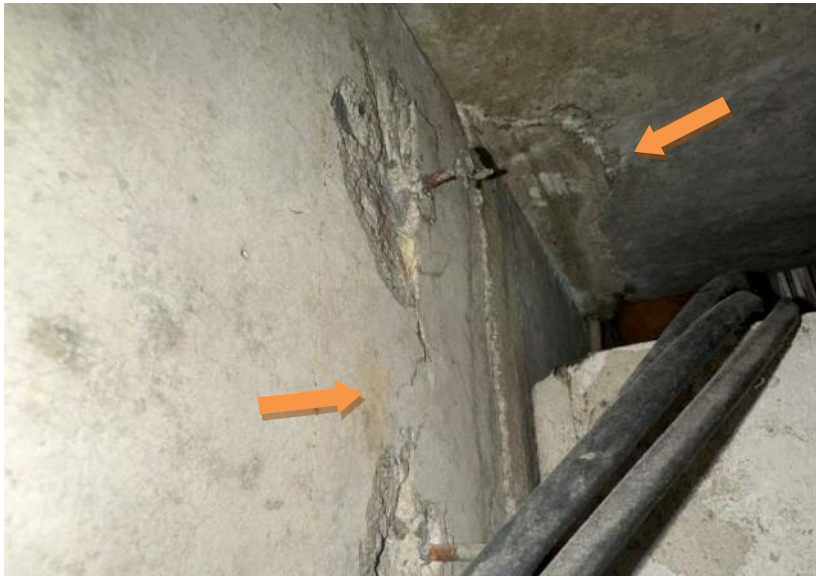
Photo 7

- One potential fall hazard above a beam adjacent to the hallway, measuring 3 in. by 6 in. (Photo 7).

Potential fall hazards in Level 2 hallway outside of the gymnasium.

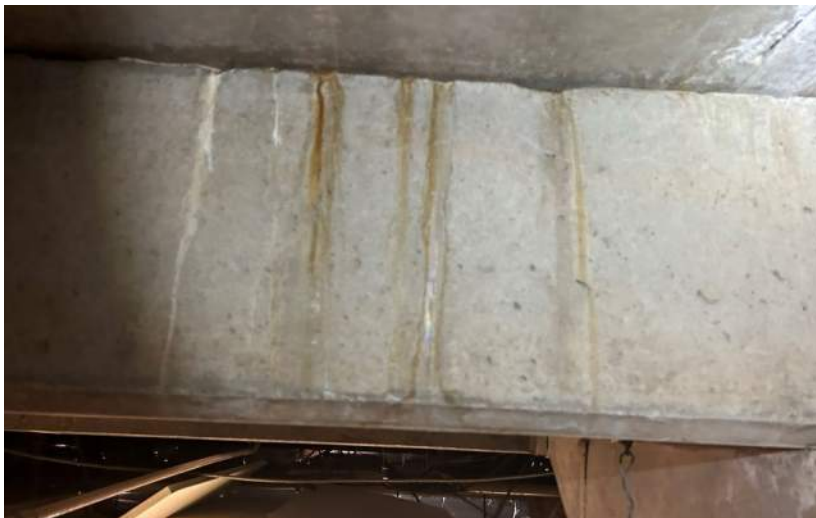
Photo 8

- Two existing spalls, measuring 6 in. by 6 in., in Office 209.
- Significant efflorescence and corrosion staining along a beam and corbel in Office 205 (Photo 8).
- An existing spall along a panel joint in Room 210, measuring 2 in. by 4 in.

Corrosion staining at beam in Office 205.

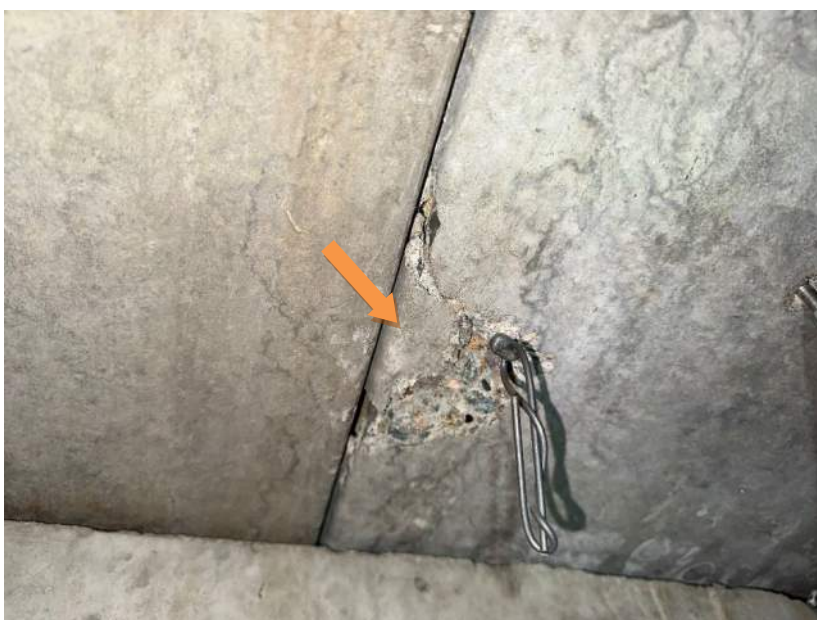
Photo 11

Potential fall hazard in Room 413.

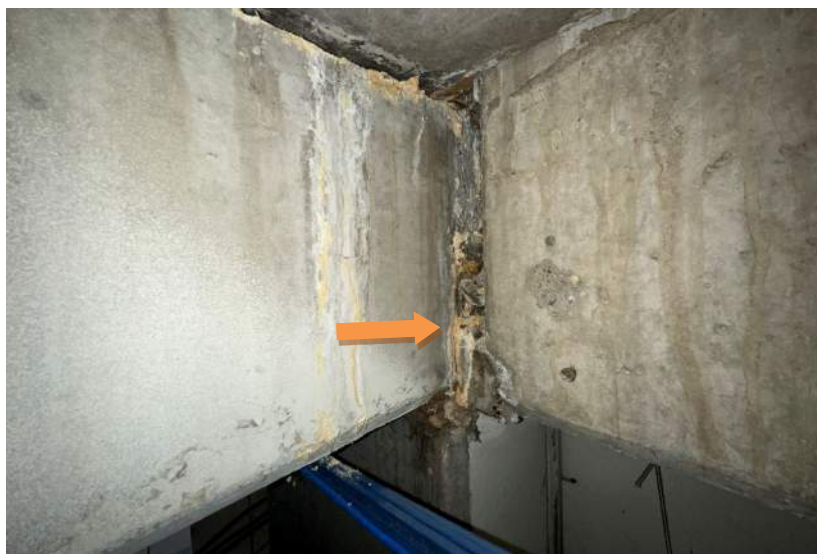
Photo 12

Loose grout along a beam joint in the computer lab.

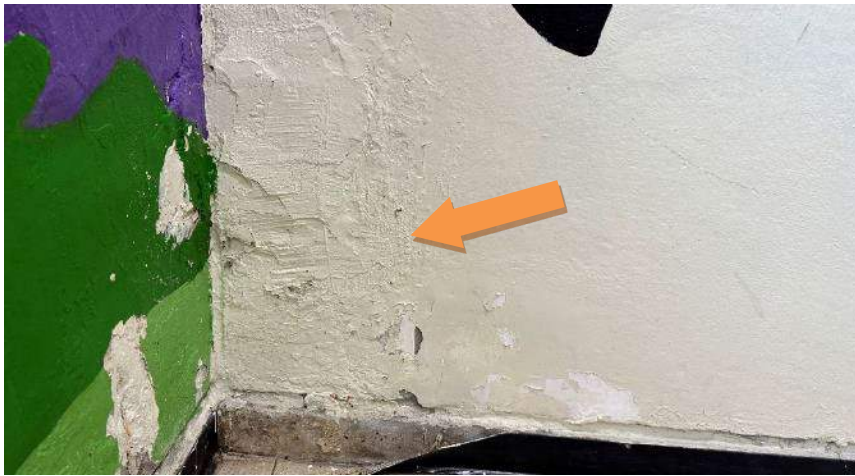
Photo 1

Loose grout at connection.

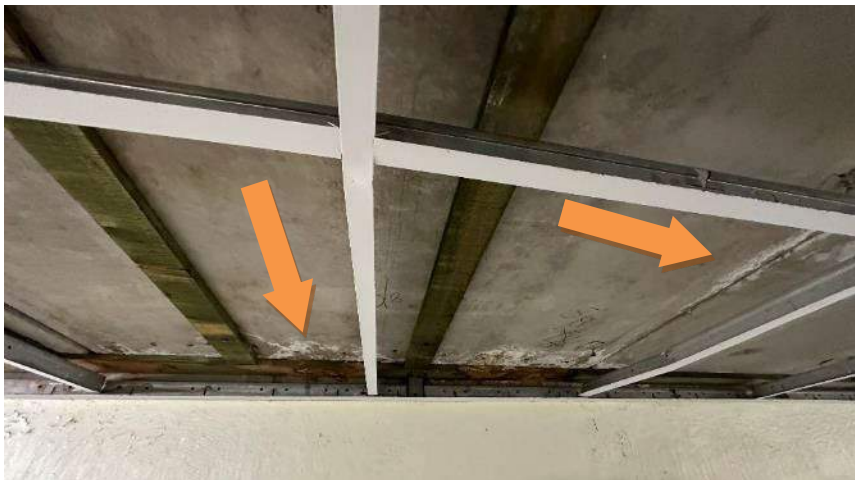
Photo 2

Heavy efflorescence at panel joints at the roof level.

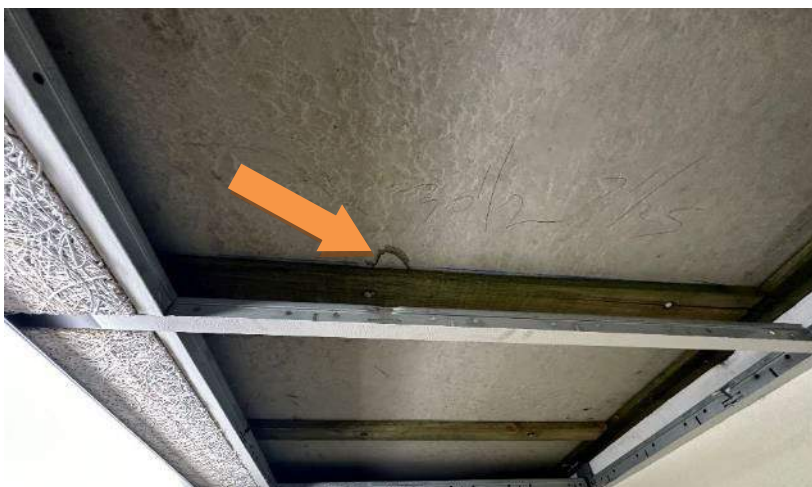
Photo 3

Potential fall hazard at wood furring.

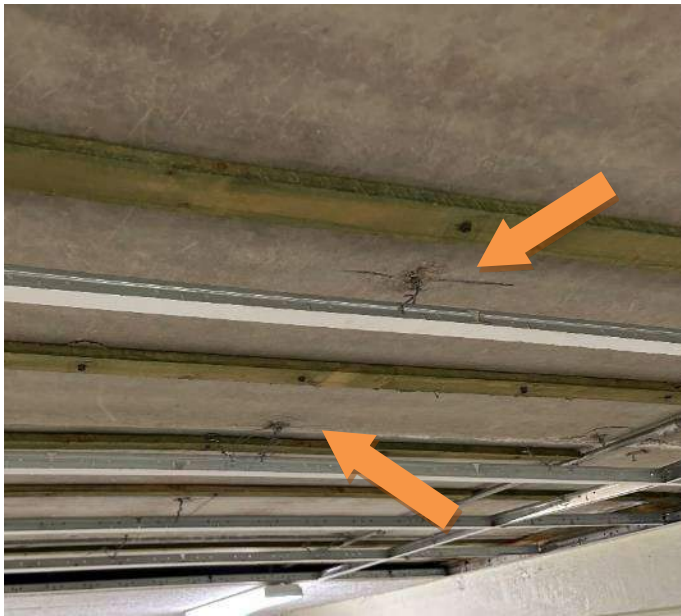
Photo 4

Existing spalls adjacent to mechanical hangers.

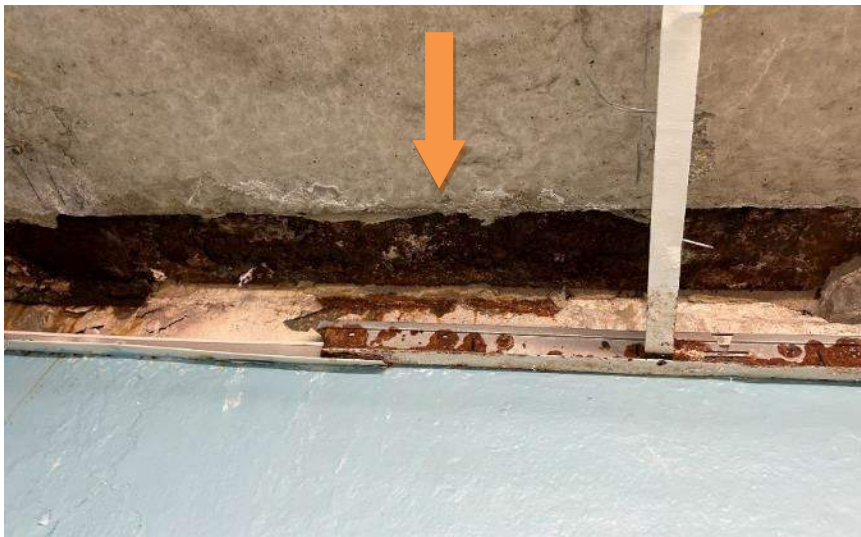
Photo 5

Corroded steel bearing plate at landing and wall connection.

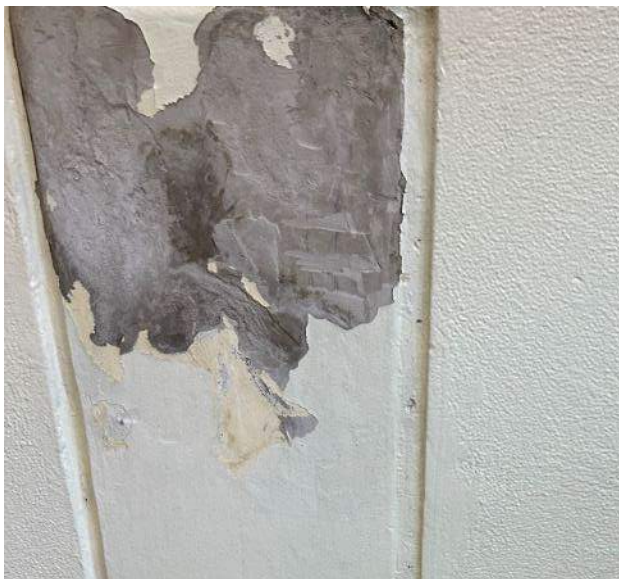
Photo 6

Deteriorating cementitious coating at Stair 1 wall.

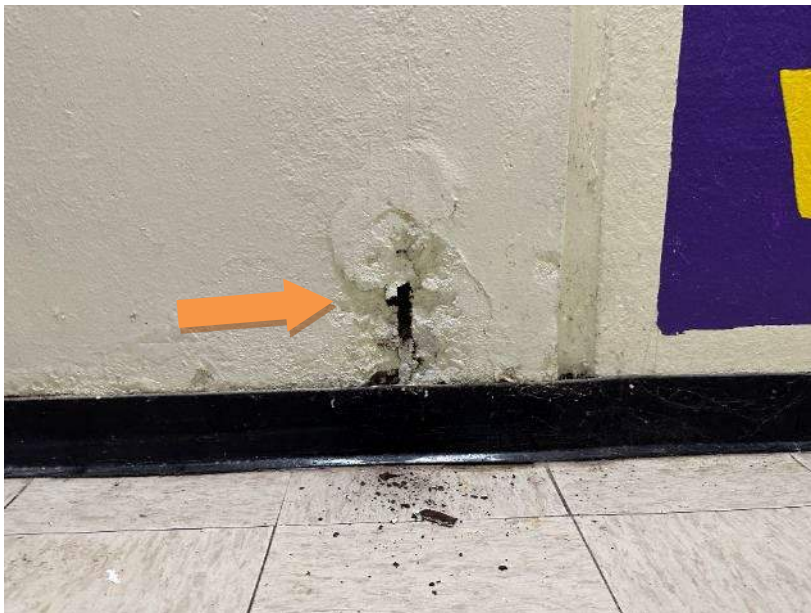
Photo 8

Potential fall hazard at Stair 1 with exposed bar.

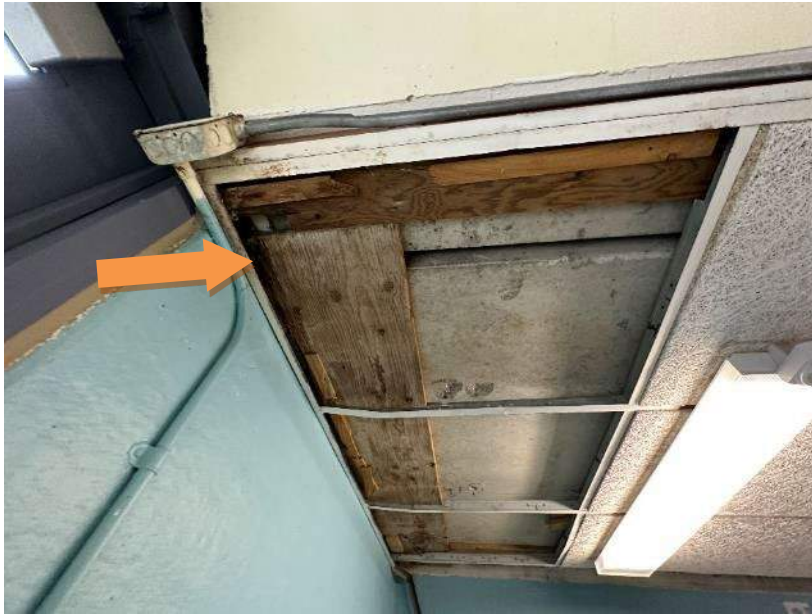
Photo 10

Wet plywood covering bearing plate at the Stair 3 landing between Levels 2 and 3.

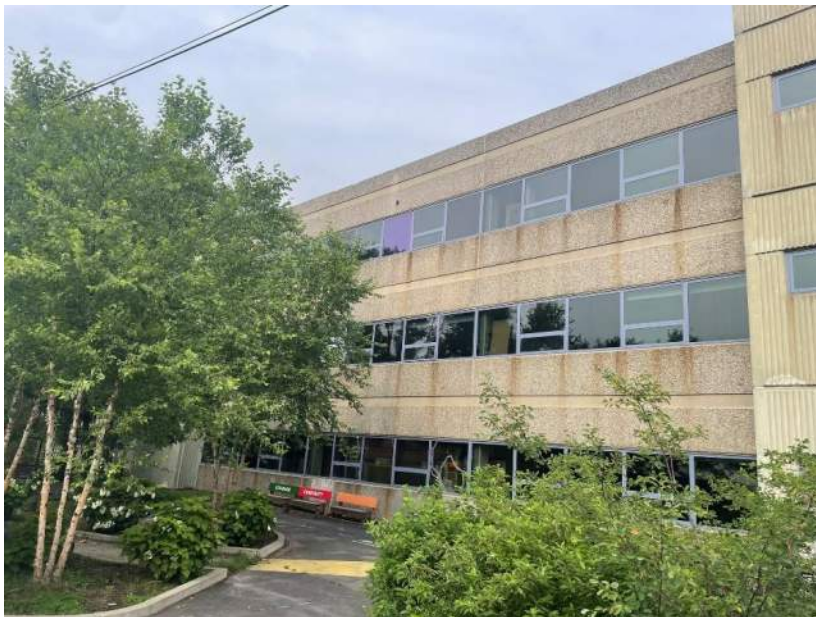
Photo 1

Corrosion staining along East facade.

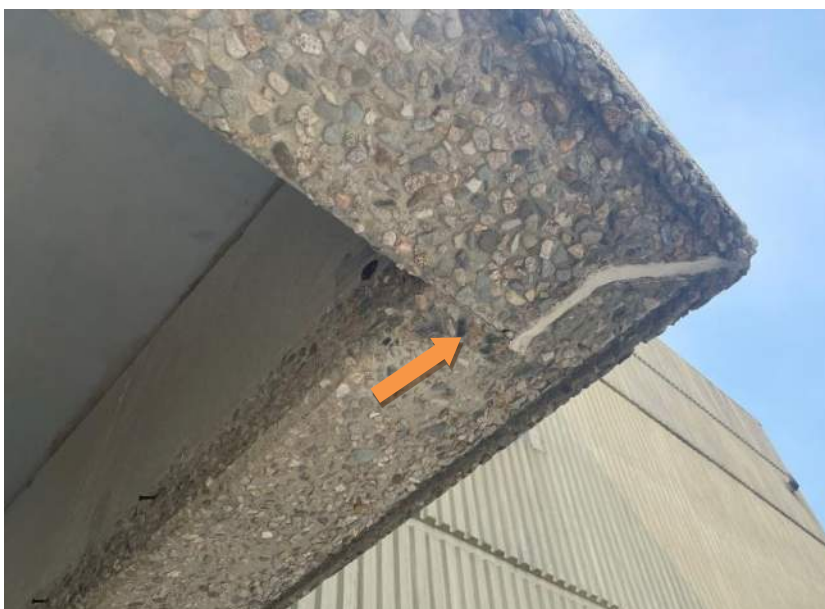
Photo 3

Crack at beam joint above north entry.

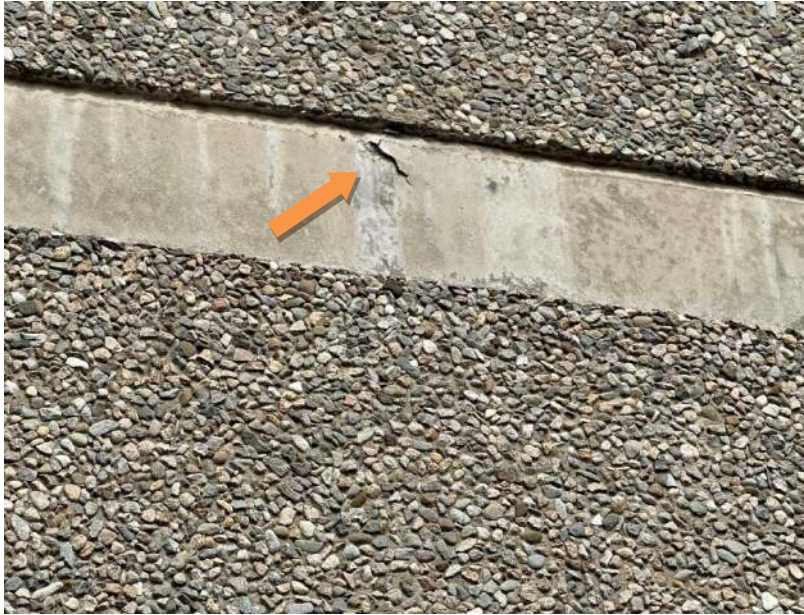
Photo 4

Potential fall hazard at facade.

- Remove concrete identified as a potential fall hazard. Removal of unsound concrete at these locations does not compromise the facade's structural integrity, and therefore, does not require immediate repairs.
- Inspect and resecure loose fixtures.
- Perform a hands-on inspection of representative and suspect areas.

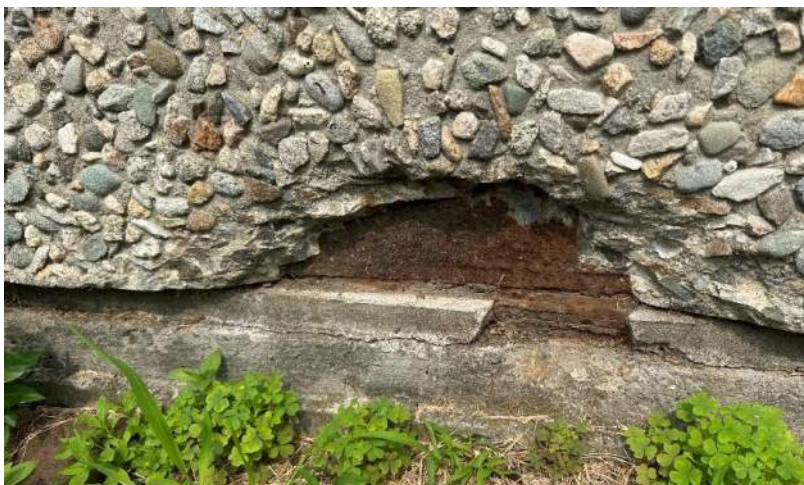
Photo 5

Existing spall at east facade.

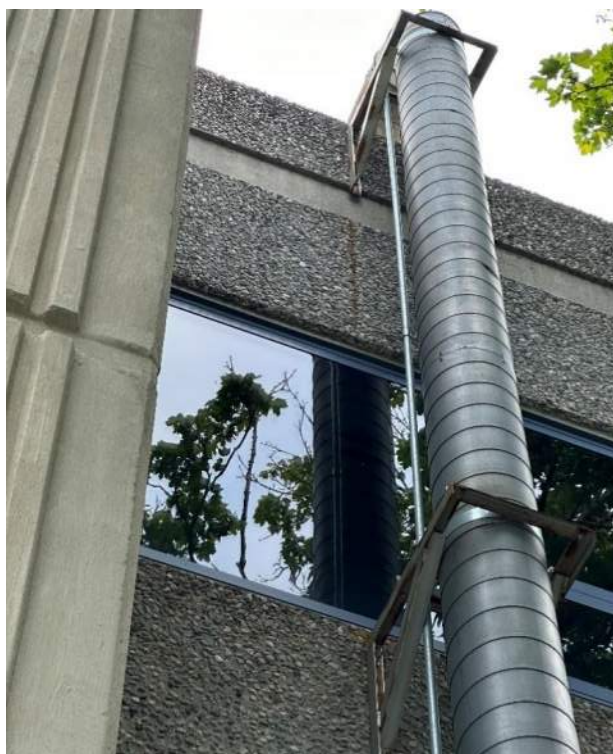
Photo 6

Corroded steel frames at
Stair 1.

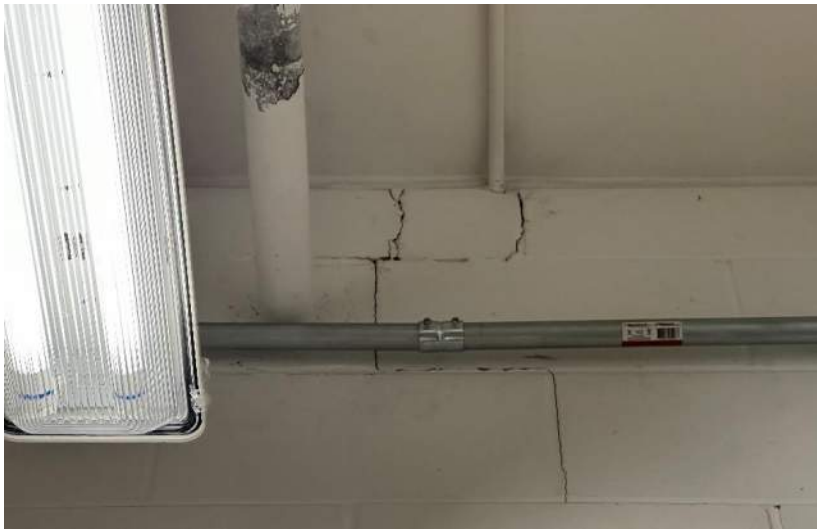
Photo 1

Cracked CMU partition walls at Level 1.

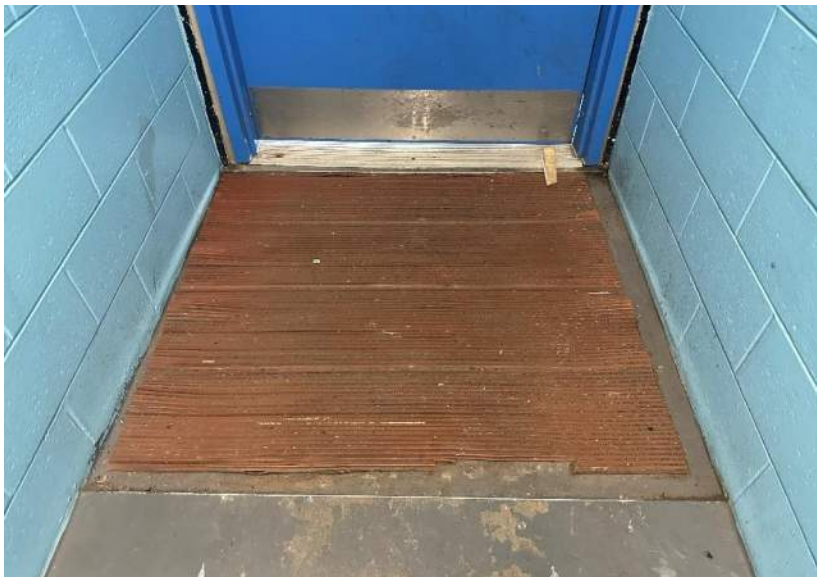
Photo 2

Tripping hazard at exterior door.

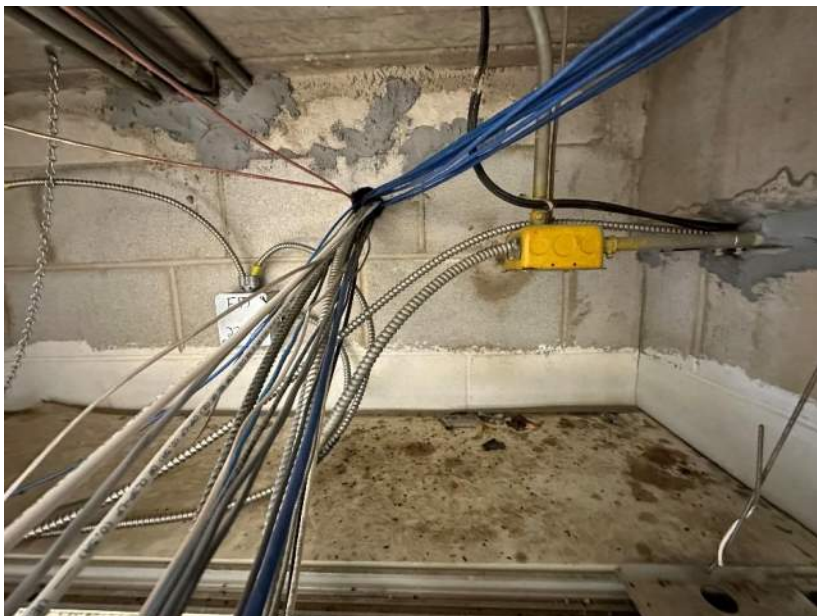
Photo 3

Mouse droppings in kitchen ceiling.

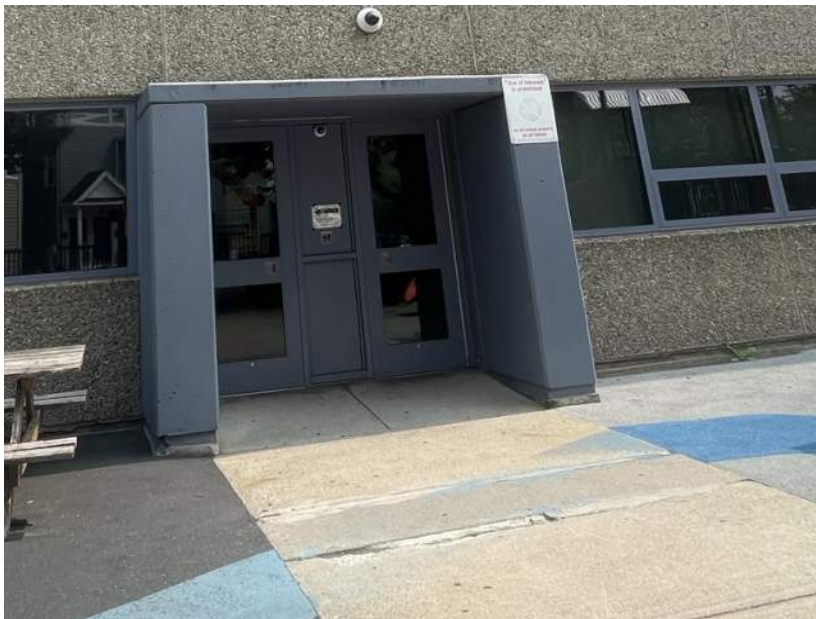
Photo 6

Damaged sidewalk at southern entrance.

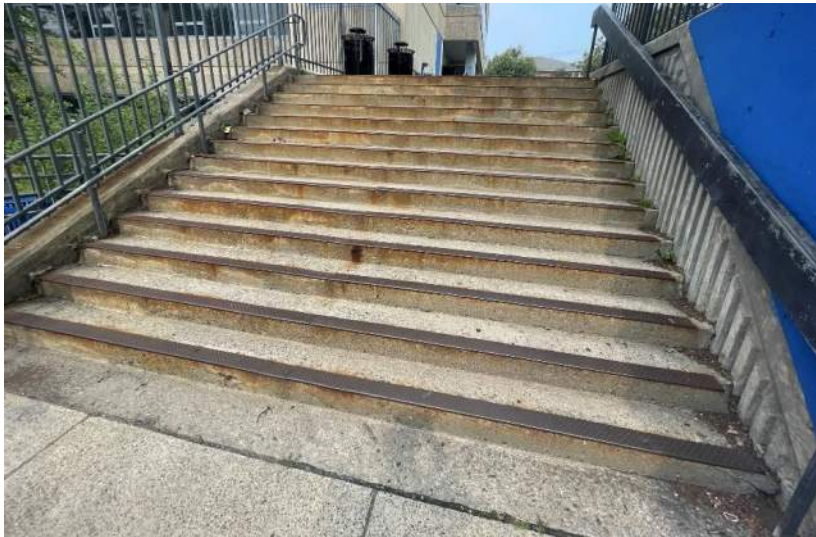
Photo 7

Worn and corroded exterior stairs to Thurston Street.

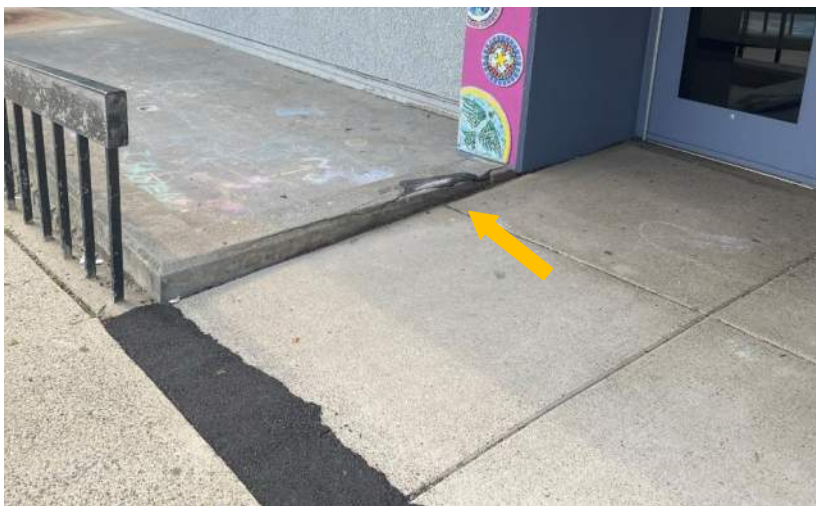
Photo 8

Spalled curb at north entry.

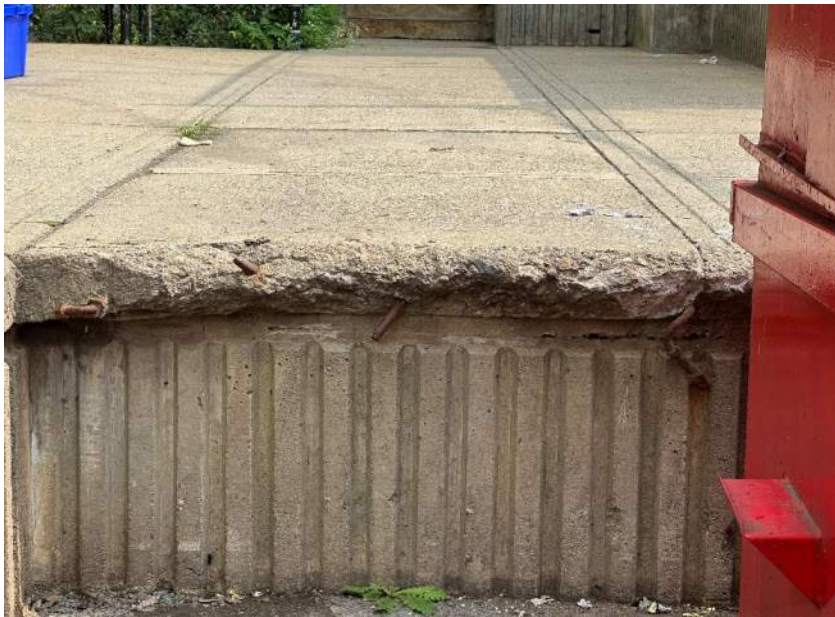
Photo 9

Spalling at edge of loading dock.

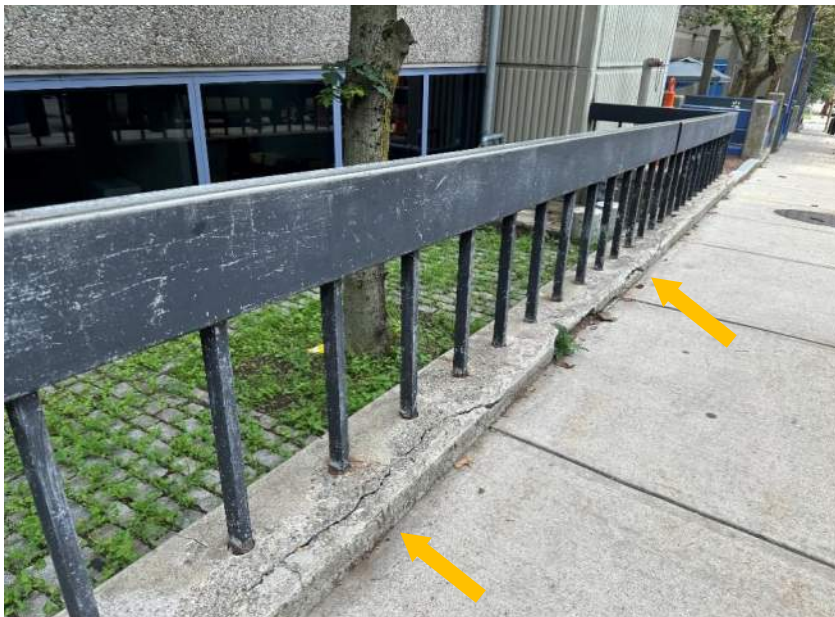
Photo 10

Cracked and spalled curb along the ramp to the west entrance.

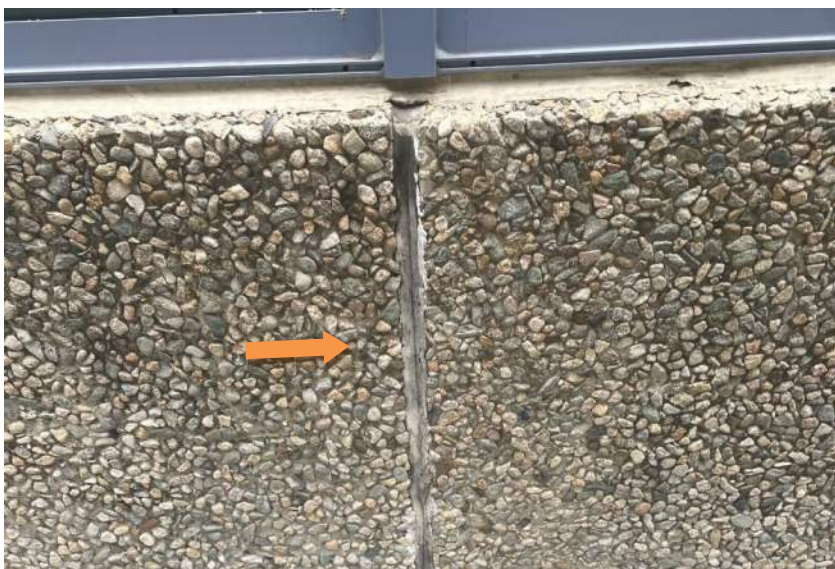
Photo 11

Cracked joint sealant at concrete panels.

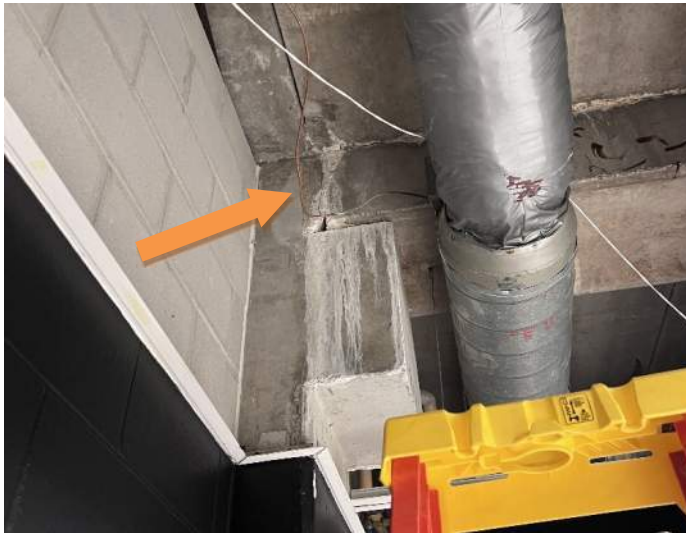
Photo 1

Potential fall hazard at column in Room 104.

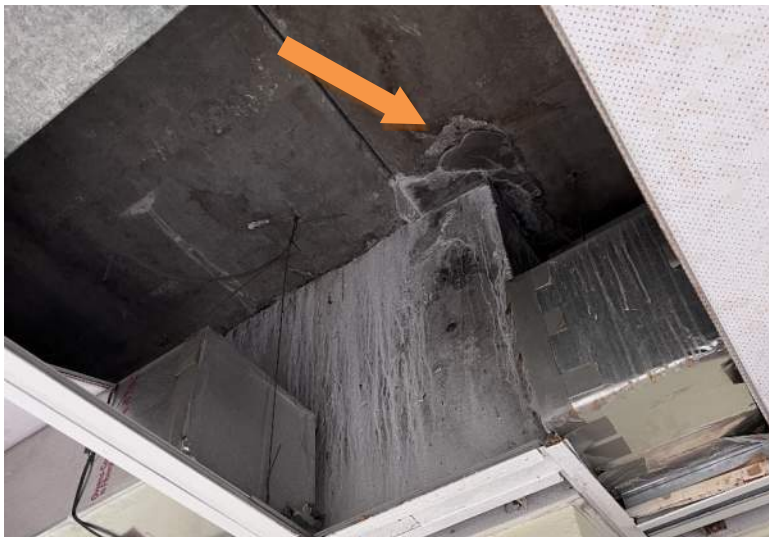
Photo 2

Potential fall hazard above a column in Room 103.

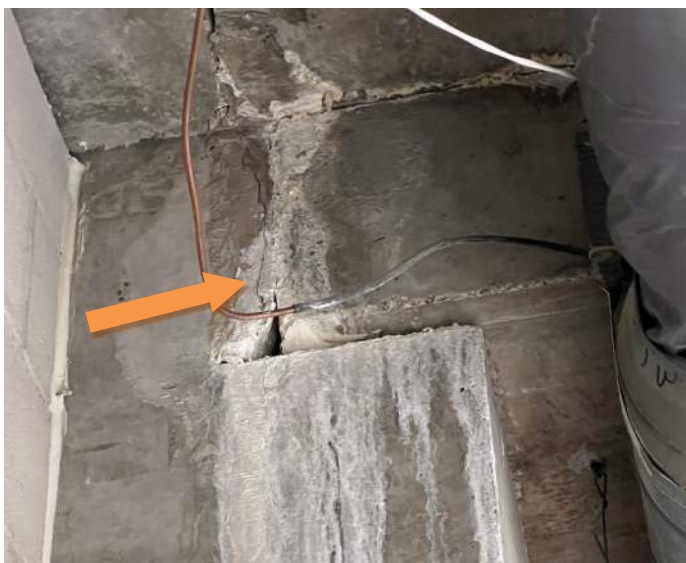
Photo 3

Loose grout at a joint in Room 103.

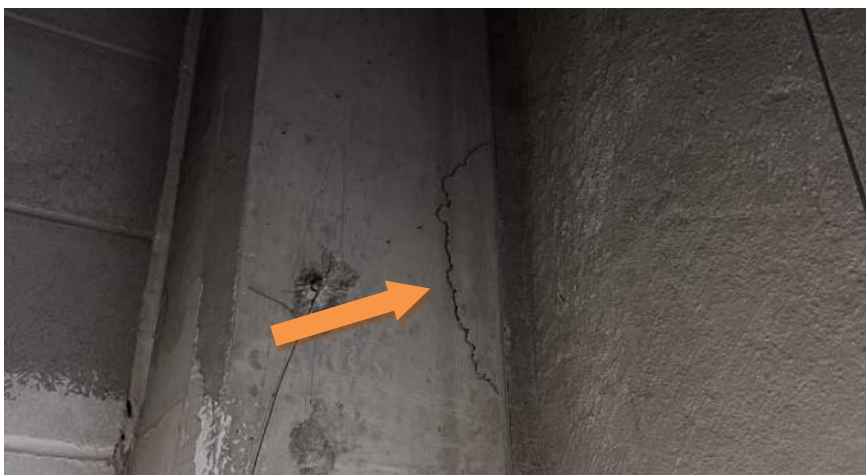
Photo 5

Potential fall hazard at
column in Room 108.

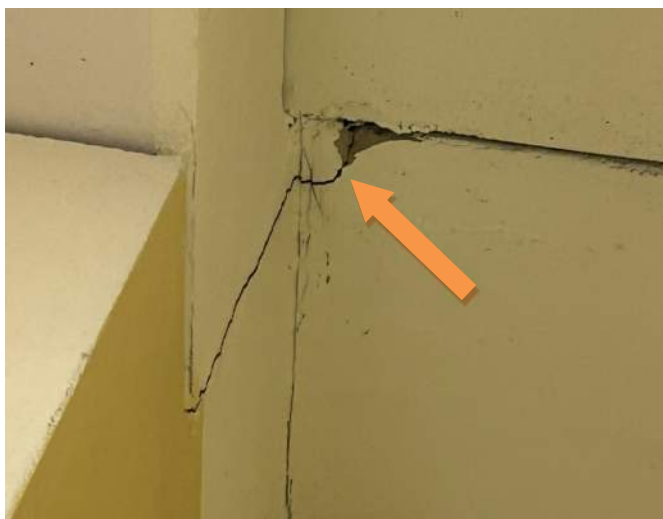
Photo 6

Potential fall hazard in
Room ST-108.

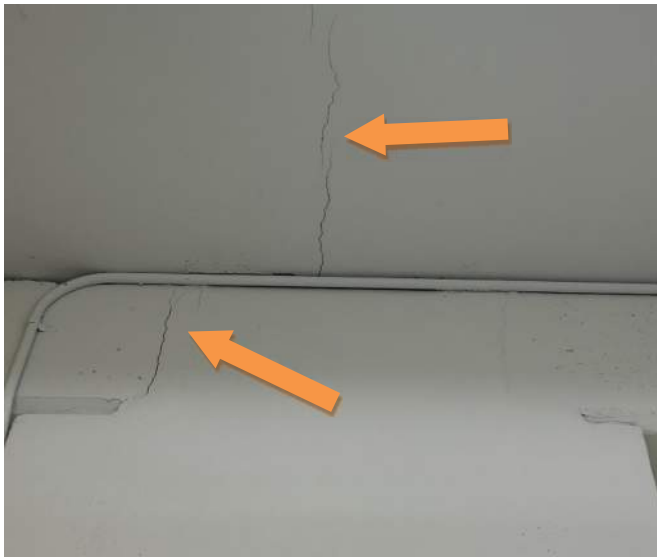
Photo 7

Crack along panel and at beam and column joint in Room 107.

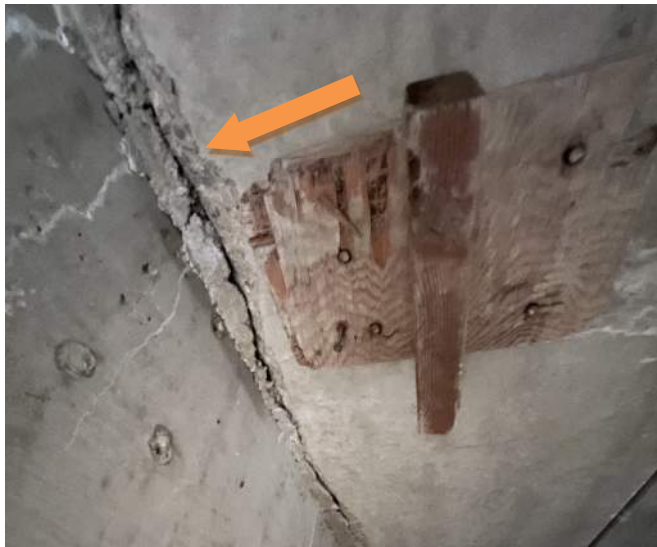
Photo 8

Loose grout at top of CMU wall.
