INSPECTIONS FOR FALL HAZARDS AT BUILDING INTERIOR AND FACADE

Winter Hill Community Innovation School

3 October 2023

SGH Project 230889

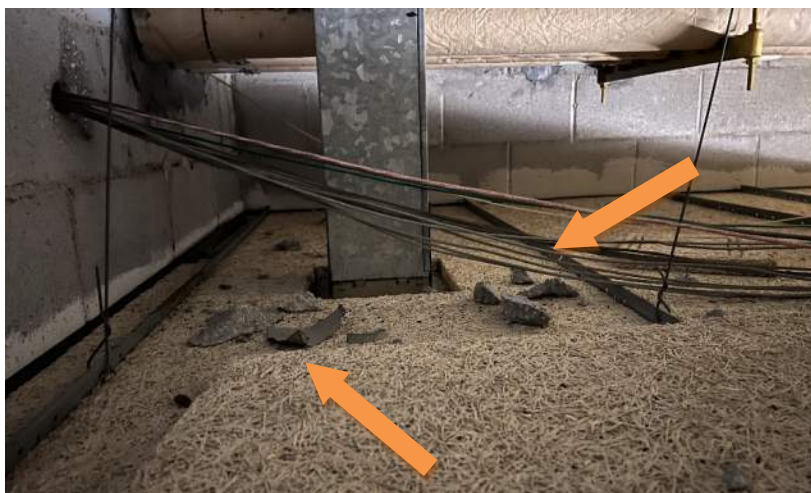
Photo 9

Grout debris on ceiling tiles.

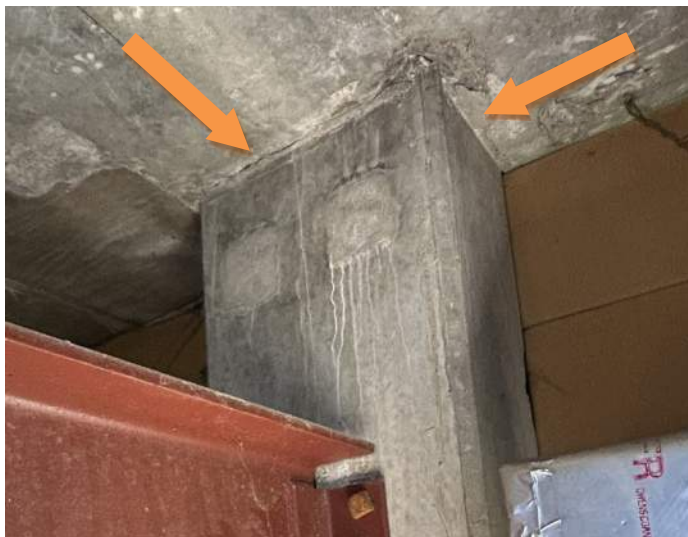
Photo 11

Potential fall hazard in Rooms 216 and 218.

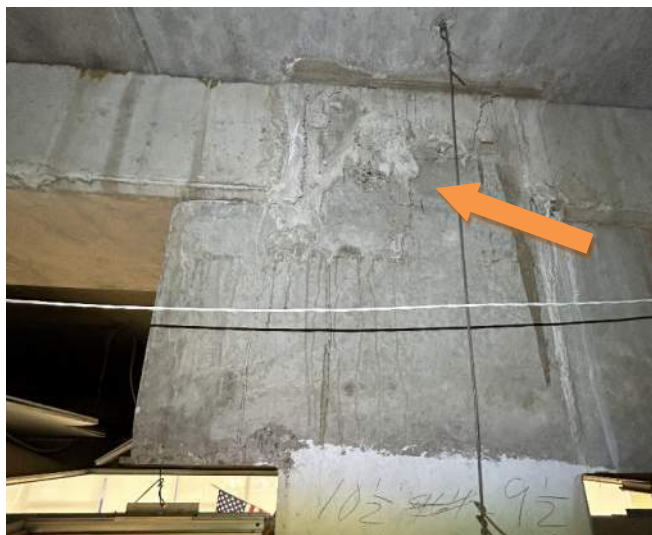
Photo 12

Potential fall hazard at column in Room ST-203.

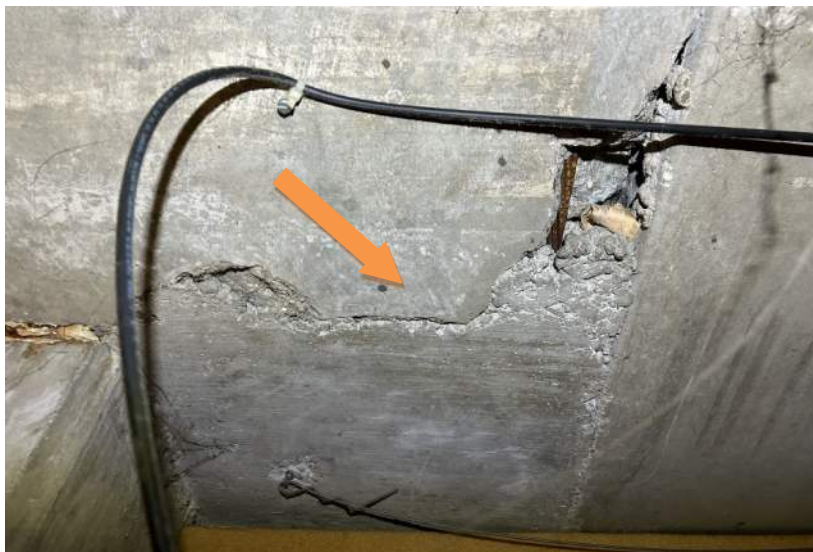
Photo 14

Potential fall hazard with exposed reinforcement at a previous repair in Room 215.

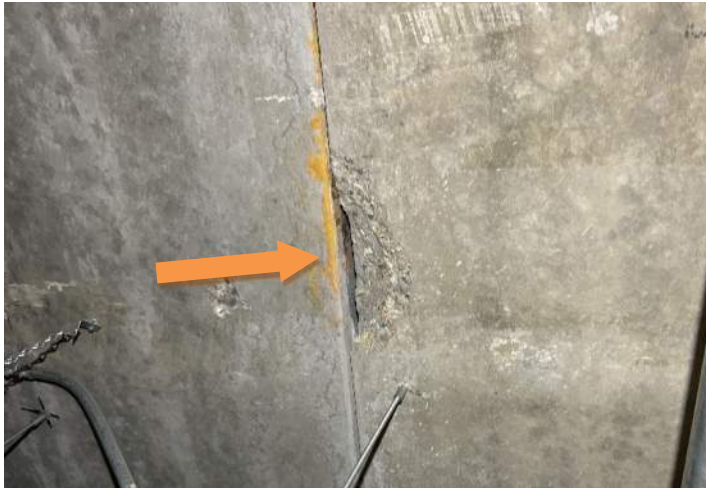
Photo 16

Existing spall with corrosion staining in hallway adjacent to gymnasium.

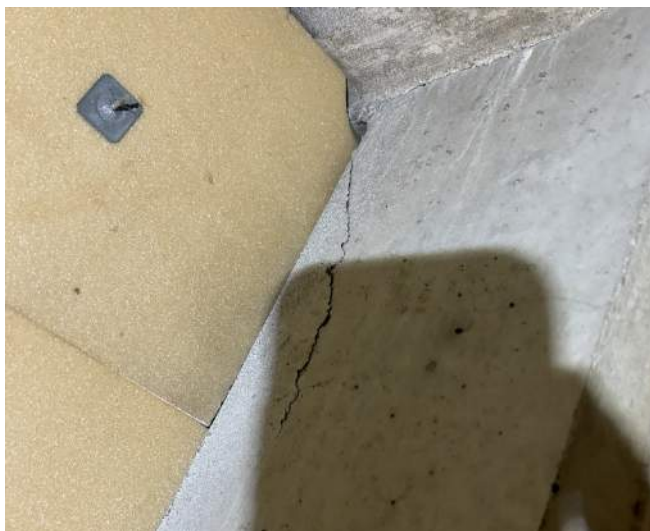
Photo 21

Potential fall hazard at a column in Room 315.

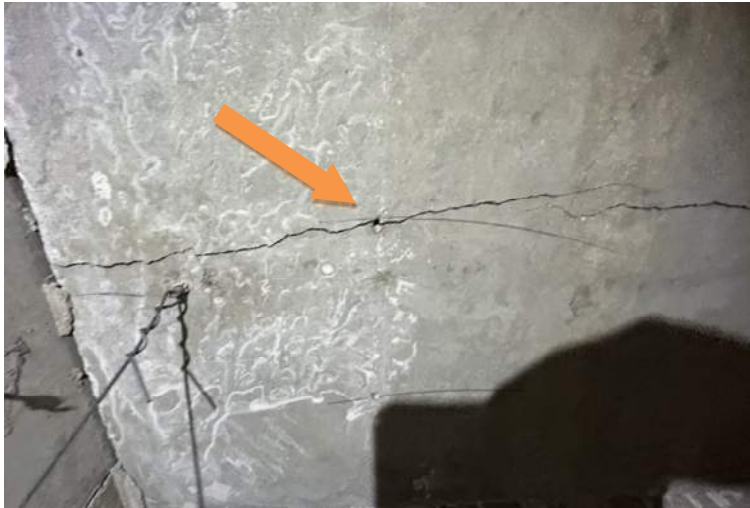
Photo 22

Crack along panel span in workshop.

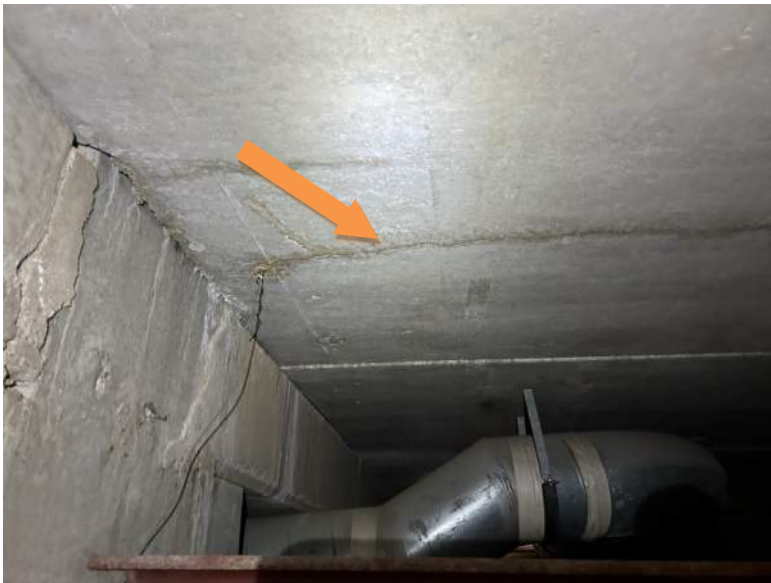
Photo 23

Crack with corrosion stains between Rooms 316 and 318.

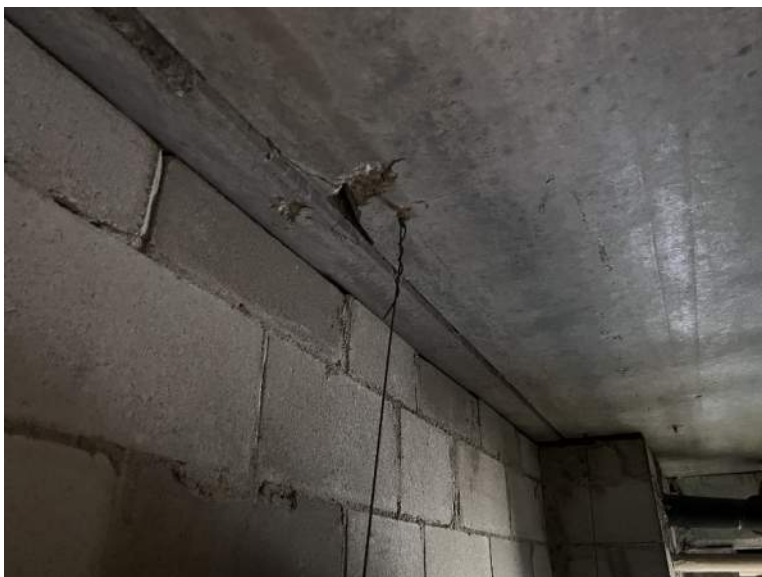
Photo 24

Potential fall hazard between Room 306 and the northern hallway.

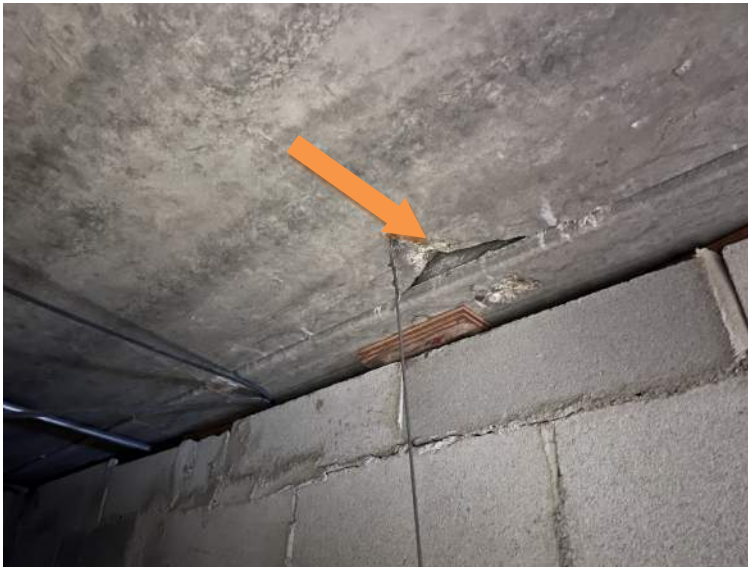
Photo 25

Existing spall between Room 306 and the northern hallway.

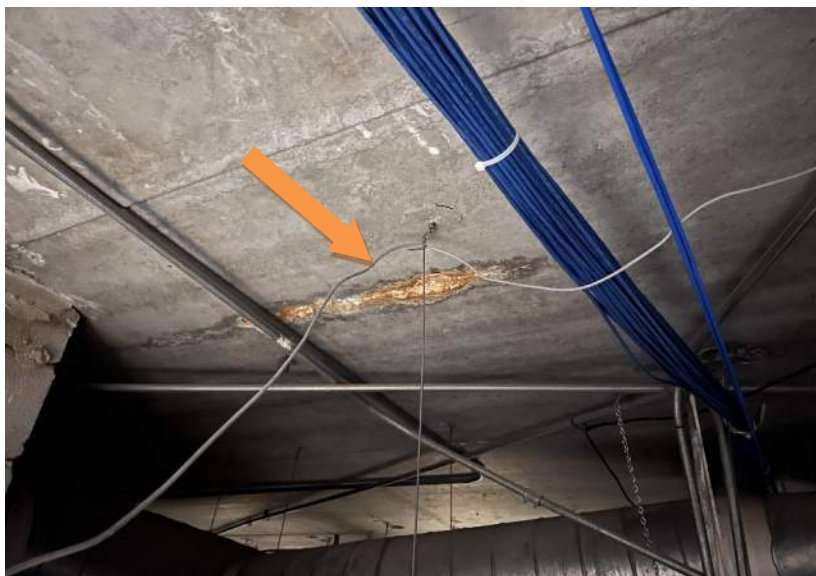
Photo 31

Crack with corrosion staining above the hallway outside of the library.

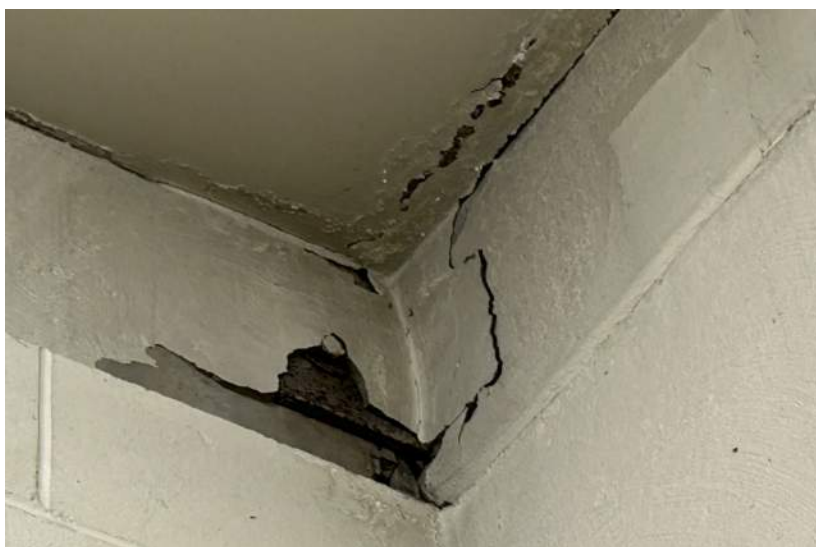
Photo 32

Potential fall hazard and exposed reinforcement at wall in Level 4 storage room.
