**Tree Health Assessment Report**  
**Kennedy Schoolyard**

Somerville Parks Tree Health Program

IFB 25-26

February 8, 2025

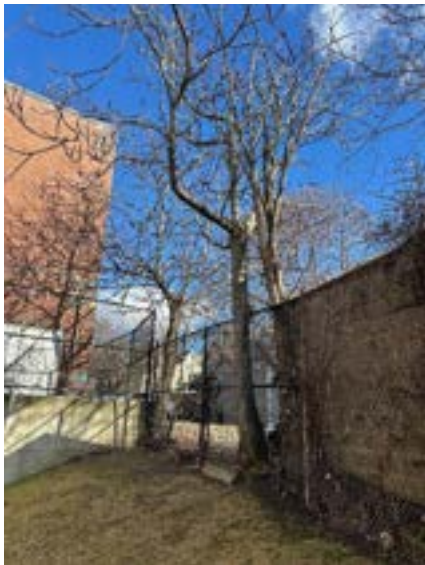
There is also an *Ailanthus* tree 40229, labeled in red on the Tree ID Map, and several unlisted *Ailanthus* volunteers, located on the eastern border by a play area, that are growing through a fence. This invasive plant species is a preferred host of a recently introduced invasive insect pest known as Spotted Lanternfly (SLF). SLF populations have been increasing and encroaching into this area with the potential to infest trees and cause damage to surrounding structures. This is because they secrete a substance called honeydew while feeding which can subsequently produce sooty mold that can cover anything below the tree. The honeydew also attracts stinging insects. We recommend removing all *Ailanthus* specimens, 40229 and the adjacent volunteers, to help stop the spread of these invasive pests and prevent potential sooty mold or stinging insects from this active schoolyard.

*Invasive Ailanthus 40229, dead Elm, and volunteer Sycamore Maples growing through fence near southeast Schoolyard*

Finally, as mentioned above in the Pests and Disease section, we recommend removing the *Ailanthus* tree 40229 and adjacent *Ailanthus* volunteers growing through the southeast chain-link fence. In this same location, there is a dead Elm and (2) invasive Sycamore Maples that are not identified on the Tree Inventory that we recommend removing as they are interfering with the fence and may create potentially hazardous situations to children utilizing the play area below.

- **13" diameter Tree-of Heaven (#40229) and non-inventory 12" diameter Tree-of-Heaven growing out of the chainlink fence over the driveway and playground behind school :**

**Tree Removal** - Take down and cut stump low to grade as equipment allows, dispose of brush, logs and chipped debris generated from removal operations. (portions of trunk growing close to chainlink may not be accessible with stump grinder unless fence is removed)

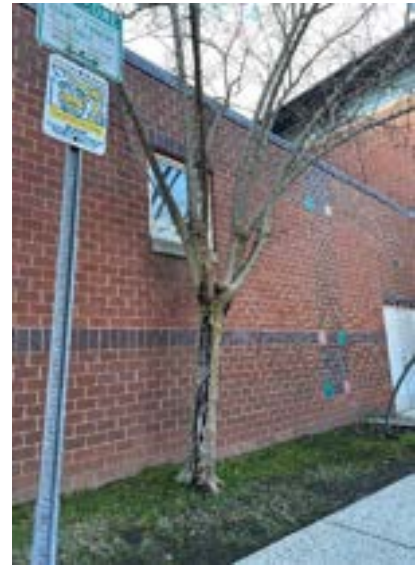
There is a Mulberry 40148, labeled in red on the Tree ID Map, located in the northeastern portion of the property growing against one of the school buildings. See photo at right. Due to poor structure, an extensive trunk wound with significant decay, and its proximity to the building we recommend removing this tree to make way for a healthier plant.

*We recommend removing this Mulberry 40148*

- **6.2" diameter Mulberry (#40148) growing close to building on Sartwell and 8" Dead Elm growing through chainlink behind playground.**

**Tree Removal & Stump Grinding** - Take down, dispose of brush, logs and chipped debris generated from removal operations. Grind stump and exposed flare deep for replant grade; backfill with topsoil and remove excess grinding debris. (portions of trunk growing close to chainlink may not be accessible with stump grinder unless fence is removed)

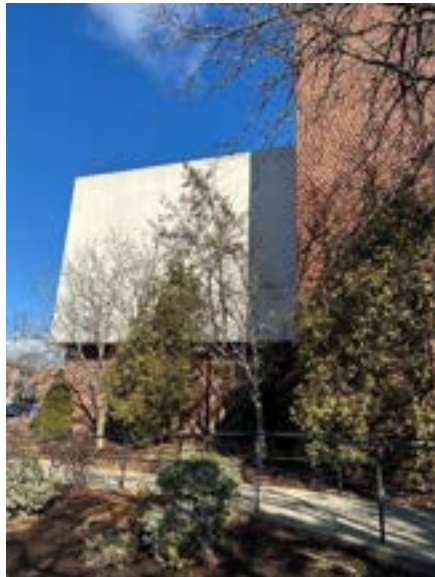
There is also a Black Locust, labeled in red on the Tree ID Map as 40093, located against a school building in a crowded grouping of trees on the southern portion of the site along Elm Street. We recommend removing this likely volunteer specimen to open up space for current plantings and because of its close proximity to the building. See photo below.

*Overcrowded grouping of trees near southern border. The Black Locust 40093 volunteer can be seen as the tallest tree growing against the white wall of the school building.*

- **5" diameter invasive Black Locust (#40093) off Elm Street**

**Tree Removal & Stump Grinding** - Take down, dispose of brush, logs and chipped debris generated from removal operations. Grind stump and exposed flare deep for replant grade; backfill with topsoil and remove excess grinding debris.

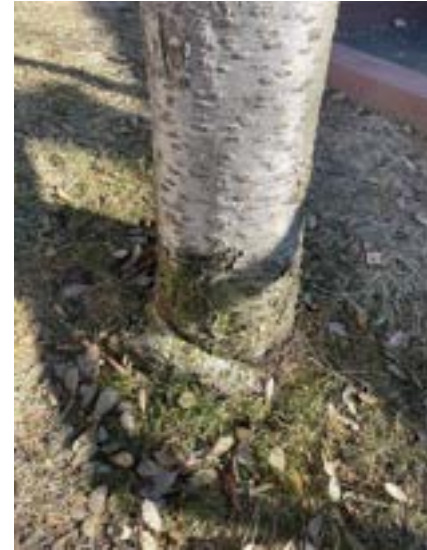
There are (6) Cherry Trees near the schoolyard located in the southeastern portion of the site (row of 40173-40217 on Tree ID map) that we recommend receive crown-cleaning and pruning to reduce their spread over the play area. We also recommend raising the volunteers growing out of the border fence in this area 8-10' for clearance in the play area. Cherry Tree 40173 also has an exposed girdling root that we recommend pruning out.

*Cherry 40173 with exposed, girdling root*

#### - 6" diameter Flowering Cherry in rear playground (#40173):

Prune to Sever/remove girdling surface roots

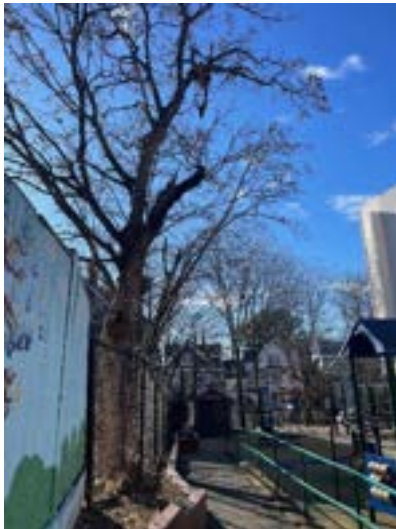
There is a row of mature volunteer Sycamore Maples that are on neighboring private property growing along the southeastern fence-line. These trees have extensive deadwood and hangers in their canopy that pose a threat to targets below. We recommend removing the deadwood/hangers and pruning to raise these canopies 12-14' off of the playground structures and the Cherry Trees below.

*Neighboring Sycamore Maples needing canopy-cleaning and raising*

| Misc | Sycamore Maples | NA | Row of volunteer sycamore maples growing along the southeastern fence line, going over the playground from private property: Prune to remove extensive deadwood, hangers, prune to raise 12-14' over the playground and Cherries. | Poor | Mod | | |
