**Tree Health Assessment Report**

**Lincoln Park**

Somerville Parks Tree Health Program

February 8, 2025

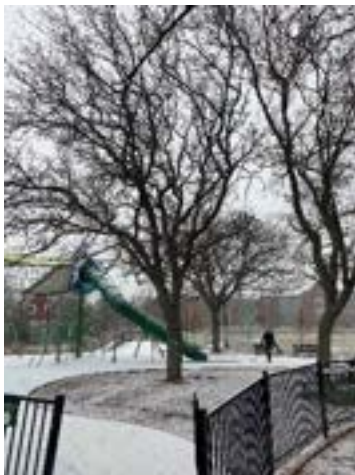
*Honeylocusts  
near Playground*

There are (6) Honeylocusts (41951, 41952, 41904, 41750, 41748, 41941) located over the playground depicted on the eastern side of the West Zone on the Tree ID Map that have been relatively unmaintained. We recommend pruning to remove deadwood greater than 2 inches and any crossing or damaged limbs and also raising these 4-6' from playground structures, 8-10' off sidewalks and 14' over the street. There are (4) Red Maples (41483, 41496, 41505, 41517) with 15-22" DBHs located along the southern portion of the eastern zone. As mentioned in previous

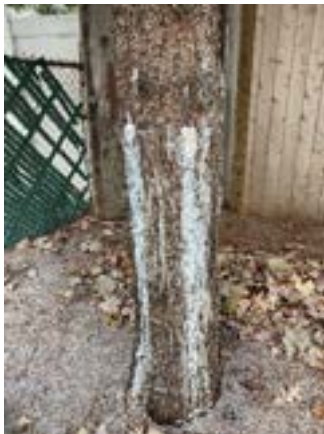
The only observed pest/disease at the time of assessment was possible *Cytospora* cankering on the trunk of a Colorado Spruce (41909, pictured below) located in the southeastern corner of the West Zone, marked in blue on the Tree ID Map. *Cytospora* is a fungal disease that is common on Spruce species, mainly infecting trees under stress such as soil compaction or trees with mechanical injuries such as bark wounds. We recommend applying a systemic bark spray of Phosphite to help manage the disease and increase immunity within the tree.

*Colorado Spruce 41909 with possible Cytospora cankering on trunk*

| 41909 | spruce: Colorado (Picea pungens) | 12.5 | Cytospora canker. Treat w systemic fungicide | Fair | Low | | |

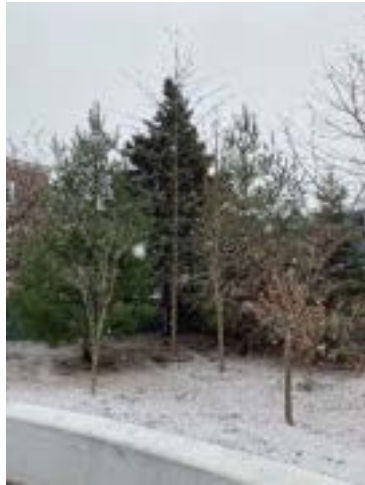
This same corner located just south of the Skate Park in the Western Zone contains an over-crowded grouping of trees, both evergreen and deciduous. It is our concern that these deciduous

trees may shade out the small evergreens in this area, including White Pines and Red Spruce which could make them more susceptible to needle-cast diseases that favor hosts with less light and air getting to them. Therefore, we recommend raising the canopies of the Crabapple 41918 and the White Mulberry 41938 and other small, unlisted deciduous trees (Pin Oak, Linden, etc) in this immediate area to promote sunlight penetration for screening growth and air circulation to help prevent damaging fungal diseases from infecting the adjacent Evergreens. Note: this is in addition to pruning specs detailed in the Excel spreadsheet.

*Over-crowded corner with Deciduous and Evergreen species*

| NA | Various | NA | multiple young-establishing trees in the southern corner of the skate park area: prune to raise canopy to limit encroachment onto surrounding evergreens, allow light and airflow into area. | good | Low | |

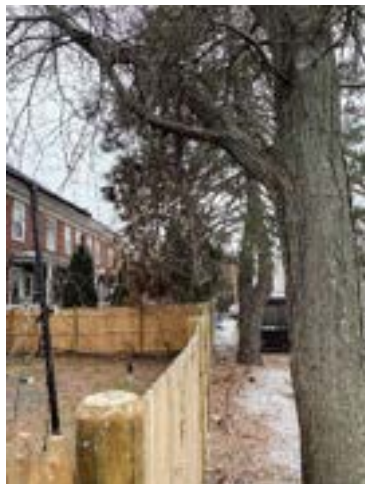
Along the southern border of the West Zone, invasive vines from neighboring properties are starting to encroach onto the park’s trees, especially onto Honeylocust 41910 and the immediate area around this tree. We recommend cutting these vines at their base or where we have access and leaving them to desiccate to prevent further interference with planted trees. See photo below.

*Invasive vines are encroaching from neighboring residential properties*

| 41910 | honeylocust:<br>thornless<br>(Gleditsia<br>triacanthos<br>inermis) | 23.6 | Unmaintained, overgrown with bittersweet vines. Prune to remove low deadwood greater than 3" over park only, cut vines at base, leave to desiccate. | Fair | Low | |

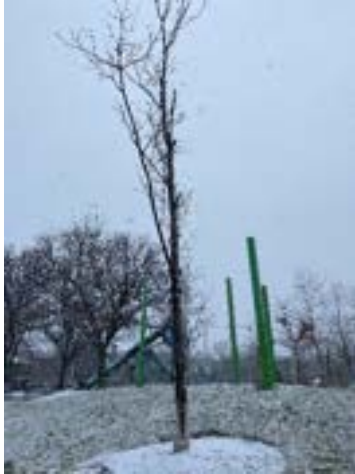
Sugar Maple 41471 located in the southwest portion of the Eastern Zone and highlighted in pink on the Tree ID map has been selected for removal. The recently planted tree is showing extensive trunk wounding with approximately 60% dieback in the canopy, including a dead top. We recommend removing this tree now to prevent future safety or maintenance issues, and grinding the stump to make space for a replacement in the future. See photo below.

*Sugar Maple #41471 with trunk wounds and significant dieback*

| 41471 | maple: sugar<br>(Acer saccharum) | 4 | 60% dieback, decay in stem. Remove, grind<br>stump | Poor | Low | |

**- 4.5" diameter declining Sugar Maple (#41471)**

**Tree Removal & Stump Grinding** - Take down, dispose of brush, logs and chipped debris generated from removal operations. Grind stump and exposed flare deep for replant grade; backfill with topsoil and remove excess grinding debris.

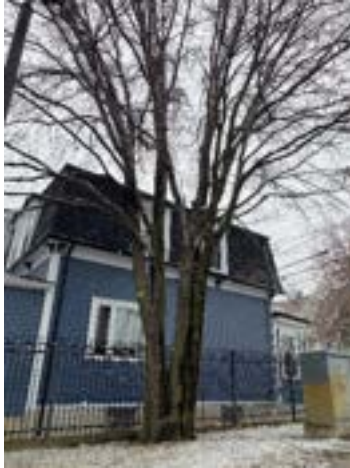
There is (1) Slippery Elm 41516 located at the northern border of the Eastern Zone, along Washington Street. The UMass Extension Program calls this species “susceptible to somewhat resistant” to Dutch Elm Disease (DED), a lethal vascular wilt disease that is spread by Elm bark beetles. We recommend monitoring the upper canopy for scattered branches with wilting or yellowing leaves, known as flagging, which is an early symptom of DED.

The Slippery Elm 41516 located at the northern border of the Eastern Zone, along Washington Street, is a large sprawling tree with portions of the canopy over neighboring private residences and the entrance to Argenziano Middle School. We recommend canopy cleaning, raising 8-10' off the house and fence, and 14' over the street.

*Slippery Elm 41516 near entrance to Argenziano Middle School*

| Site ID | Species | DBH | Recommendations | Condition | TRAQ-Risk | GTC Cost | PHC |
|---|---|---|---|---|---|---|---|
| 41516 | elm: slippery (Ulmus rubra) | 36 | Large tree over private residence. Prune to remove deadwood, crossing limbs, raise 8-10' off house and fence, 14' over street. | Good | Low-Moderate | | |
