**Tree Health Assessment Report**

**Lou Ann David Park**

Somerville Parks Tree Health Program

February 13, 2025

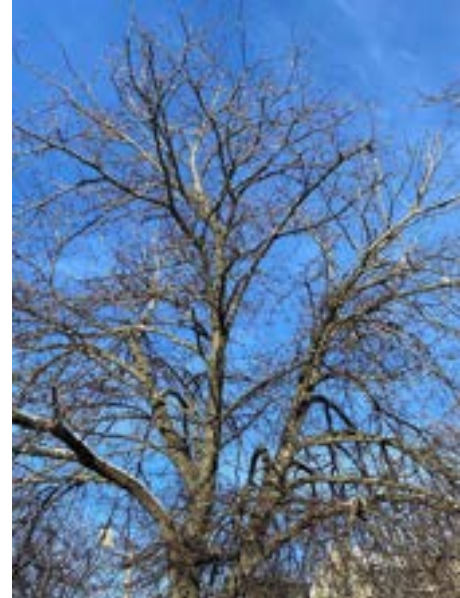
The mature Lindens on this site have been subject to construction activity, including grade changes and likely compaction from construction vehicles/equipment. They are showing signs of stress including approximately 10-20% dieback in the canopy. They are also encroaching into nearby buildings and structures. With the exception of one problematic Boxelder Maple, the remaining trees are in relatively good health and are in need of pruning to improve their structure for future success.

*Linden canopy exhibiting dieback likely due to stress from construction*

We recommend applying an organic biostimulant as a soil amendment to the root zone of most trees in this park: the (7) construction-damaged Lindens located in the eastern portion of the park (Note: we cannot apply biostimulant to Linden 202820 located on the northern border near Broadway because there is Poured-in-Place surrounding it's trunk.), the Tulip Trees receiving a structural prune, and the newly planted trees including the Gingko grouping located in the southern portion of the park and (1) Oak 202824 located in the southeast corner of the park. This soil amendment consists of a blend of humic acids, kelp extract, and natural compounds that will aid in enhancing soil structure, nutrient availability, and vitality for these stressed and/or establishing trees.

For all (8) Lindens located in the eastern portion of the park, we recommend canopy-cleaning, and pruning to provide clearance from park pathways and the neighboring building. For all (7) Tulip Trees scattered throughout the park, we recommend pruning to improve structure, provide clearance from buildings, and canopy-raising to lessen interference with pedestrians. Of note, Tulip Tree 202843, pictured below, located near the eastern border close to Broadway has codominant stems and needs extra structural attention.

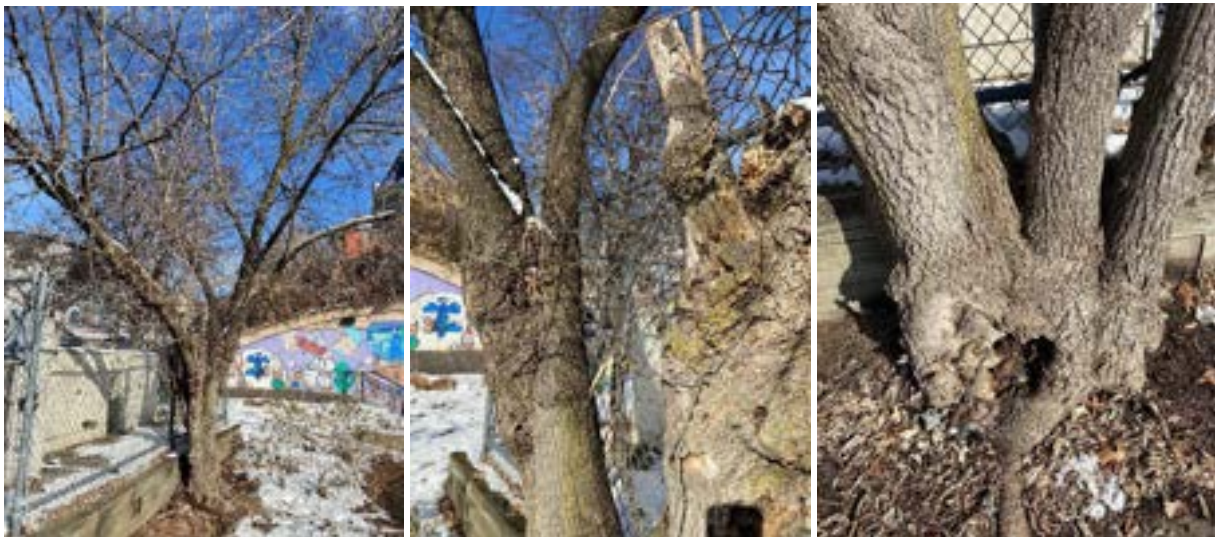
There is a triple-leader Boxelder Maple 202823 (approximately 26" total DBH) located in the northwest corner of the park that has been growing into the fence surrounding a utility unit. It is showing poor structure and significant decay in the trunk as evidenced in photos below.

*Boxelder Maple 202823 with poor structure growing into fence*

| Site ID | Species | DBH (in) | Recommendations | Condition | TRAQ | Pruning | PHC |
|---|---|---|---|---|---|---|---|
| 202823 | Boxelder (Acer negundo) | multistem<br>total 26" | Remove. Growing through the fence, over utilities | poor | moderate | | |

Therefore, we recommend removing this tree down to the trunk. We will not be able to stump grind this tree due to its proximity to the fence and multiple pieces of metal already present throughout the trunk. Thus, it will likely sprout and require maintenance-pruning in the future to keep the sprouts at bay.

**Tree Removal** - Take down and cut stump low to grade as equipment allows, dispose of brush, logs and chipped debris generated from removal operations. Note: per discussion w project manager this stump cannot be ground due to proximity to fence and utility. We will cut as low as able.

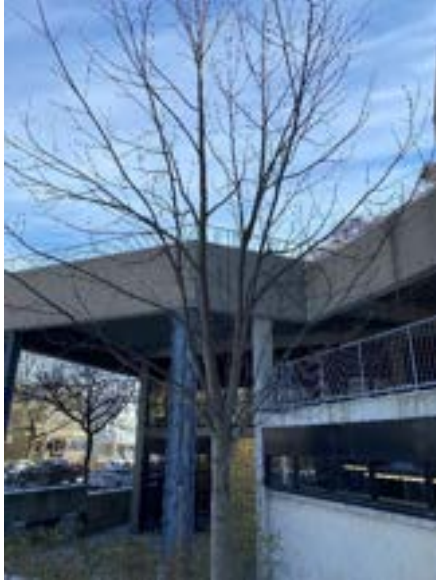
*Tulip Tree 202843 with codominant stems*

| 202843 | tuliptree<br>(Liriodendron<br>tulipifera) | 5.1 | competing leader raise low non-permanent branches to encourage a higher canopy tree. (co-dominant stems) biostim | Good | low | |
