**Tree Health Assessment Report**  
**Veterans Memorial Cemetery**

Somerville Parks Tree Health Program

IFB 25-26

February 6, 2025

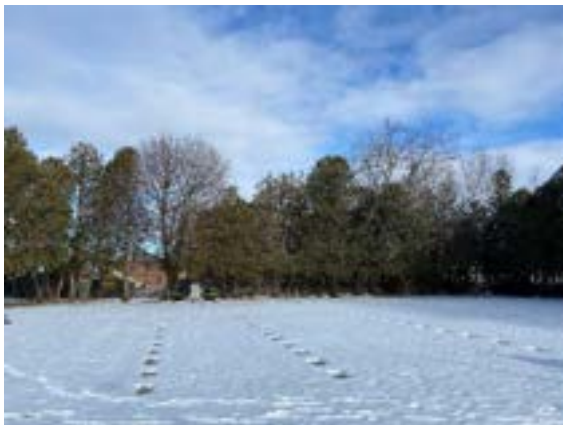
The interior Japanese Maples, Dogwood, and Crabapple are in fair to good condition and will be the focus of the work proposed here. The perimeter Arborvitaes all appear to be in good condition and successfully employed as a hedgerow screen. These trees were grouped and not inventoried as individual trees, and likewise they are not reported on individually on the attached sheet. The remaining deciduous trees are invasives/volunteers growing through the fence competing with the screening evergreens and are in poor to fair condition because of their location in and amongst the fence and lack of maintenance.

*Deciduous trees and Evergreens at the rear, northern border*

All trees in the park were issued a “low” risk rating based on a Level 1 TRAQ assessment. No removal recommendations at this time. Consider removing volunteer shade trees growing through the fence as budget allows over the next decade.

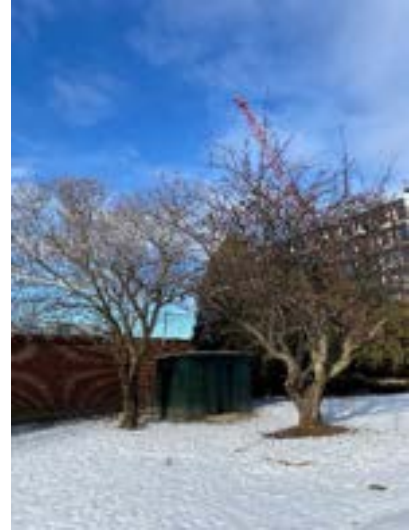
The Crabapple 40522 located in the southwest portion of the property is very susceptible to common fungal issues including scab and rust. The adjacent Flowering Dogwood 40513 is also susceptible to common fungal issues including anthracnose and powdery mildew. Because a series of prophylactic, foliar sprays are not a practical option here due to restricted access and budgetary concerns, we recommend applying a systemic bark spray of Phosphite to both of these trees to help manage disease infection and increase their natural defense system.

*Flowering Dogwood 40513 and Crabapple 40522*

We recommend pruning both the Crabapple 40522 and Flowering Dogwood 40513 to remove all dead and broken branches, to raise them 3-5' off the small building structure underneath them, and to thin out the canopies for increased airflow and weight reduction. We also recommend pruning the (2) Young Japanese Maples located at the entrance to the site to remove deadwood and to improve structure.

- **Fungal Leaf Disease and Canker Control** - Early season. Apply a systemic fungicide to the lower trunk and flare to help manage disease infection on the 18" Dogwood and 26" Crabapple on the left side of the Cemetery. [REDACTED]

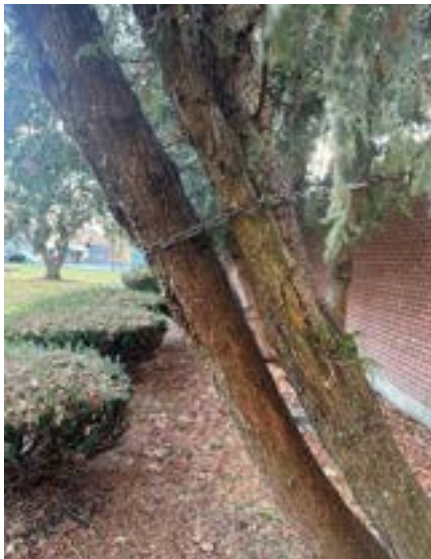
There is an Arborvitae located on the western border in the rear, northwest corner of the property that has chains around its trunk likely meant to correct a lean in this tree. The chain is starting to girdle the trunk of this tree as shown in the photo. We recommend the city remove or adjust the chains on this tree, and for any other corrective material used on the perimeter evergreens.

*Arborvitae with chain girdling its trunk*
