## **Tree Health Assessment Report**

### **West Branch Library**

Somerville Parks Tree Health Program

Jan 10, 2025

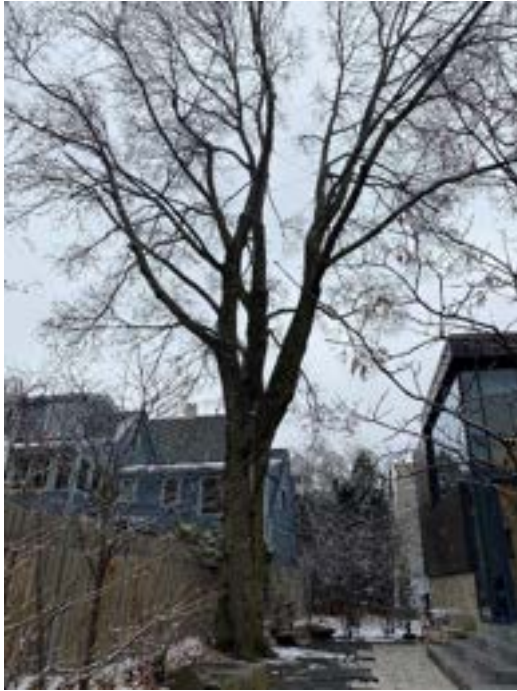
The Norway Maple #40894 has visible decay in the main union and evidence of decay on the lower trunk.

We recommend removal of the rear Norway Maple #40894. This tree was inspected from the ground on December 20, 2024 by a TRAQ Arborist. The tree has a history of recent storm damage and canopy breakage. Open visible decay in the main union and evidence of decay on the lower trunk, as well as several large breaks in the upper canopy were observed in this brittle species. There is a highly-used outdoor seating area directly below as well as a new library addition with large glass windows and several residential yards and buildings under tree. (See photos below) Failure of the tree in the next 3-5 years is probable, and failure would likely lead to significant damage to persons and/or property below. Based on these observations, the tree was determined to be a moderate to high risk. Cabling or pruning are not practical long-term mitigation options in this case. The tree is therefore recommended for removal.

*Norway Maple #40894, showing potential targets including seating area, residential sites and new glass library addition*

We recommend grinding the stump of the Norway Maple after removal to make space for new plantings. Finally, we recommend removing all Silver Maple volunteer saplings located at the northeast corner of the building to prevent further establishment and encroachment into other plants or the building.

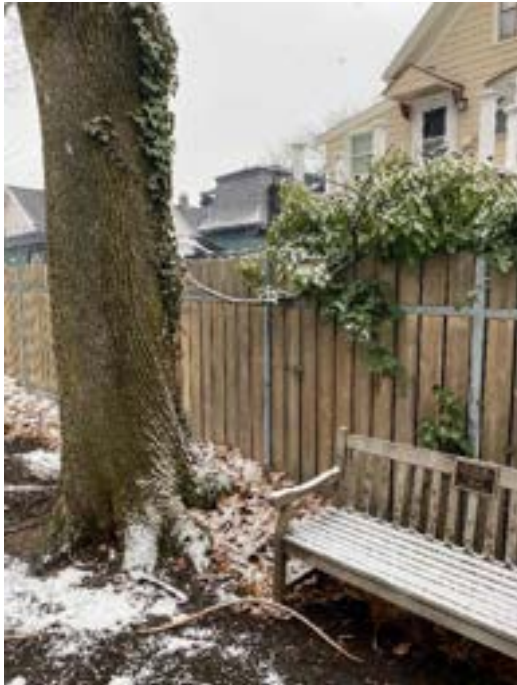
*Library bench directly under Norway Maple #40894. There was a broken branch resting on the fence during the assessment*

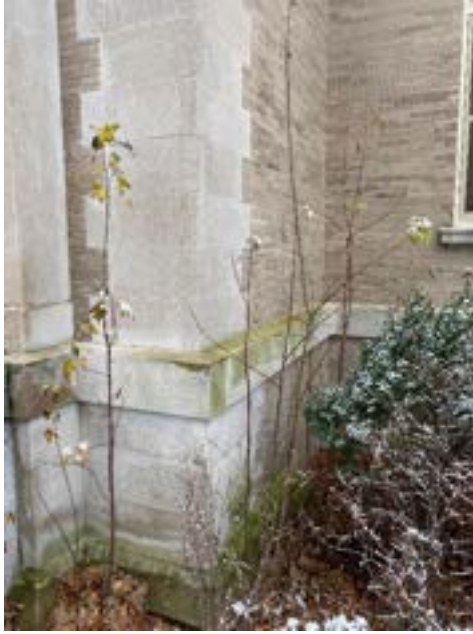
*Silver Maple sapling against the northeast side of the library building*
