MEMORANDUM

RE: Somerville IDDE Investigation – Permit Year 6 Catchment Inspection Memo

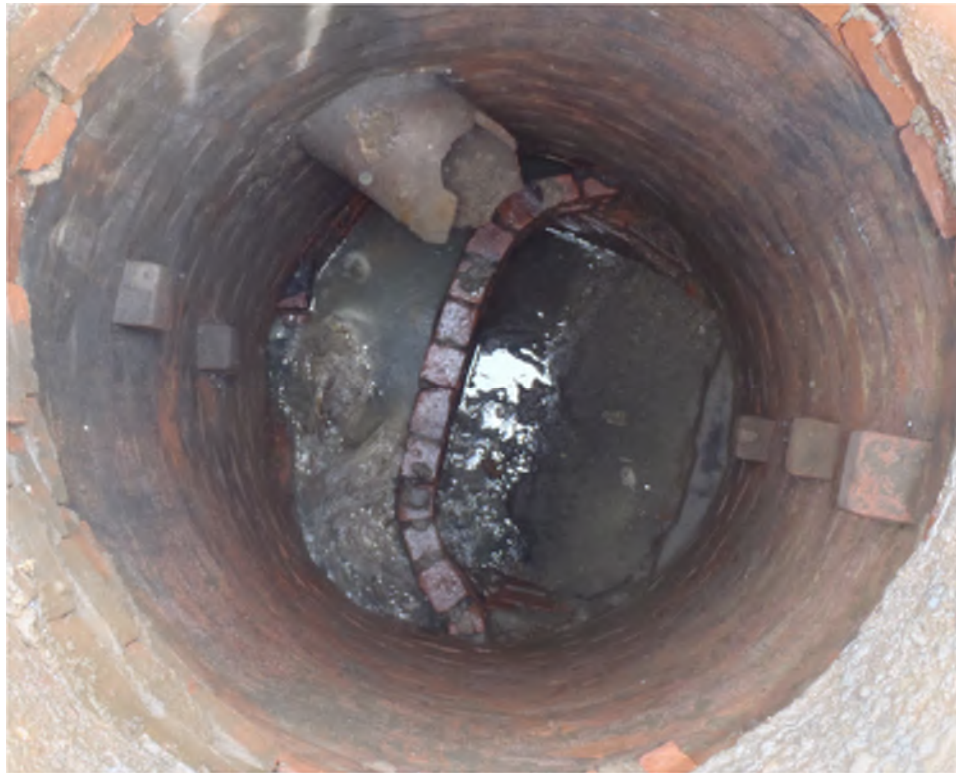
FIGURE 1: SMH A-61 (BROADWAY AND BELKNAP STREET)

A post-correction manhole inspection was completed at manhole 7-6377 on May 9, 2023 and the manhole was still found to be contaminated with an ammonia concentration of 3.00 milligrams per liter (mg/L) and a chlorine concentration of 0.05 mg/L. The results are below the likely sewer indicator thresholds however, the ammonia concentration is high enough to warrant additional follow up. Woodard & Curran reviewed closed-circuit television (CCTV) footage of the storm drain and sanitary sewer pipes on Belknap Street and Broadway to look for possible sources of contamination and noticed several structural defects which may allow wastewater to infiltrate into the storm drain. Additionally, SMH A-61 at the intersection of Belknap Street and Broadway is likely contributing to the contamination by wastewater spilling over the weir or infiltration through old bricks. SMH A-61 is shown in Figure 1 below.

Sanitary sewer rehabilitation in the Belknap Street area is included in the City's ongoing West Somerville Sewer and Storm Rehabilitation project. The project scope includes full replacement of SMH A-61 and cured-in-place pipe lining of the sanitary sewer on Belknap Street. This project is currently under construction and is anticipated to be completed by July 2025. Post-construction sampling will be completed to ensure the problem is resolved.

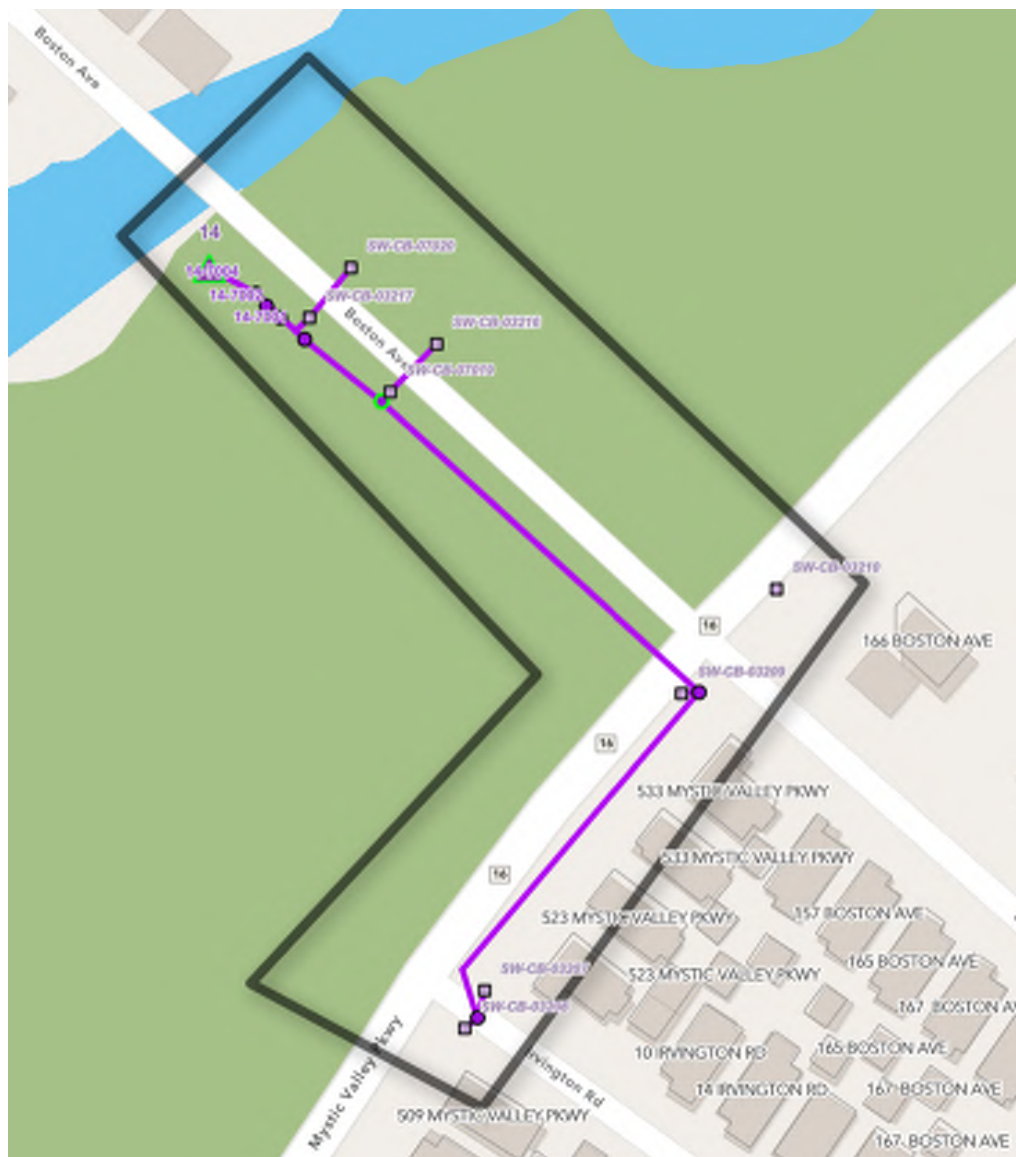
FIGURE 3: UPDATED IRVINGTON ROAD DRAINAGE CONFIGURATION

Both the drainage line on Boston Ave and the newly discovered outfall the line contributes to were determined to be owned by the City. This line includes one DCR interconnection, which is the catch basin at the intersection of Boston Ave and Mystic Valley Parkway. The updated Irvington Road drainage configuration is shown in **Figure 3**.

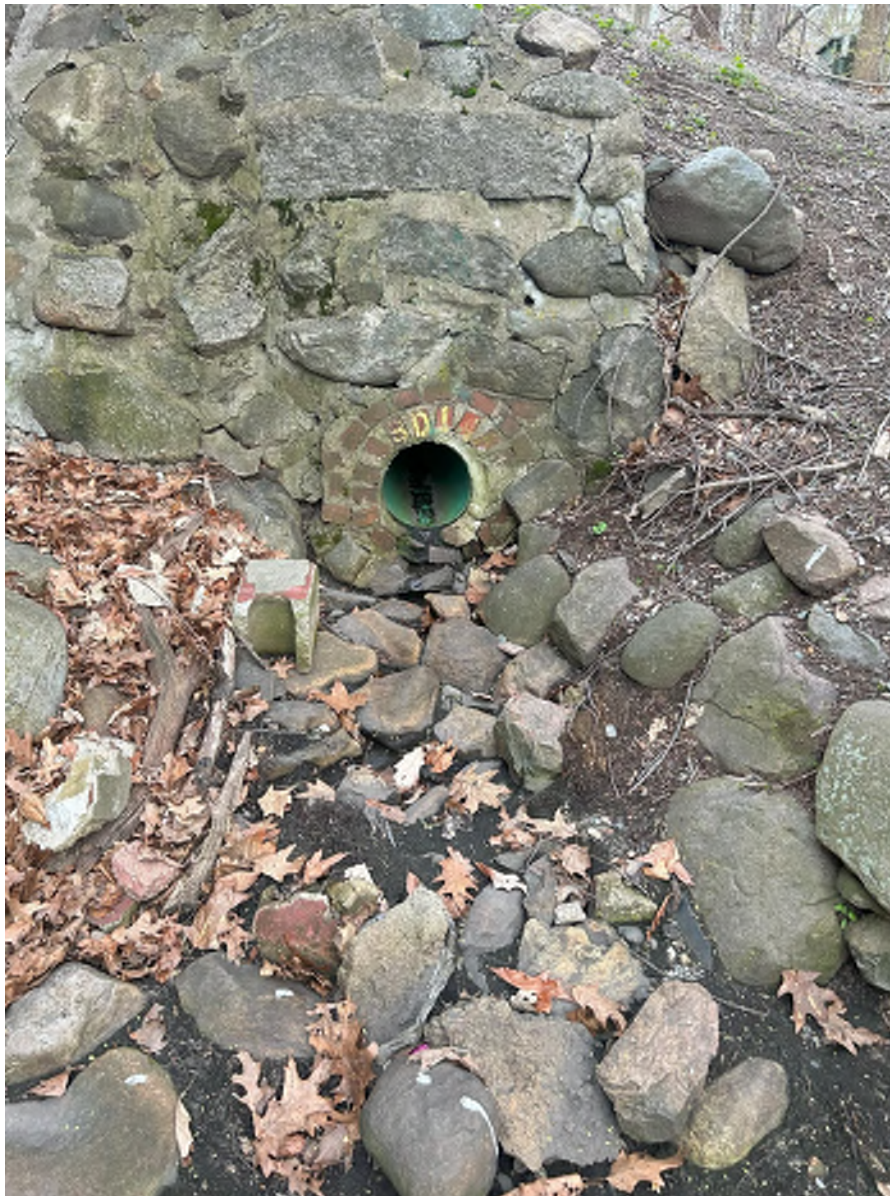
FIGURE 4: OUTFALL 14

This new MS4 outfall will be referred to as Outfall 14 (**Figure 4**). It was screened during dry weather on May 21, 2024 and was found to be dry. Wet weather screening will take place as weather allows. .

Outfall 14 is a newly identified Somerville-owned outfall; therefore, it requires dry and wet weather screening. Dry weather screening was completed on May 21, 2024, and the outfall was found to be dry. Wet weather screening will take place when the weather allows. This new catchment will be included in the next MS4 compliance report.

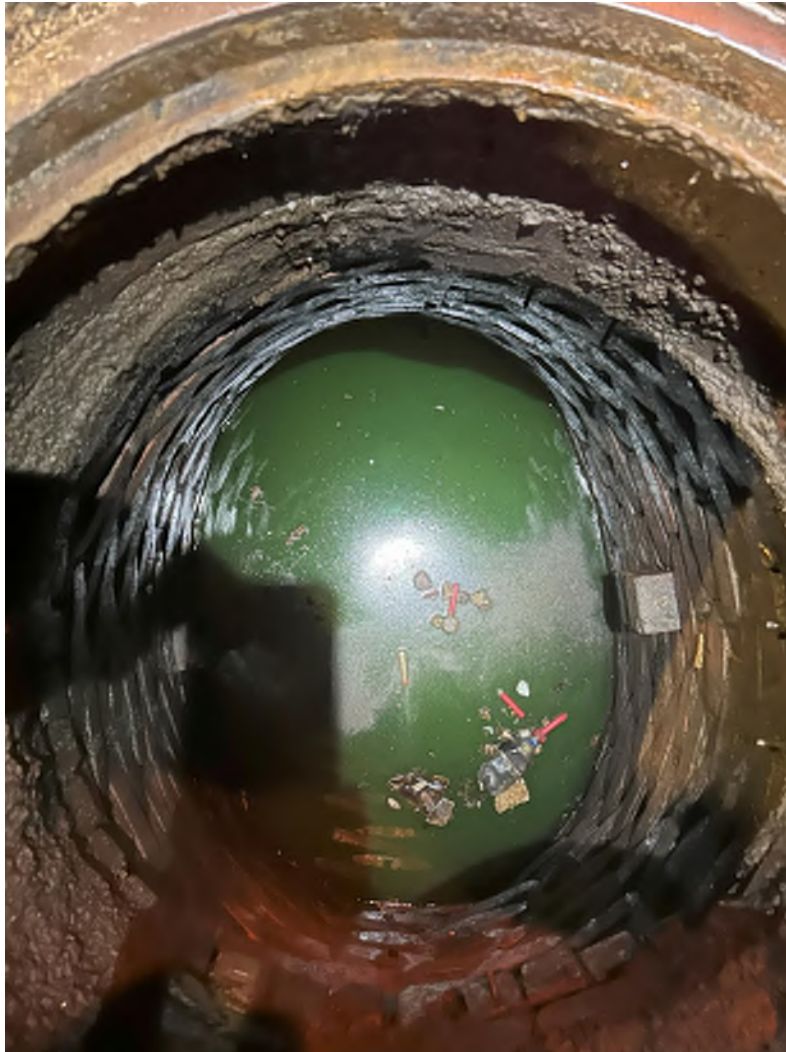
FIGURE 5: DYE IN DMH 11-6039

This drainage pipe ends up in DMH 11-6035 at the intersection of Woods Ave and Alewife Brook Parkway. Flow then travels to DMH 11-6039, which is located near 379 Alewife Brook Parkway. It should be noted that this manhole has a BWSC cover which should be replaced with the City's standard drainage manhole cover. The dye in DMH 11-6039 is shown in **Figure 5**.

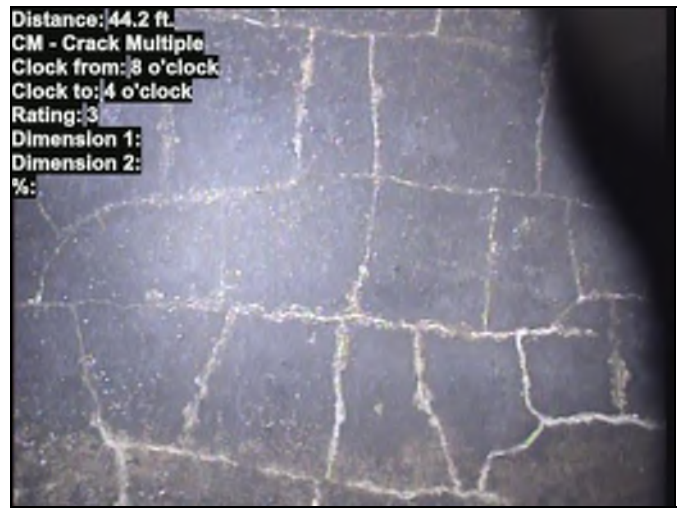
Distance: 44.2 ft.
CM - Crack Multiple
Clock from: 8 o'clock
Clock to: 4 o'clock
Rating: 3
Dimension 1:
Dimension 2:
%:
Photo: 666667947.00-22084.00-20240421-205127-205608.JPG
At: 44.2 ft. 8/4 CM - Crack Multiple
Joint: No

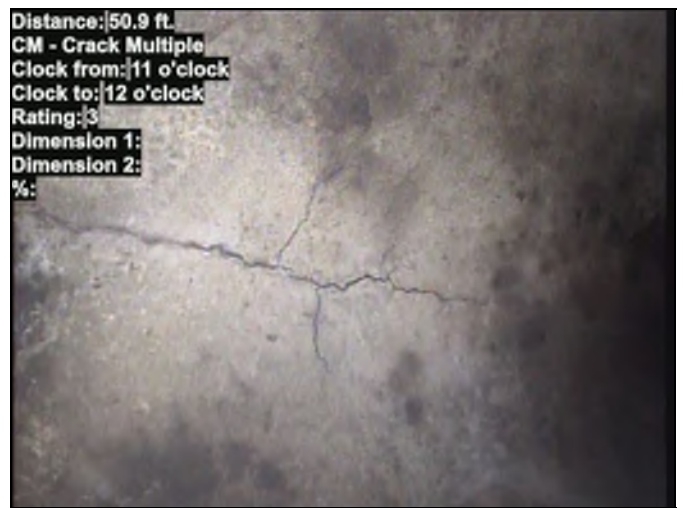
Distance: 50.9 ft.
CM - Crack Multiple
Clock from: 11 o'clock
Clock to: 12 o'clock
Rating: 3
Dimension 1:
Dimension 2:
%:
Photo: 666667947.00-22084.00-20240421-205127-205651.JPG
At: 50.9 ft. CM - Crack Multiple
11/12
Joint: No

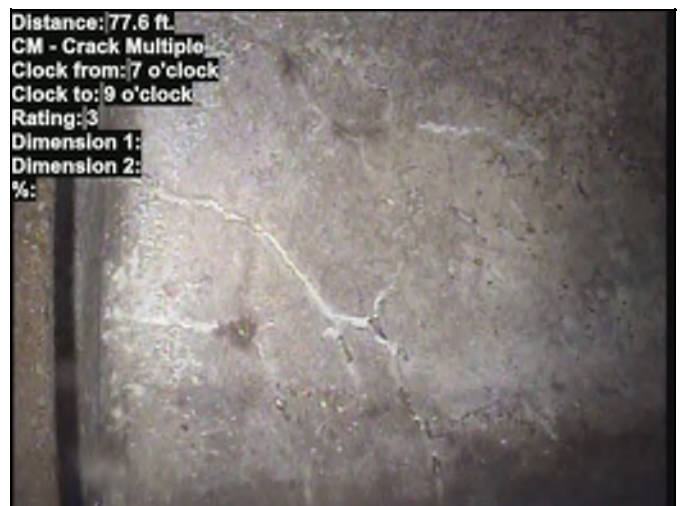
Distance: 77.6 ft.
CM - Crack Multiple
Clock from: 7 o'clock
Clock to: 9 o'clock
Rating: 3
Dimension 1:
Dimension 2:
%:
Photo: 666667947.00-22084.00-20240421-205127-205821.JPG
At: 77.6 ft. 7/9 CM - Crack Multiple
Joint: No

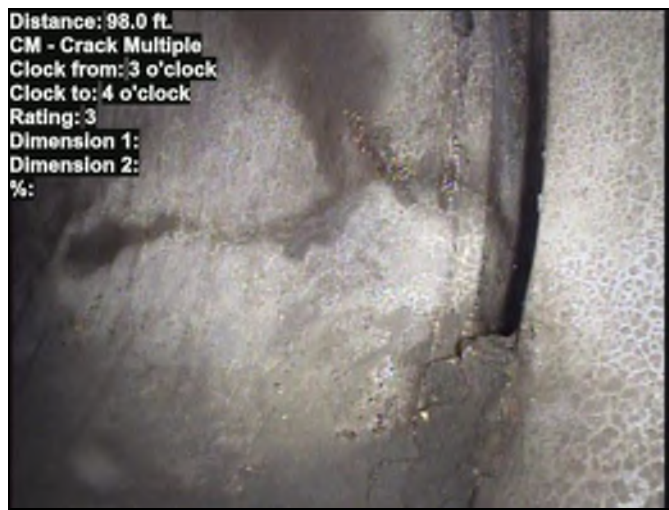
Distance: 98.0 ft.
 CM - Crack Multiple
 Clock from: 3 o'clock
 Clock to: 4 o'clock
 Rating: 3
 Dimension 1:
 Dimension 2:
 %:
 Photo: 666667947.00-22084.00-20240421-205127-205907.JPG
 At: 98 ft. 3/4 CM - Crack Multiple
 Joint: No

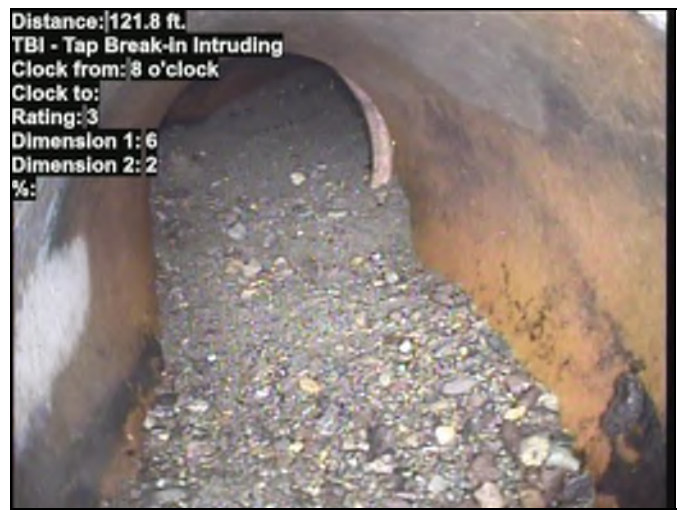
Distance: 121.8 ft.
 TBI - Tap Break-in Intruding
 Clock from: 8 o'clock
 Clock to:
 Rating: 3
 Dimension 1: 6
 Dimension 2: 2
 %:
 Photo: 666667947.00-22084.00-20240421-205127-210016.JPG
 At: 121.8 ft. 8/. TBI - Tap Break-in Intruding
 Joint: No

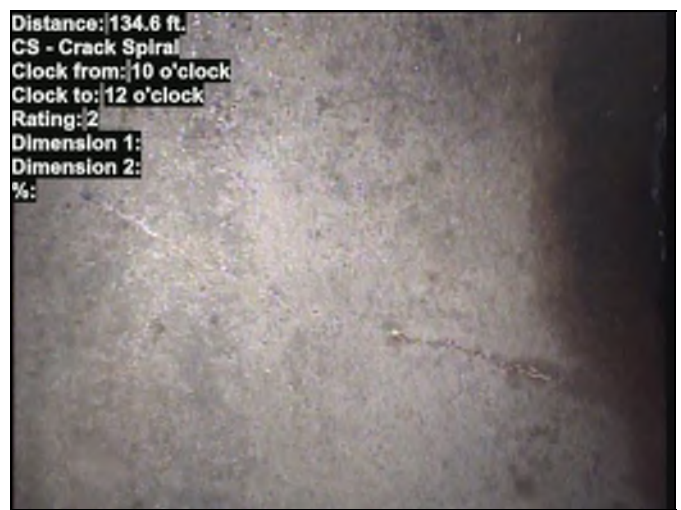
Distance: 134.6 ft.
 CS - Crack Spiral
 Clock from: 10 o'clock
 Clock to: 12 o'clock
 Rating: 2
 Dimension 1:
 Dimension 2:
 %:
 Photo: 666667947.00-22084.00-20240421-205127-210108.JPG
 At: 134.6 ft. CS - Crack Spiral
 10/12
 Joint: No

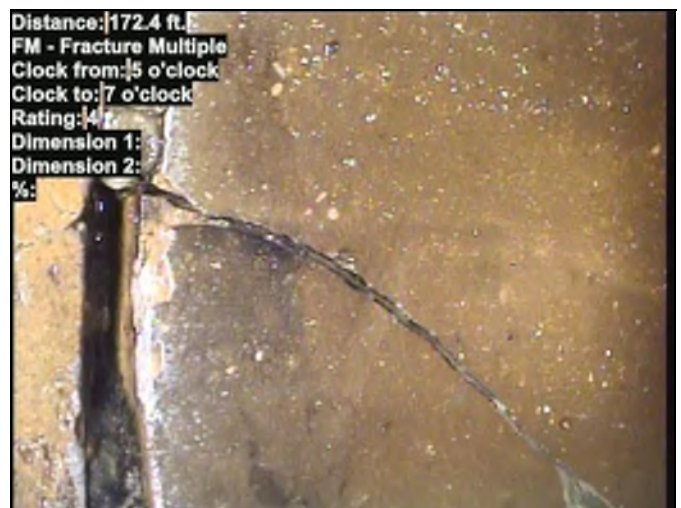
Distance: 172.4 ft.
FM - Fracture Multiple
Clock from: 5 o'clock
Clock to: 7 o'clock
Rating: 4
Dimension 1:
Dimension 2:
%:
Photo: 666667978.00-30328.00-20240422-010742-012041.JPG
At: 172.4 ft. 5/7 FM - Fracture Multiple
Joint: No

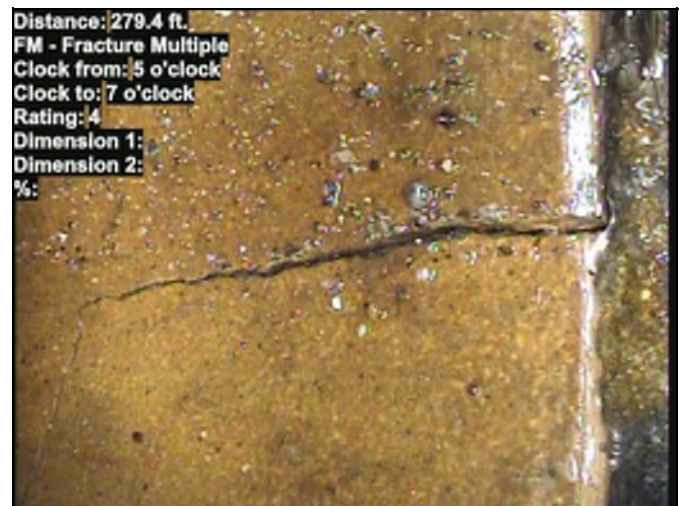
Distance: 279.4 ft.
FM - Fracture Multiple
Clock from: 5 o'clock
Clock to: 7 o'clock
Rating: 4
Dimension 1:
Dimension 2:
%:
Photo: 666667978.00-30328.00-20240422-010742-012752.JPG
At: 279.4 ft. 5/7 FM - Fracture Multiple
Joint: No
