5830  
4 Feb 22

From: CAPT (b) (6), (b) (3) (A), USN  
To: Commander, U.S. THIRD Fleet

SUBJ: COMMAND INVESTIGATION INTO THE FACTS AND CIRCUMSTANCES  
SURROUNDING THE 31 AUGUST 2021 AVIATION MISHAP THAT OCCURRED  
ONBOARD USS ABRAHAM LINCOLN (CVN-72)

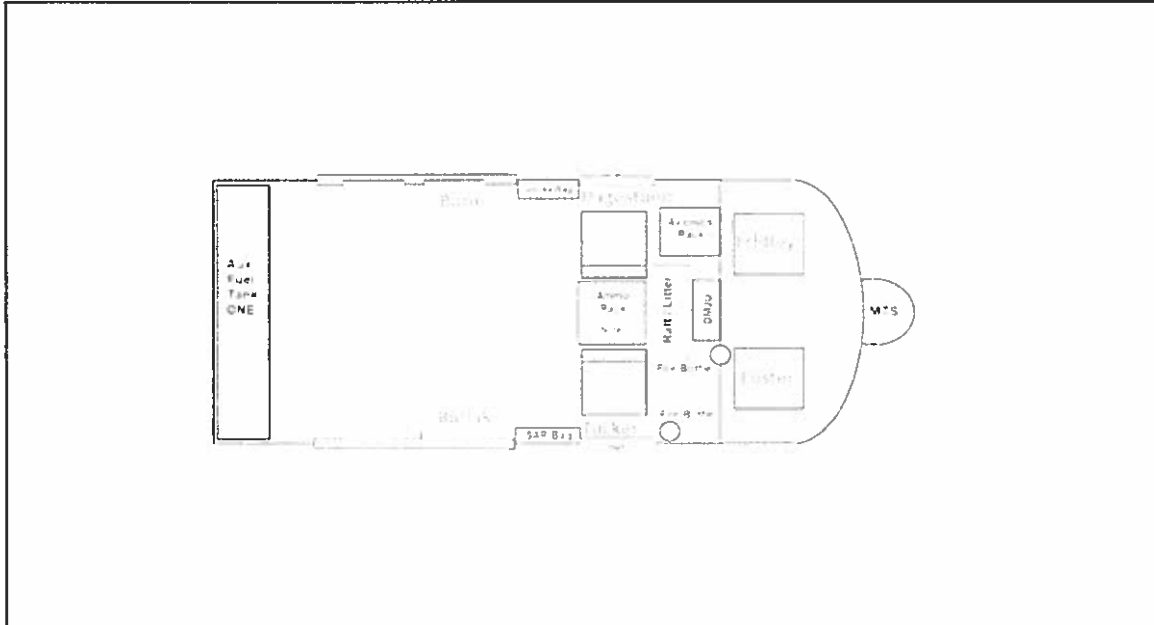
Figure 1. LT 616 Cabin Configuration

46. See Figure 1 above for cabin configuration at the time of the mishap. Four cabin seats were onboard LT 616, but only the two front gunner seats were installed. The other two seats were stored folded in the cabin. LT 616 was equipped with an auxiliary fuel tank installed in the rear of the cabin. [Enclosures (2), (9), (20), (55), (78) - (79)]

47. During landing, AWS3 (b) (6), (b) (3) (A), (b) (7)(C) was standing in the left gunner's window with HM2 Burns standing to his left at the left gunner's door. AWS2 (b) (6), (b) (3) (A), (b) (7)(C) was standing and holding onto two green handles above the left gunner's window. According to AWS3 (b) (6), (b) (3) (A), (b) (7)(C), both crewman were restrained in gunner's belts. [Enclosures (11), (12), (20), (78) - (80)]
