DEPARTMENT OF THE NAVY
VICE CHIEF OF NAVAL OPERATIONS
2000 NAVY PENTAGON
WASHINGTON DC 20350-2000

FINAL ENDORSEMENT on RDML Christopher J. Cavanaugh, USN ltr 5830 of 14 Jan 22

Subj: COMMAND INVESTIGATION INTO THE 6 MAY 2021 AND 20 NOVEMBER 2021
INCIDENTS AT RED HILL BULK FUEL STORAGE FACILITY

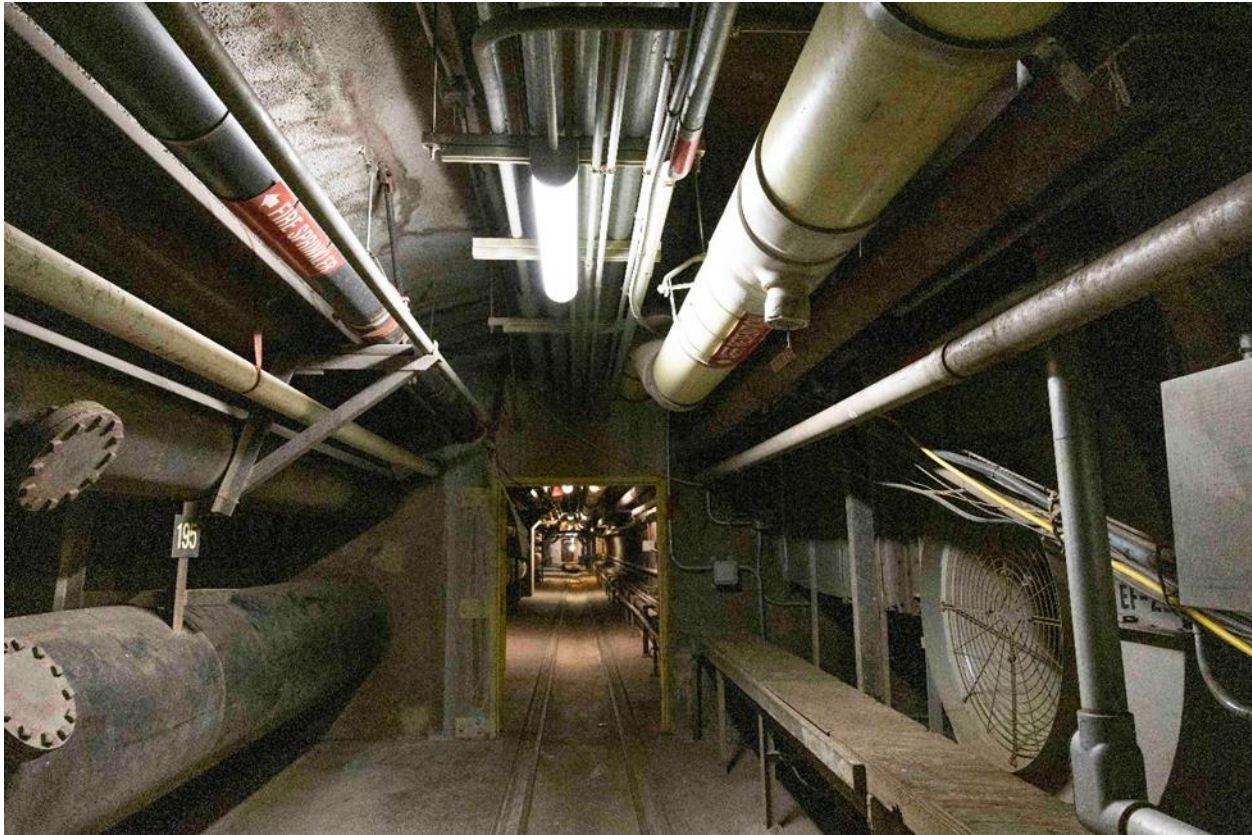
Lower Access Tunnel with AFFF retention line in top right (PVC pipe)

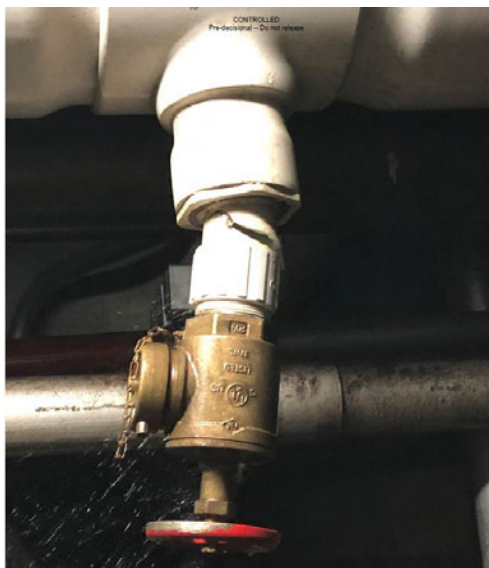
Cracked Low Point Drain

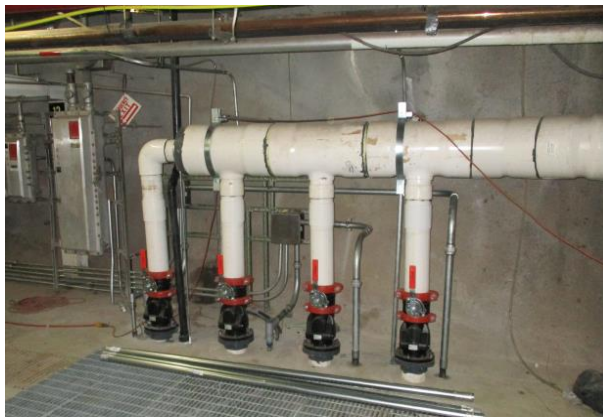
Original AFFF Retention Line Piping in Immediate Area of an AFFF Sump

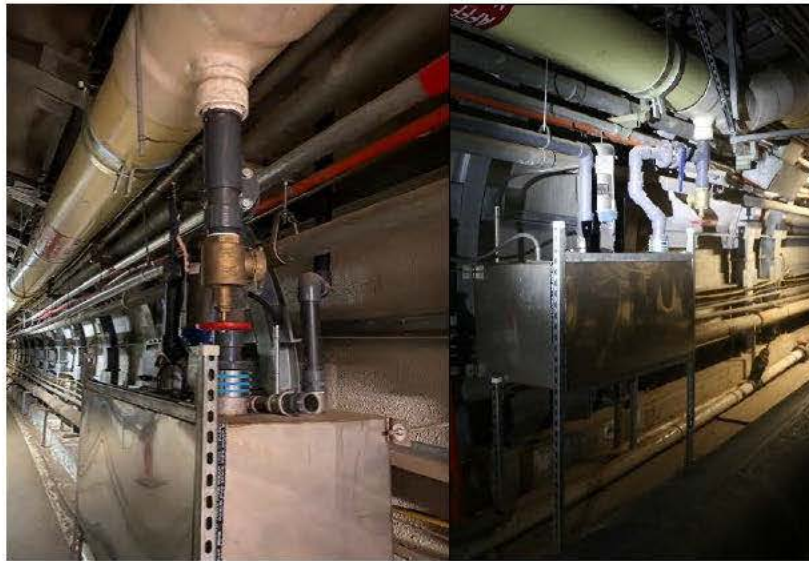
384. On 13 Apr 17, the contractor proposed a revised AFFF retention line low area drain plan which is a self-contained unit with new tank and sump pump to move AFFF retention line

drainage out to a new manual hose connection at the Adit 3 entrance via new 3" PVC piping. This system does not utilize the groundwater sump system. This is the installed configuration today and is in close proximity to the Adit 3 groundwater sump, but does not connect with that sump. This system was not used to drain the AFFF retention line following the November spill. [Encl (354)]

Final Installed Low Point Drain System with PVC Retention Line

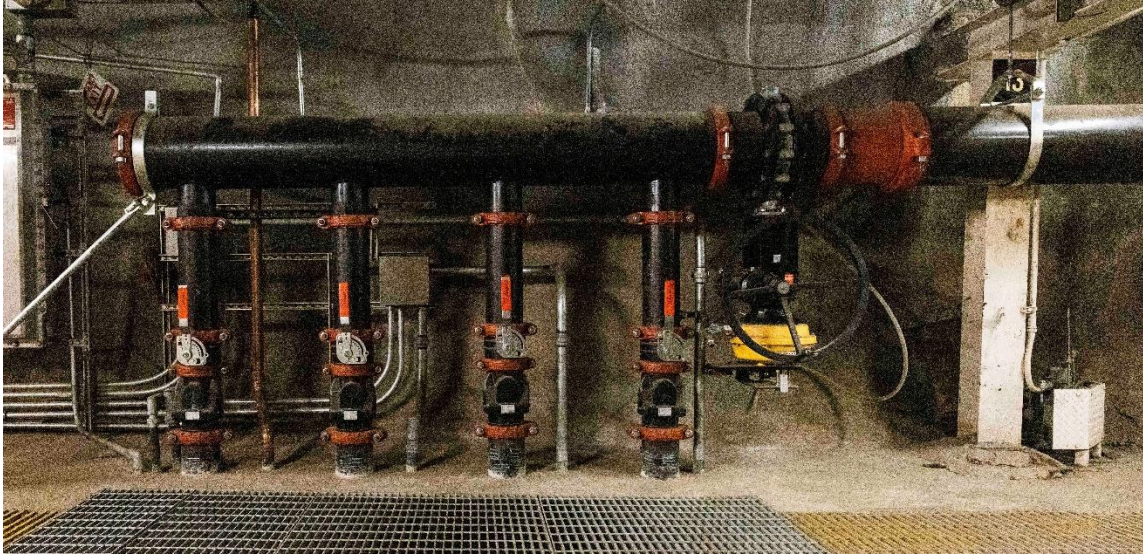
405. On 19 Jun 19, Change R was completed by the construction contractor. This is the configuration today. Commissioning testing was not performed again on the AFFF waste system. However, servicing was performed on the sump pumps (grease, rotation, cleaning) during connection of the new steel piping in the immediate area of the pumps. It was noted at the time that some of the pumps were seized due to lack of preventative maintenance, but were operational at the completion of servicing. [Encls (332), (362), (364)]

Final Change R Piping in Immediate Area of an AFFF Sump

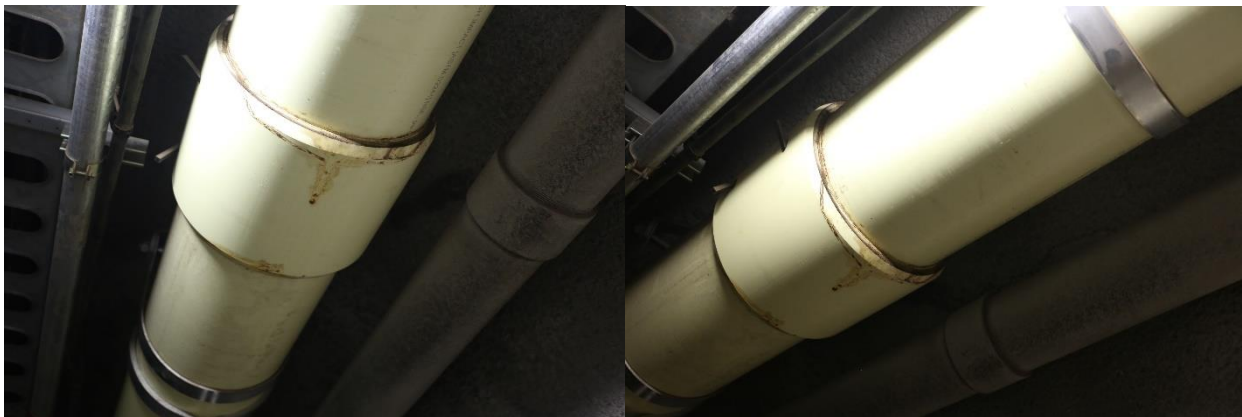
414. On 17 Mar 22, during a walkthrough of Red Hill, the supplement investigation team noted visual evidence of a foreign substance on the outside of the PVC AFFF retention line piping joints that appears to have seeped out.

Installed PVC AFFF Retention Line with Joint Seepage

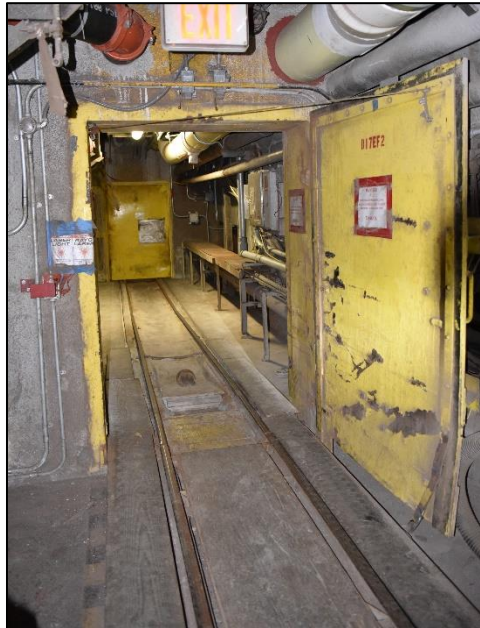
Figure 1: Image of open oil-tight door (foreground) and closed ventilation door on either side of the damaged fire suppression system low point drain valve. [Encl (169)]

178. After driving through the doorway, he again stopped the train and disembarked to close the ventilation control door. As he turned to close the door, he discovered liquid spraying from the low point drain of the fire suppression system retention line. He reported the leak immediately to the CRO. He recognized the source was a non-fuel system, first reporting it was from a sewage line, then fire suppression agent, then water. Finally, he reported the leak as water with a fuel smell. This line should have been empty. [Encls (83), (173)-(186)]
