**DEPARTMENT OF THE NAVY**  
COMMANDER NAVAL AIR FORCE  
UNITED STATES PACIFIC FLEET  
BOX 357051  
SAN DIEGO CALIFORNIA 92135-7051

Subj: COMMAND INVESTIGATION INTO THE FACTS AND CIRCUMSTANCES  
SURROUNDING THE F-35C CLASS A AVIATION MISHAP OF 24 JAN 22

15 Apr 22

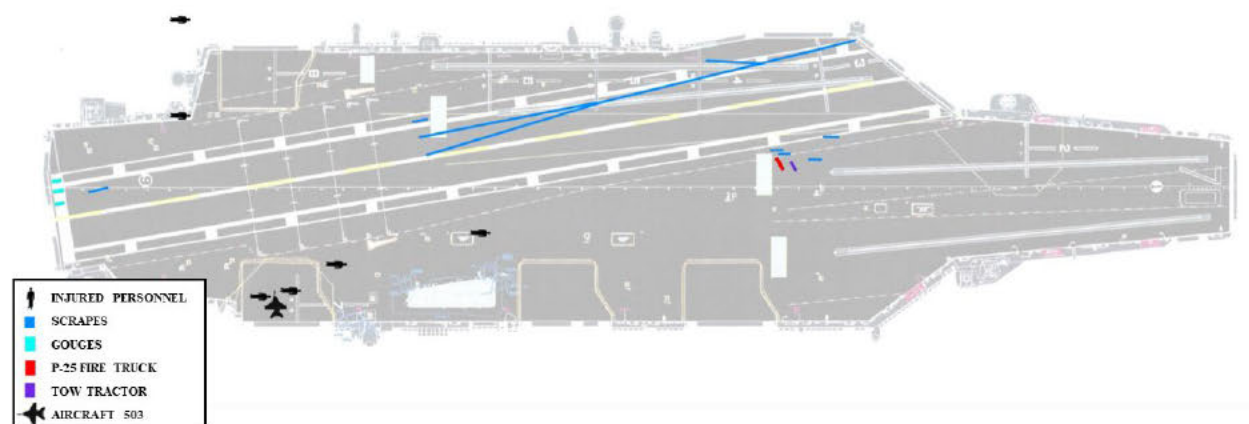
**Figure 6 depicts the Location of Injured Personnel and Damages**

148.    The mishap resulted in the destruction of BUNO 169304, significant damage to EA-18G BUNO 169211 (IRONCLAW 503), and minor damage to the CVN 70 flight deck and ground support equipment. [Encl 4-6, 69, 70-72, 84]

150.    Aircraft BUNO 169211 (IRONCLAW 503) was parked on aircraft elevator 3 of CVN 70 and struck by debris from MA impacting the flight deck. The following monetary costs are for replacement of IRONCLAW 503's respective component, which is the expected course of action at the organizational level. [Encl 4-6, 69]

(3) To ensure survivability of the upwind Mobile Firefighting Vehicle (MFFV) and its ability to help respond to a crash in the landing area, position upwind MFFV away from the foul line.
