*Clark, William/Ane Marie*

Enclosed is a report that was issued to our insurance company Fidelity National Property and Casualty, by U.S. Forensic, LLC, in reference to a denial for foundation damage to our home at [REDACTED] Avenue, West Wildwood, NJ 08260. This report was issued after our request for an engineer to come and inspect the foundation damage done to our home by Hurricane Sandy on October 29, 2012. Please note the engineer came on April 26, 2013 which was a six months from the date of the hurricane, and the report is dated June 6, 2013. After careful review, we decided to contact FEMA as directed by Fidelity if we disagree with their denial of the claim.

**Building Damage Evaluation**

**USF Report No. 13.22.1524**  
**Attachments**

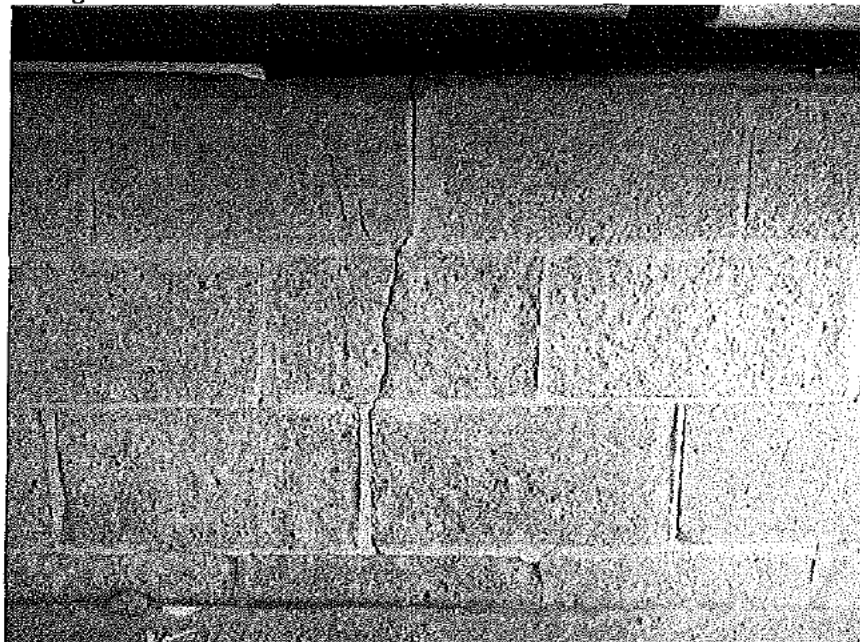
Photograph 5

View of cracks in the foundation wall on the south side of the building.

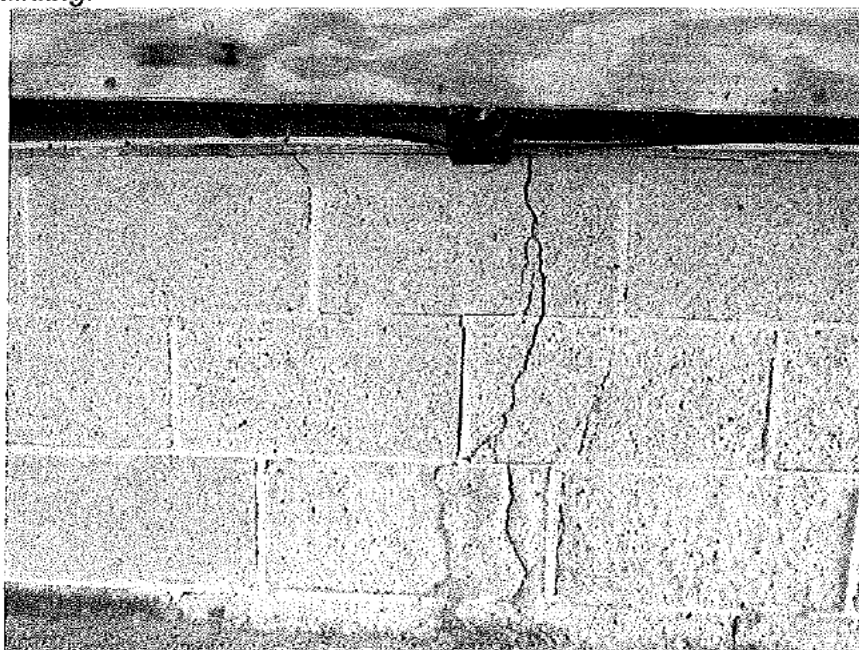
Photograph 6

#6 This crack is under front deck and we don't recall ever seeing it before the hurricane.

View of cracks in the foundation wall on the south side of the building.

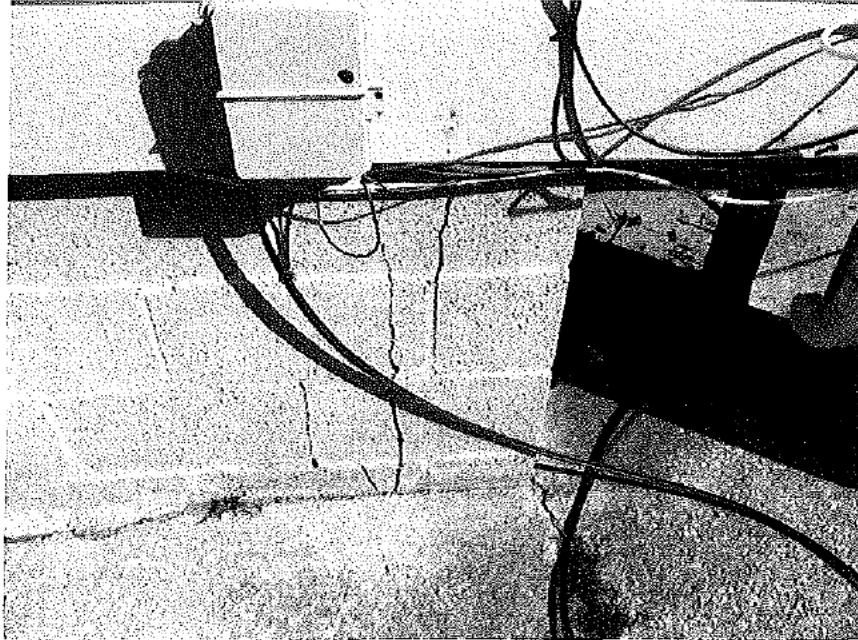
Photograph 7

#7 NEW CRACK

View of cracks in the foundation wall on the west side of the building.

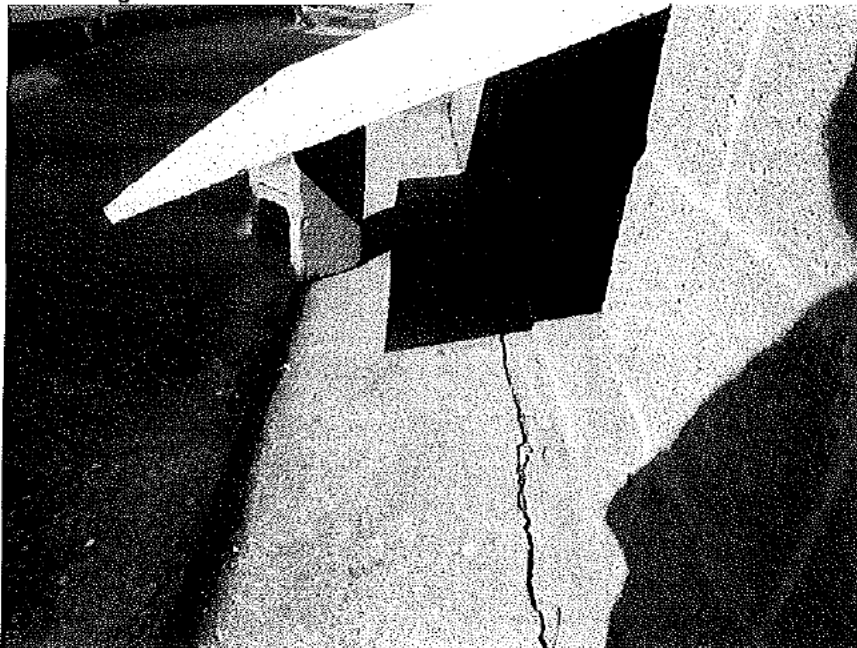
Photograph 8

"Cracks in the walkway around the whole perimeter of the property" are not true. The crack that appears in their picture #8 is the only crack in the walkway.

#8 CRACK IN SIDEWALK – This is the only area with a crack in the sidewalk. They claim cracks all around the foundation.

View of cracks in the concrete walkway paving on the west side of the building.

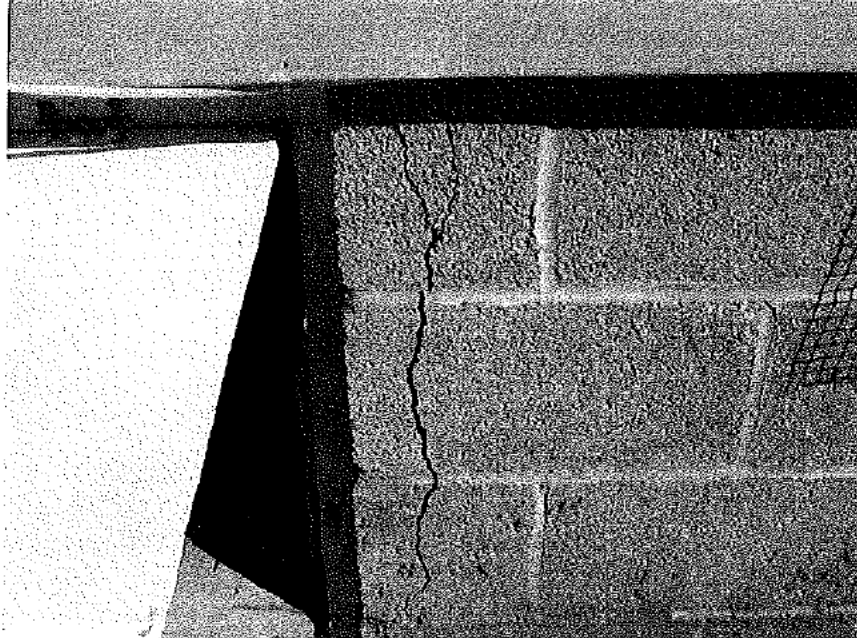
Photograph 9

#9 NEW CRACK

View of cracks in the foundation wall on the west side of the building.

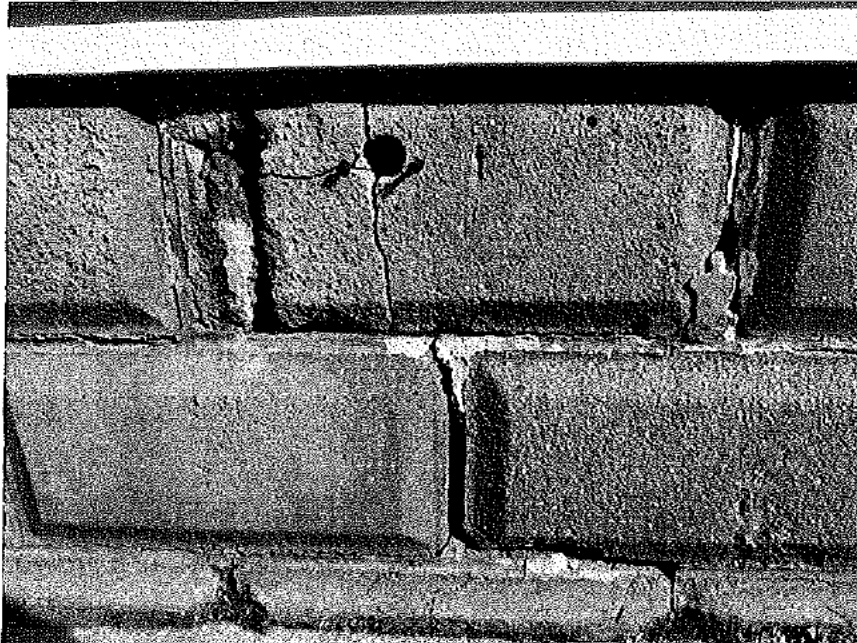
Photograph 10

View of cracks in the foundation wall on the west side of the building. Note the previous repair mortar between the CMU blocks.

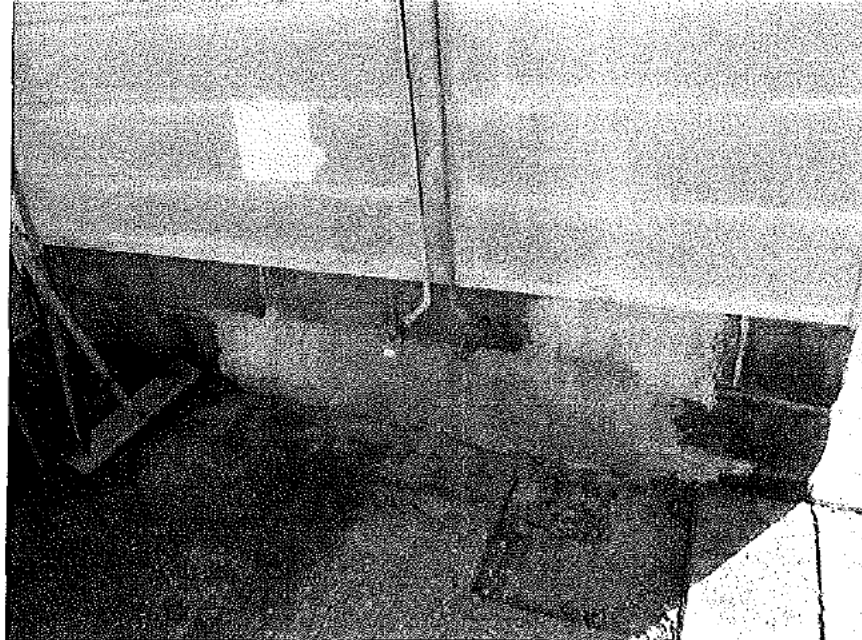
**Photograph 11**

View of previous repairs to the foundation wall on the north side of the building.

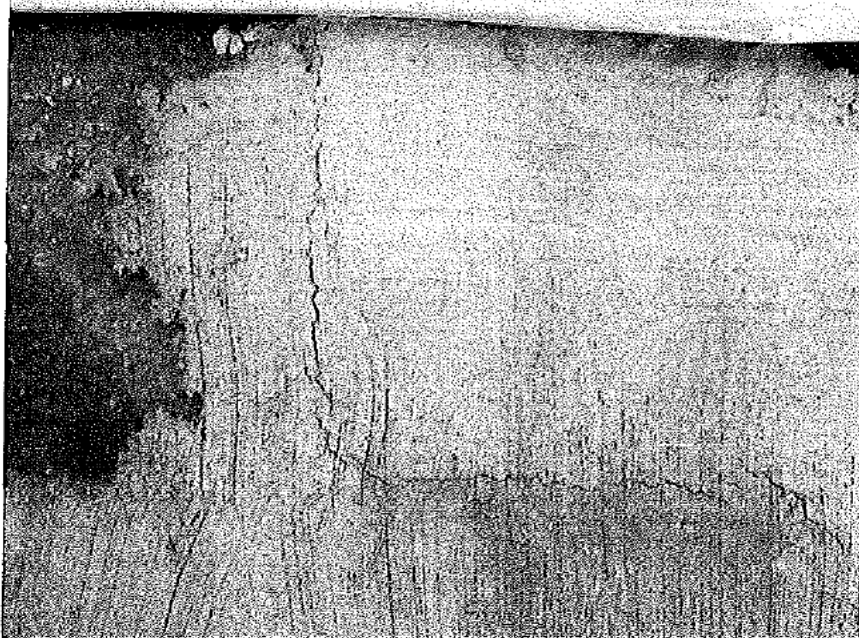
**Photograph 12**

View of cracks in the previous repairs to the foundation wall.

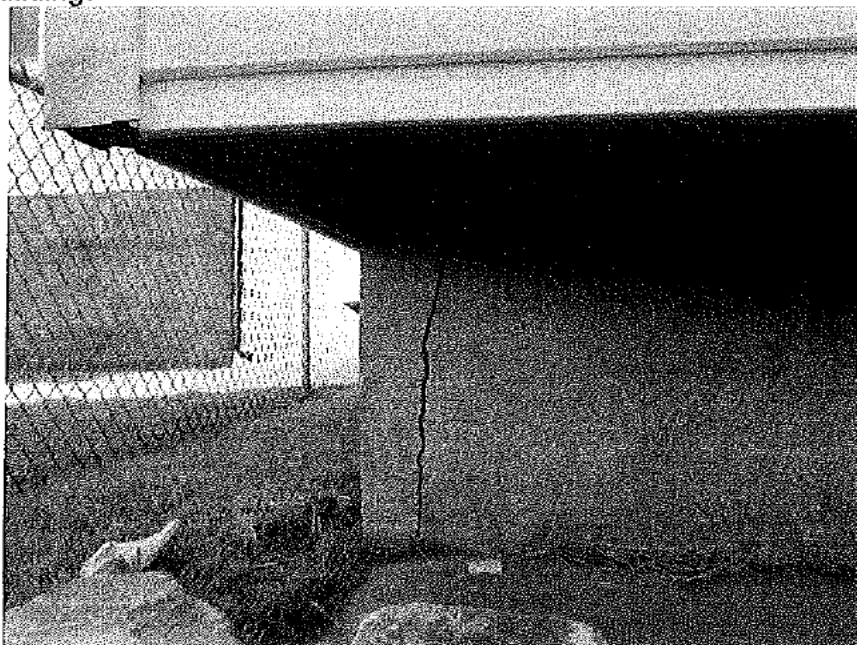
Photograph 13

#13 NEW CRACK

View of a crack in the foundation wall on the north side of the building.

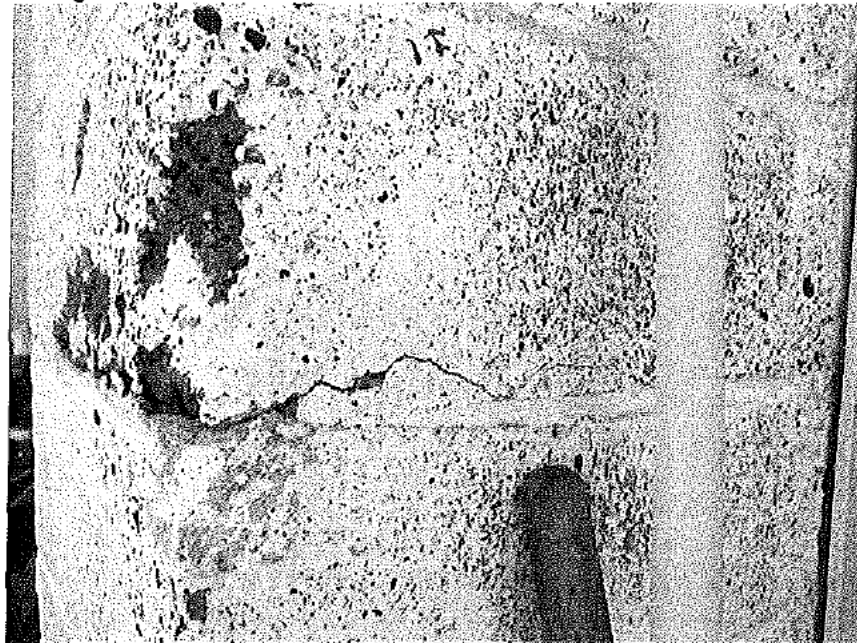
Photograph 15

View of a crack in the CMU chimney on the north side of the building.

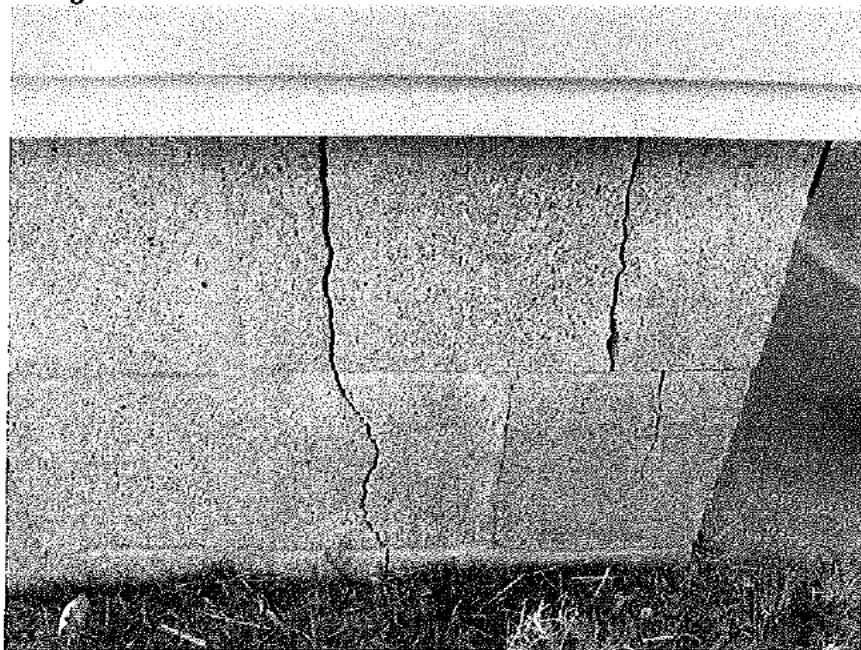
Photograph 16

#16 NEW CRACK

View of cracks in the foundation wall on the east side of the building.

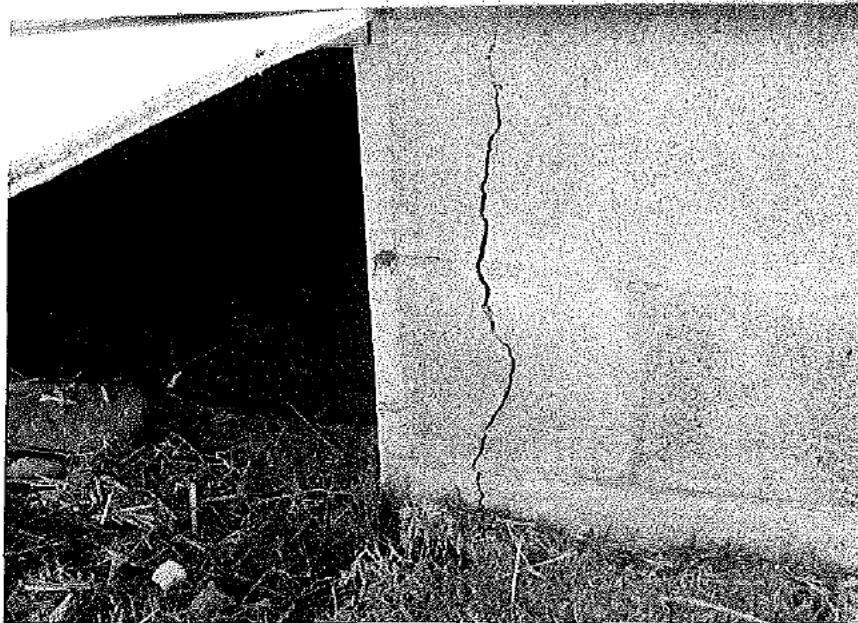
Photograph 17

#17 NEW CRACK

View of cracks in the foundation wall on the east side of the building.

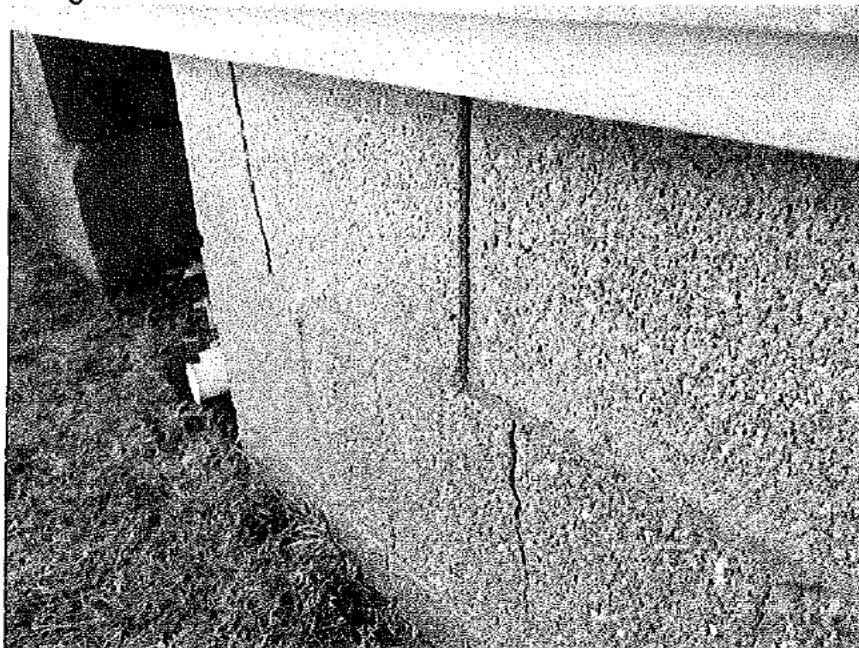
Photograph 18

View of cracks in the foundation wall on the east side of the building. Note the offset between the CMU blocks.

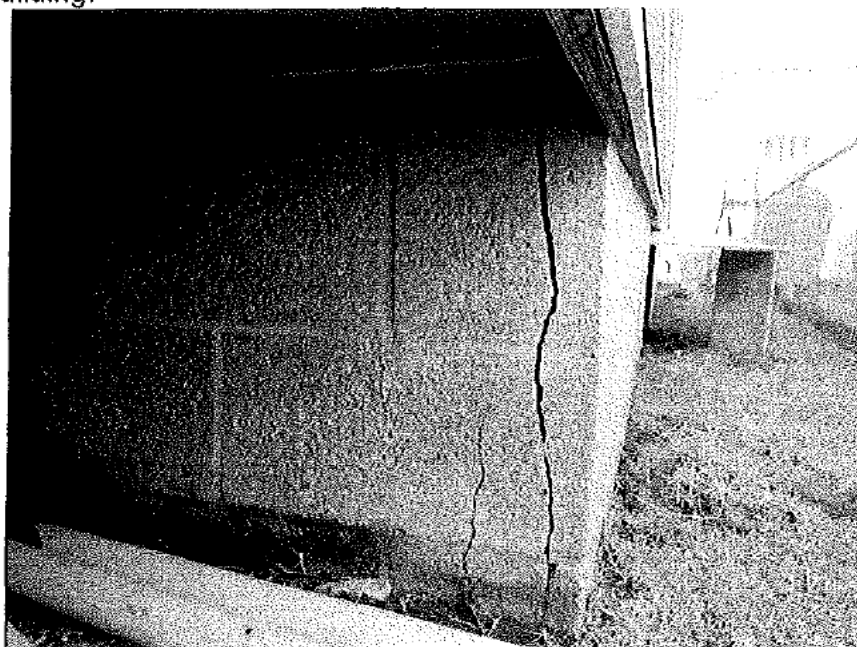
Photograph 19

#19 **NEW CRACK AND VERY CONCERNED ABOUT THIS ONE.**

View of cracks in the foundation wall on the east side of the building.

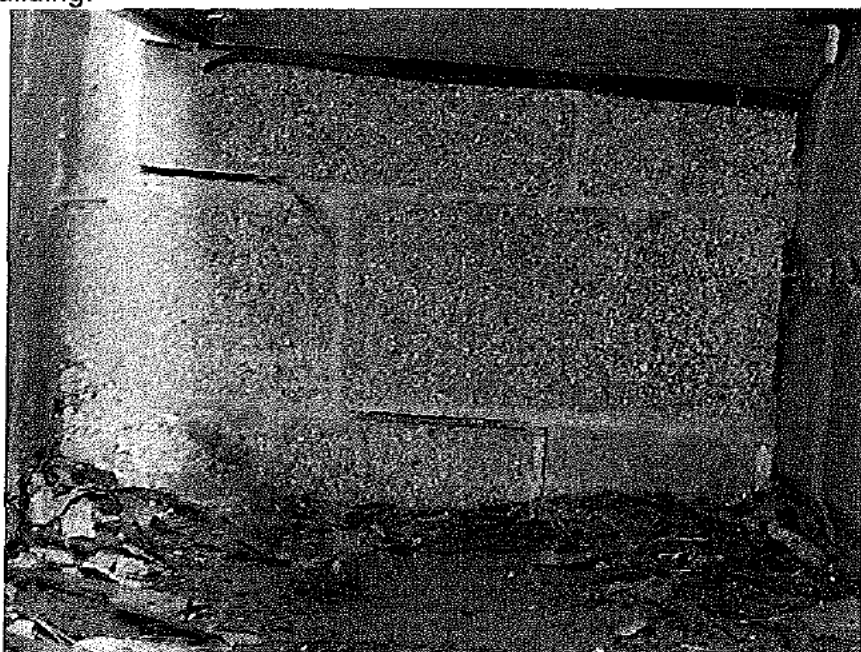
Photograph 20

View of cracks in the foundation wall on the east side of the building.

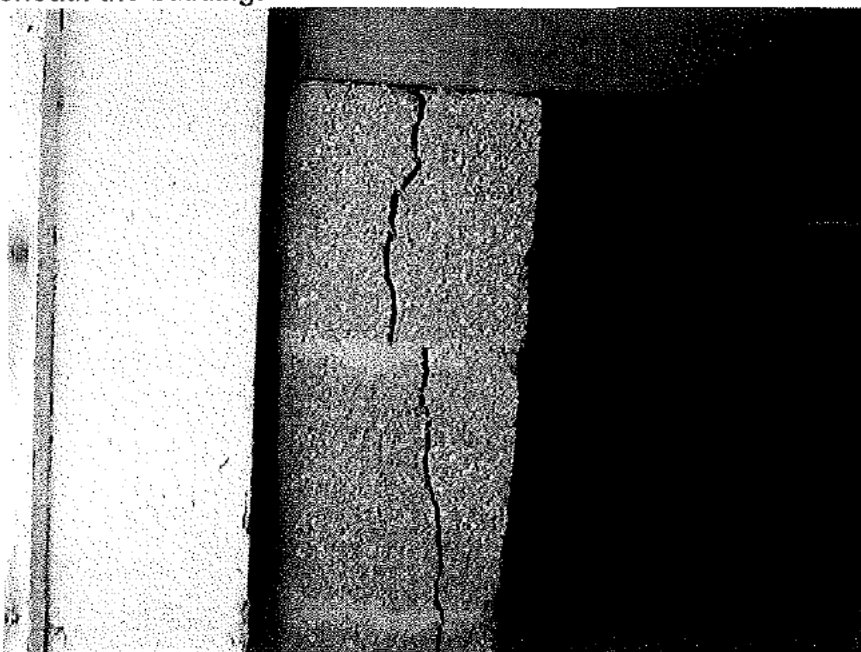
Photograph 22

View of a crack in a foundation wall within the crawlspace area beneath the building.

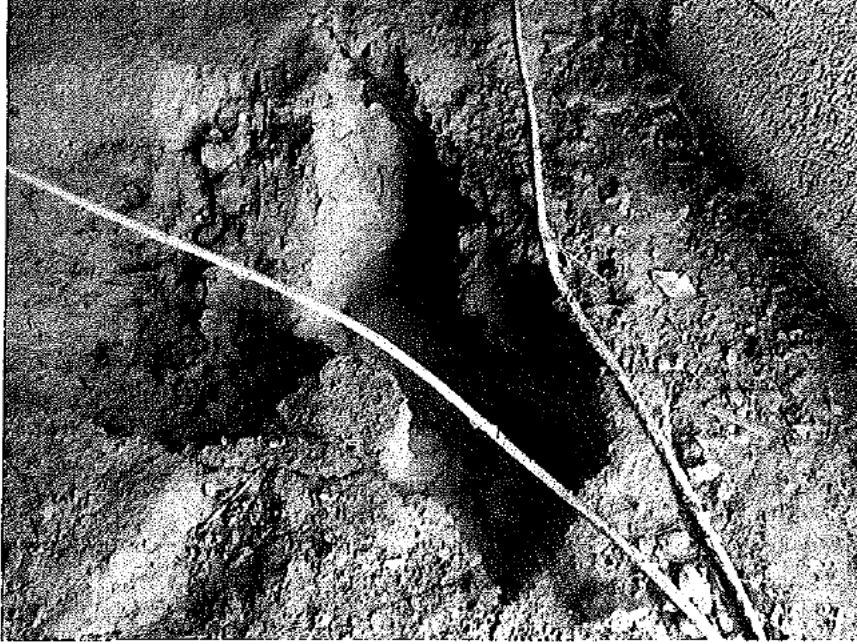
Photograph 23

View of a void in the ground surface within the crawlspace area beneath the building.

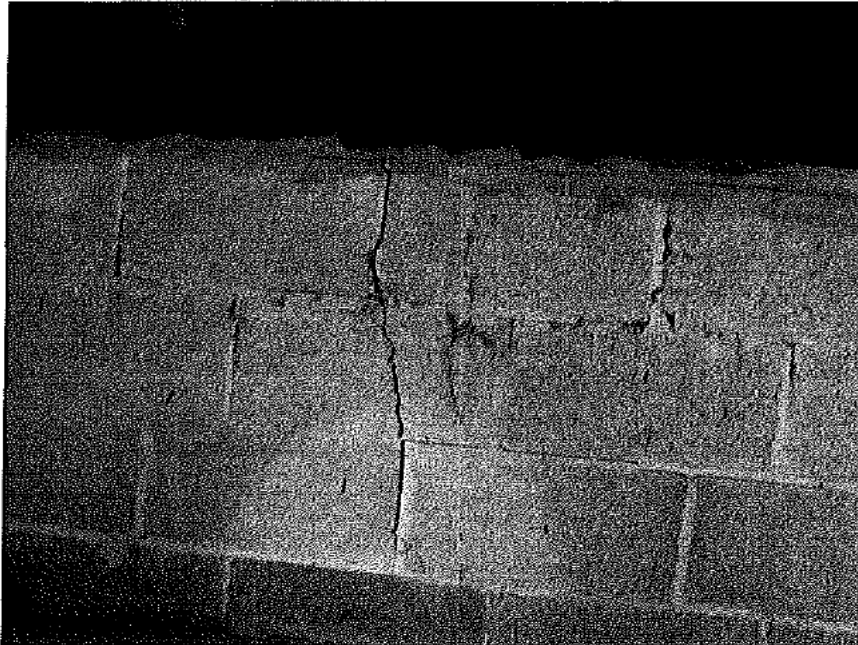
Photograph 24

#24 NEW CRACK IN CRAWL SPACE WINDOW

View of a crack in a foundation wall within the crawlspace area beneath the building. Note the water mark on the foundation wall.

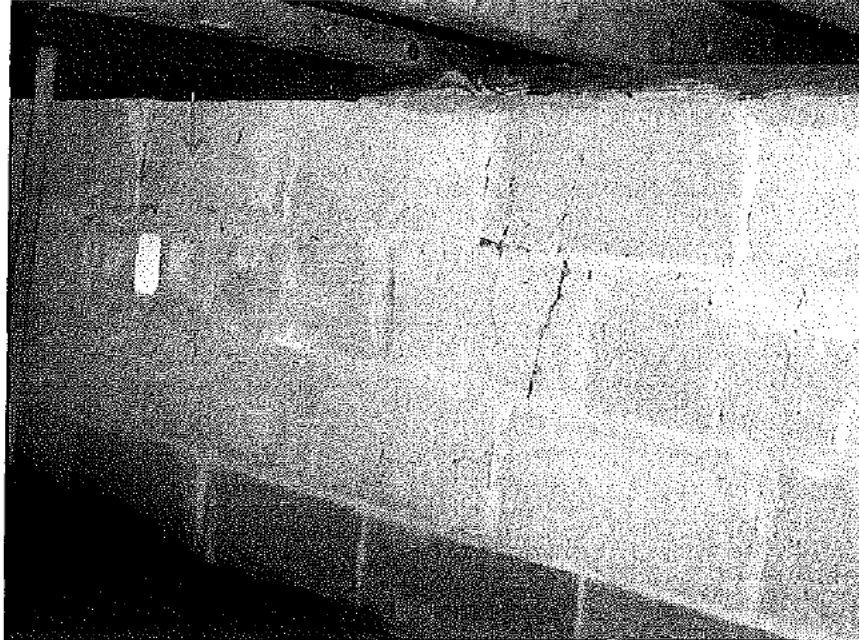
Photograph 25

View of a crack in a foundation wall within the crawlspace area beneath the building. Note the water mark on the foundation wall.

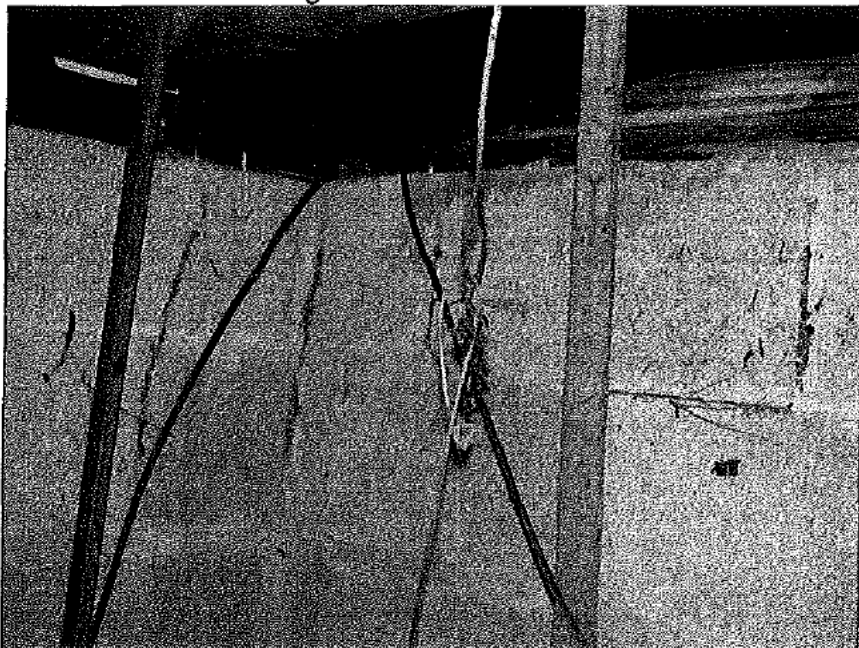
Photograph 26

View of a water mark on the foundation wall within the crawlspace area beneath the building.

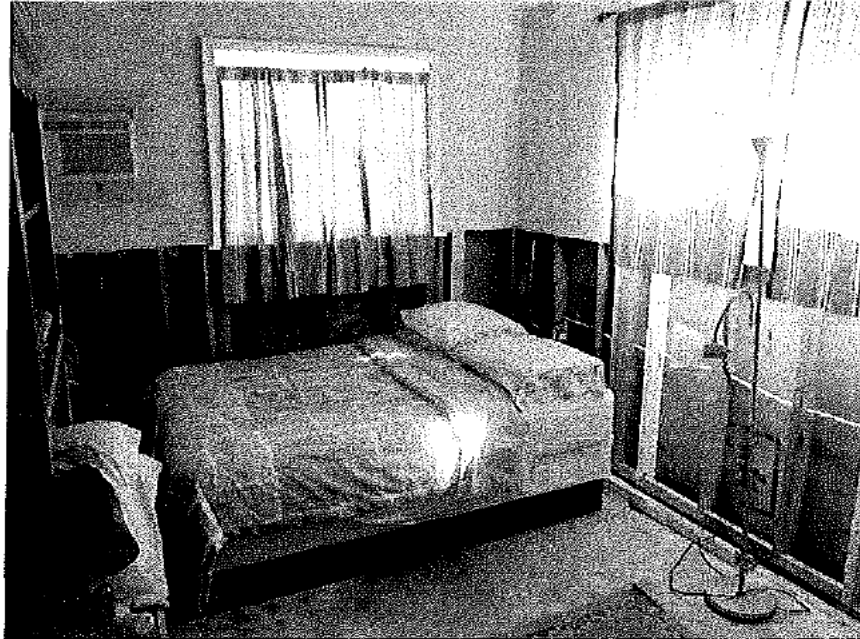
Photograph 29

View of a bedroom on the rear side of the building. Note the removed floor finishes and a removed section of wall finishes.

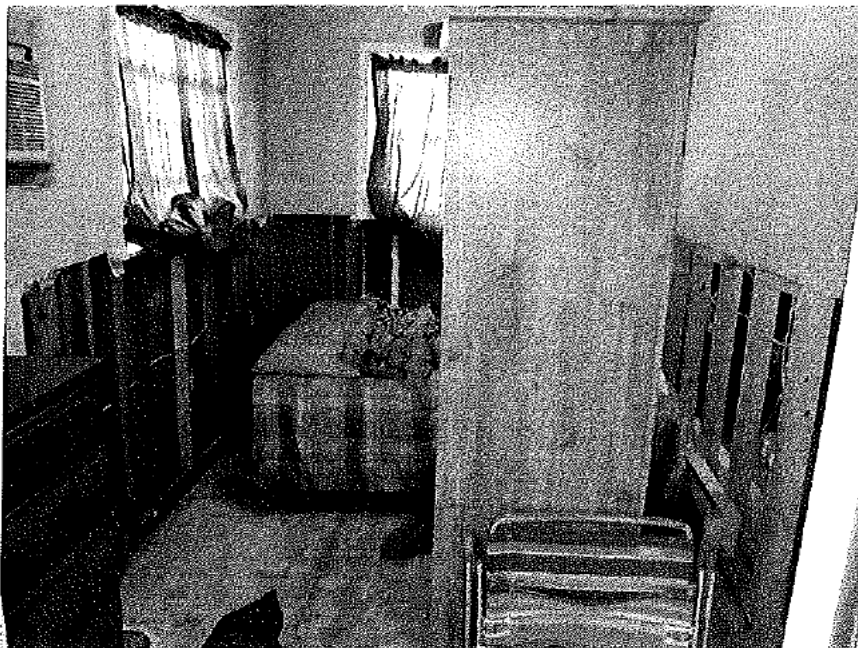
Photograph 30

View of a bedroom on the rear side of the building. Note the removed floor finishes and a removed section of wall finishes.
