**Subject: 2017 Annual USEPA CCR Landfill Inspection Report
Brunner Island Ash Disposal Area No. 8**

This report presents the findings of the 2017 annual inspection of the Brunner Island Ash Disposal Area No. 8 Landfill (Landfill). This inspection was performed on August 25, 2017, by Talen Energy. This annual inspection was conducted in accordance with the requirements of the United States Environmental Protection Agency (USEPA) 40 CFR Parts 257 and 261 Hazardous and Solid Waste Management System; Disposal of Coal Combustion Residuals from Electric Utilities; Final Rule, April 17, 2015 (CCR Final Rule).

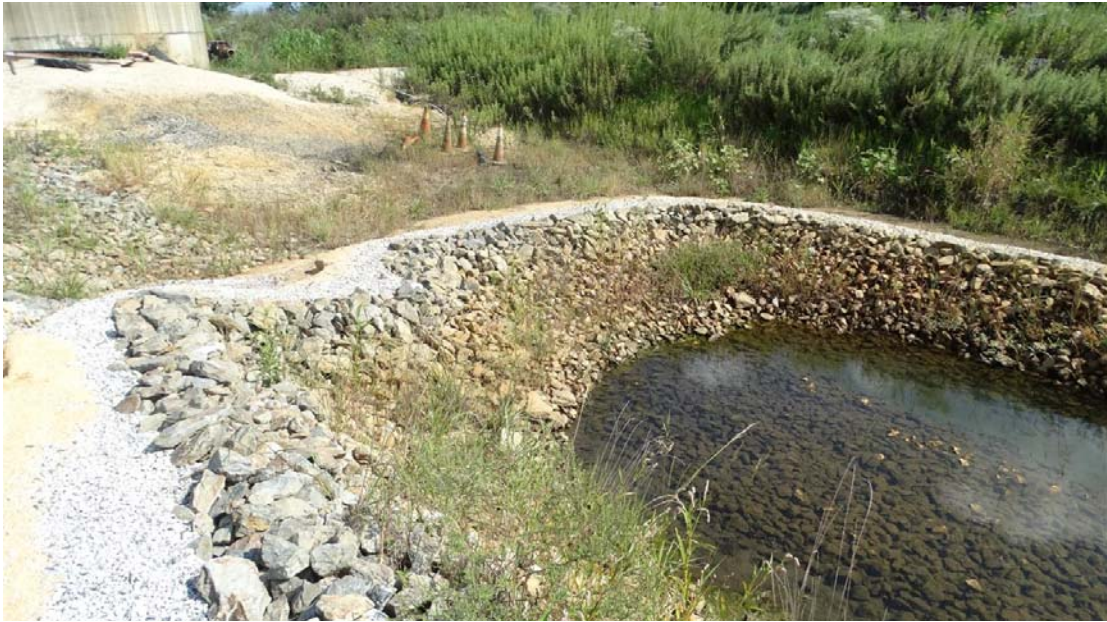
Picture 1 – New sand and rock filter around the sump area to reduce the sediment in the sump area.

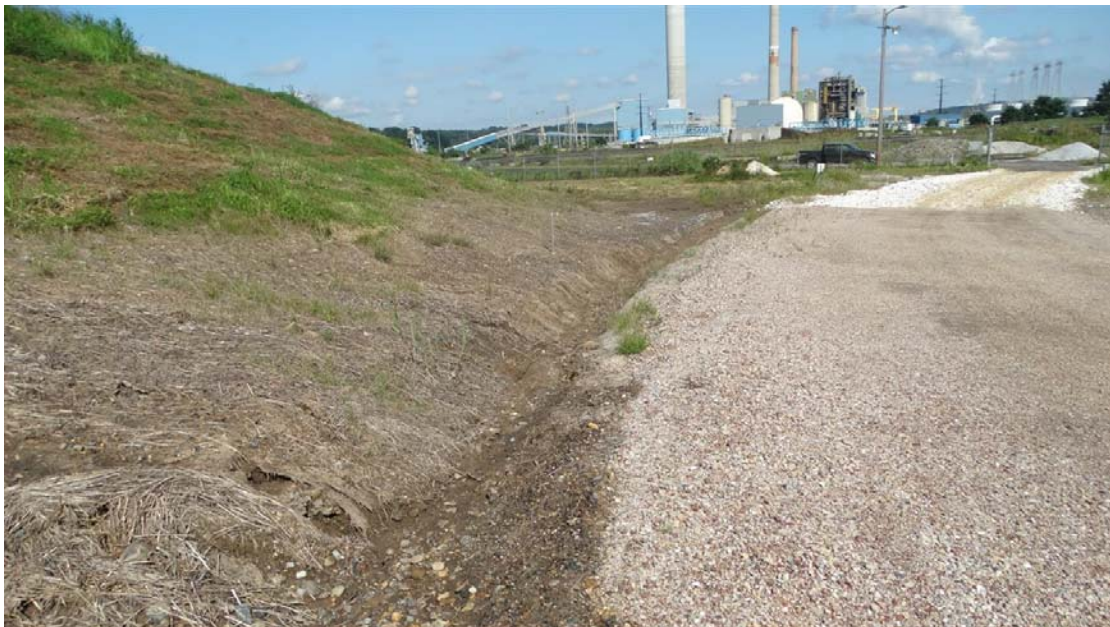
Picture 2 – Recently regraded entrance road, looking north. Note the clean water runoff swale was fertilized and seeded, but the vegetation died and should be reseeded.

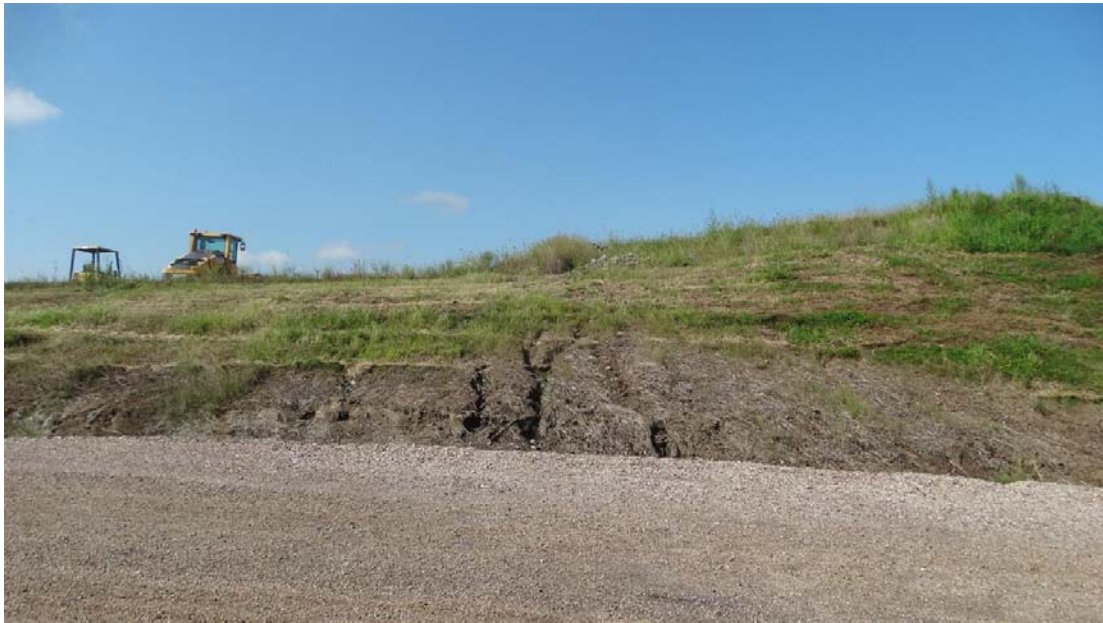
The filled area of Cell 1 was well formed and maintained. The locally steep area observed along the north slope of Cell 1 in 2015 had been regraded. Locally steep, unvegetated areas with erosion rills were observed within the landfill upslope of the entrance road and should be filled in and stabilized. This slope was recently regraded with soil and attempted to be vegetated. The receiving channel upslope of the entrance road was also regraded with soil and stabilized; however, the vegetation died and exposed the temporary geotextile matting. The channel should have the proper seed re-applied to achieve stabilization. A small dike separating the active area from the clean water runoff area, where equipment is staged, was less than the design height and should be raised.

Picture 3 – Erosion scar in the recently regraded slope above the entrance road.

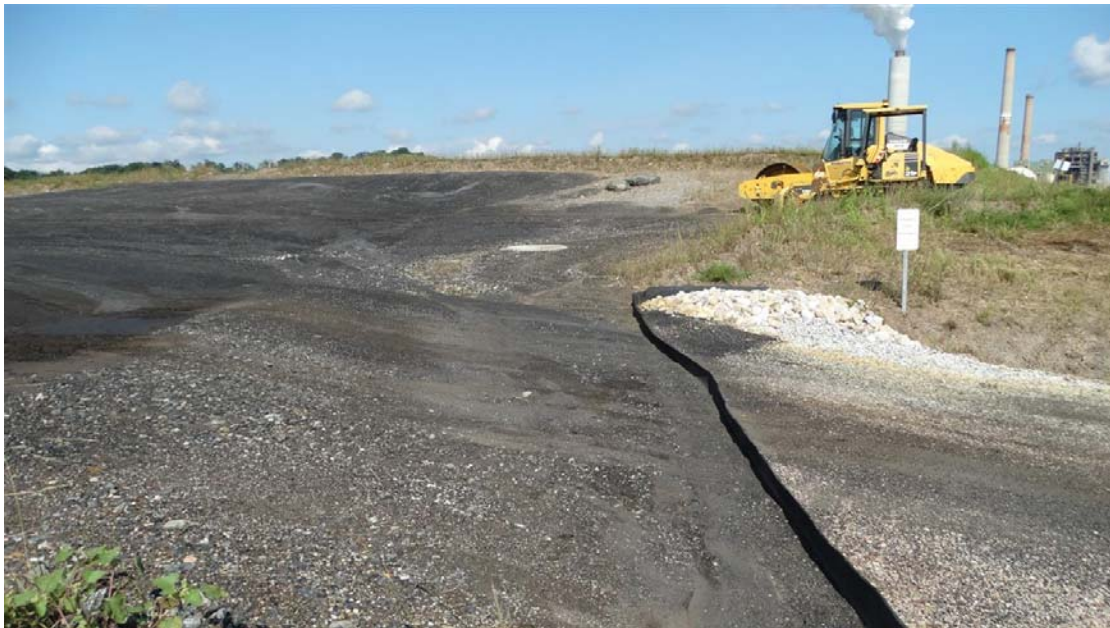
Picture 4 – BMP in the roadway used to assist in the separation of the active area and the entrance roadway.

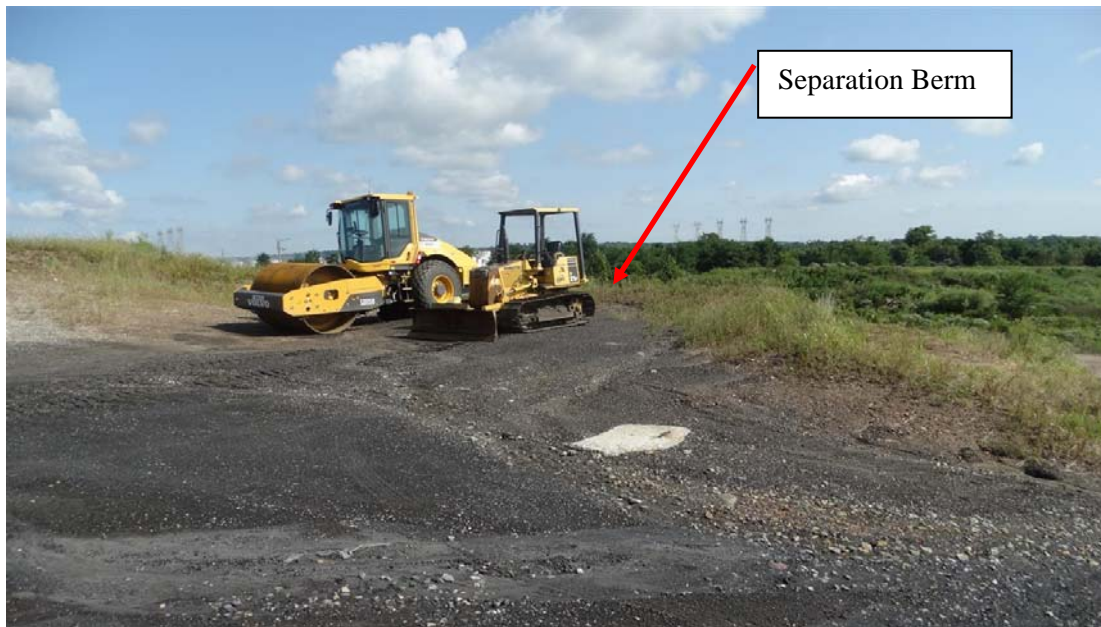
Picture 5 – Berm behind the equipment is less than 2' high.

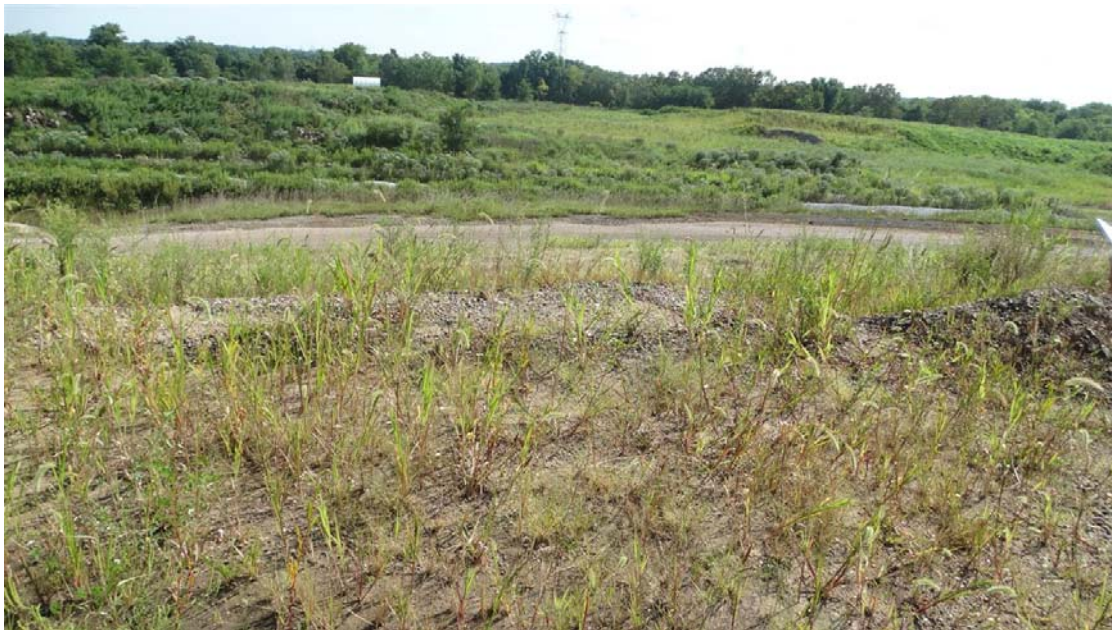
Picture 6 – Low separation berm as located in picture 5.

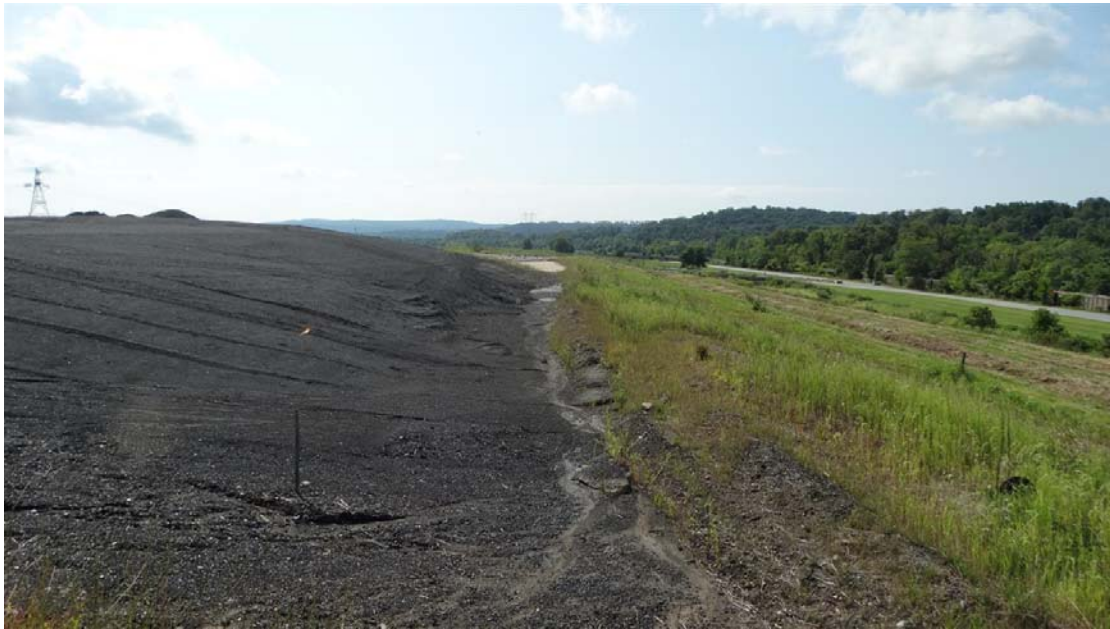
Picture 7 – Active landfill area with internal channel.

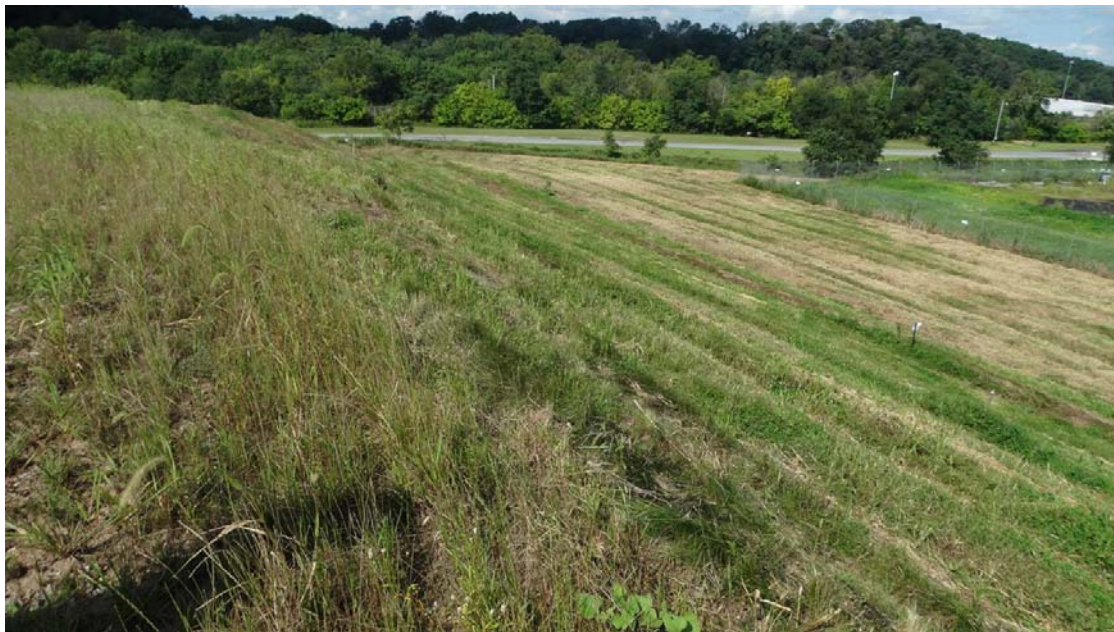
Picture 8 – Outside northern embankment is well vegetated and stabilized.

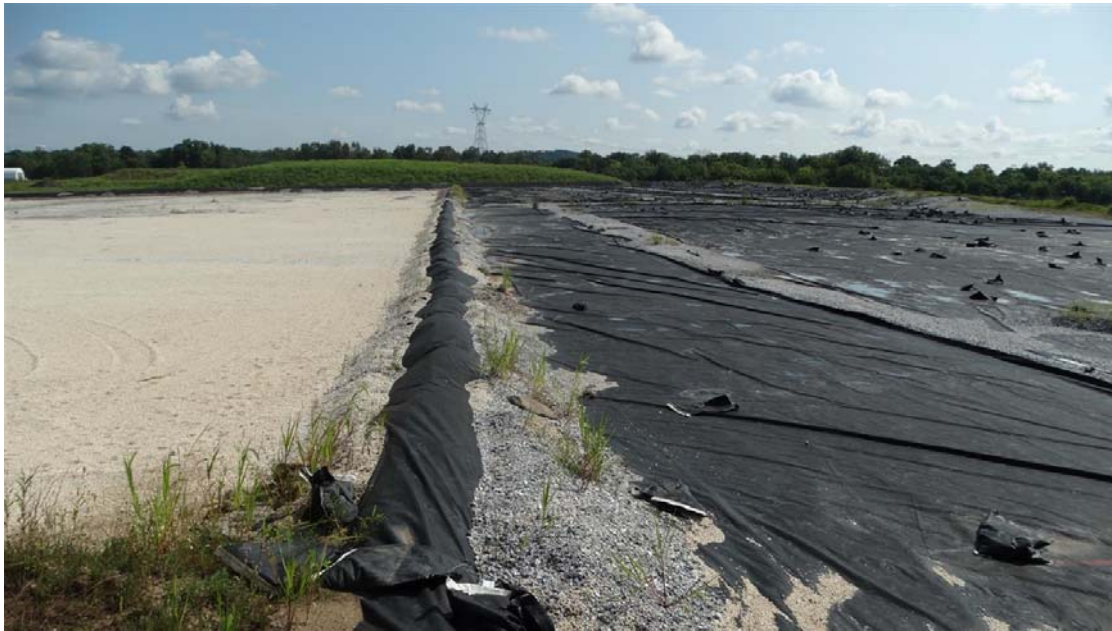
Picture 9 – Recently relocated separation berm between inactive and active portions of the landfill.

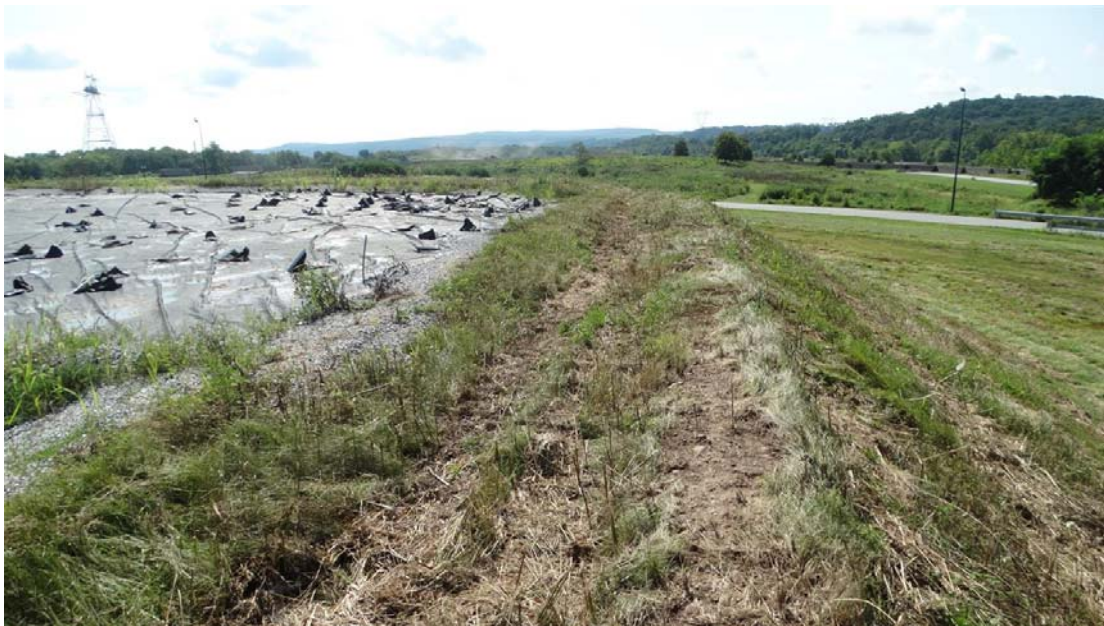
The clean water swale on the west edge of Cell 1 was recently mowed, which is an improvement from the 2016 inspection. A review of the stormwater run-off analysis indicated that the channel was designed to allow for heavy vegetation characteristic of high grass and dense brush so a mowed swale would be a more efficient channel and is acceptable. The grading of the access road at the entrance to Cell 1 was re-worked in 2016 and 2017 to pitch the runoff into the drainage basin / leachate collection sump.

Picture 10 – Perimeter stormwater channel was recently mowed.

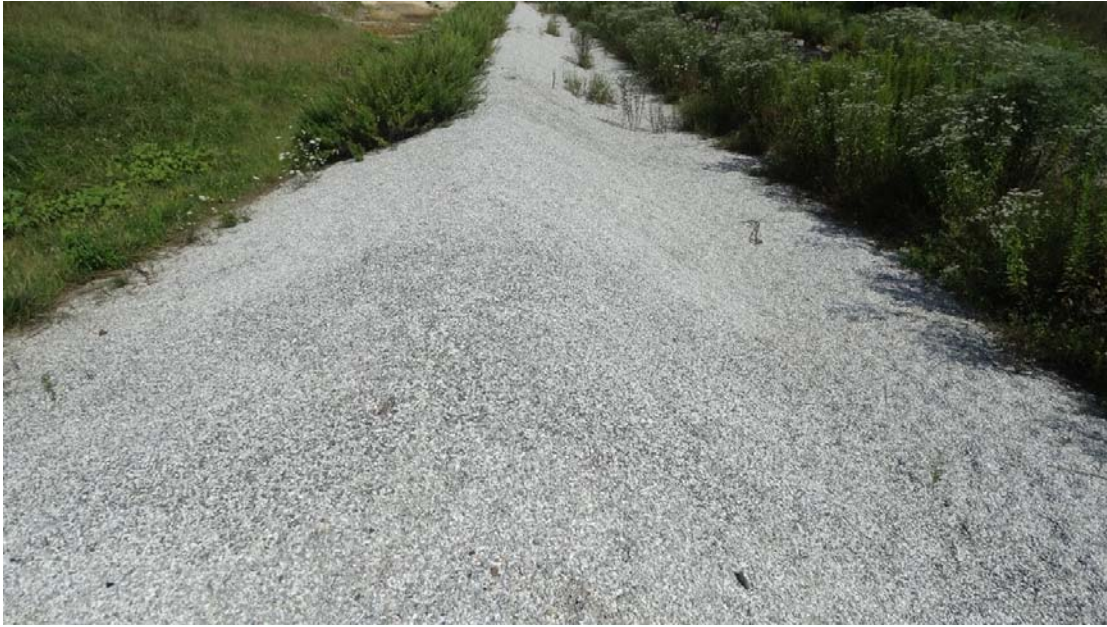
Exposed rain flap was observed along the east edge of the Landfill, under the separation berm, between the ditch draining contaminated run-off from the active section of Cell 1 and the swale draining clean run-off from the inactive section of Cell 1. The exposed sections of liner should be covered.

Picture 11 – Berm between Cell 1 and future Cell 2. A geo-membrane rain flap liner has been installed separating the two cells. The liner was exposed in a few areas.

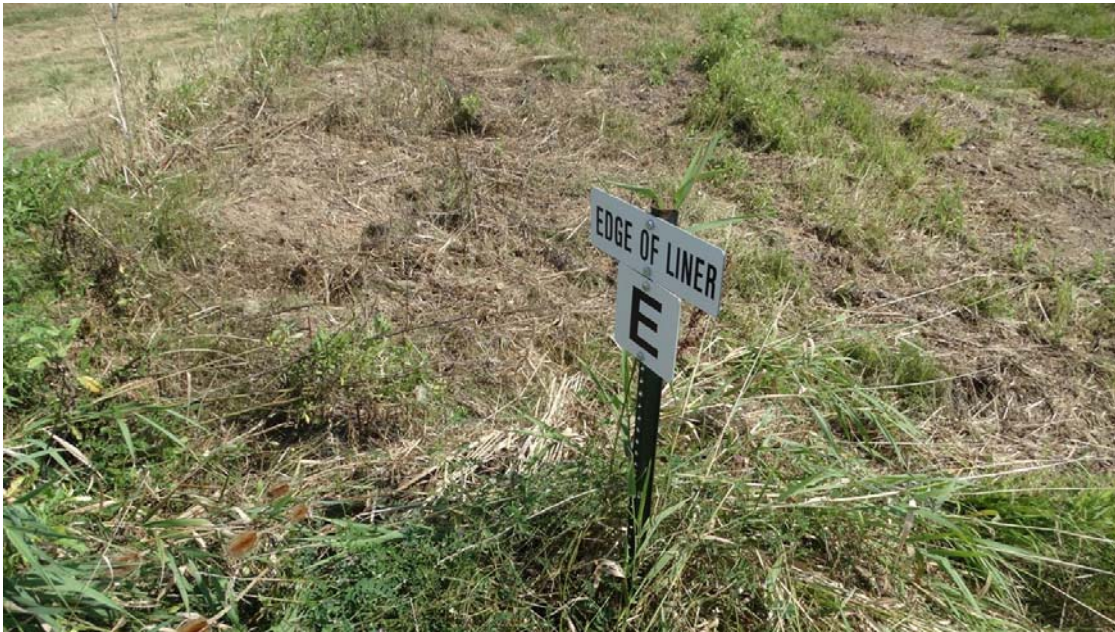
Picture 12 – Edge of liner marker with grid location.

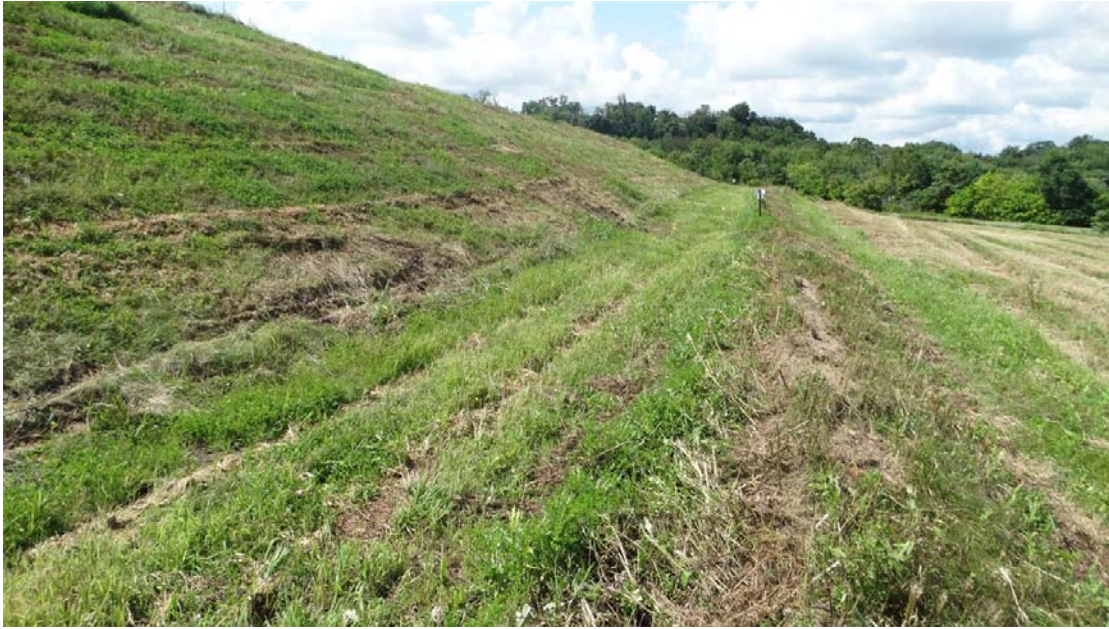
Picture 13 – Clean water runoff channel around the northern end of the landfill.

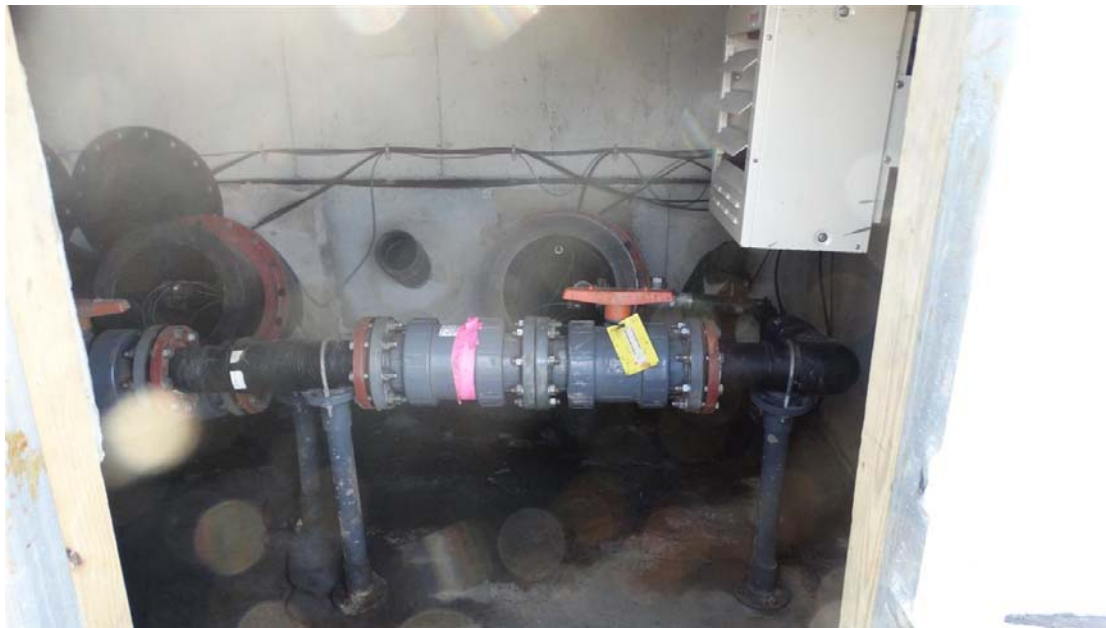
Picture 14 – Valve house with pipes leading to the sump where the pumps are located. The horizontal pipe is a common header for the leachate pumps 1 & 2 and the leak detection pump #3.

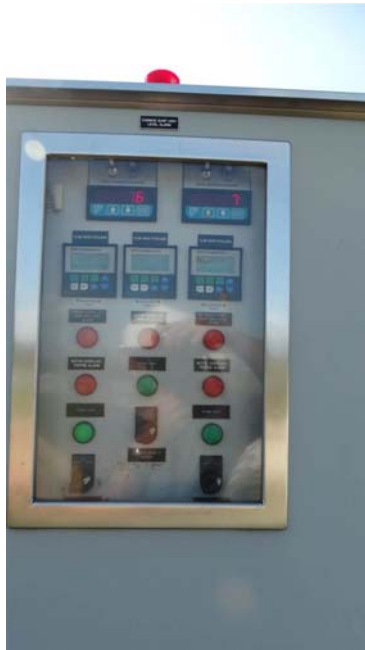
Picture 15 – Control board showing the pumps with runtime, flow meters, and depth of water in the leachate collection zone and the leak detections zone.

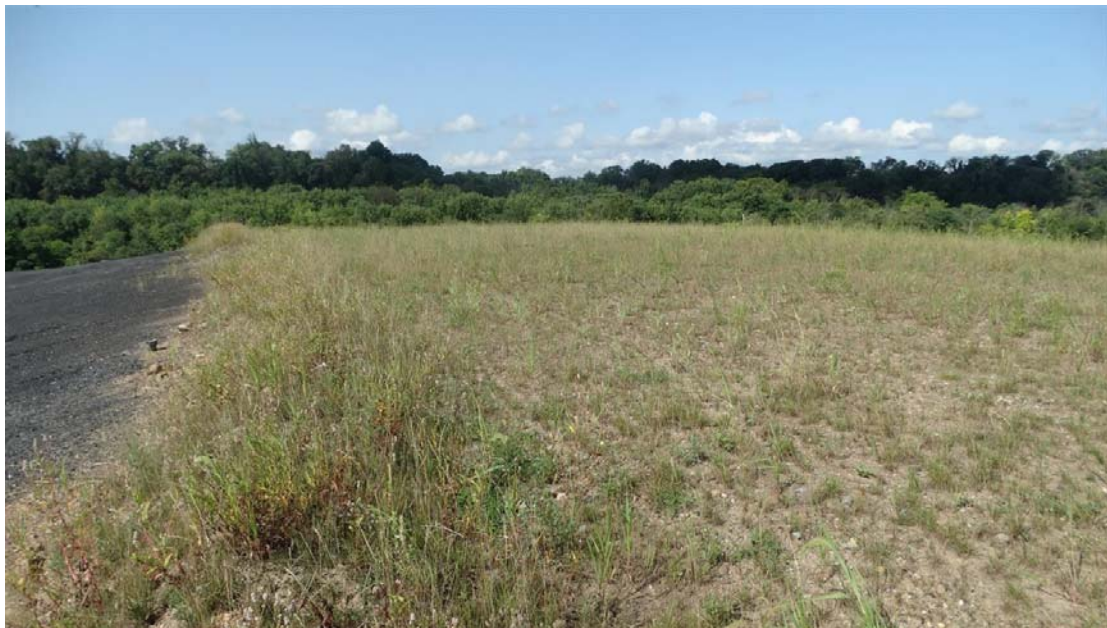
Picture 16 – Area to the north that is to grade on an intermediate lift. This area received soil and had seed applied.
