**Subject: 2018 USEPA CCR Surface Impoundment Annual Inspection Report  
Brunner Island Ash Basin No. 6**

This report presents the findings of the 2018 annual inspection for the Brunner Island Ash Basin No. 6 facility. This inspection was performed by a Talen Energy employee on October 11<sup>th</sup>, 2018. The annual inspection was conducted in accordance with the requirements of the United States Environmental Protection Agency (USEPA) 40 CFR Parts 257 and 261 Hazardous and Solid Waste Management System; Disposal of Coal Combustion Residuals from Electric Utilities; Final Rule, April 17, 2015 (CCR Final Rule).

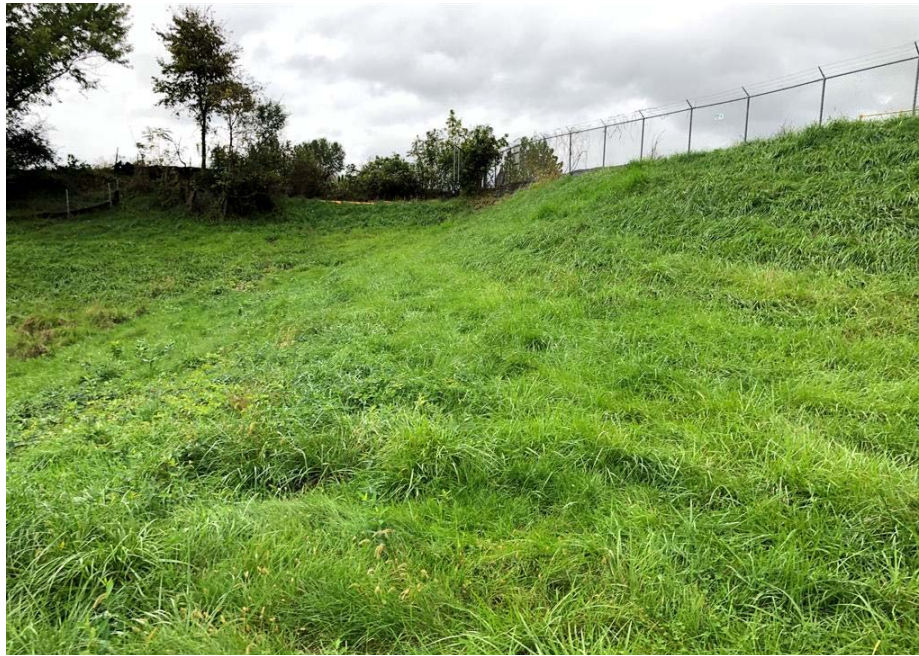
Picture 1 – Northern side of AB6

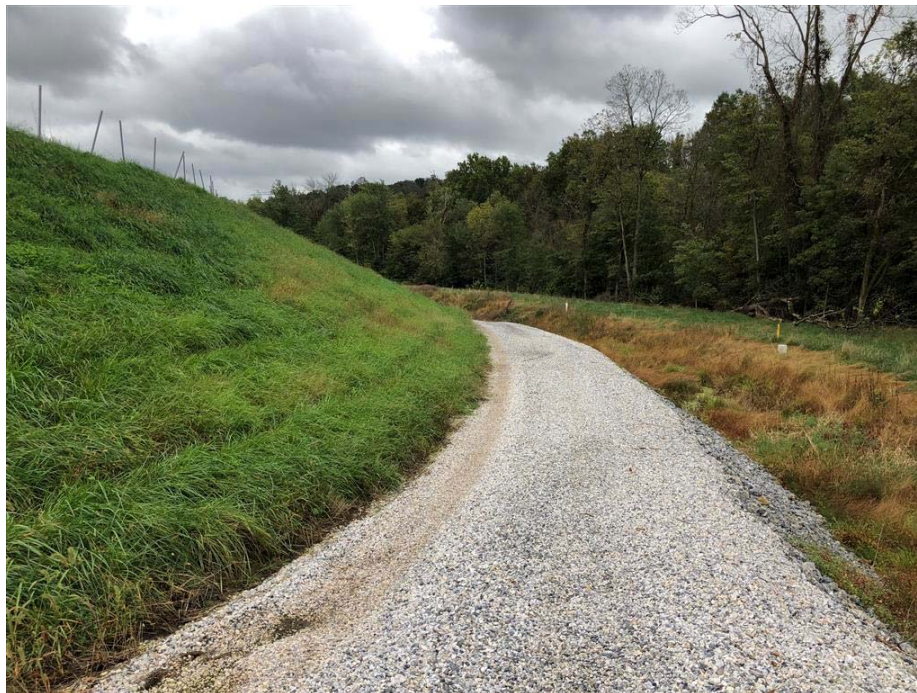
Picture 2 – Gravel road on nw corner of AB6. Old E&S (sedimentation pond 1) pond on right side of photo.

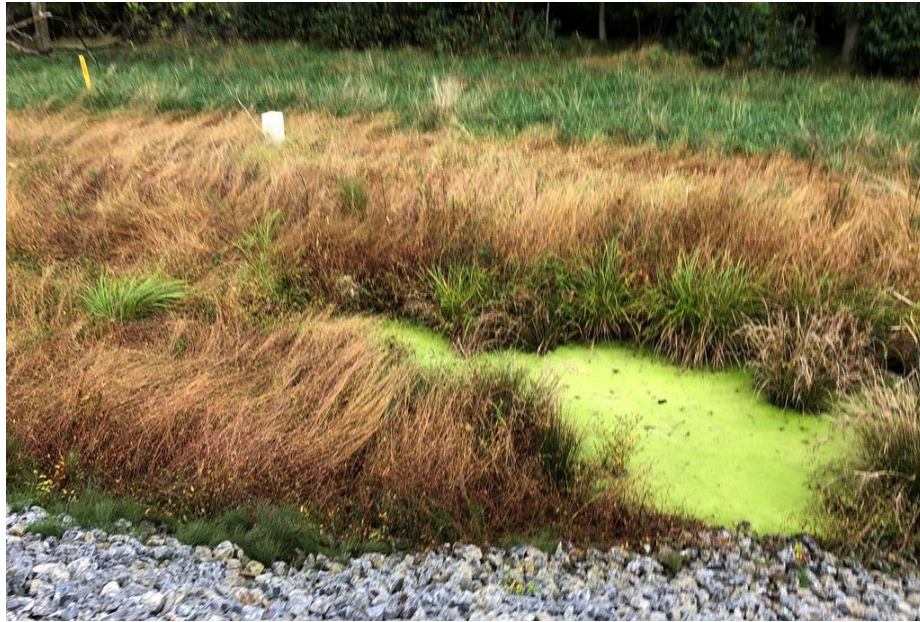
with flow coming from a hole in the riser about 2 feet above grade (approximately 3 to 4 feet above the embankment toe and 8 feet above the Sedimentation Basin No. 1 drainage ditch). This is indicative of the wet conditions in this area. The ditch adjacent to Sedimentation Basin No. 1, located along the toe in the northwest corner of the basin, was vegetated with standing water, but no flow.

Picture 3 – Saturated area with a trickle of water flowing into the riser pipe.

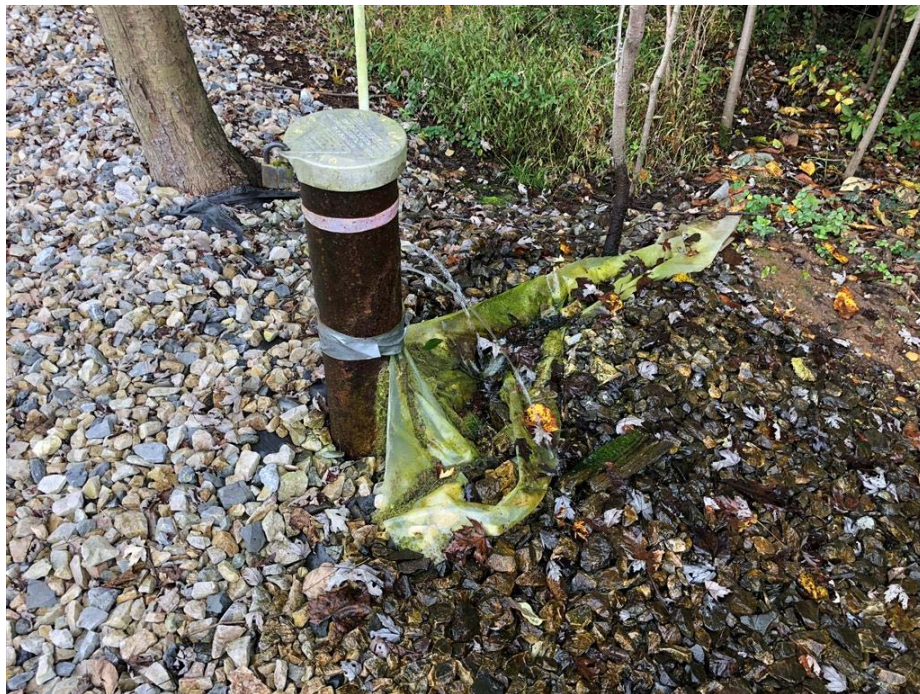
There was no evidence of movement, seepage, sinkholes, distress, or erosion, except as noted below. Minor slope irregularities were observed along the upper edge of the slope at the northwest corner, which were likely due to mowing equipment, road traffic, or snow plowing and unchanged from the previous year's inspection. There was no evidence of cracking. The toe of the downstream slope was observed to have standing water in the Sedimentation Basin No. 1 (located outside of the basin at the toe of slope) and a trickle of water was flowing out of the pond's discharge pipe. There was no evidence of piping, material deposition, or entrained fines and is similar to past observations. Artesian conditions were observed in the riser of Monitoring Well 6-1B near the northwest corner of the basin,

Picture 4 – Well in artesian condition. The flowing water showed no signs of turbidity.

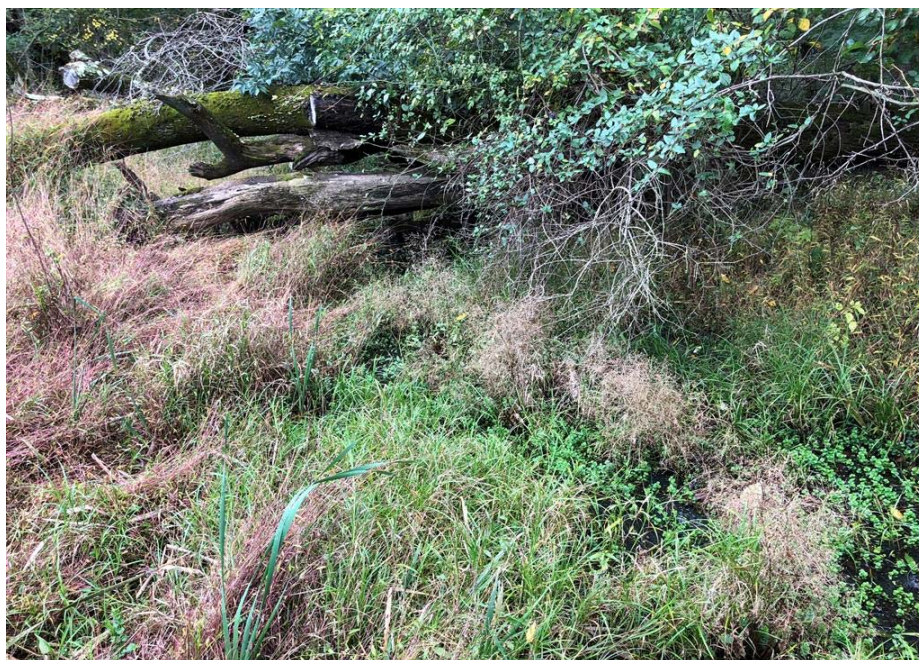
Seepage was observed at the toe of the embankment at the northwestern, and southeastern sections of the embankment. The observed seepage is not considered particularly unusual, and there is no evidence of piping or internal erosion. Non-flowing saturated areas were observed along the southwestern corner of the impoundment at the toe of the polishing pond and also at the northeastern section of the dam.

Picture 5 – Standing water at toe of slope of the polishing pond.

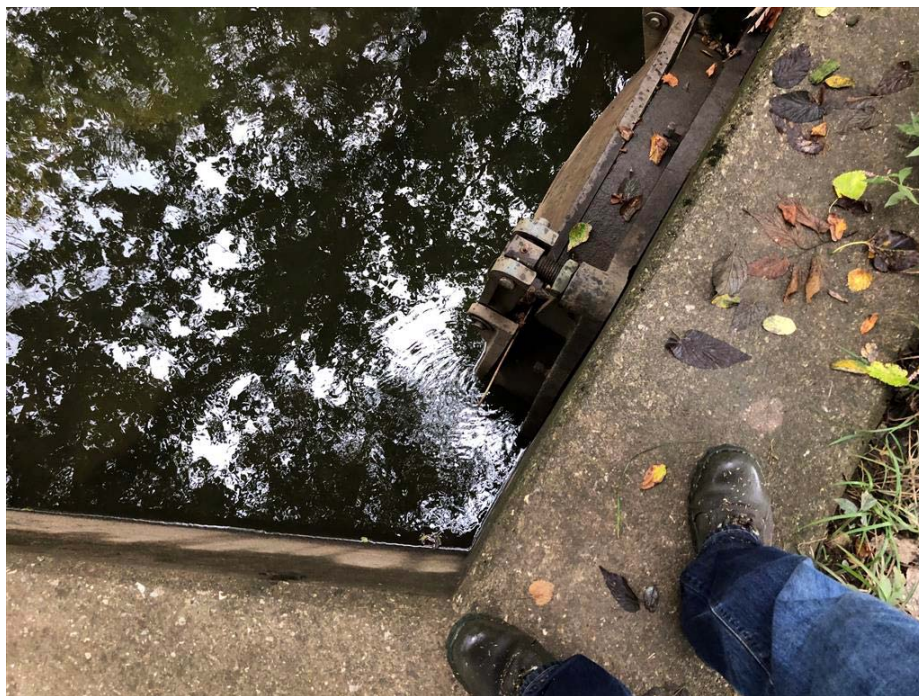
Picture 6 –No issues observed at the discharge.

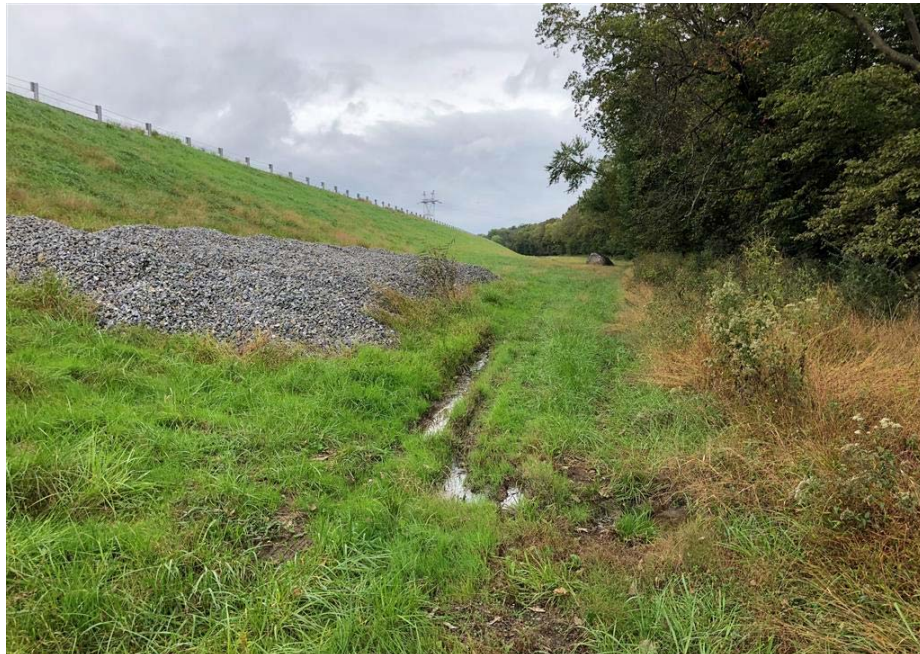
Picture 7 –Weighted filter blanket at the SE corner.

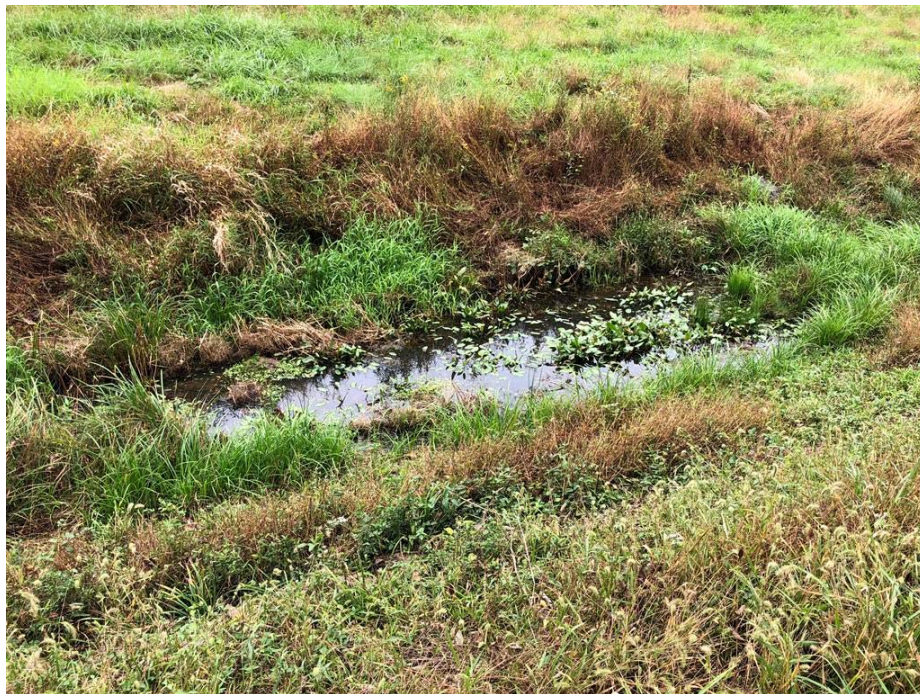
- Picture 8 – Standing water in the old E&S pond (sedimentation pond 2) on the Eastern side of the dam between the river. No water was leaving the discharge pipe.

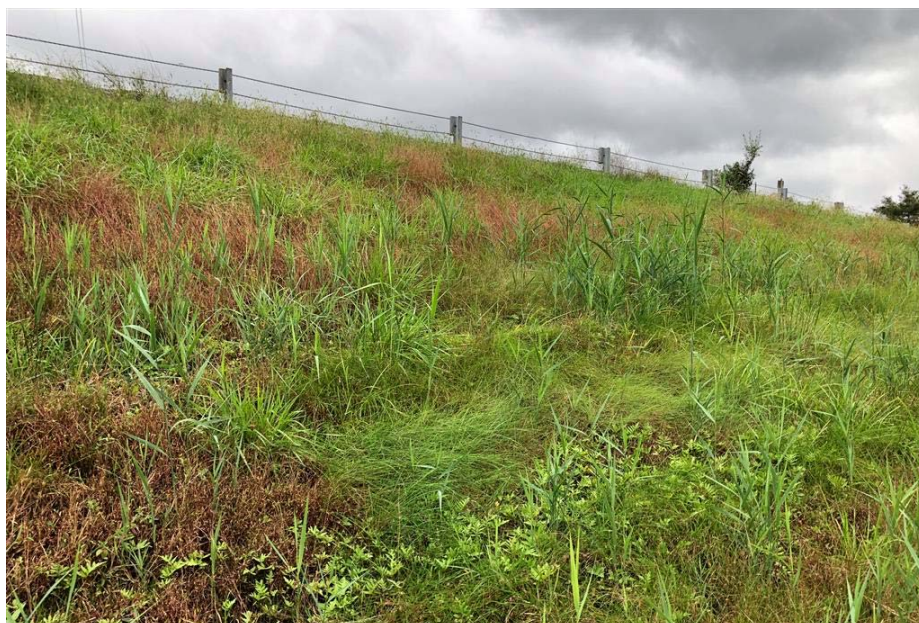
At the northeastern corner of the embankment wet soils were observed roughly 4' up the slope and appears unchanged from previous inspection. No flow or any signs of instability was observed.

Picture 9 – Saturated area at the NE corner.

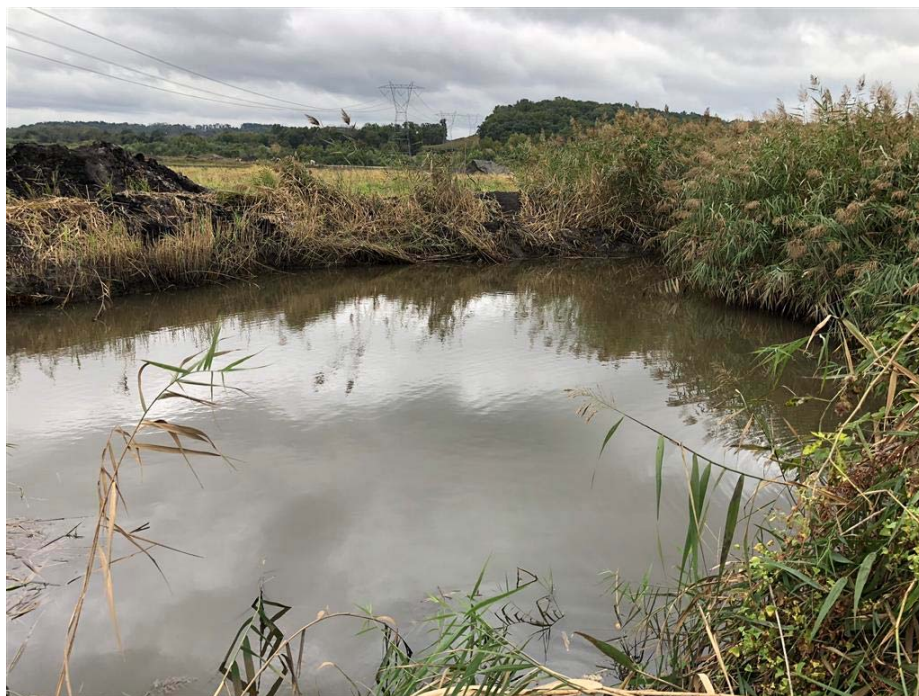
Picture 10 – Area where the EQ pond discharges into the basin at the NE corner.

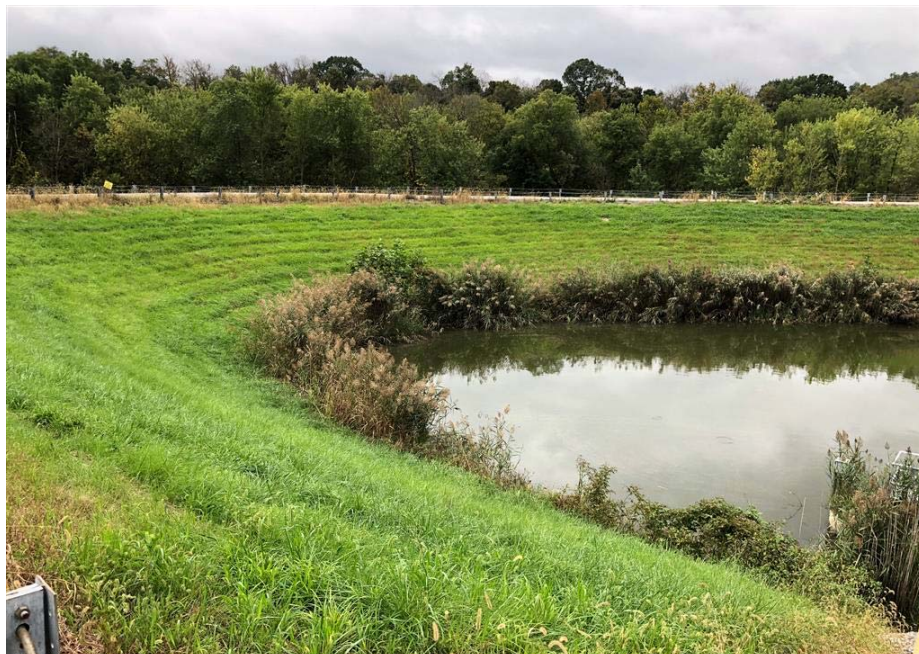
The upstream slope appeared to be in good condition, and the vegetation along the upstream slope had been trimmed recently. Wetland vegetation along the waters edge and growing on the outlet works was observed during the inspection, and Talen reports that it has been removed following the inspection. There was no evidence of movement, sinkholes, or distress. The small amount of erosion observed at the stairway footing leading to the riser intakes from the previous year's inspection has been repaired.

Picture 11 – Vegetation should be cut and removed from the water's edge around the polishing pond.

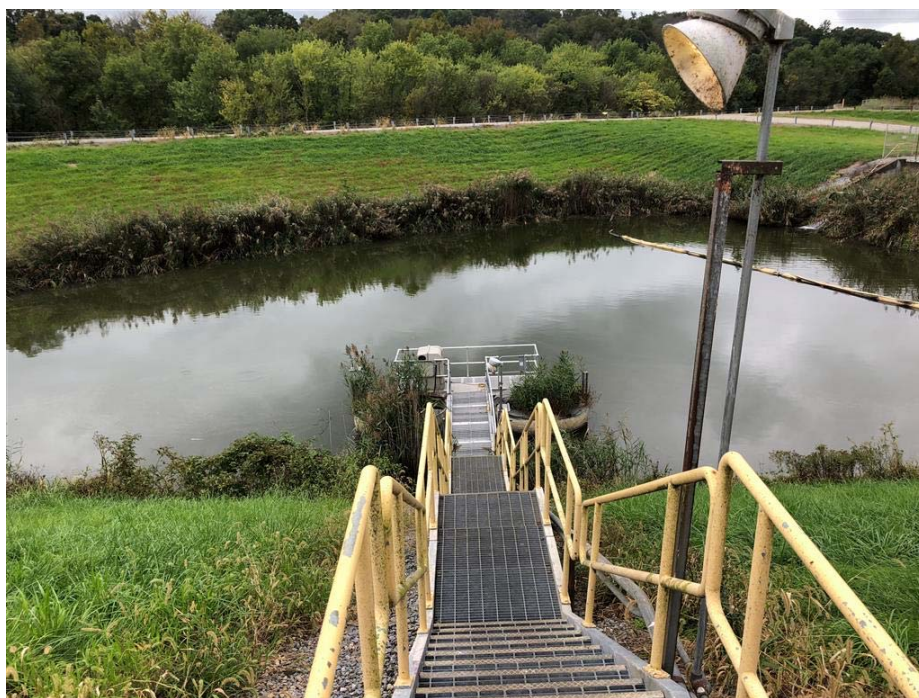
Picture 12 – Vegetation should be removed from the risers.

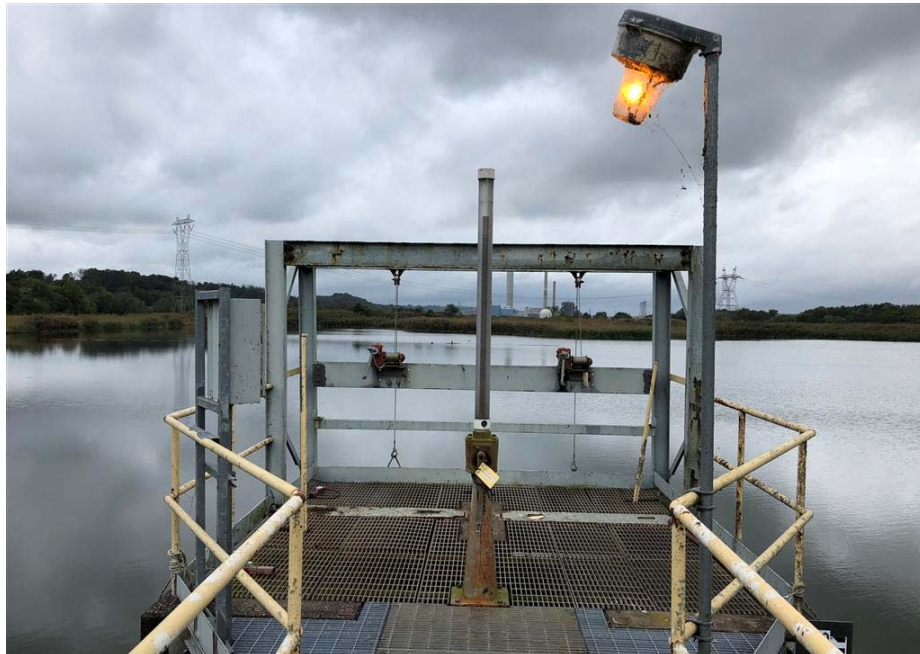
Picture 13 – Gate open and locked.

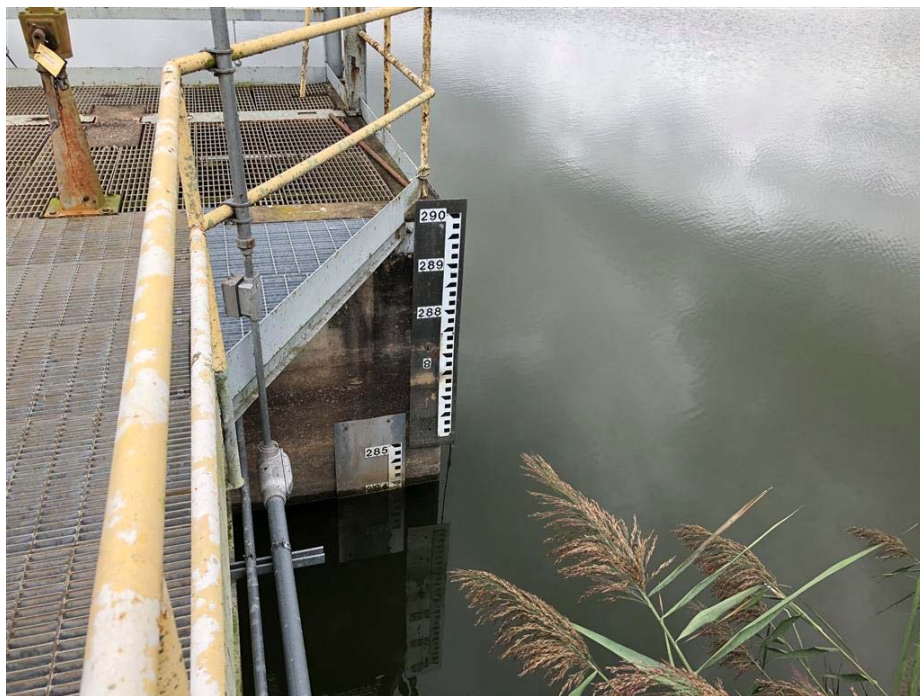
Picture 14 – Staff gage on side of structure.

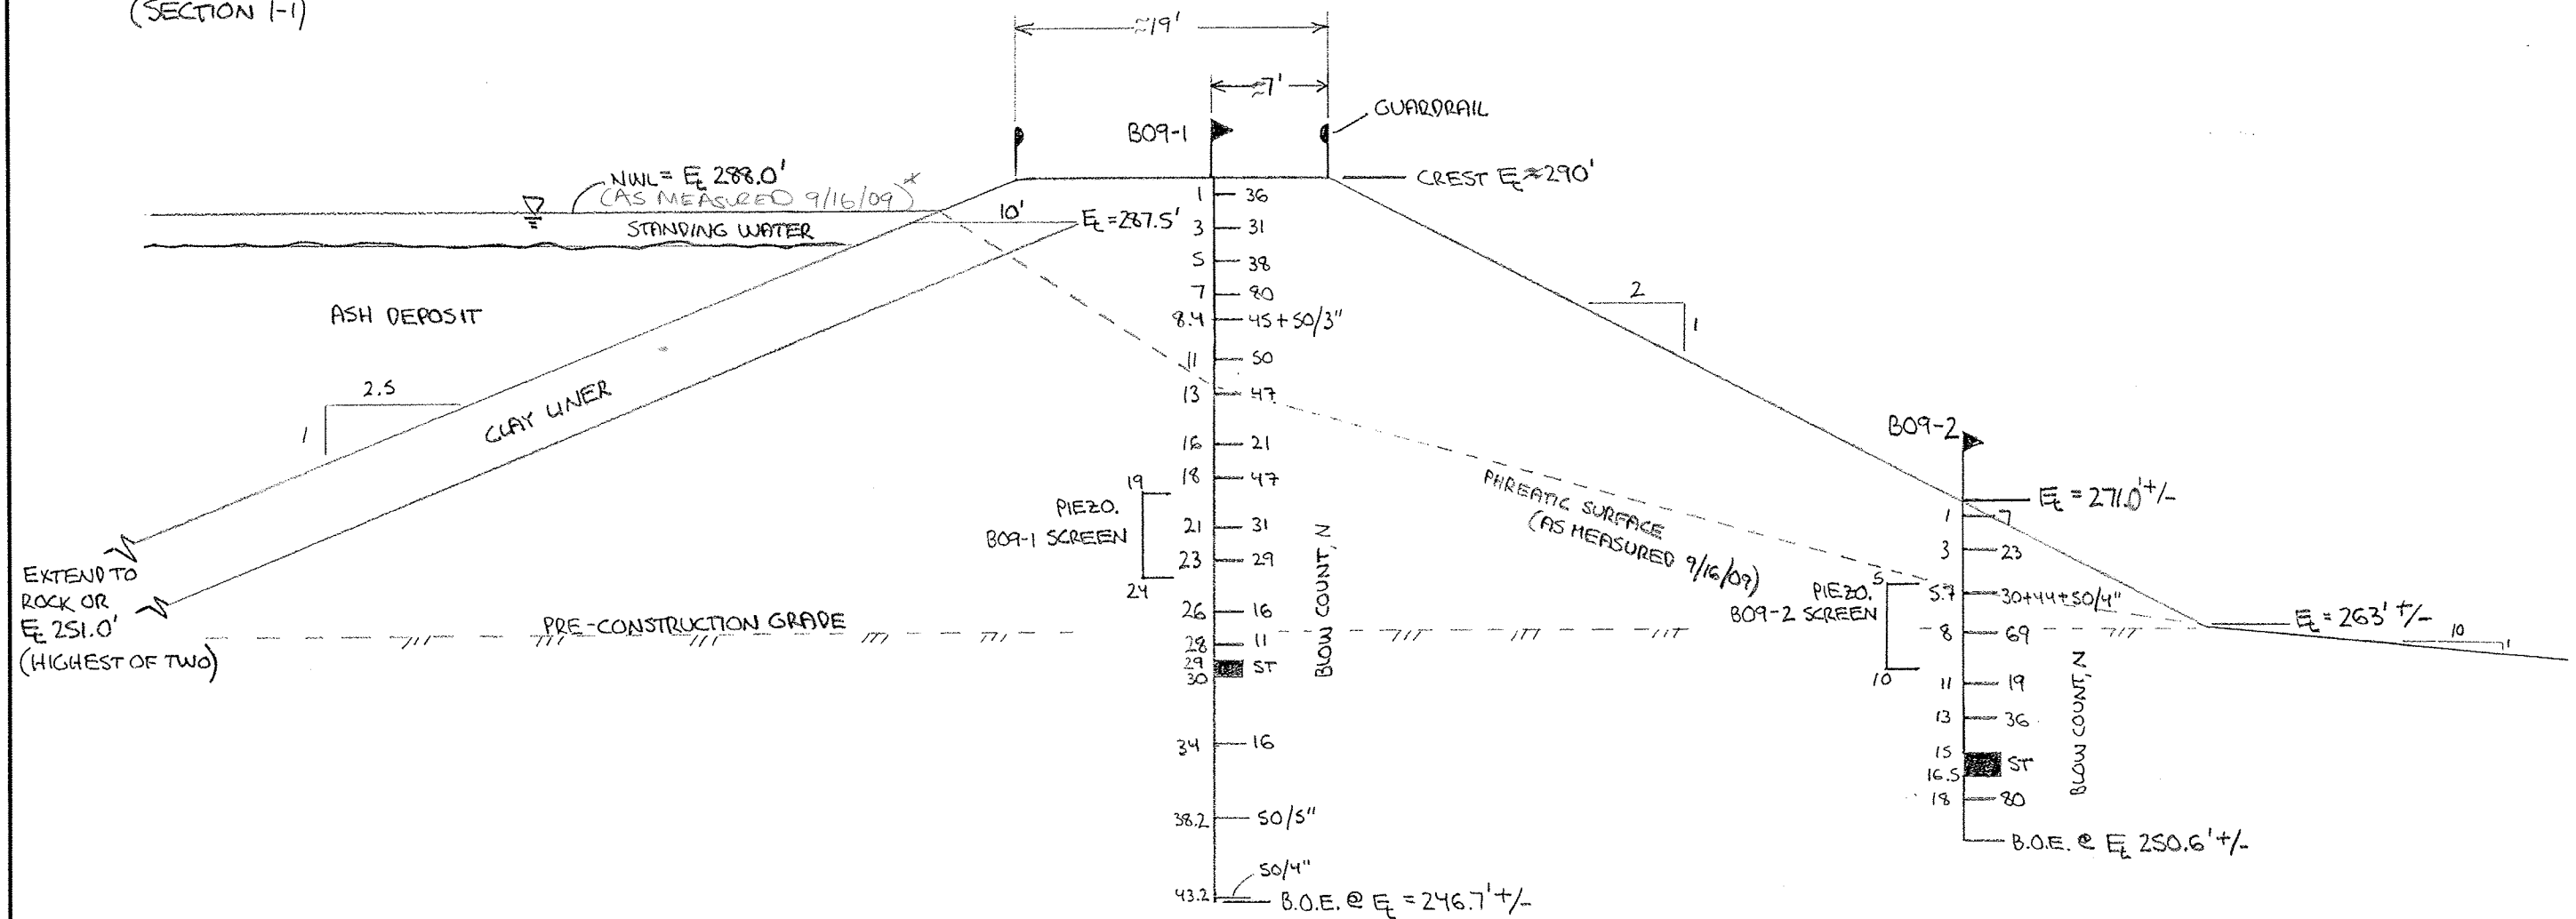
STATION 22+60 +/- :  
(SECTION 1-1)

\* NOTE, TALEN HAS REMOVED STOPLOGS FROM THE BASIN WHICH HAS LOWERED THE POOL TO ABOUT EL 284.75'.

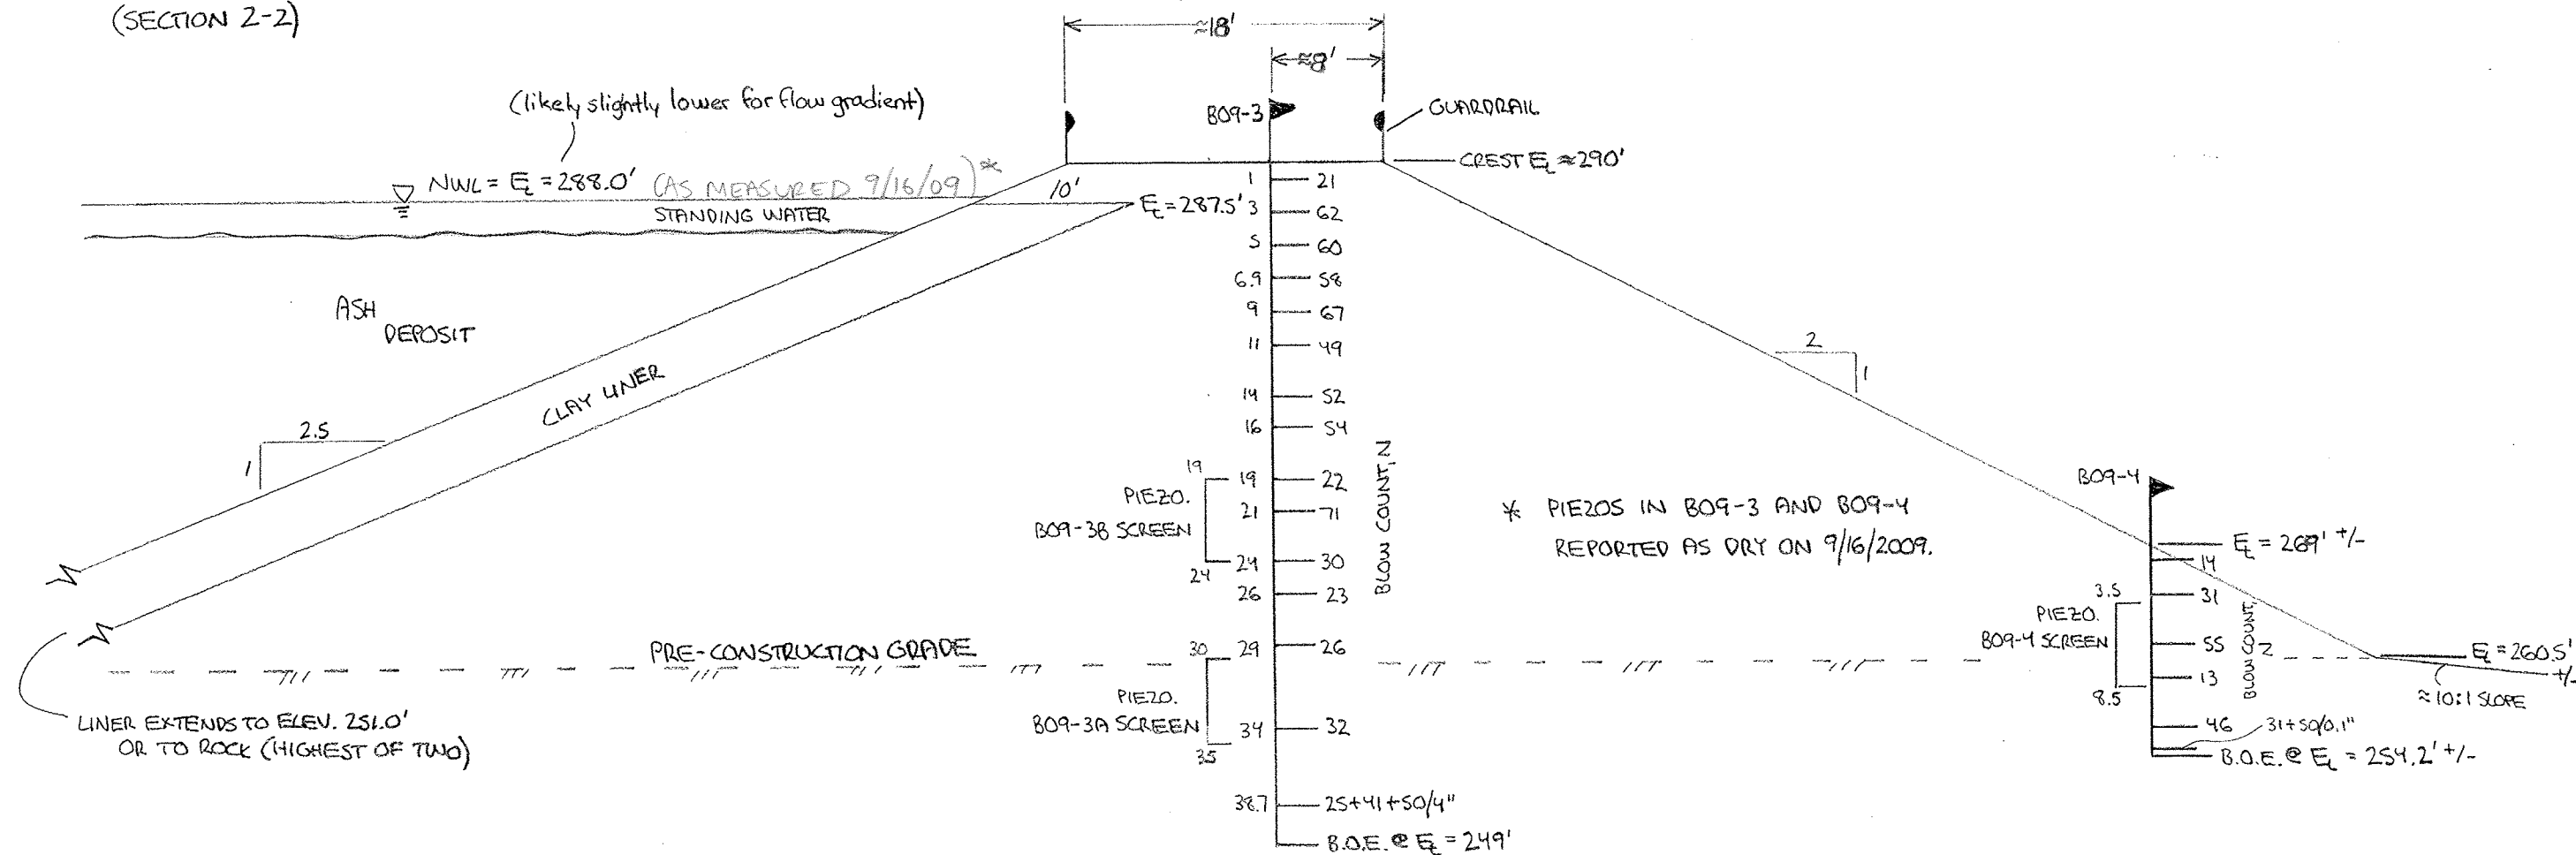
STATION 7+30 +/-:  
(SECTION 2-2)

\* NOTE, TALEN HAS REMOVED STOPLOGS FROM THE BASIN WHICH HAS LOWERED THE POOL TO ABOUT EL 284.75'
