**2018 SURFACE IMPOUNDMENT
ANNUAL INSPECTION REPORT
COLSTRIP STEAM ELECTRIC STATION
COLSTRIP, MONTANA**

January 17, 2019

**RE: 2018 SURFACE IMPOUNDMENT ANNUAL INSPECTION REPORT,
COLSTRIP STEAM ELECTRIC STATION, COLSTRIP, MONTANA**

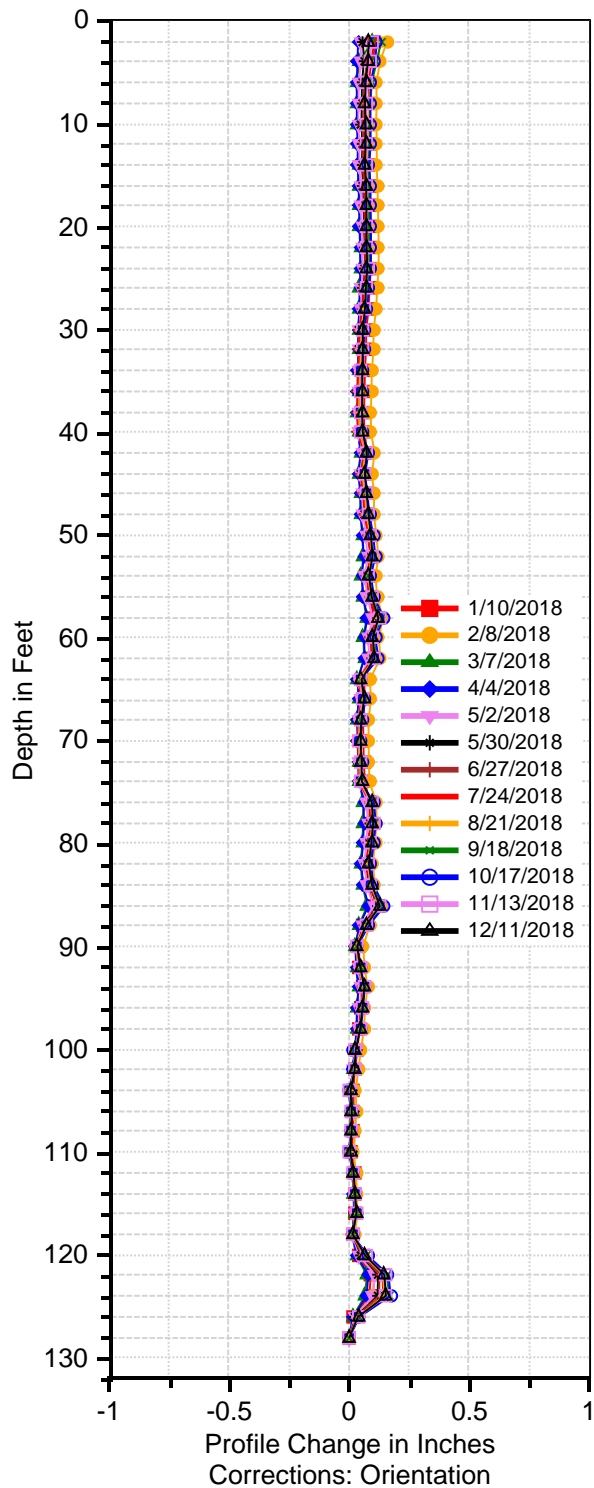
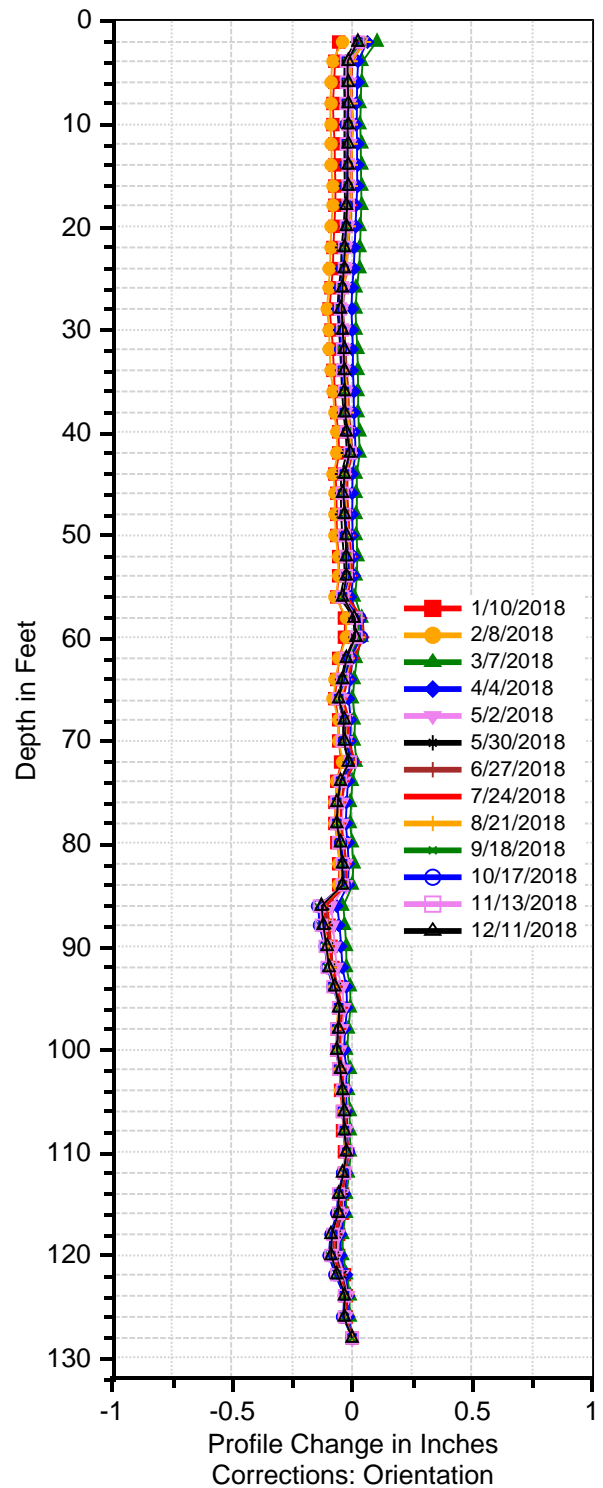
Location: Units 1&2 STEP
Instrument: STEP-09-2INC

- Inclinometer STEP-09-2INC installed in the 1&2 STEP Main Dam is exhibiting small (less than 0.25-inch) deflection between depths of 120 to 126-ft below the top of the casing (TOC) in the A0 direction (i.e., northeast). Data are plotted in Appendix A.

The displacements described above are attributed to localized settlement near the instrument location causing the slope inclinometer casing to buckle into a “D” or “S” shape. We do not believe this is a cause for concern for several reasons:

- 1) Nearby inclinometer casings are not exhibiting the same apparent deflection, either at the same depths or the same behavior.
- 2) In general, measured deflection is not purely perpendicular to outside face of the embankment which, if observed, may be cause for concern.
- 3) Measured deflections are small and spread over a length of the inclinometer casing of 6-ft or more, rather than in a discrete zone (as would be expected from shearing associated with slope movement).
- 4) No surface expression exists to indicate movement of embankments.

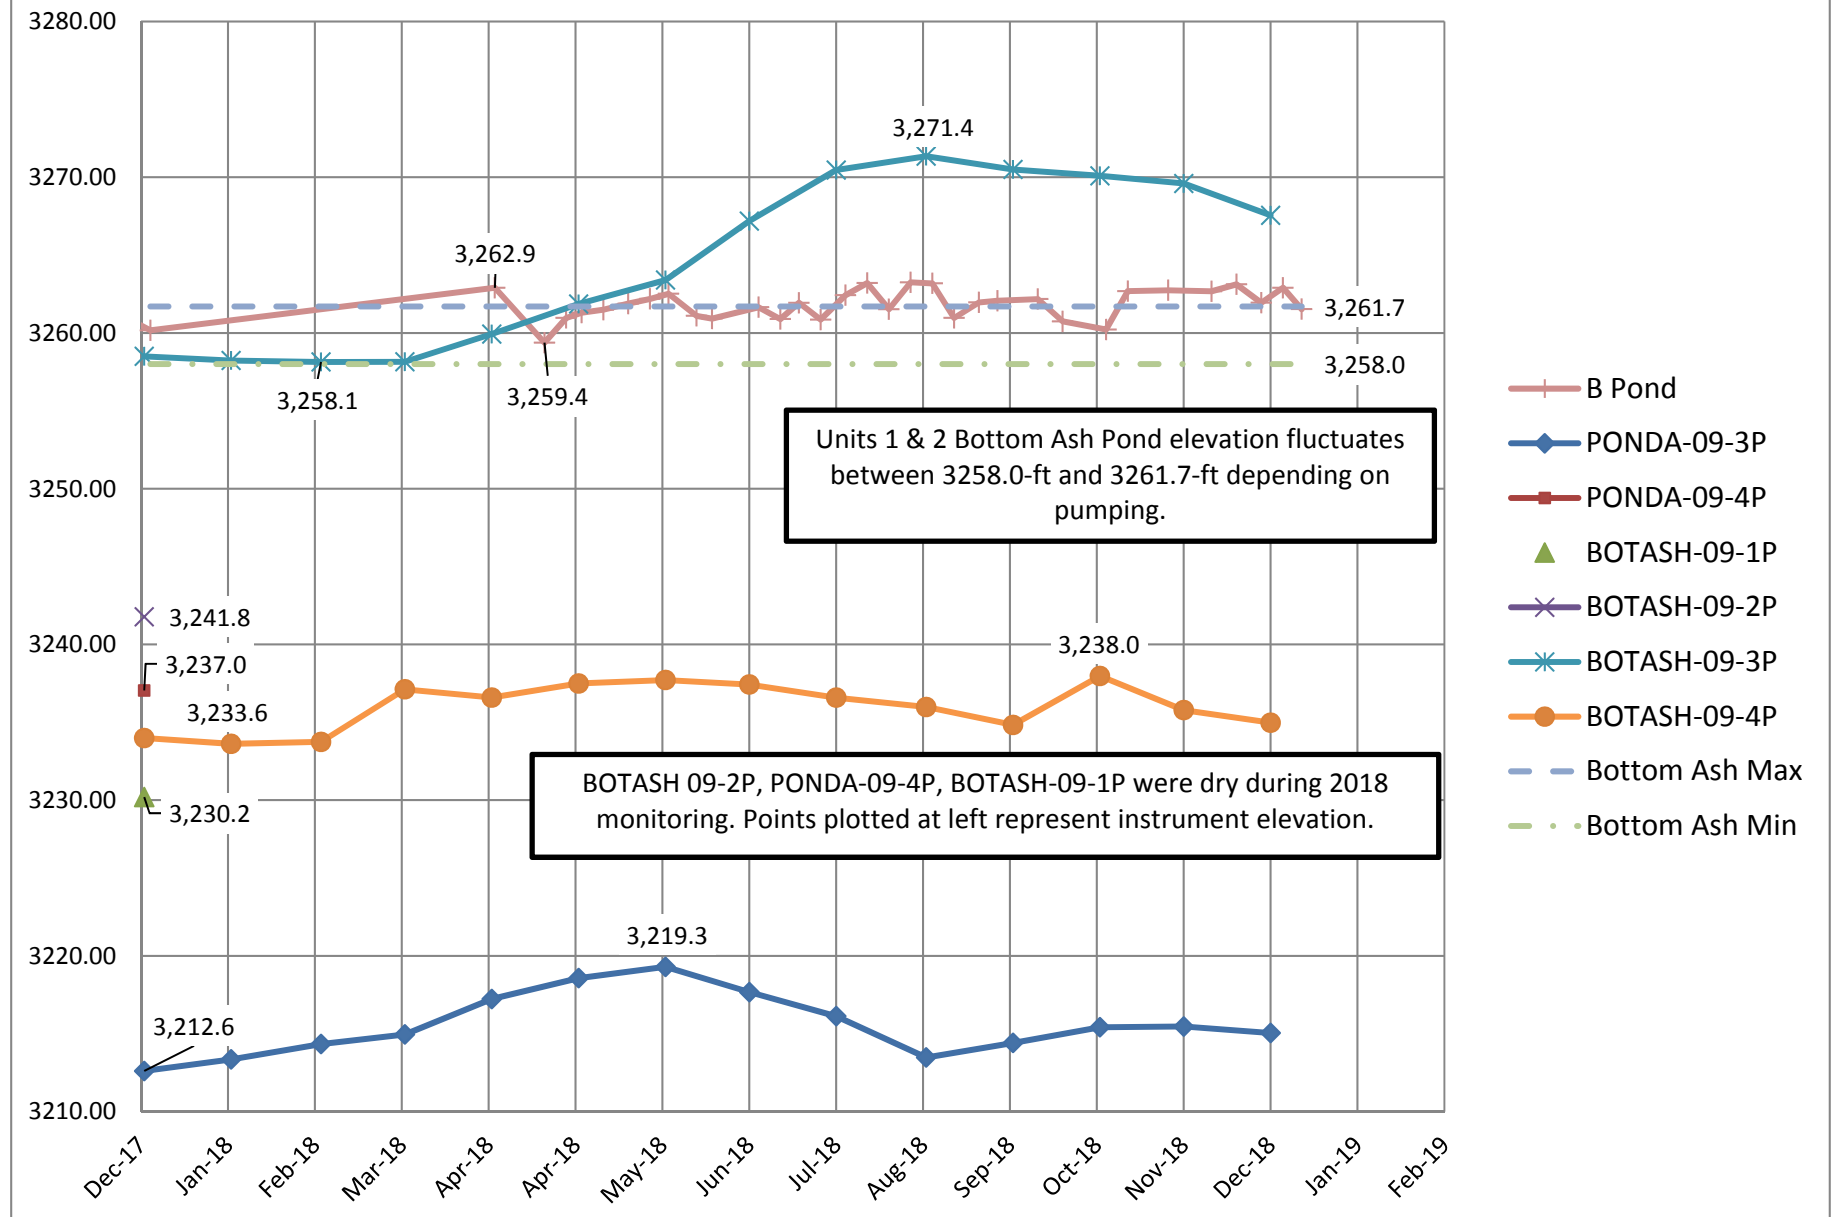
Plantsite Units 1 & 2 Bottom Ash Pond Piezometers

- At the Plantsite Units 1 & 2 Bottom Ash Pond, instruments BOTASH-09-4P and PONDA-9-3P appear to be detecting seasonal fluctuations in groundwater underlying the pond. BOTASH-09-1P, BOTASH-09-2P, and PONDA-09-4P were installed into embankment material and have generally recorded dry conditions since installation, the one exception being June 2011, which was an unusually wet year. Elevated water measurements recorded in BOTASH-09-3P have been carefully observed in 2018. It has been determined the instrument has malfunctioned and we recommend abandoning and/or replacing the instrument in 2019.
