Inspection Report

Property Address:
4901 Buchanan Ave SW
Wyoming MI 49548

Acuity Inspection Professionals, LLC

General Repair Summary

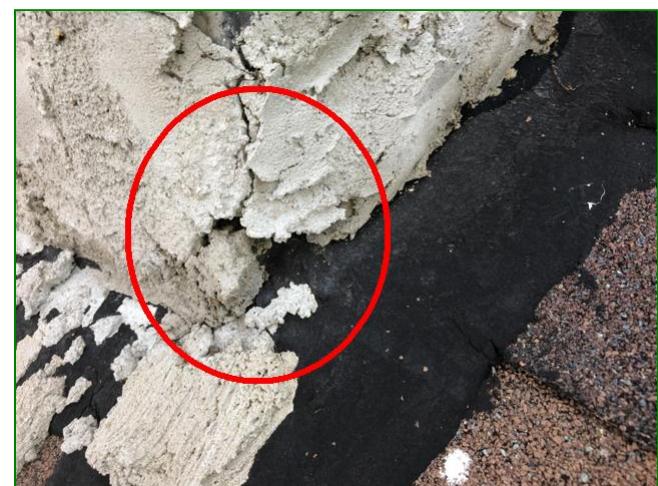
(2) The chimney brick was coated with a stucco like material. *The stucco was cracking and chipping away in a number of areas. The chimney surfaces should be examined and repaired or resurfaced.*

Item 4 - Cracking Stucco

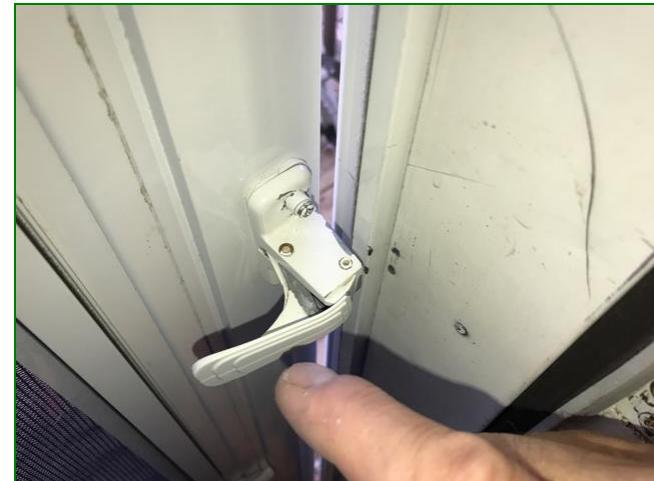
7 (2) **The storm door was intact and in relatively good condition. However the door handle was broken and malfunctioning. The door handle should be examined and repaired or replaced.**

Item 7 - Inoperable Interior Handle

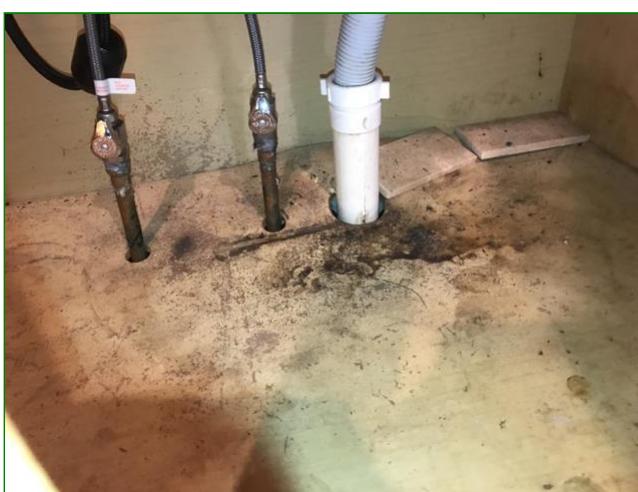
8 (3) **The floor of the kitchen cabinet under the sink had obvious water damage. The floor was buckling, contorted and moisture stained. Also there was fungal growth around the plumbing. Consideration should be given to replacing the the floor in this cabinet. (See the Ancillary Tests and Examinations section regarding the fungal development in this cabinet.)**

Item 8 - Deteriorated Cabinet Floor

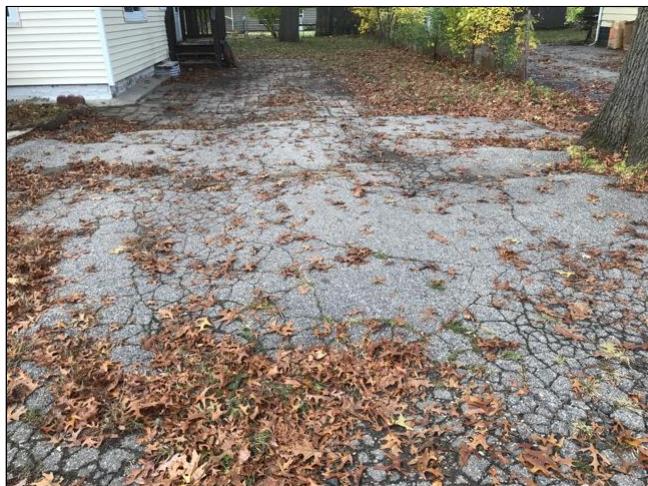
1.0 Asphalt Driveway

1.0 The driveway was paved asphalt and paver stones. The driveway was in relatively good solid condition. **However there were numerous cracks and uneven sections of the driveway. Consideration could be given to sealing the asphalt surface to prolong the life of the material and deter additional deterioration.**

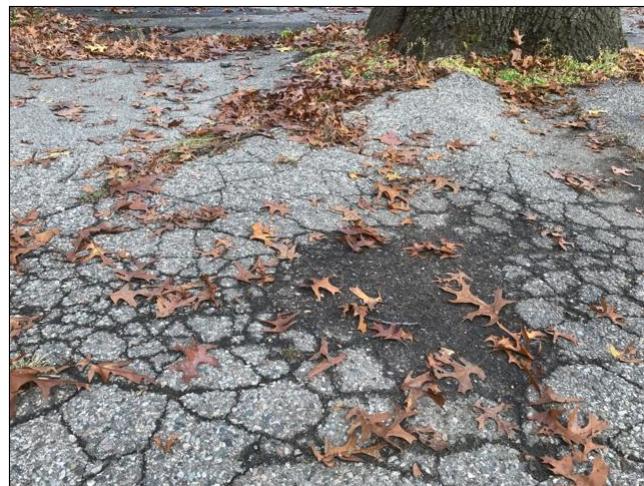
1.0 Cracking & Uneven Asphalt

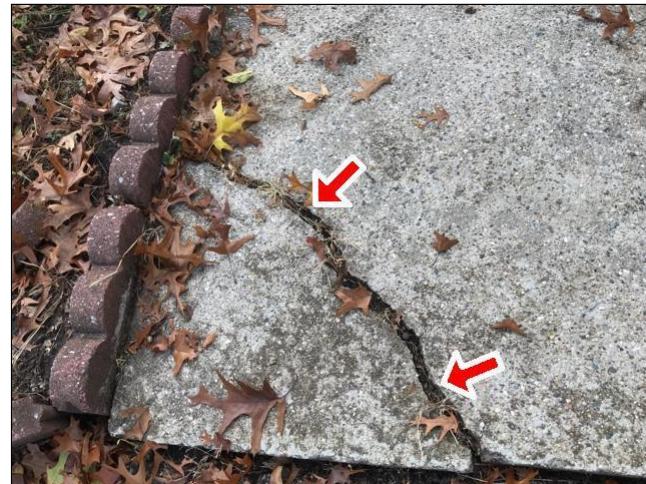
1.1 The front concrete walkway was in relatively good solid condition with some defects. **If possible the defective areas should be examined and repaired to prevent further deterioration.**

1.1 Cracked & Sunken Corner

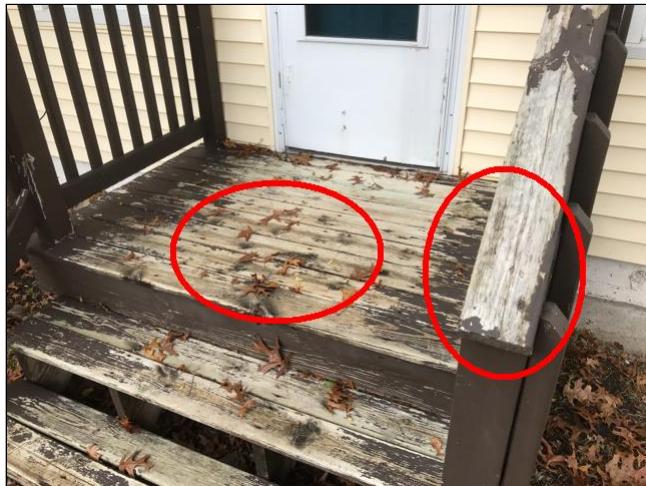
(2) ***The wood surfaces of the front porch were weathered. We recommend cleaning the wood decking and weatherproofing it with an appropriate product or stain.***

1.2 Weathered Porch Syrfaces

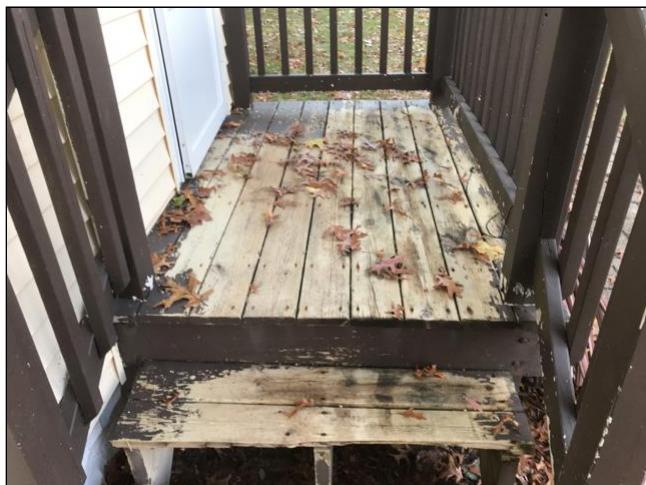
1.3 (1) The side porch was in relatively good solid condition with cosmetic defects. *However the wood surfaces of the side porch were weathered. We recommend cleaning the wood decking and weatherproofing it with an appropriate product or stain.*

1.3 Weathered Side Porch

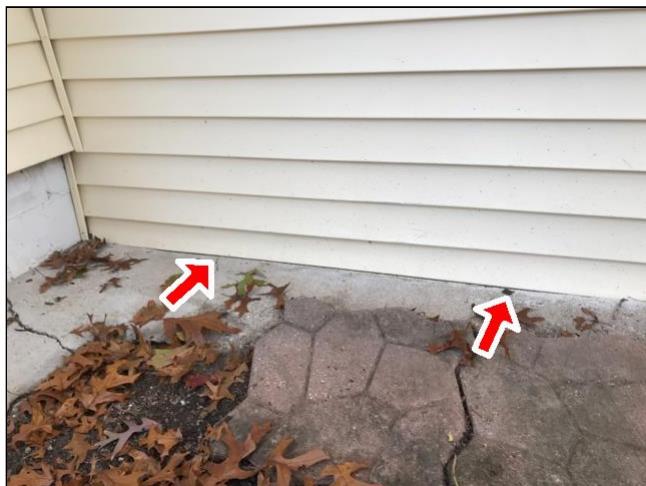
(3) ***The siding on the north west corner was installed at ground level. The siding should be installed approximately 6 inches above ground grade to prevent moisture moisture and insect intrusion behind the siding.***

1.4 Siding at Ground Level

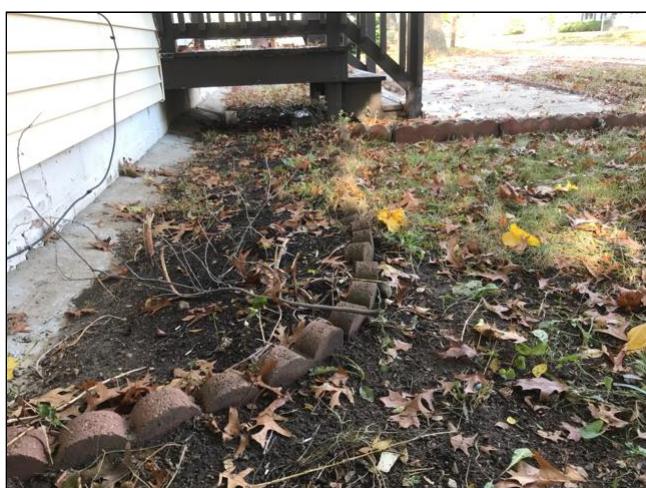
1.5 The grade of the property appeared to be predominantly flat. Although there did not appear to be any areas where water or moisture had infiltrated the foundation at this time.

1.5 Flat Grade of Property

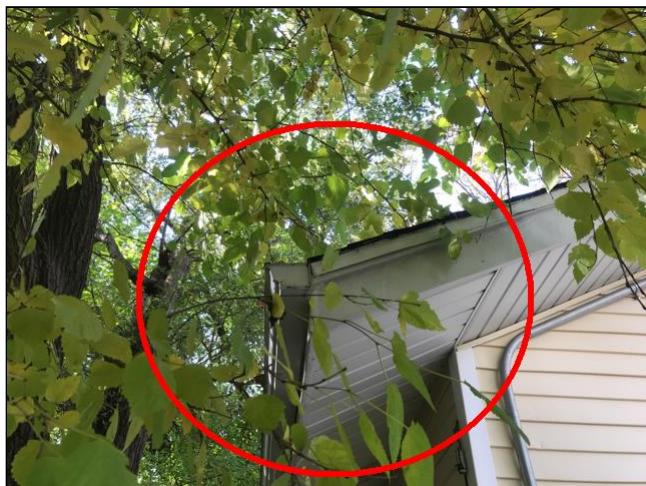
1.6 The vegetation had not been maintained or controlled and appeared to encroach upon the structure in some areas. **The vegetation should be trimmed so that there is a minimum of 6 inches between the foliage and the house structure.**

1.6 Overhanging Tree Branches

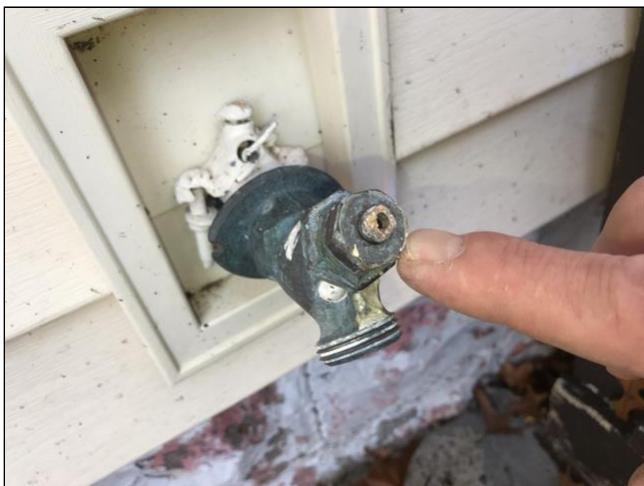
2 The exterior water spigot appeared to be in good working condition. However the exterior spigot had a broken valve handle and could not be tested in operation. The valve needs to be examined and repaired or replaced.

1.11 The exterior water spigot appeared to be in good working condition. *However the exterior spigot had a broken valve handle and could not be tested in operation. The valve needs to be examined and repaired or replaced.*

1.11 Missing Spigot Handle

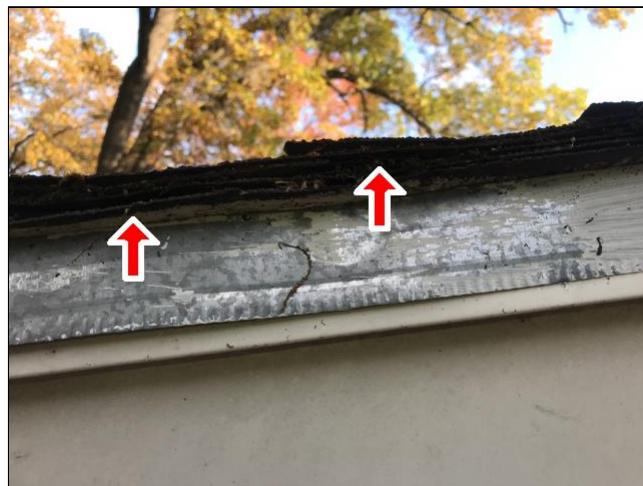
2.2 (1) The roof covering on the original portion of the house was standard fiberglass/asphalt shingles. The shingles appeared to be approximately 15 years old and in relatively good condition. **NOTE: There were two layers of shingles on the original section of roof. A third layer should not be installed.**

2.2 Two Layers of Shingles

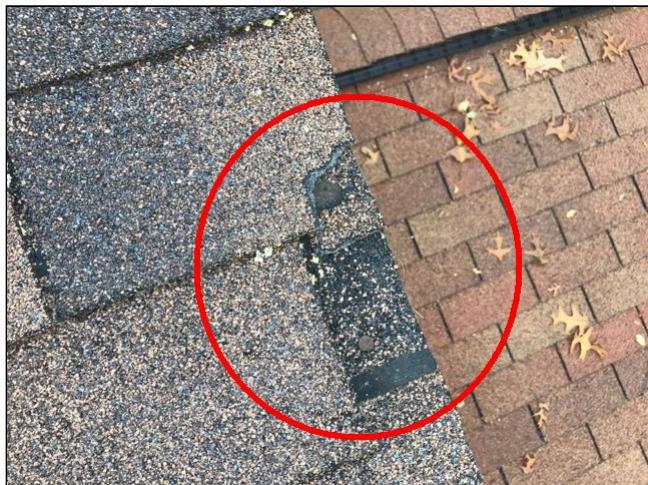
(2) There were areas of the original roof where there were torn or missing shingles along the north west edge. **Although the affected pieces were small and did not appear to create leak points at this time. Regardless, consideration should be given to repairing or replacing the damaged and missing shingles.**

2.2 Broken Shingle

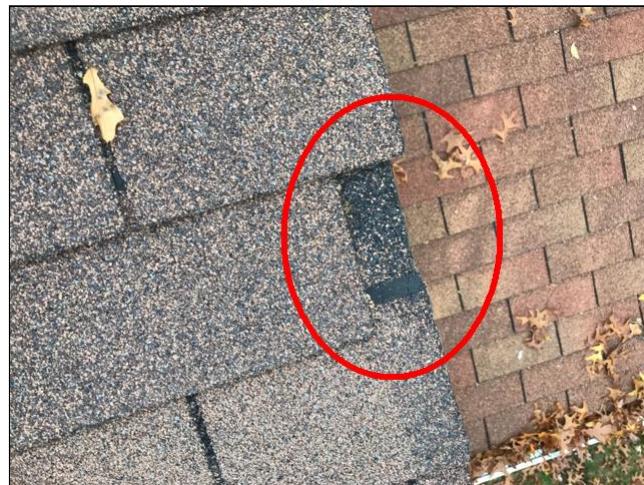
2.2 Missing Shingle

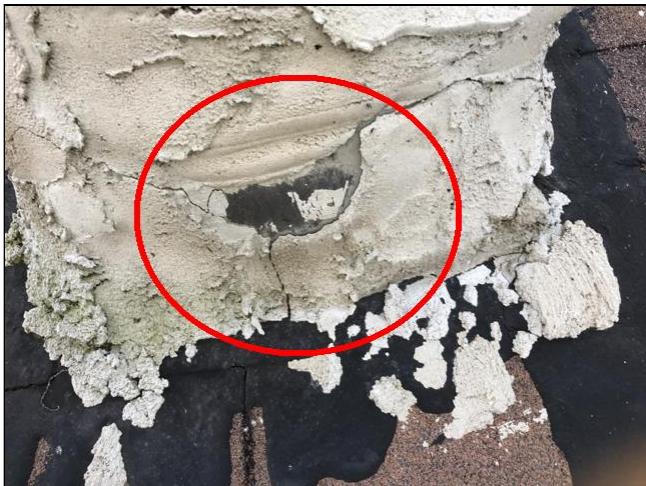
(2) The chimney brick was coated with a stucco like material. **The stucco was cracking and chipping away in a number of areas. The chimney surfaces should be examined and repaired or resurfaced.**

2.4 Deteriorating Stucco

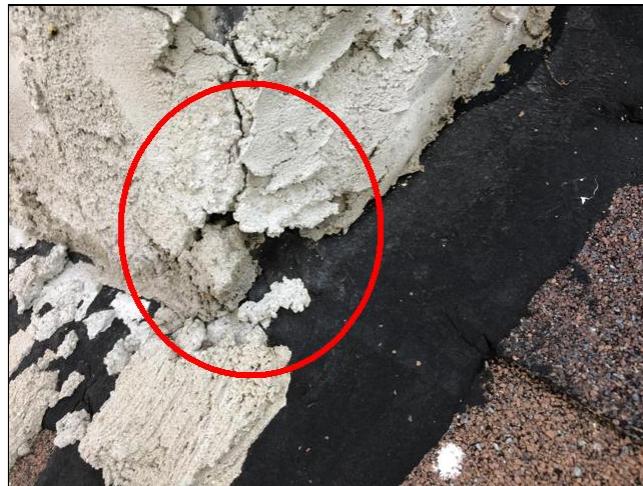
2.4 Cracking Stucco

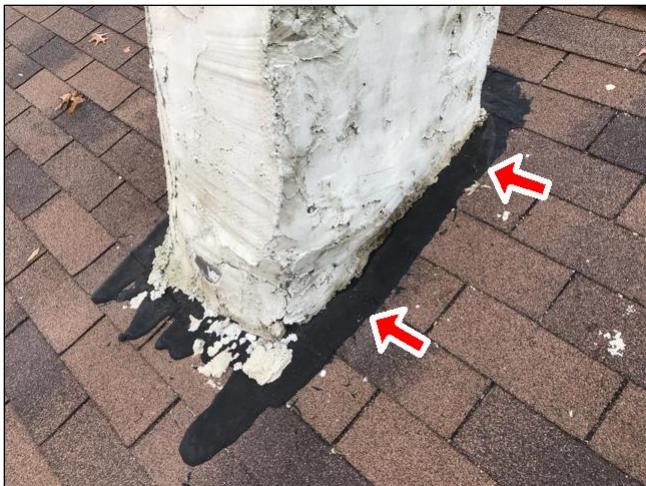
(3) The flashing around the base of the chimney was only tar. **Over time, tar tends to break down and crack. The chimney flashings should be monitored periodically and fresh tar should be applied when cracks occur.**

2.4 Tarred Flashing

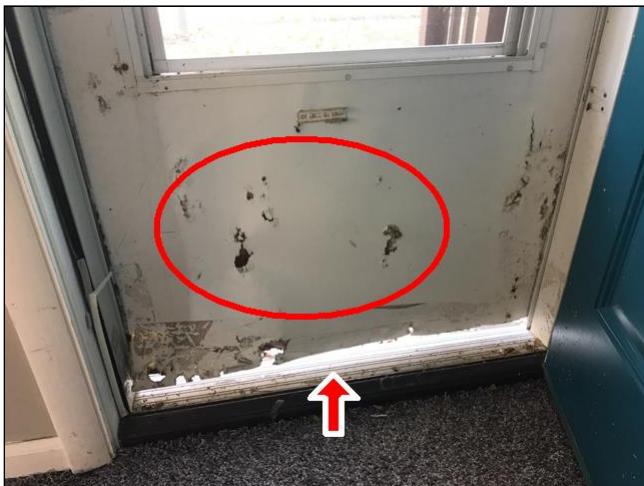
6 (2) **The bottom panel of the front storm door was damaged. The door should be replaced.**

(2) The bottom panel of the front storm door was damaged. The door should be replaced.

5.3 Damaged Storm Door

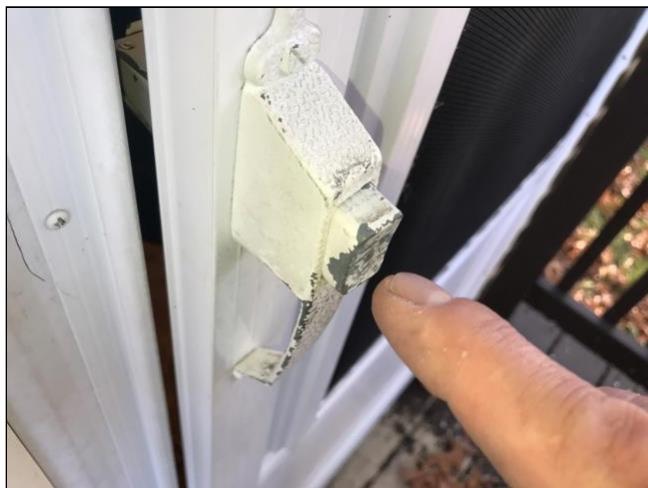
6.5 (2) **The storm door was intact and in relatively good condition. However the door handle was broken and malfunctioning. The door handle should be examined and repaired or replaced.**

6.5 Damaged Exterior Handle

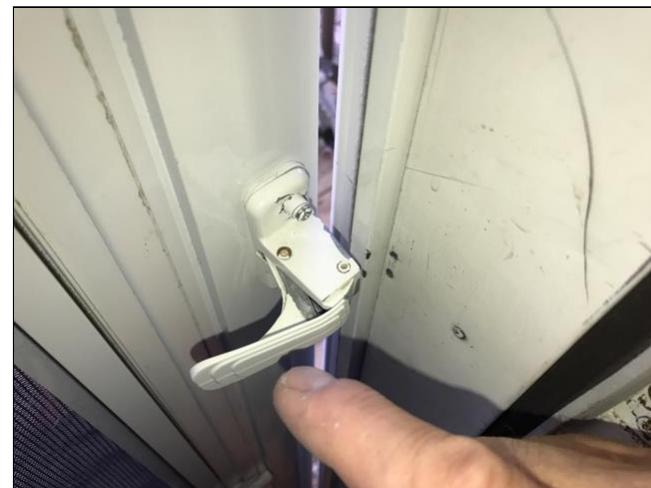
6.5 Inoperable Interior Handle

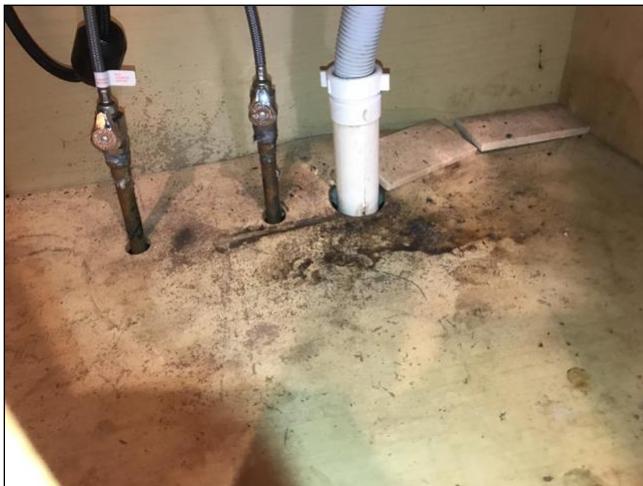
6.8 (3) The floor of the kitchen cabinet under the sink had obvious water damage. *The floor was buckling, contorted and moisture stained. Also there was fungal growth around the plumbing. Consideration should be given to replacing the the floor in this cabinet. (See the Ancillary Tests and Examinations section regarding the fungal development in this cabinet.)*

6.8 Deteriorated Cabinet Floor

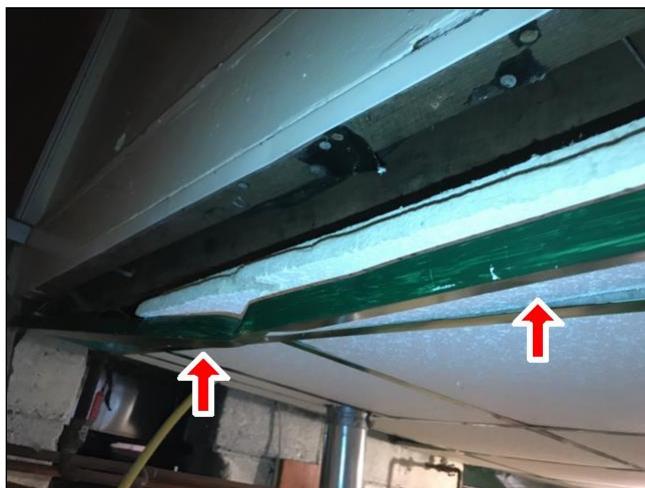
(2) ***There was a damaged suspended ceiling rail located near the stairway. Although the ceiling appeared to be stable at this time. The rail should be examined and repaired or replaced.***

7.1 Damaged Ceiling Rail

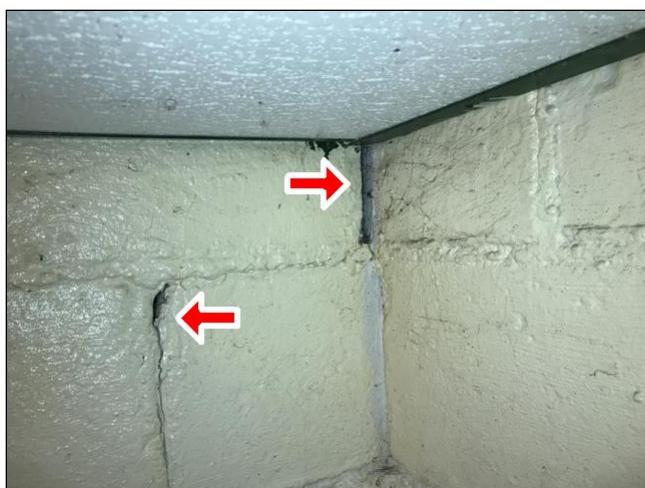
(2) ***There were two gaps in the mortar of the blocks on the north east corner. Although the wall appeared to remain structurally stable at this time. All mortar gaps in structural foundation walls should be filled and sealed whenever found.***

7.2 Mortar Gaps

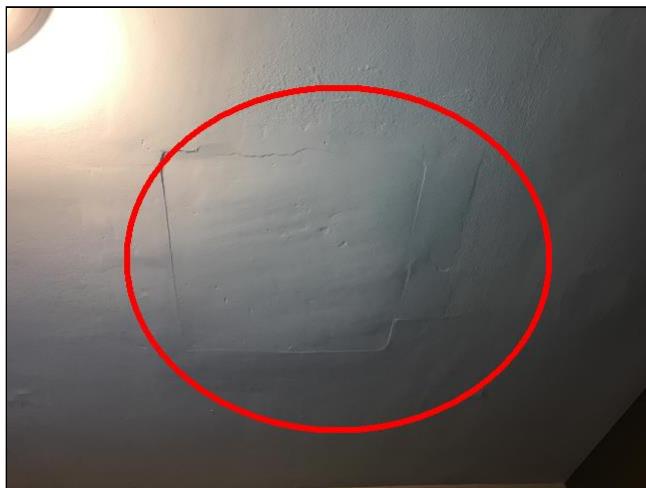
(2) ***The was a section of ceiling that was patched. The patched area was uneven and visible. Consideration could be given to reworking the patch to better blend with the rest of the ceiling surface.***

8.1 Visible Ceiling Patch

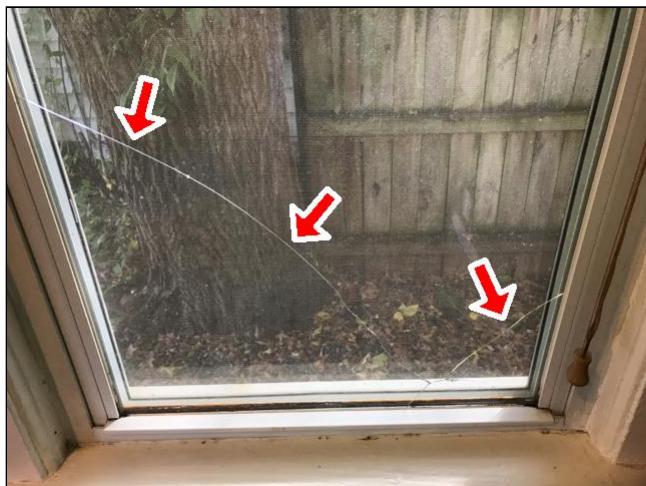
10 (2) The window on the south east corner was cracked. The broken glass should be replaced.

⬆ (2) The window on the south east corner was cracked. The broken glass should be replaced.

8.4 Broken Window Pane

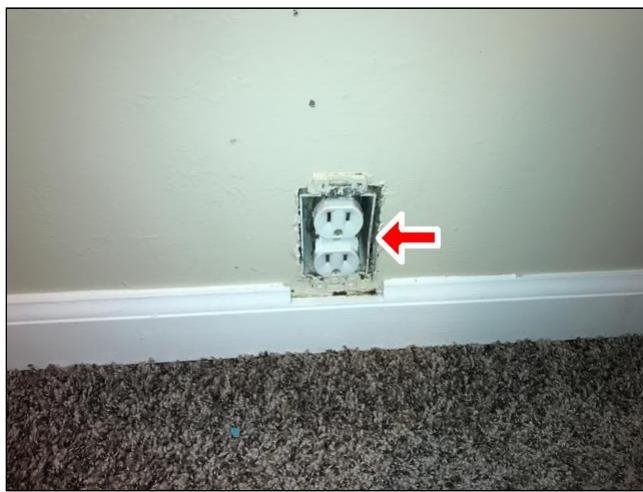
(2) ***There were missing cover plates on the receptacles in this room. All electrical junction boxes containing wiring or receptacles need to have cover plates installed.***

8.7 Missing Cover Plate

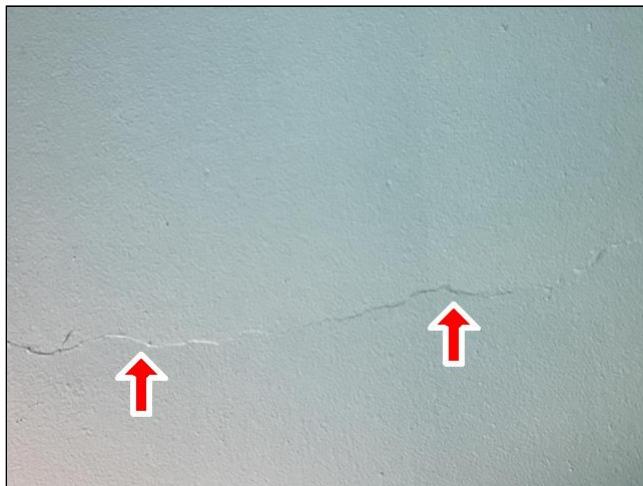
9.1 The bedroom ceiling was in relatively good condition with cosmetic crack defects.

9.1 Ceiling Crack

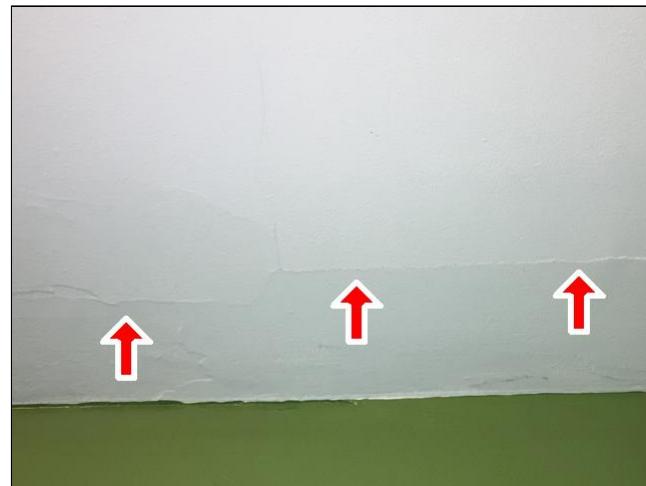
9.1 Ceiling Cracks

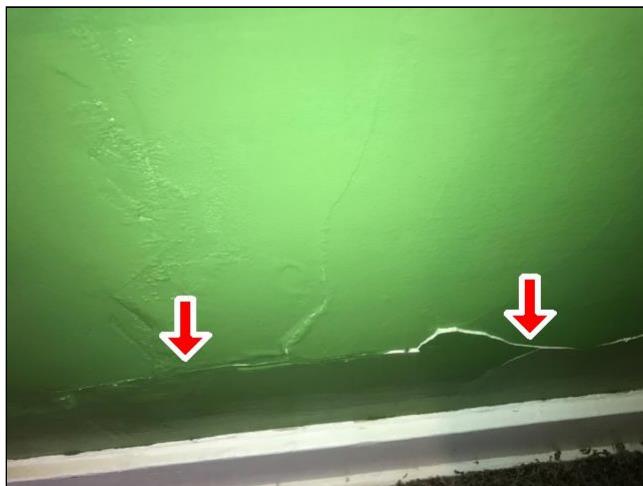
9.2 The bedroom walls were in relatively good condition with cosmetic defects.

9.2 Wall Cracking

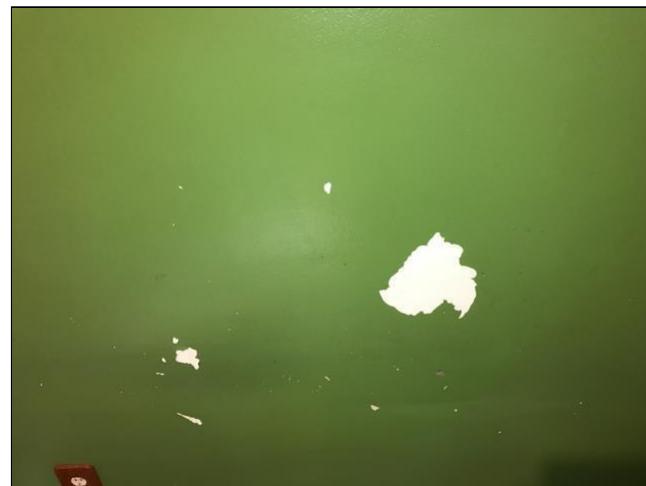
9.2 Chipping Paint

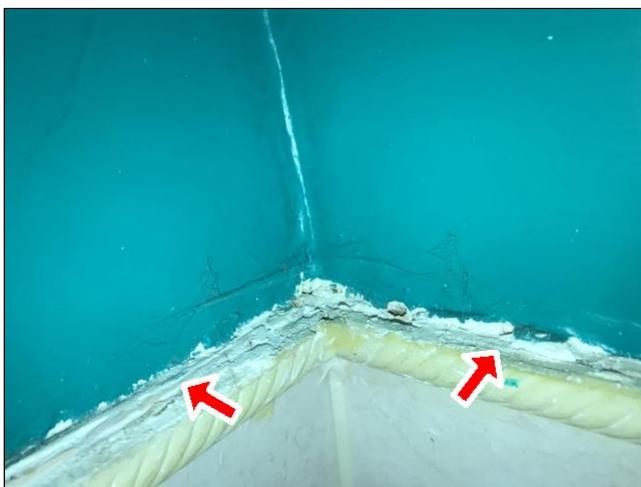
11 (2) The caulk sealant along the top edge of the shower surround walls was poorly installed and deteriorating. The silicone caulk should be applied around the seams where the walls meet the shower surround.

10.2 (2) **The caulk sealant along the top edge of the shower surround walls was poorly installed and deteriorating. The silicone caulk should be applied around the seams where the walls meet the shower surround.**

10.2 Deteriorating Caulk

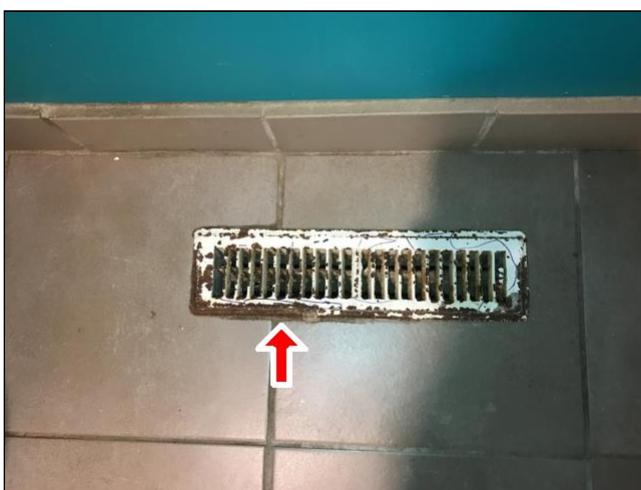
10.6 The heating vent was in relatively good condition. ***However the metal grille had worn paint and was rusting. Consideration should be given to replacing the vent grille.***

10.6 Rusting Vent Grille

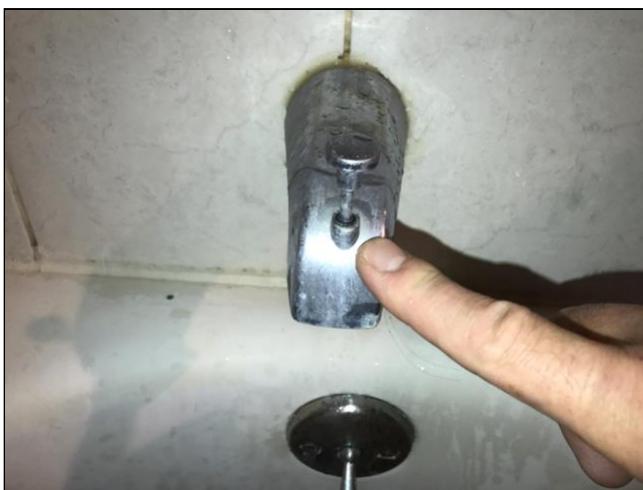
12 (3) The water flow diverter of the tub spout was stuck in the shower head position. Consequently the spout could not be used to fill the bath tub. The spout needs to be examined and repaired or replaced.

(3) **The water flow diverter of the tub spout was stuck in the shower head position. Consequently the spout could not be used to fill the bath tub. The spout needs to be examined and repaired or replaced.**

10.10 Stuck Water Flow Diverter

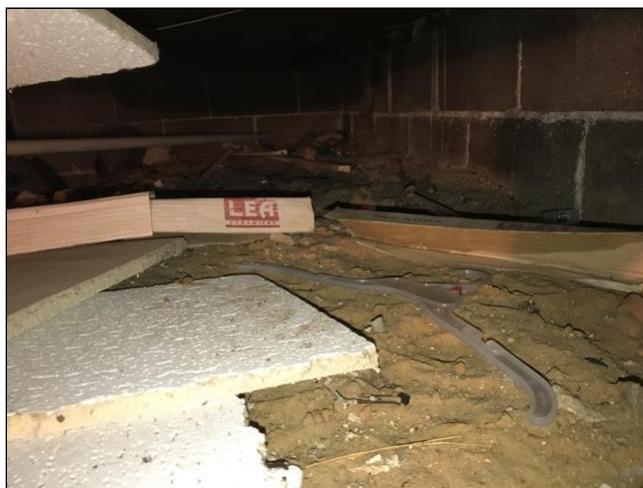
11.4 The dirt floor was intact. ***However there was a significant amount of debris strewn around the crawl space floor. The crawl space would be easier to access and service if the debris was removed.***

11.4 Construction Debris

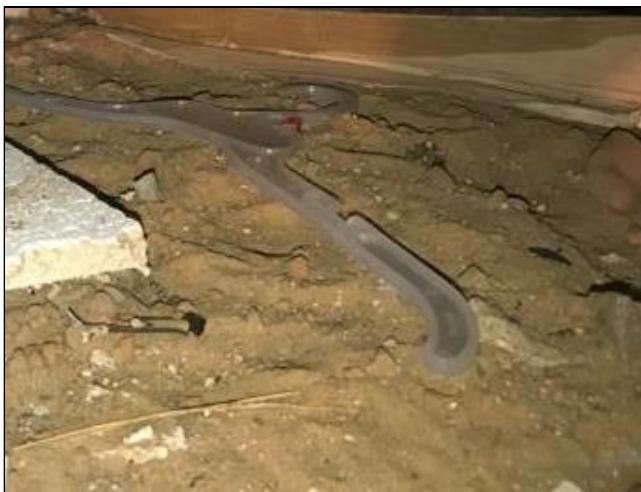
13 The crawl space floor did not have any vapor barrier. The dirt floor should be lined with a plastic sheeting throughout. NOTE: Vapor barriers protect the crawl space from moisture leaching up from the ground and creating an environment where fungal organisms can breed. Some fungal organisms are health hazards.

11.6 **The crawl space floor did not have any vapor barrier. *The dirt floor should be lined with a plastic sheeting throughout.* NOTE: Vapor barriers protect the crawl space from moisture leaching up from the ground and creating an environment where fungal organisms can breed. Some fungal organisms are health hazards.**

11.6 Missing Vapor Barrier

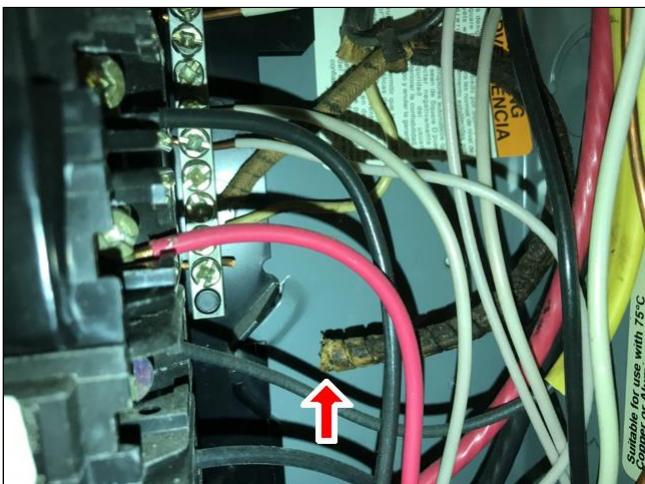
14 (2) There was a 6" long section of wire with an exposed uncovered end. The wire was terminated at the neutral bar of the panel. **Unterminated wires inside an electrical panel could cause arcing and are potential safety concerns. The wire should be removed from the electrical panel.**

13.3 (2) There was a 6" long section of wire with an exposed uncovered end. The wire was terminated at the neutral bar of the panel. **Unterminated wires inside an electrical panel could cause arcing and are potential safety concerns.** The wire should be removed from the electrical panel.

13.3 Exposed Wire End
