## Home Inspection Report

**70 Ryland Park Way, San Jose**

**Matthew Garcia**  
April 7, 2018

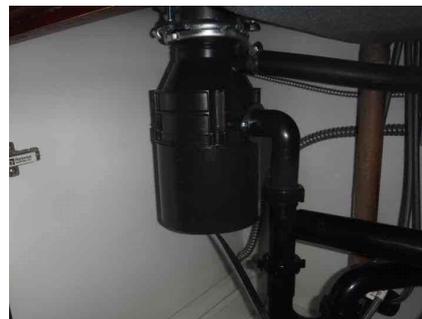
Photo 01

1. The waste disposer failed to respond to normal user controls at the time of our inspection. We recommend the disposer be repaired or replaced. For attention to the conditions noted and/or cost estimates, if necessary, we recommend the advice of a qualified appliance technician. (See Photo 1)

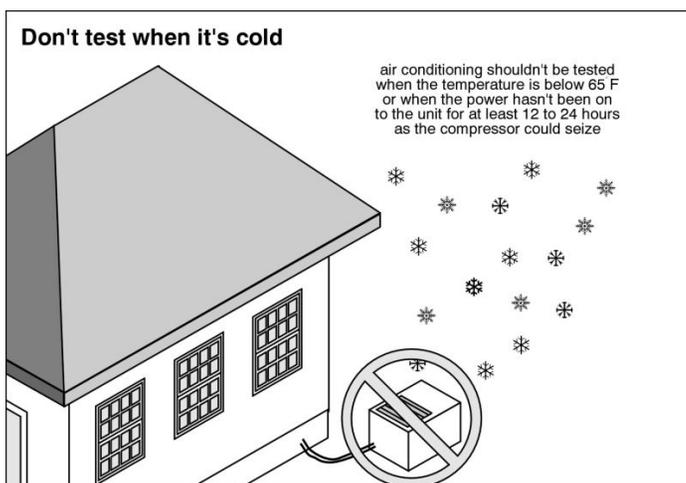
Illustration 6A

The air conditioning system could not be tested as the outdoor temperature was below 65 degrees F. (See Illustration 6A)

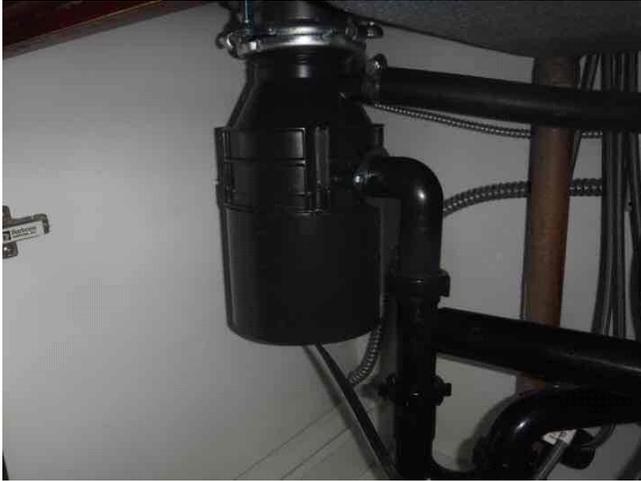
Photo 01

- ! 1. The waste disposer failed to respond to normal user controls at the time of our inspection. We recommend the disposer be repaired or replaced For attention to the conditions noted and/or cost estimates, if necessary, we recommend the advice of a qualified appliance technician. (See Photo 1)
2. Due to the lack of clearance or owner storage at the laundry area, we were not able to inspect the laundry hook-ups. We recommend interested parties consult with the owners as to the type and condition of the laundry hook-ups.
