INSPECTION REPORT

For the Property at:
601 RUBIDGE STREET
PETERBOROUGH, ON

Prepared for: TEAM VANRAHAN
Inspection Date: Monday, July 19, 2021
Prepared by: David Sharman

RE: Report No. 3549
601 Rubidge Street
Peterborough, ON

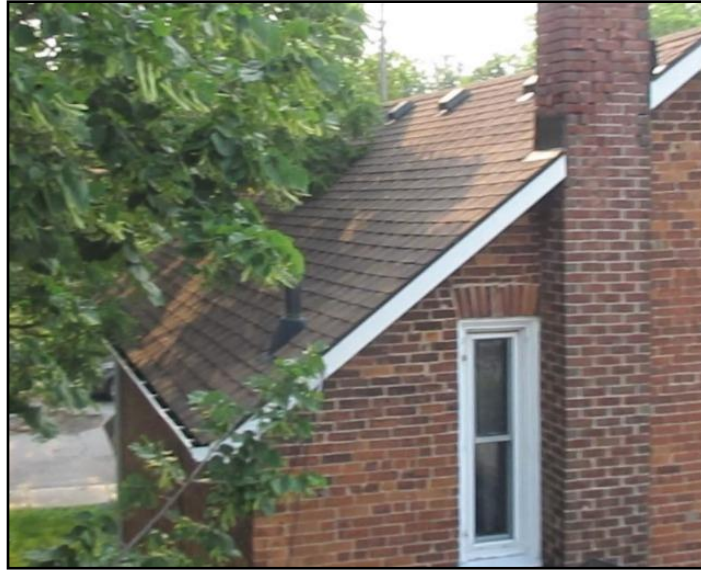
1. Condition: • Tree branches touching roof

Implication(s): Shortened life expectancy of material

Location: Right elevation

2. Tree branches touching roof

Task: Remove

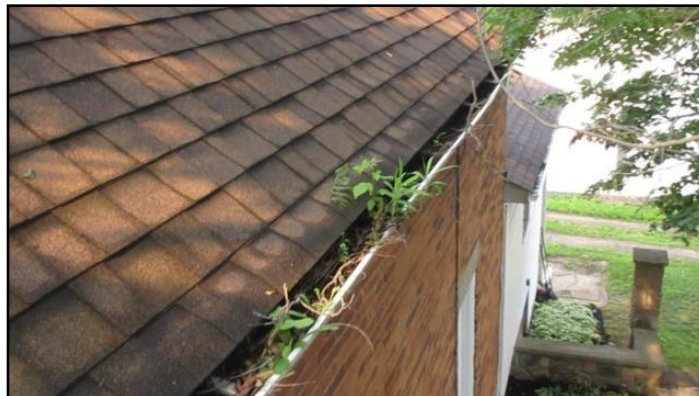
2. Condition: • Clogged

Implication(s): Chance of water damage to structure, finishes and contents

Location: Right elevation

3. Clogged

Task: Clean

NOTE:
Gutters have been cleared

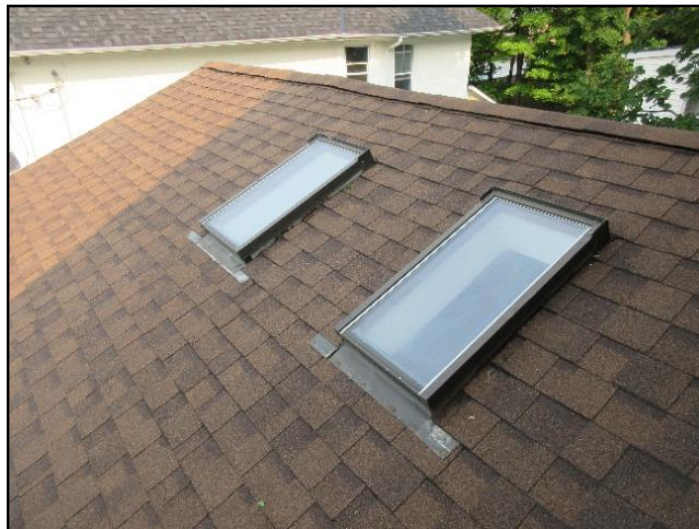
4. Condition: • Lost seal on double glazing

Implication(s): No implications exist for this item.

Location: Left elevation

4. Lost seal on double glazing

Task: Repair or replace

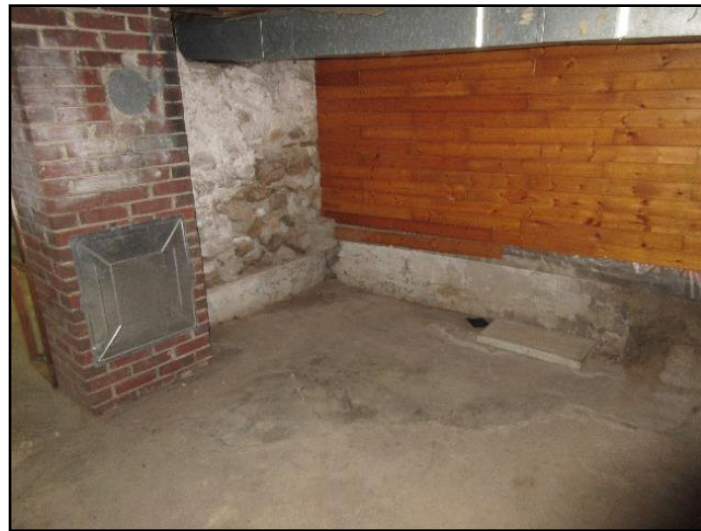
5. Condition: • Basement lowered

Implication(s): Chance of structural movement

6. Basement lowered

Task: Monitor

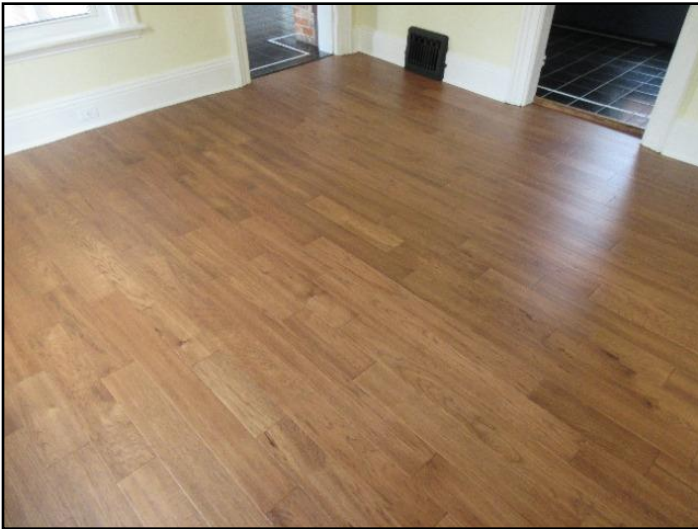
7. Condition: • Slope

Implication(s): Chance of structural movement

Location: Various locations

7. Slope

Task: Monitor

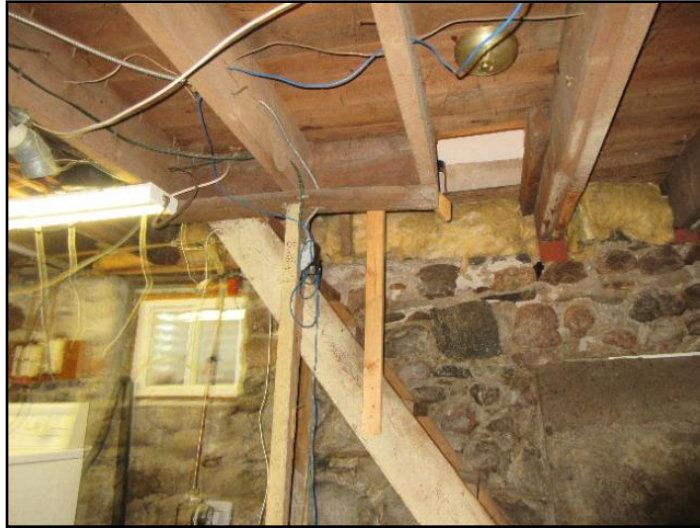
8. Condition: • Weak openings

Implication(s): Weakened structure | Chance of structural movement

Location: Basement

9. Weak openings

Task: Improve

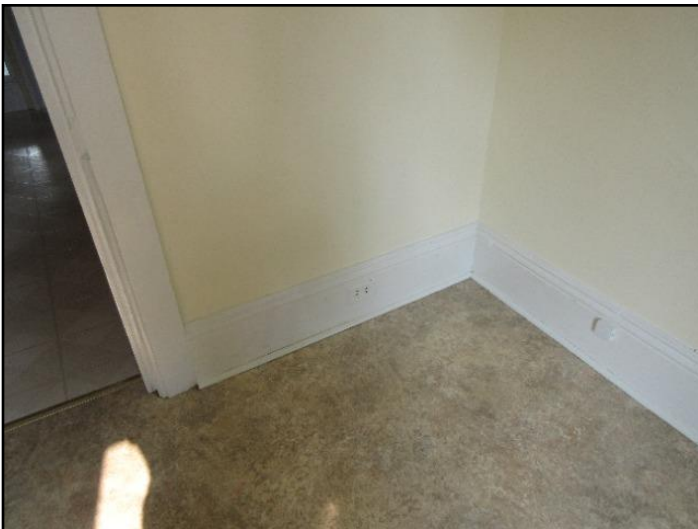
9. Condition: • Ungrounded

Implication(s): Electric shock

Location: Various locations

12. Ungrounded

Task: Upgrade

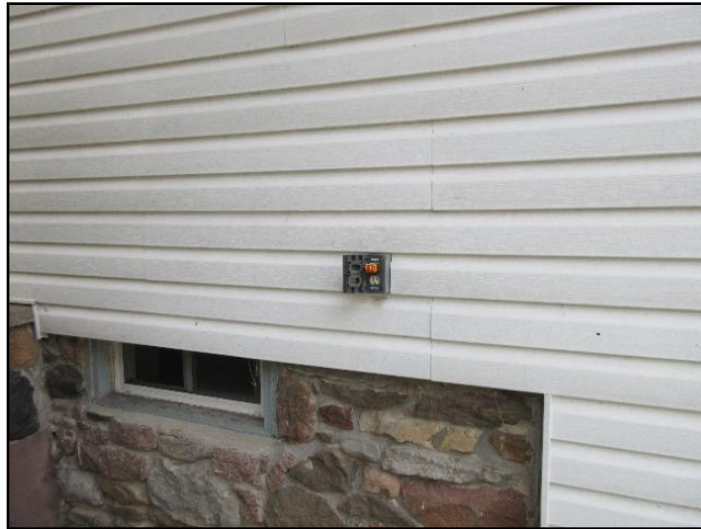
10. Condition: • Test faulty on GFCI/GFI (Ground Fault Circuit Interrupter)

Implication(s): Electric shock

Location: Exterior wall

15. Test faulty on GFCI/GFI (Ground Fault...

Task: Replace

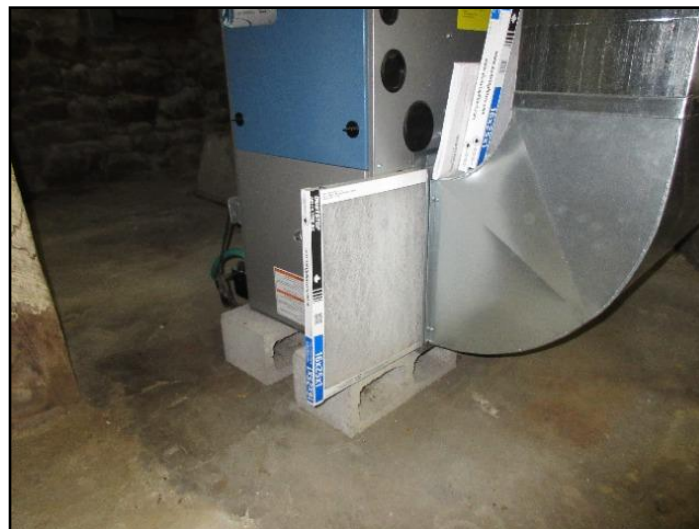
11. Condition: • Replace - regular maintenance

Implication(s): Increased heating & maintenance costs, Reduced comfort

Location: Cold air return

23. Replace - regular maintenance

Task: Replace

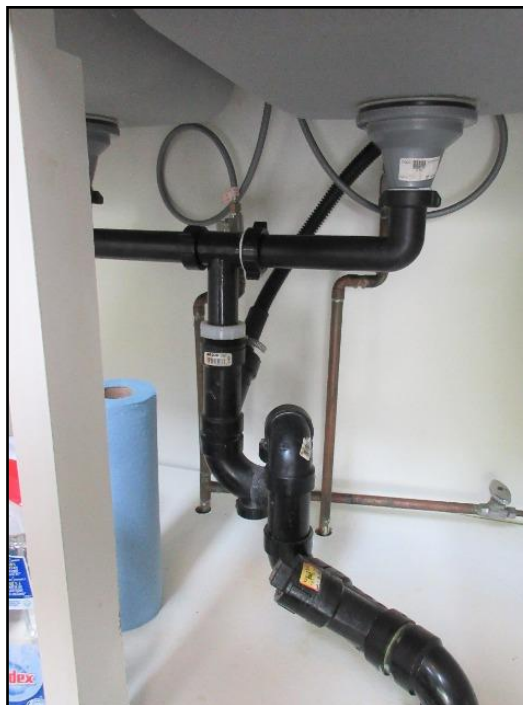
13. Condition: • Leak

29. Leak

Task: Repair

This has been repaired

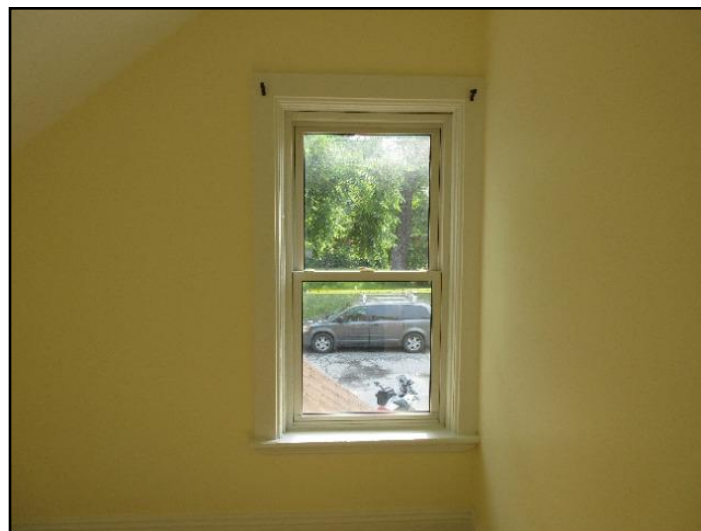
14. Condition: • Won't stay open

be careful when operating double-hung and single-hung windows (and also self-storing storms)

if they're defective, they could fall unexpectedly - injuring your hands and/or the window

30. Won't stay open

Task: Repair

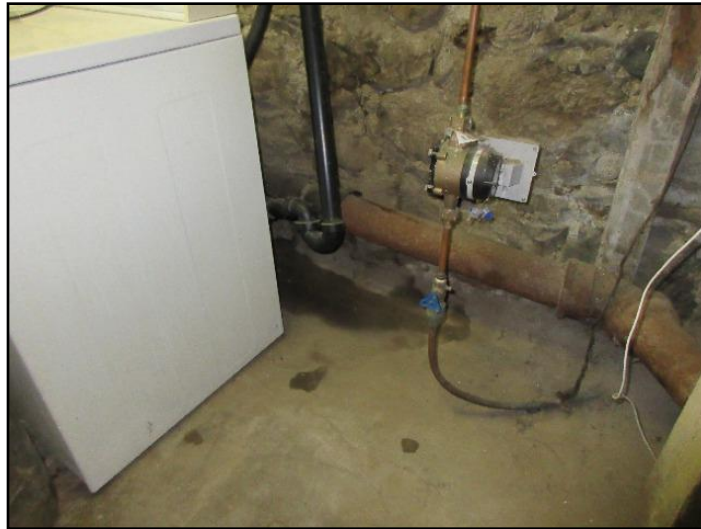
Dampness may be indicative of the clogged eaves troughing above at this location.

15. Condition: • Dampness on floor or walls

Implication(s): Chance of water damage to structure, finishes and contents | Material deterioration

31. Dampness on floor or walls

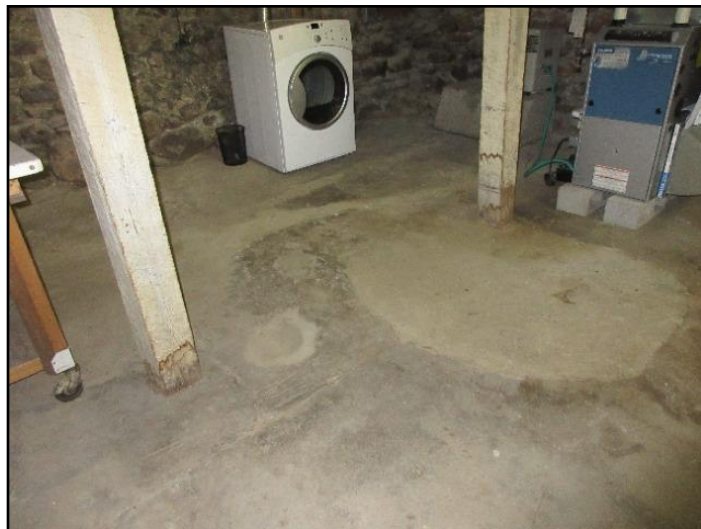
16. Condition: • Stains

Implication(s): Chance of water damage to structure, finishes and contents

32. Stains

Task: Monitor
