INSPECTION REPORT

For the Property at:
2048 WALKER AVENUE
PETERBOROUGH, ON

Prepared for: TEAM VANRAHAN
Inspection Date: Tuesday, June 8, 2021
Prepared by: David Sharman

RE: Report No. 3509
2048 Walker Avenue
Peterborough, ON

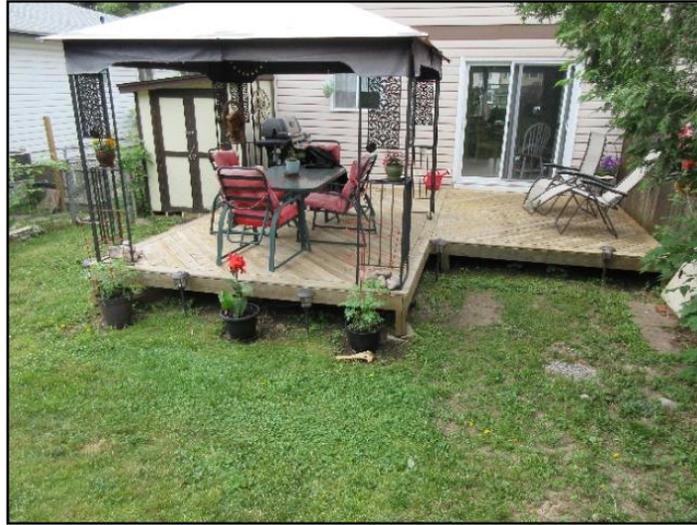
2. Condition: • Movement

Implication(s): Weakened structure | Chance of movement

Location: Rear decking

3. Movement

Task: Repair

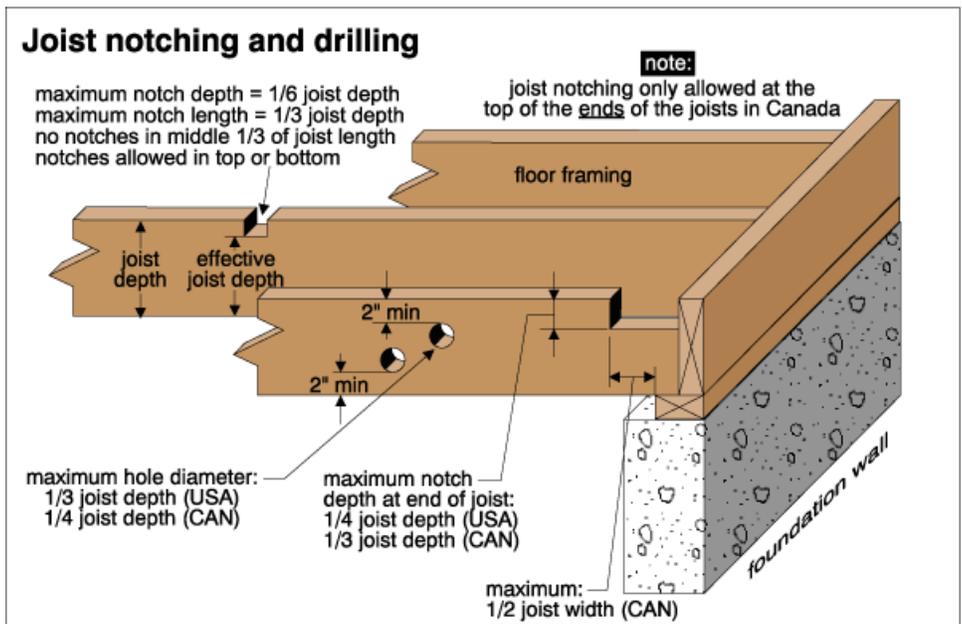
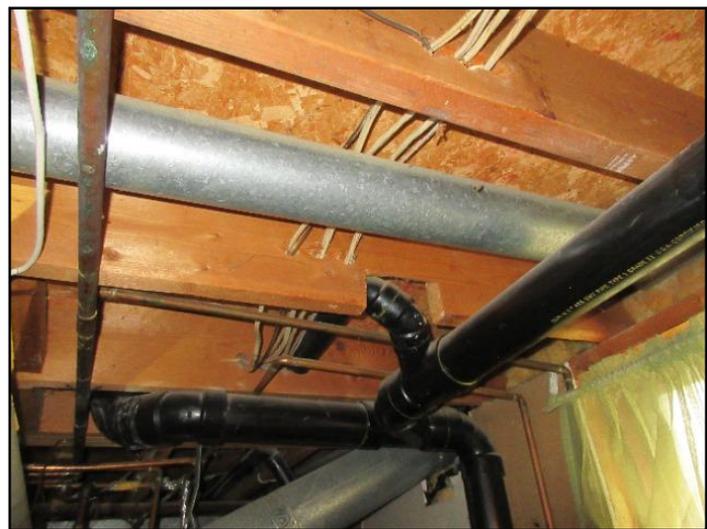
4. **Condition:** • Notches or holes

Implication(s): Weakened structure

Location: Utility room

5. Notches or holes

Task: Monitor

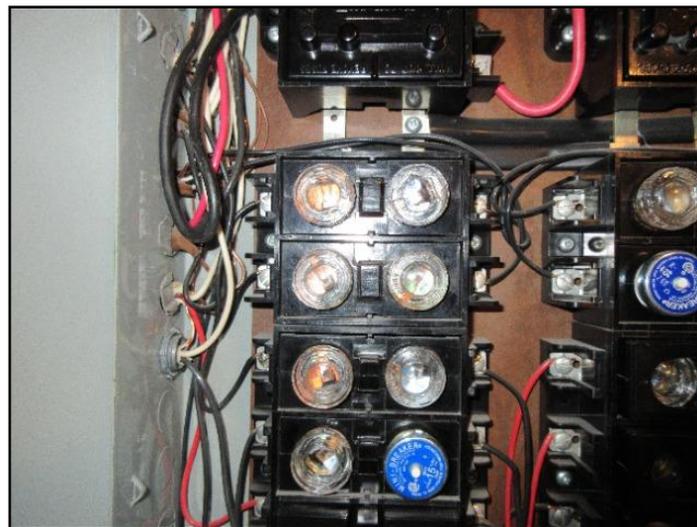
6. Condition: • Fuses too big

Implication(s): Equipment overheating | Fire hazard

Location: Distribution panel

10. Fuses too big

Task: Correct

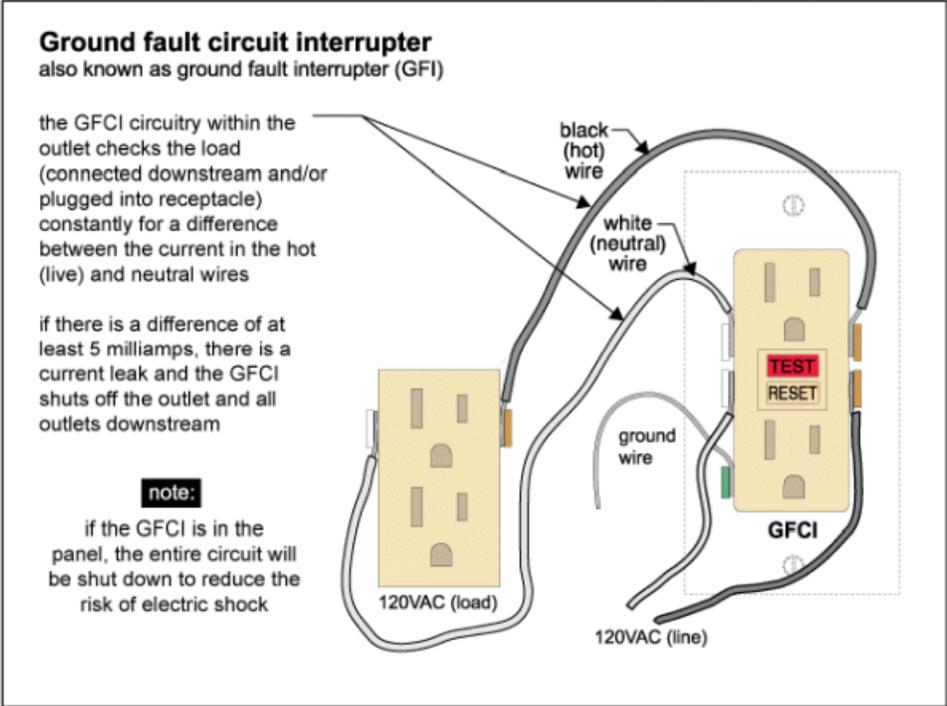
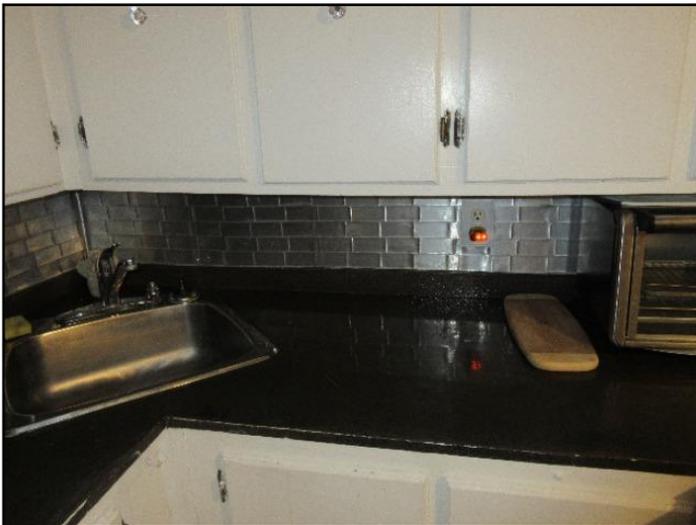
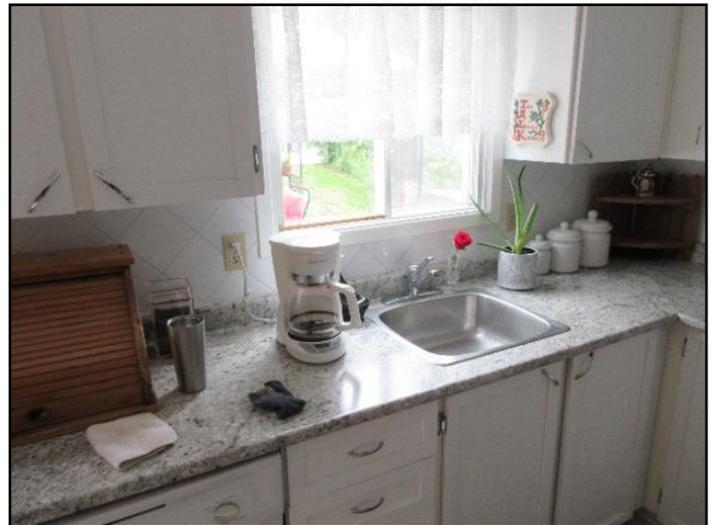
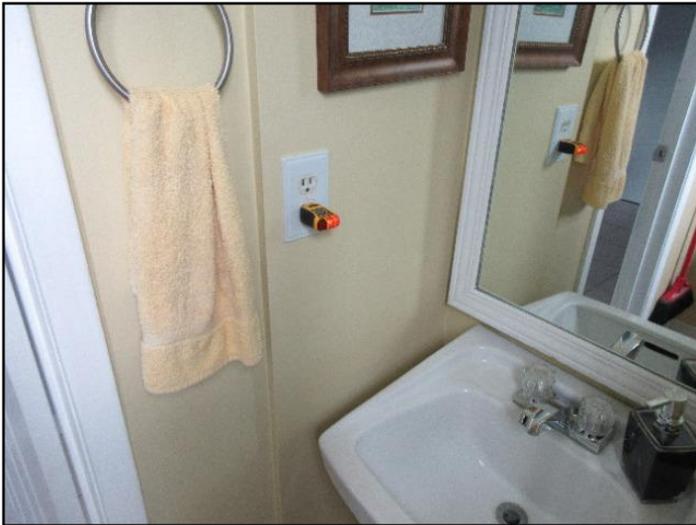
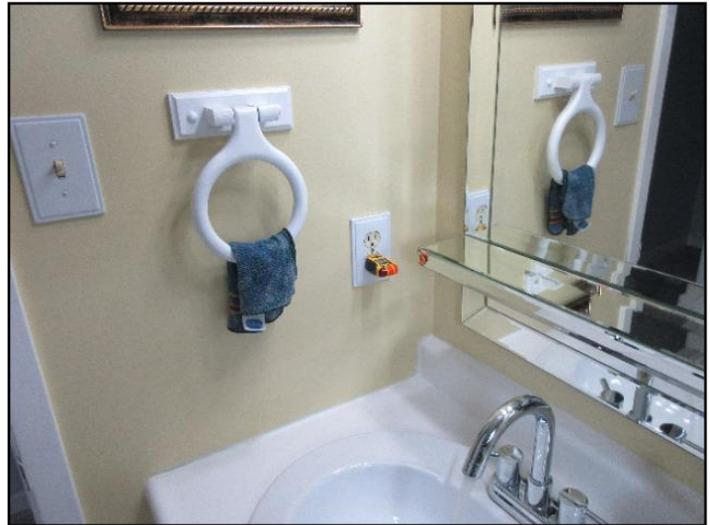
7. Condition: • No GFCI/GFI (Ground Fault Circuit Interrupter)

Implication(s): Electric shock

Location: Kitchens & bathrooms

11. No GFCI/GFI (Ground Fault Circuit...

Task: Upgrade

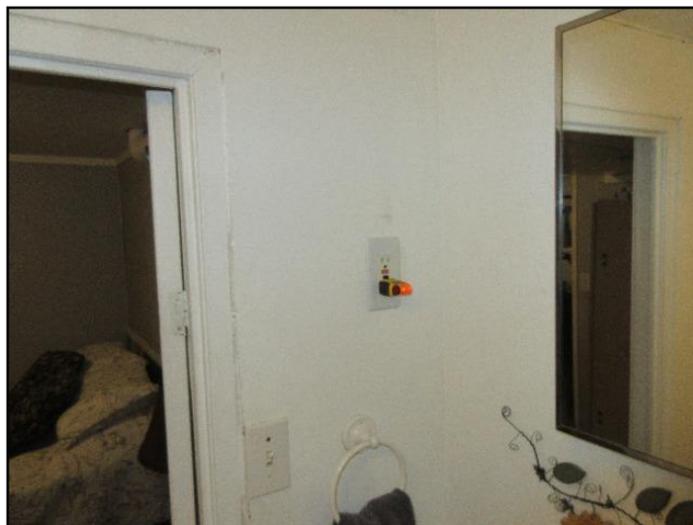
8. Condition: • Test faulty on GFCI/GFI (Ground Fault Circuit Interrupter)

Implication(s): Electric shock

Location: Basement bathroom

15. Test faulty on GFCI/GFI (Ground Fault...

Task: Replace

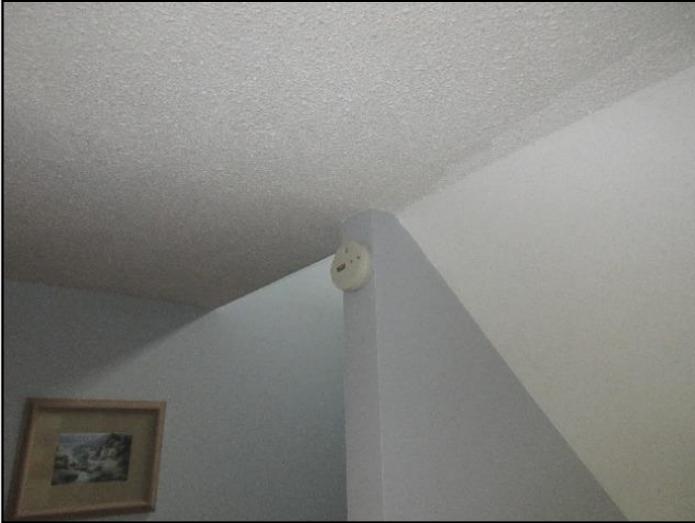
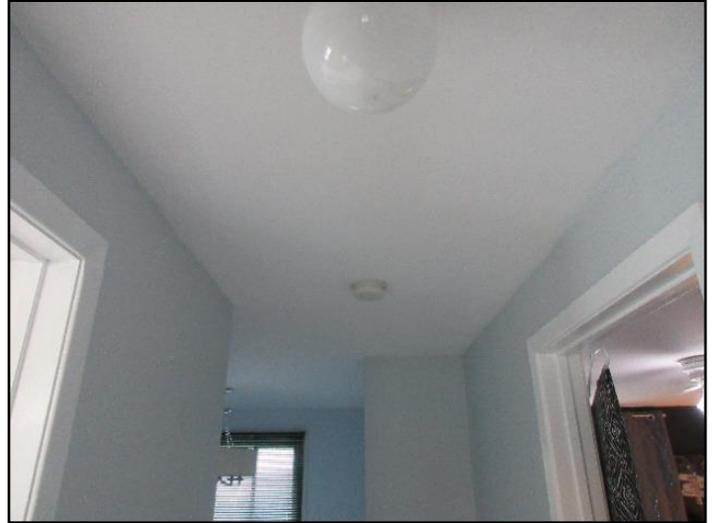
9. Condition: • More than 10 years old

Implication(s): Life safety hazard

Location: First & second floors

16. *More than 10 years old*

Task: Replace

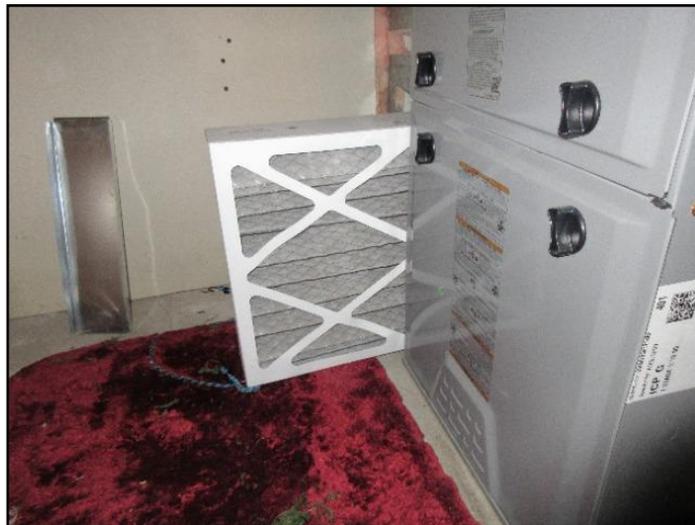
10. Condition: • Replace - regular maintenance

Implication(s): Increased heating & maintenance costs, Reduced comfort

Location: Cold air return

21. Replace - regular maintenance

Task: Replace

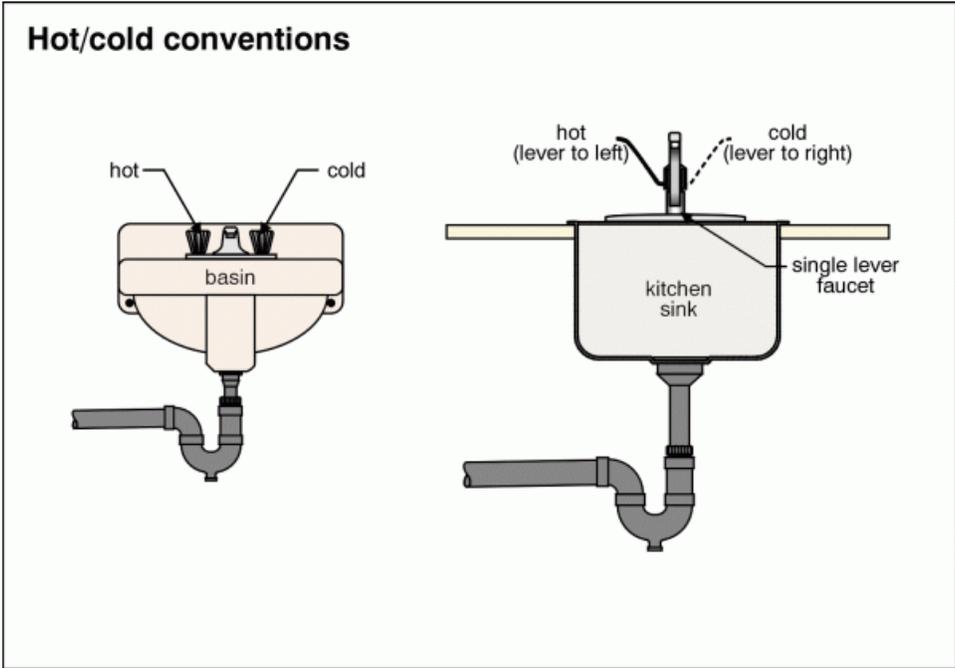
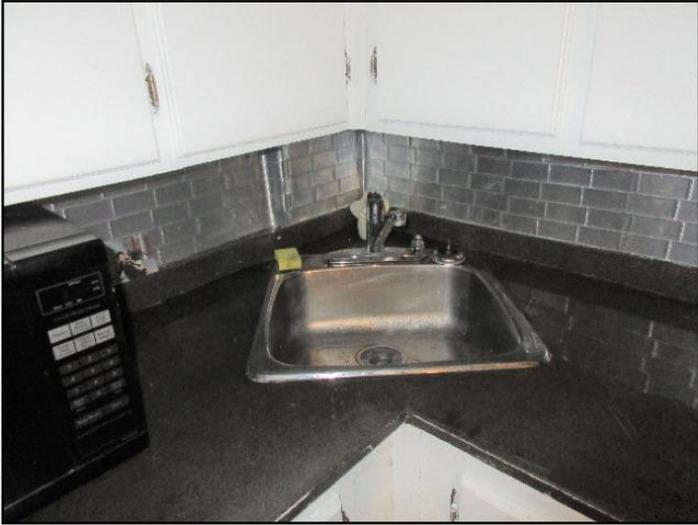
13. Condition: • Hot and cold reversed

Implication(s): Scalding

Location: Basement

28. Hot and cold reversed

Task: Correct

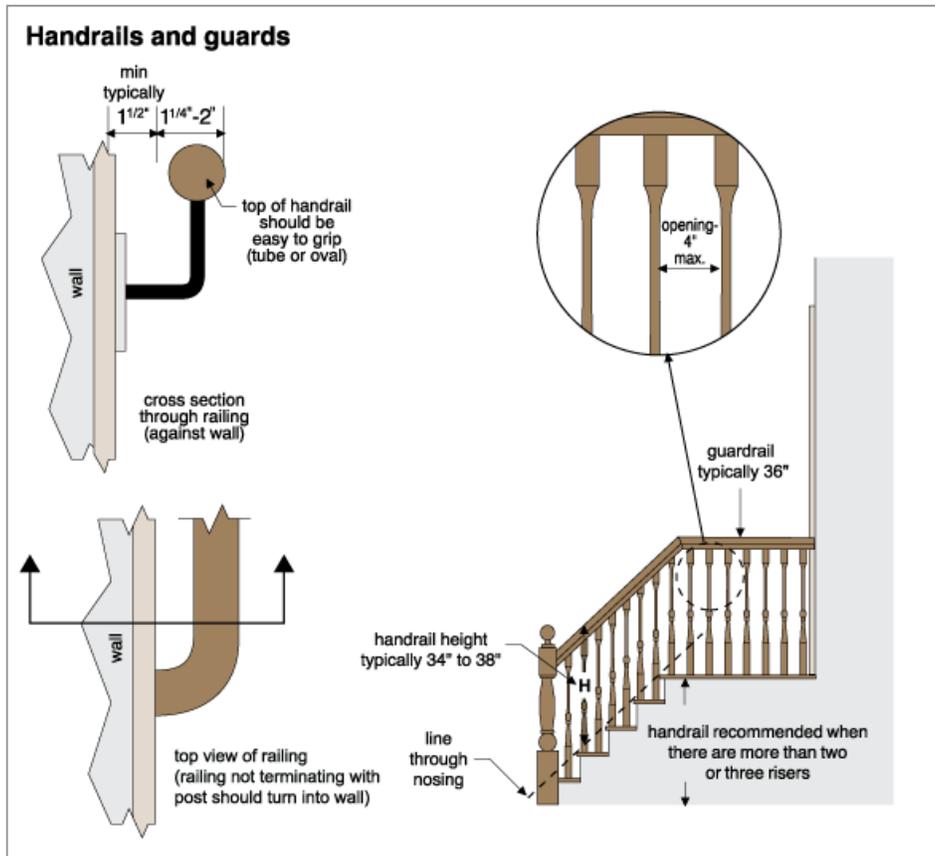
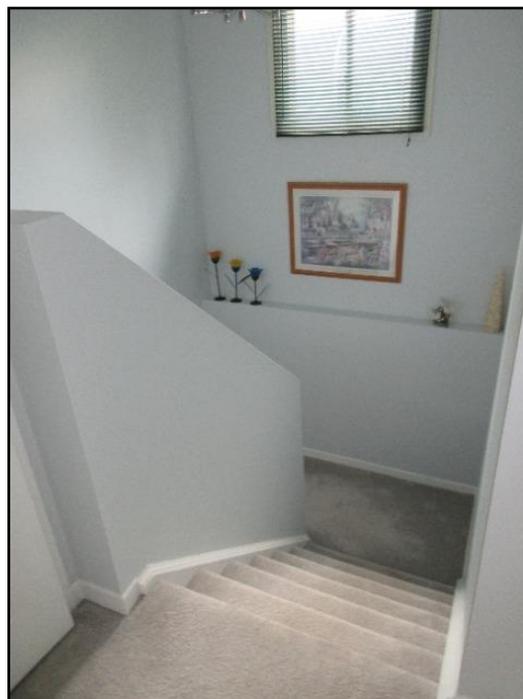
14. Condition: • Missing

Implication(s): Fall hazard

Location: Throughout

29. Missing

Task: Provide
