INSPECTION REPORT

For the Property at:
306 SPILLSBURY DRIVE, 208
PETERBOROUGH, ON

Prepared for: TEAM VANRAHAN
Inspection Date: Friday, September 16, 2022
Prepared by: David Sharman

RE: Report No. 4019
306 Spillsbury Drive, 208
Peterborough, ON

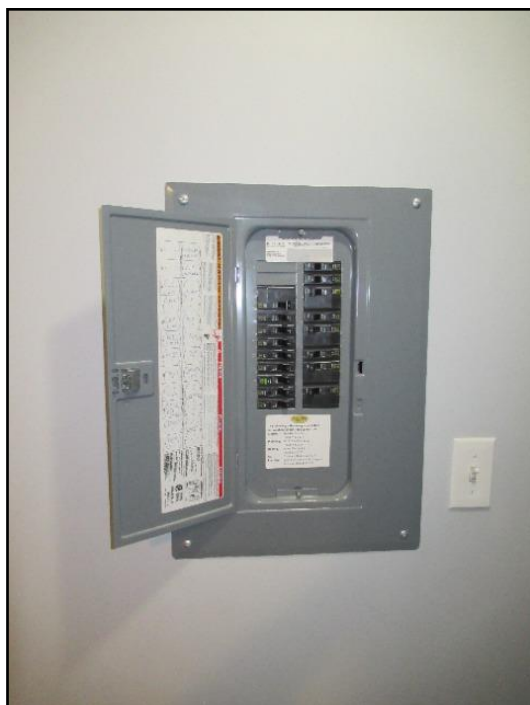
1. Distribution panel

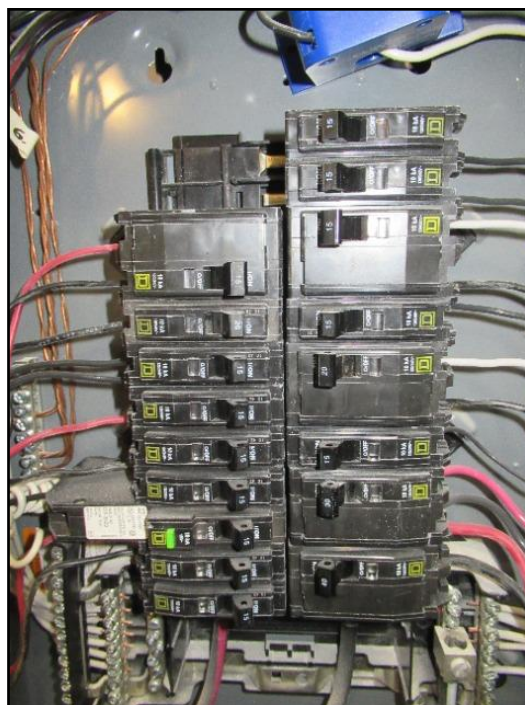
2. Breakers - hall

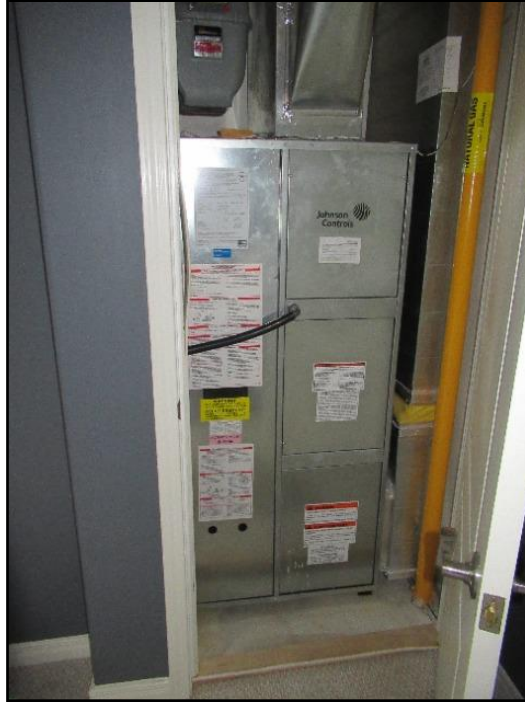
3. Furnace

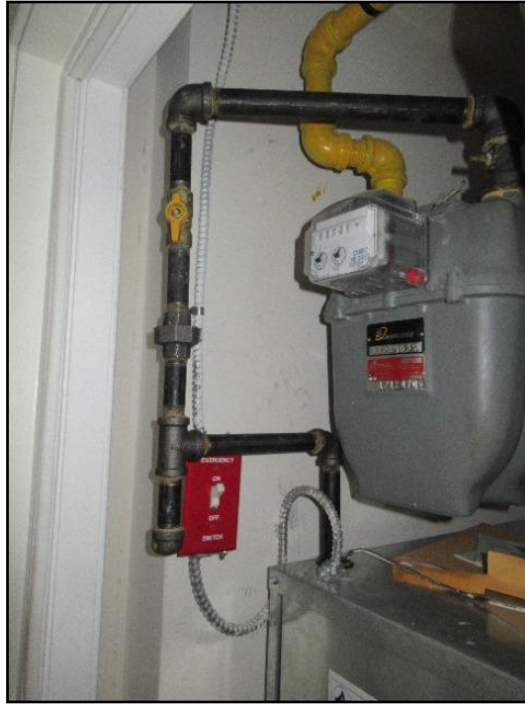
4. Main fuel shut off & electrical disconnect

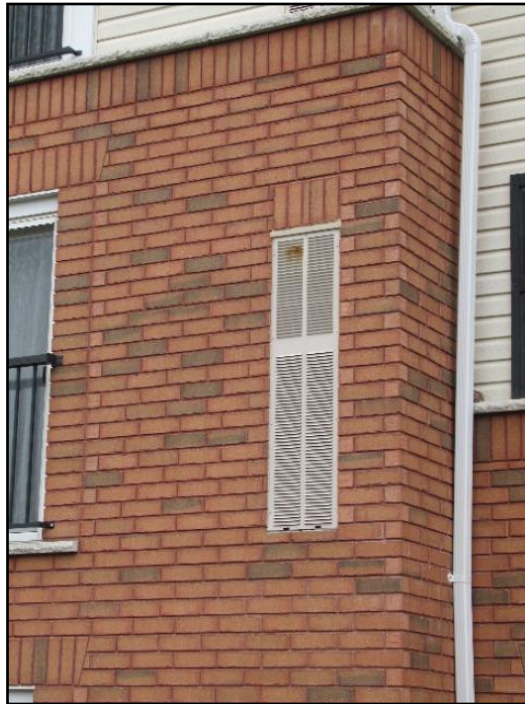
5. Sidewall venting

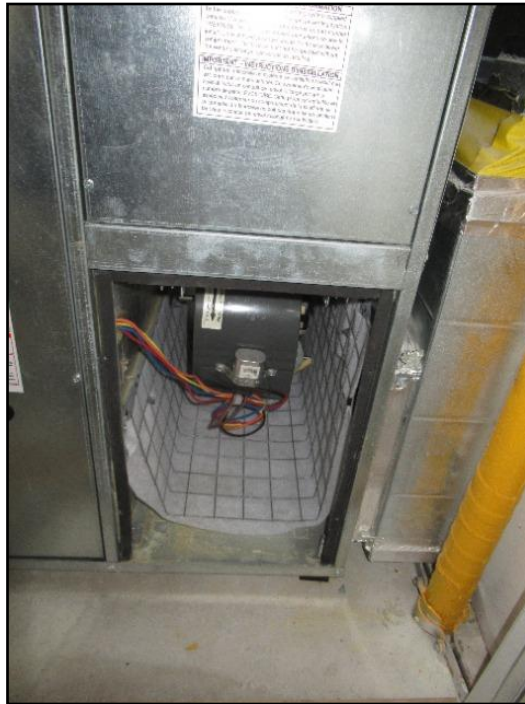
5. Condition: • Replace - regular maintenance

Implication(s): Increased heating & maintenance costs, Reduced comfort

Location: Cold air return

6. *Replace - regular maintenance*

Task: Replace

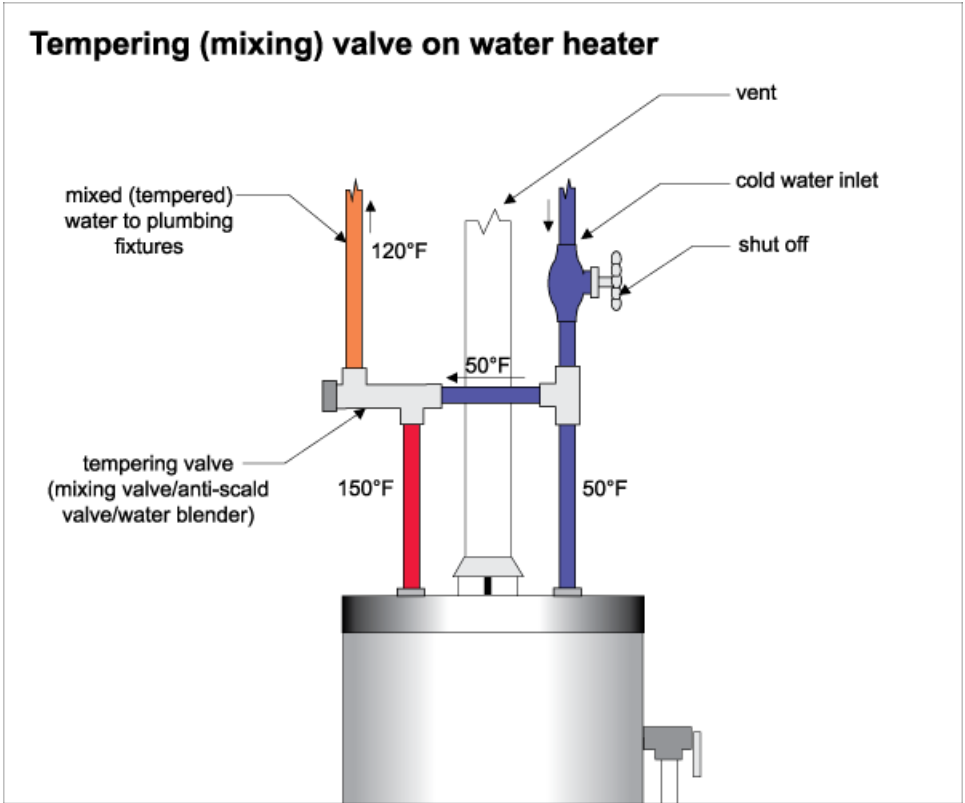
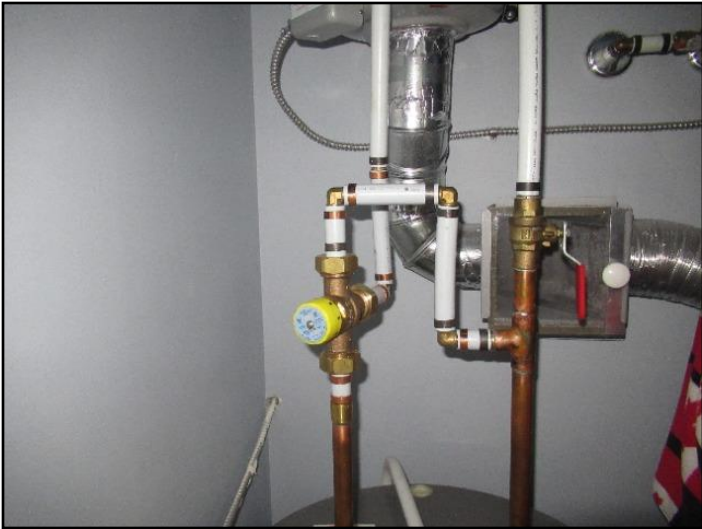
7. Tempering/mixing valve installed

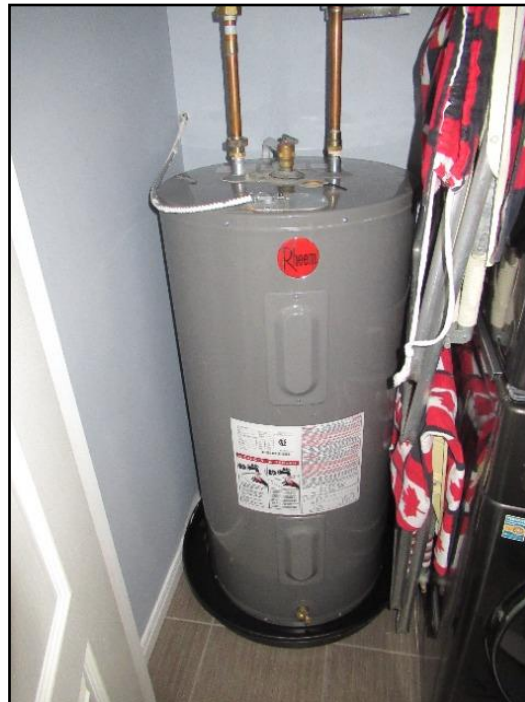
8. Electric
