Key Home Inspections
RESIDENTIAL • COMMERCIAL

Property Condition Report

25 Dunkirk Road
Toronto, Ontario

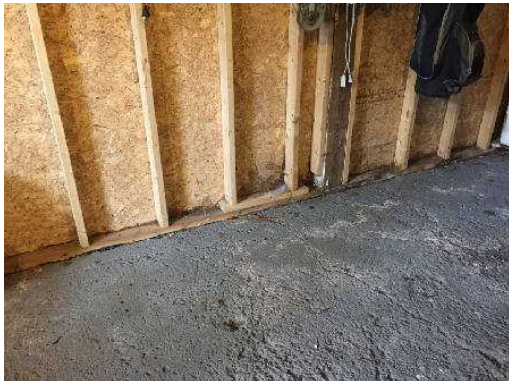
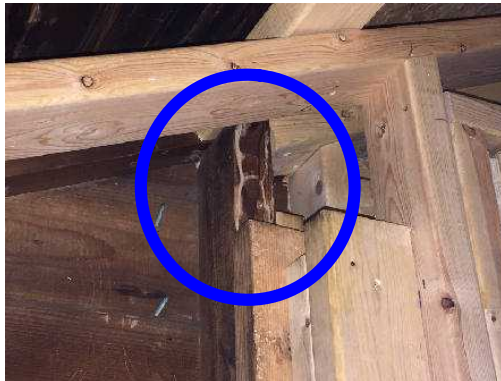
3. Rear Garage Walls: Framing & Plywood - Wood and soil contact is noted to the bottom plate of the framing members. This method may cause wood rot as well as possible past issues.

Termite tracks are noted at the framing member's located at the entry door area. Further evaluation by a pest control contractor is needed.

Aetna Pest Control has treated both the interior and exterior of the home on June 17, 2017. Upon closing buyer will receive warranty and certification.

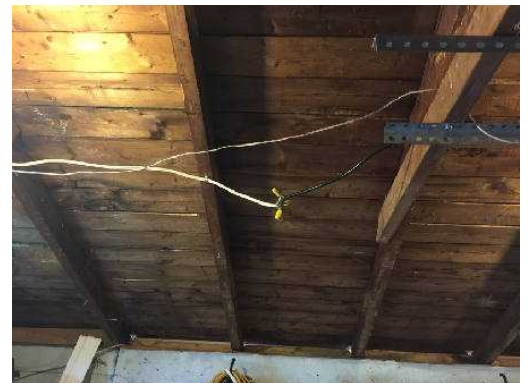
4. Rear Garage Electrical: Installed - provide a junction box to the electrical connection is required.

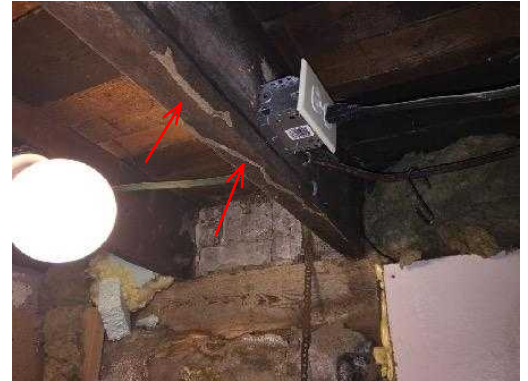
1. Joists/Trusses: 2x8 - Home is located in a high termite area of the city, visual evidence of termites were found. It is recommended to inspect the property currently and annually to ensure that no new development of infestation has occurred.

- Some floor joists have been notched to allow duct work, re support the notched floor joists is recommended (if necessary) Further evaluation may be required.

Aetna Pest Control has treated both the interior and exterior of the home on June 17, 2017. Upon closing buyer will receive warranty and certification.

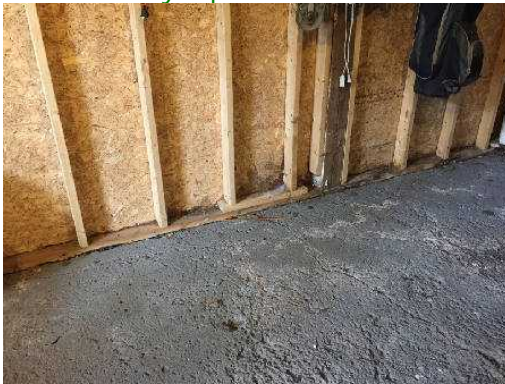
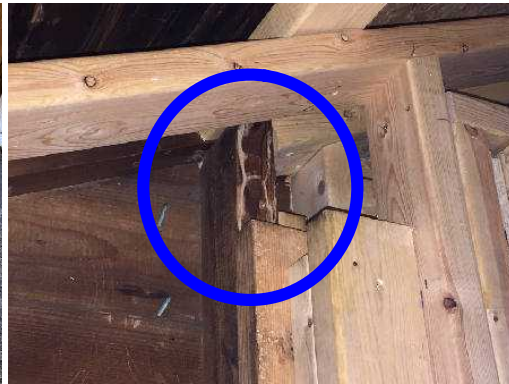
1. Type of Structure: Detached Car Spaces: 1
2. ☒ ☐ ☐ ☐ Garage Doors: Insulated aluminum
3. ☒ ☐ ☐ ☐ Door Operation: Mechanized
4. ☒ ☐ ☐ ☐ Door Opener: Operational
5. ☒ ☐ ☐ ☐ Exterior Surface: Wood siding
6. ☒ ☐ ☐ ☐ Roof: Asphalt shingle
7. ☒ ☐ ☐ ☐ Service Doors: Metal
8. ☐ ☒ ☐ ☐ Walls: Framing & Plywood - Wood and soil contact is noted to the bottom plate of the framing members. This method may cause wood rot as well as possible past issues.

Termite tracks are noted at the framing member's located at the entry door area. Further evaluation by a pest control contractor is needed.

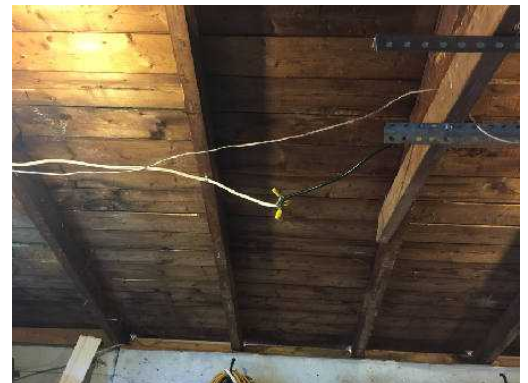
9. ☒ ☐ ☐ ☐ Ceiling: Framing
10. ☒ ☐ ☐ ☐ Floor/Foundation: Poured slab
11. ☐ ☒ ☐ ☐ Electrical: Installed - provide a junction box to the electrical connection is required.

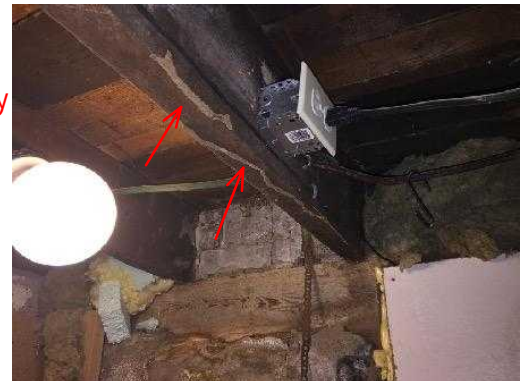
3. ☒ ☐ ☐ ☐ Beams: Bonded wood
4. ☒ ☐ ☐ ☐ Bearing Walls: Poured Concrete
5. ☐ ☐ ☐ ☒ Joists/Trusses: 2x8 - Home is located in a high termite area of the city, visual evidence of termites were found. It is recommended to inspect the property currently and annually to ensure that no new development of infestation has occurred.

- Some floor joists have been notched to allow duct work, re support the notched floor joists is recommended (if necessary) Further evaluation may be required.

Aetna Pest Control has treated both the interior and exterior of the home on June 17, 2017. Upon closing, buyer will receive warranty and certification.
