# INSPECTION REPORT

For the Property at:  
**61 ORCHARD WAY**  
WARKWORTH, ON K0K 3K0

Prepared for: TEAM VANRAHAN  
Inspection Date: Saturday, August 7, 2021  
Prepared by: David Sharman

RE: Report No. 3572  
61 Orchard Way  
Warkworth, ON  
K0K 3K0

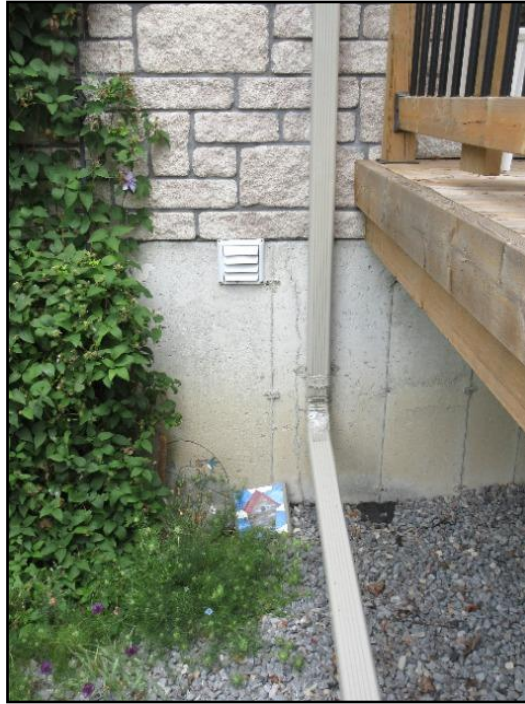
**3. Condition:** • Typical minor cracks

**Implication(s):** Chance of water entering building

**Location:** Rear elevation

4. *Typical minor cracks*

**Task:** Monitor

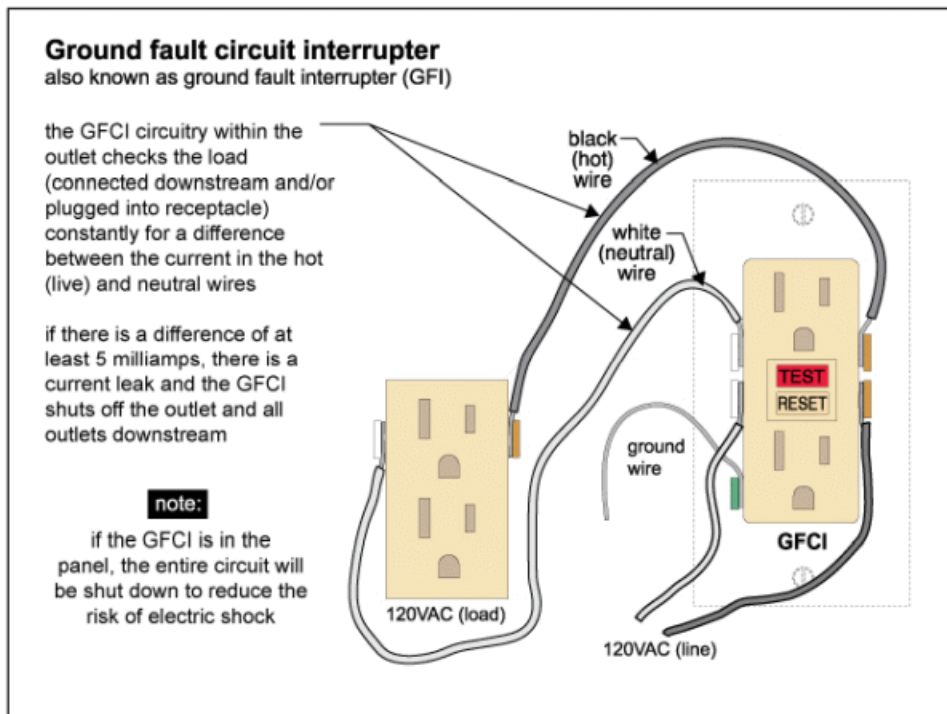
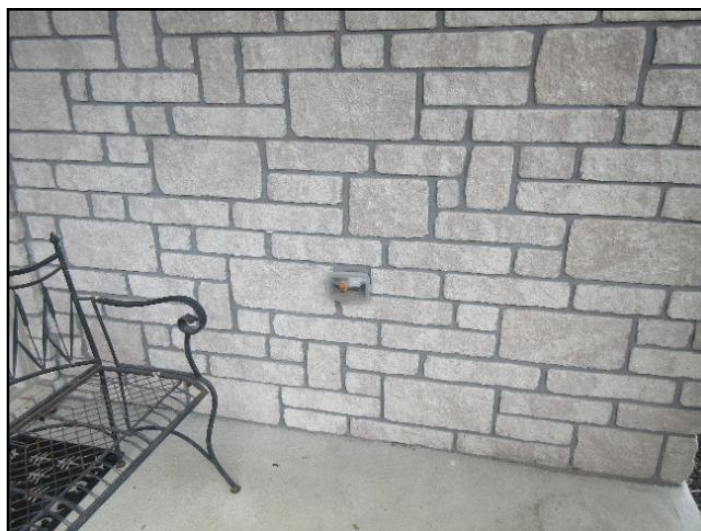
**5. Condition:** • Test faulty on GFCI/GFI (Ground Fault Circuit Interrupter)

**Implication(s):** Electric shock

**Location:** Exterior wall

7. Test faulty on GFCI/GFI (Ground Fault...

**Task:** Replace

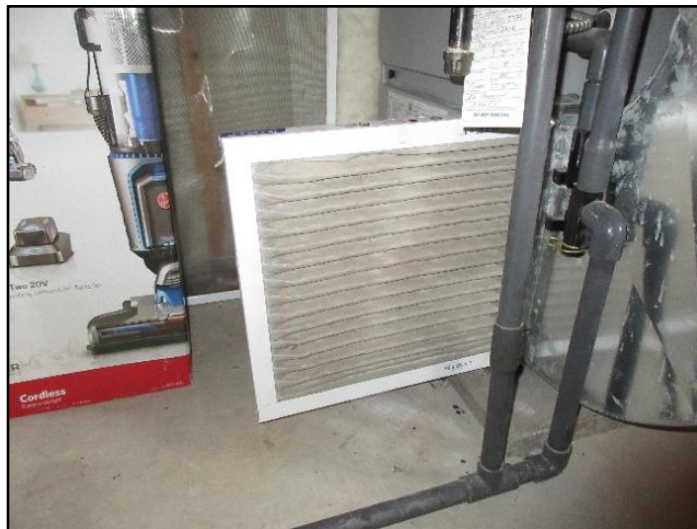
**6. Condition:** • Replace - regular maintenance

**Implication(s):** Increased heating & maintenance costs, Reduced comfort

**Location:** Cold air return

15. Replace - regular maintenance

**Task:** Replace

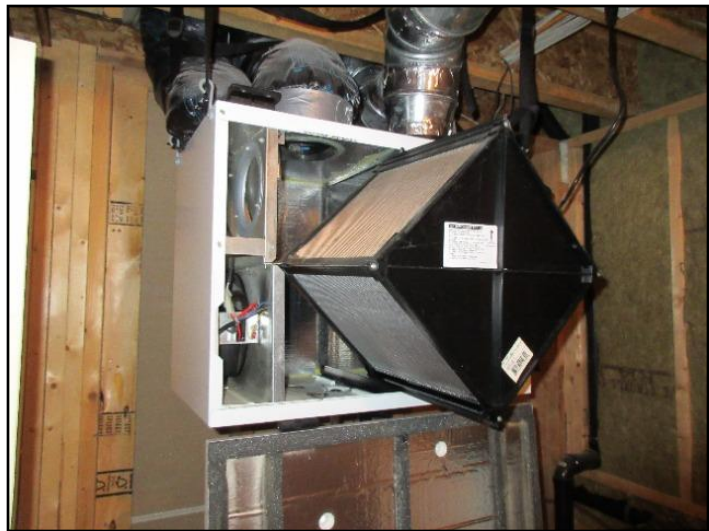
**7. Condition:** • Clean core - regular maintenance

**Implication(s):** Reduced operability & comfort

**Location:** Unit interior

16. Clean core - regular maintenance

**Task:** Clean

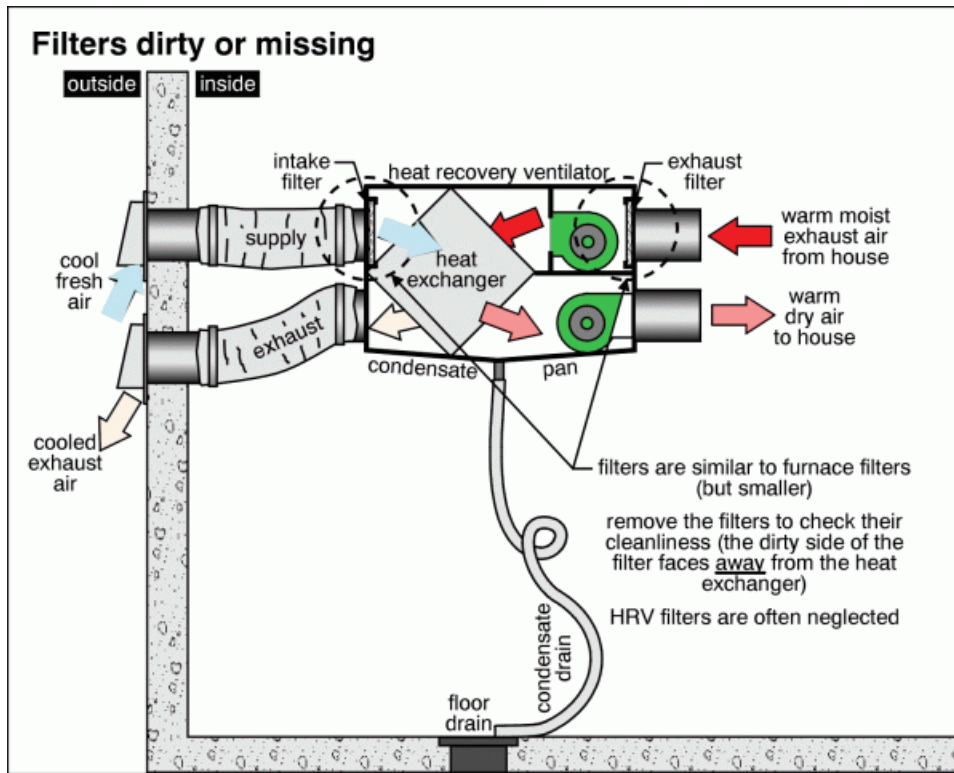
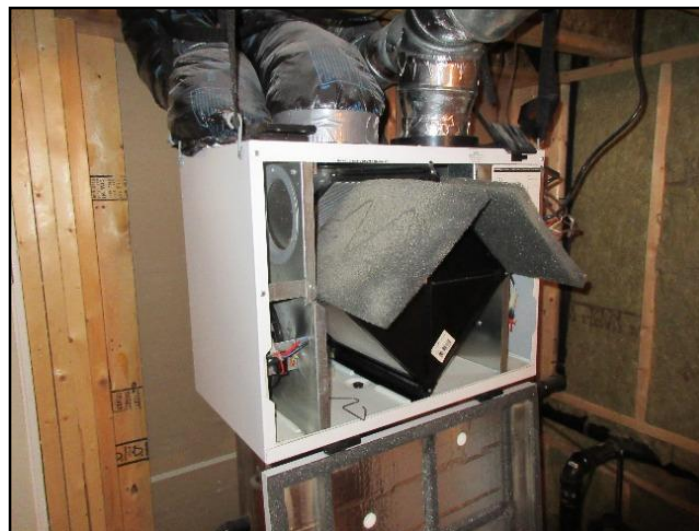
**8. Condition:** • Clean filters - regular maintenance

**Implication(s):** Reduced operability & comfort

**Location:** Unit interior

17. Clean filters - regular maintenance

**Task:** Clean

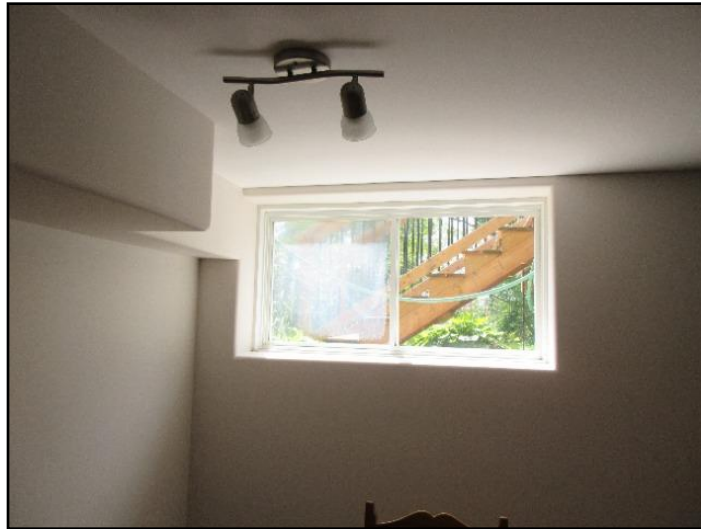
**12. Condition:** • Lost seal on double glazing

*28. Lost seal on double glazing*

**Task:** Repair or replace

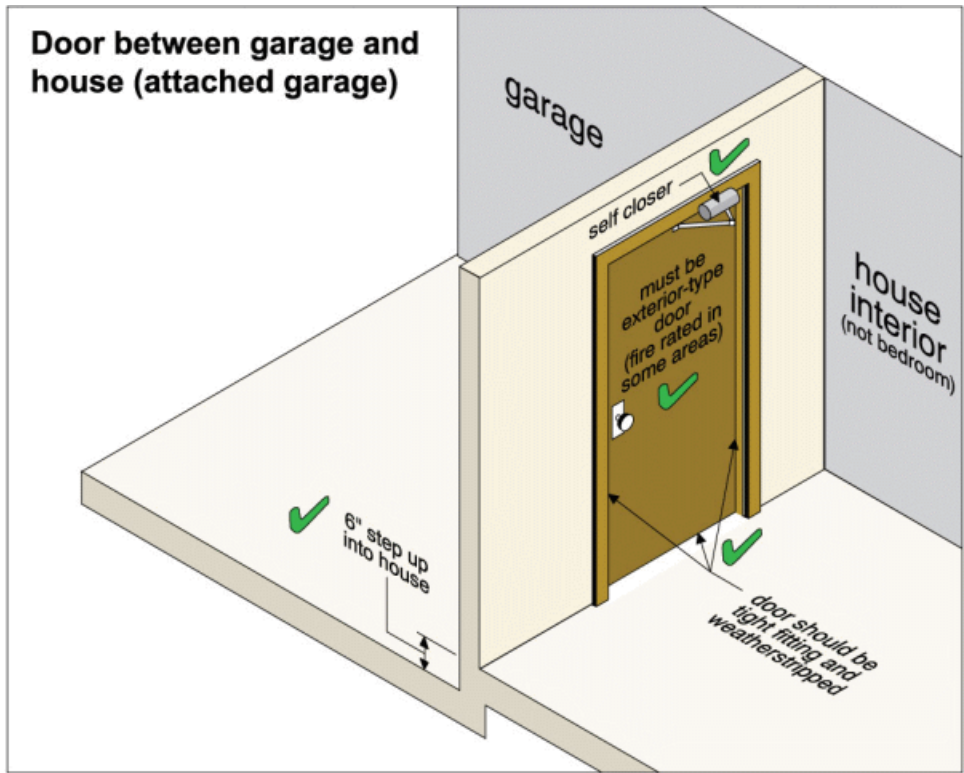
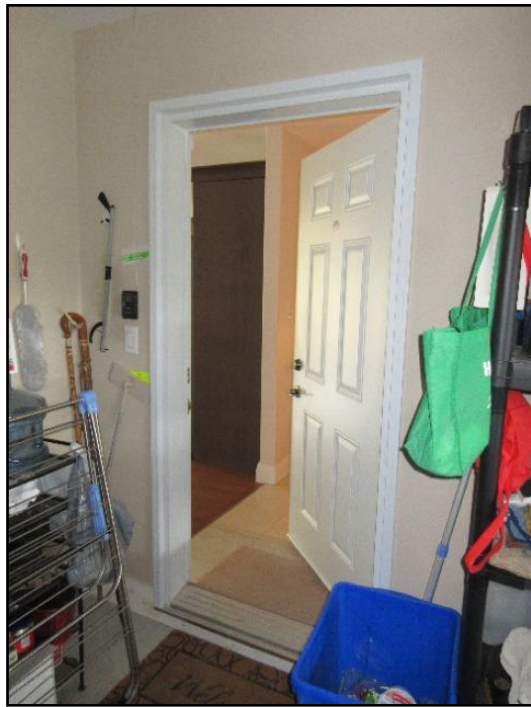
**13. Condition:** • No self closer

**Implication(s):** Hazardous combustion products entering home

29. No self closer
