## Home Inspection Report

**75 Hobson Street #4A, San Jose**

Donald Grenier  
October 4, 2016

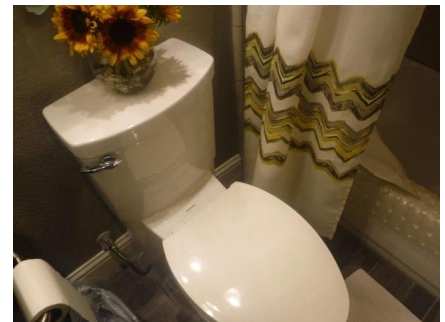
Photo 2

1. The toilet in the hall bath is loose and should be properly re-secured, tightened and caulked. (See Illustration 5B2) (See Photo 2)

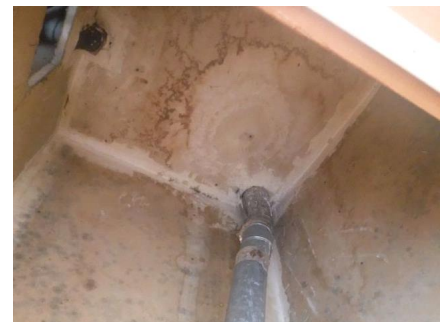
Photo 1

2. The ceiling at the heater closet shows evidence of water stains. It is recommended that the source of these stains be identified and corrected and the surface be refinished. (See Photo 1)

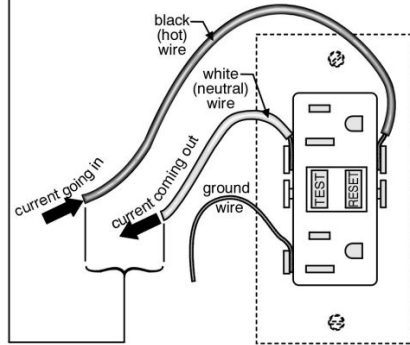
Illustration 13A

5. The installation of ground fault circuit interrupter "GFCI" devices is advisable on exterior, garage, bathroom and some kitchen outlets. Any whirlpool or swimming pool equipment should also be fitted with "GFCI"s. A ground fault circuit interrupter "GFCI" offers protection from shock or electrocution. Please note that "GFCI" may already be in one or more of these areas. See "description" section above for exact location of any "GFCI" which may be present on this property. (See Illustration 13A)

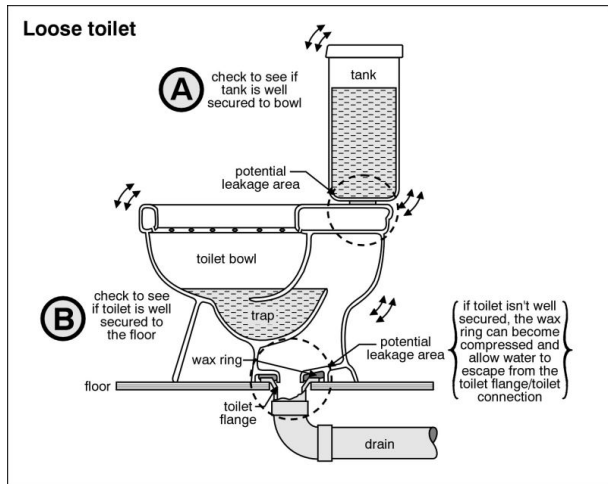
Illustration 5B2

- ! 1. The toilet in the hall bath is loose and should be properly re-secured, tightened and caulked. (See Illustration 5B2) (See Photo 2)
2. We recommend that information regarding the shut offs for the various systems (such as electricity, gas and water) be obtained from the homeowners association and that access to all appropriate areas be confirmed.

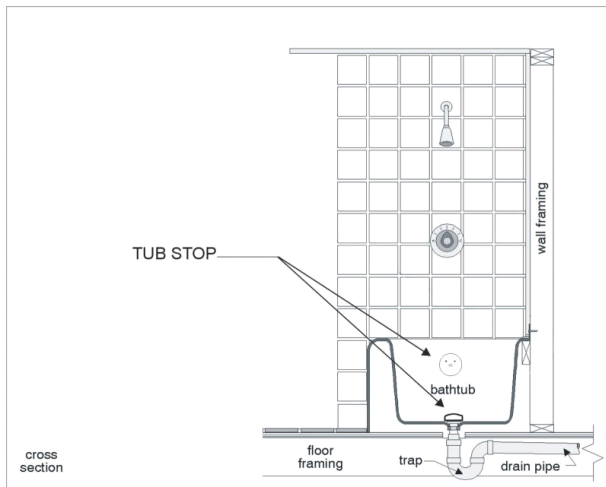
*Illustration 3C1*

- 3. The drain stopper in the hall bath tub was not functioning properly or missing. We recommend repair or replacement. (See Illustration 3C1)

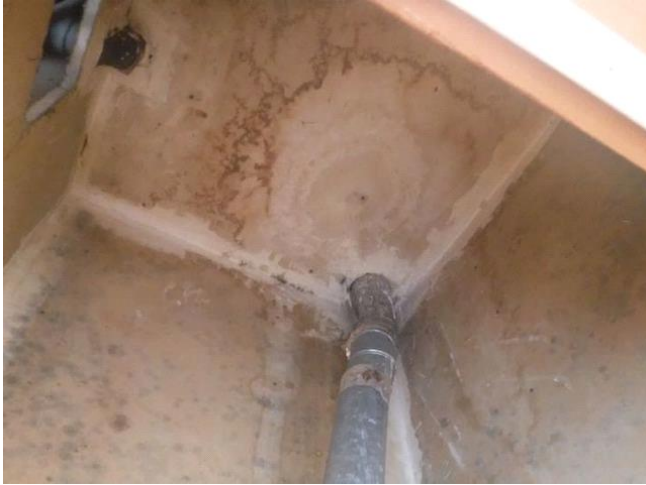
Photo 1

- ! 1. The ceiling at the heater closet shows evidence of water stains. It is recommended that the source of these stains be identified and corrected and the surface be refinished. (See Photo 1)
- 2. One or more interior closet doors have been removed. We recommend that doors be installed in all necessary openings and checked for proper operation.
