INSPECTION REPORT

For the Property at:
4 MURRAY STREET
NORWOOD, ON

Prepared for: TEAM VANRAHAN
Inspection Date: Monday, June 21, 2021
Prepared by: David Sharman

RE: Report No. 3521
4 Murray Street
Norwood, ON

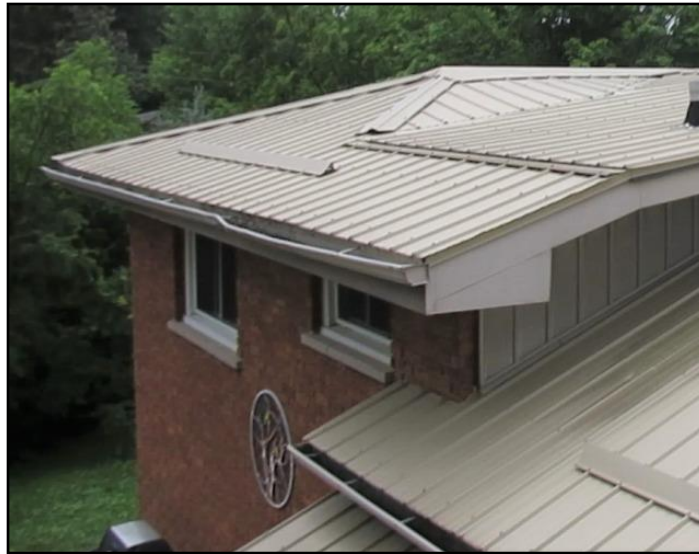
2. Condition: • Damage

Location: Rear elevation

4. Damage

Task: Repair

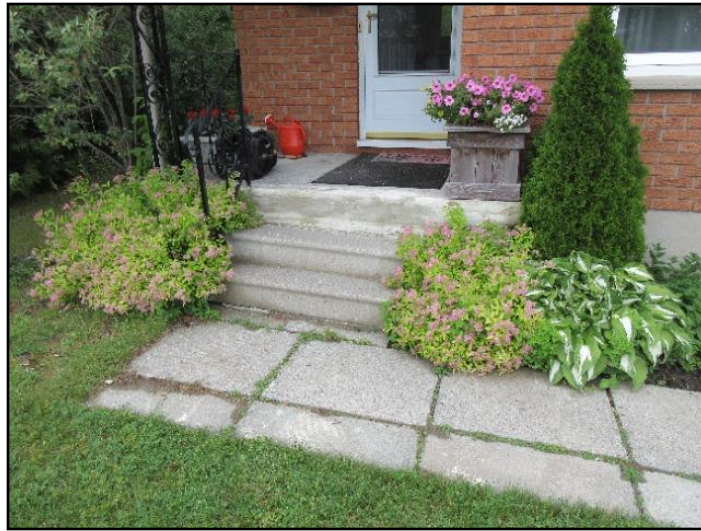
3. Condition: • Steps or landings settling or heaving

Implication(s): Weakened structure | Trip or fall hazard

Location: Front elevation

5. Steps settling

Task: Improve

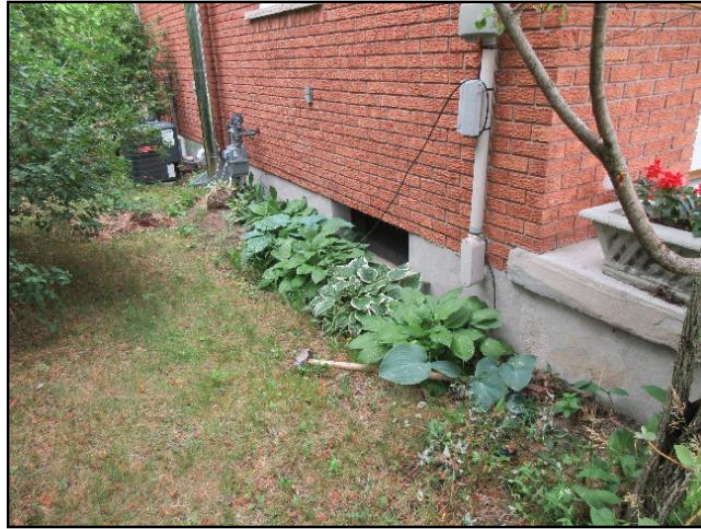
4. Condition: • Improper slope or drainage

Implication(s): Chance of water damage to structure, finishes and contents

Location: Front left corner

6. *Improper slope or drainage*

Task: Improve

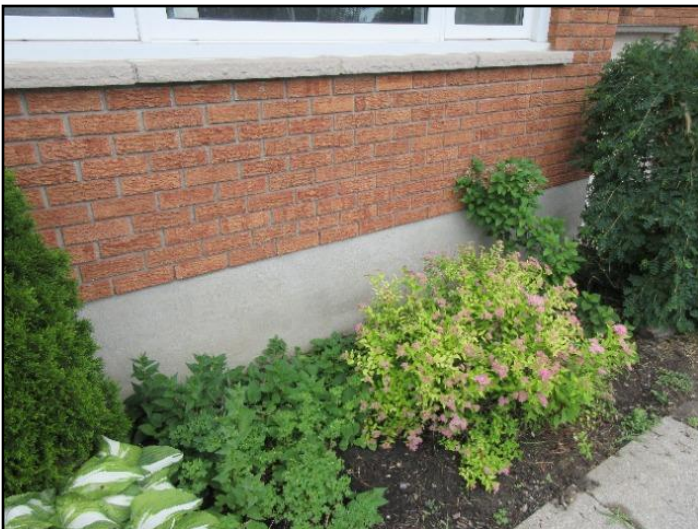
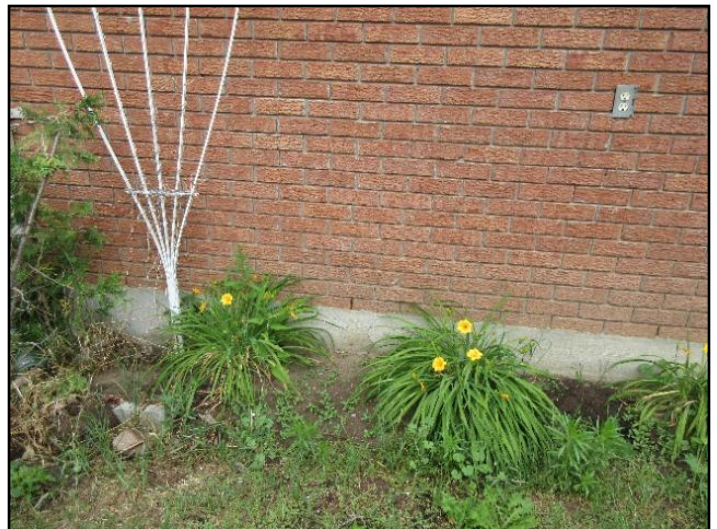
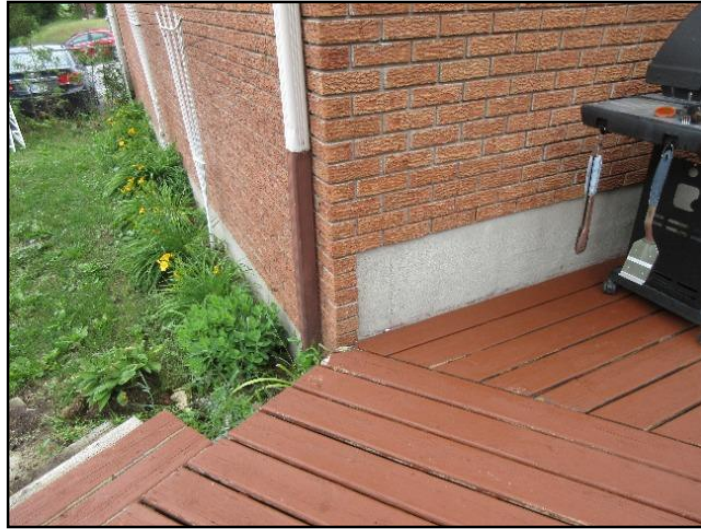
5. Condition: • Typical minor cracks

Implication(s): Chance of water entering building

7. Typical minor cracks

Task: Repair

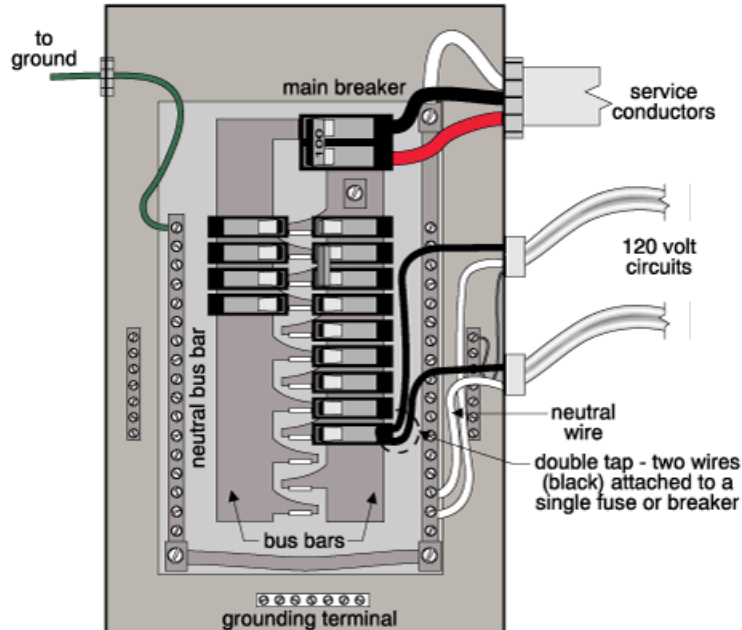
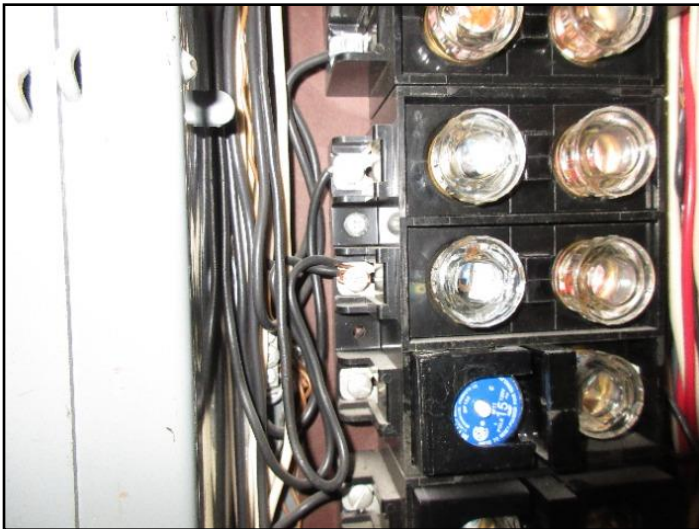
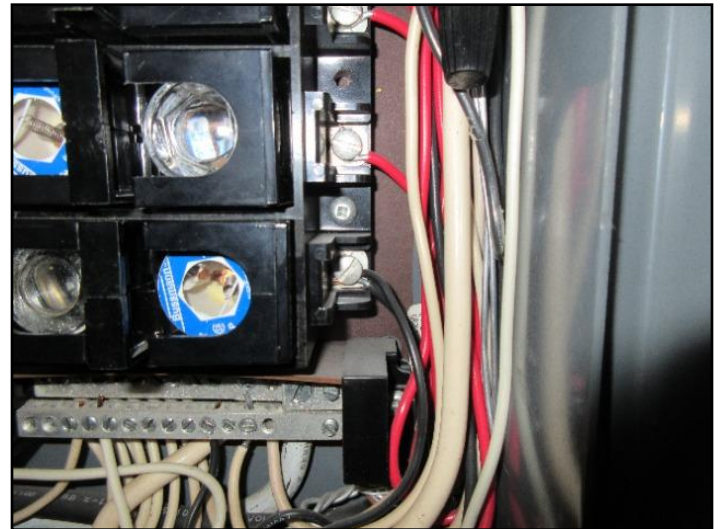
7. Condition: • Double taps

Implication(s): Fire hazard

Location: Distribution panels

14. Double taps

Task: Correct

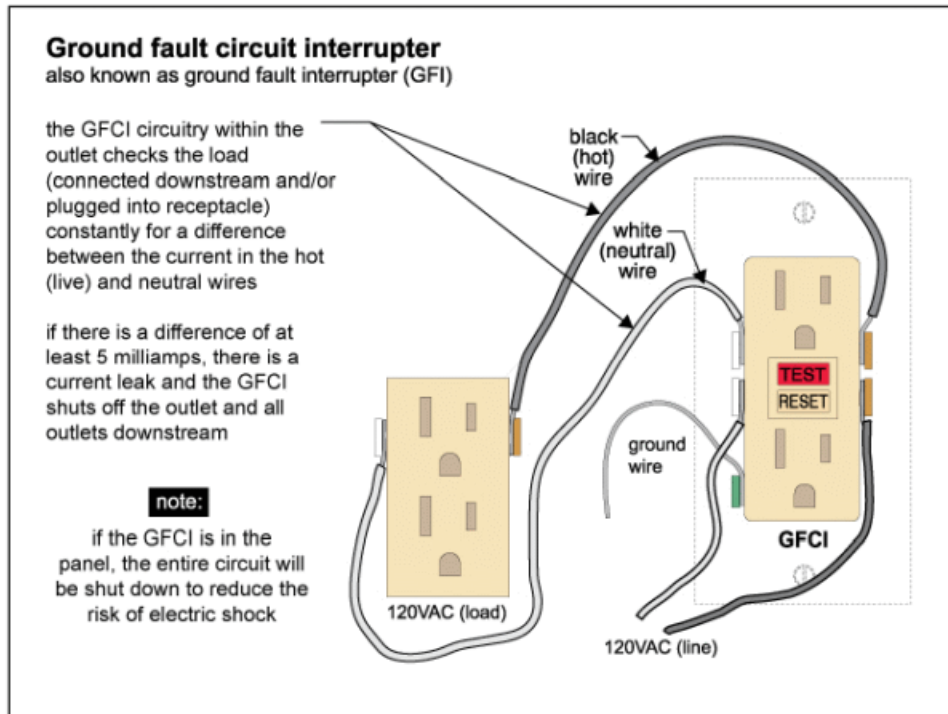
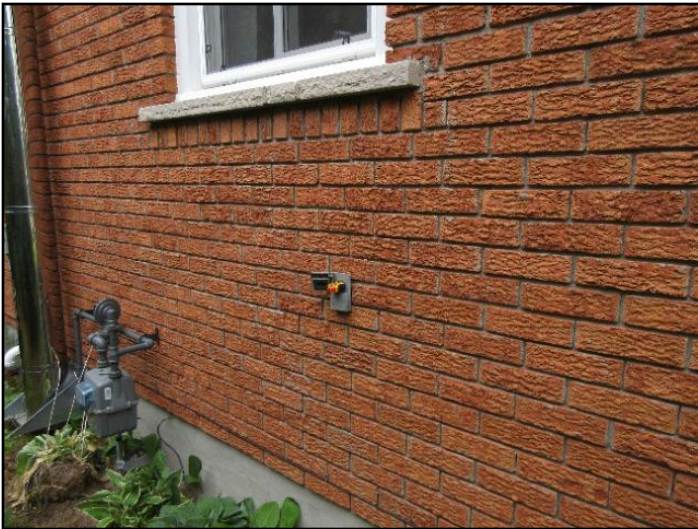
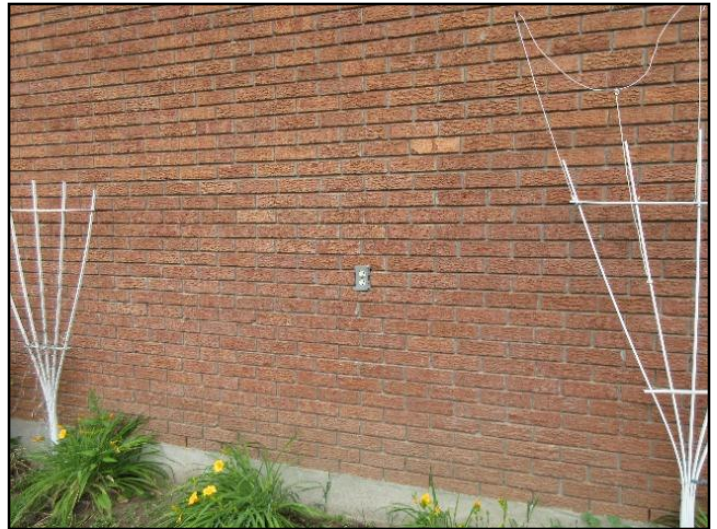
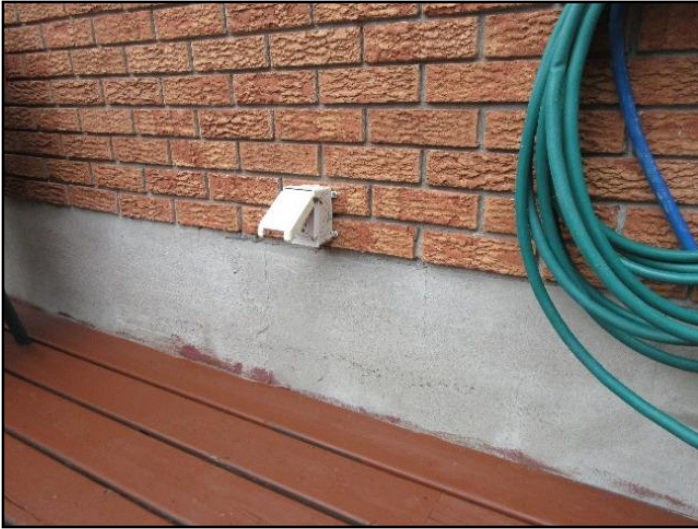
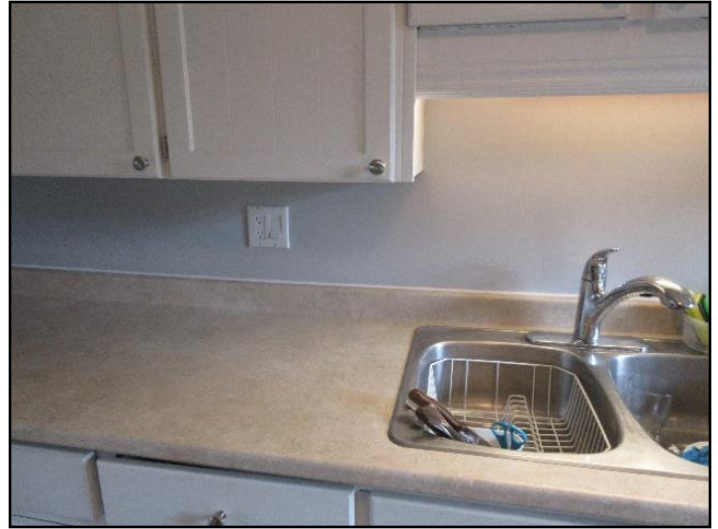
8. Condition: • No GFCI/GFI (Ground Fault Circuit Interrupter)

Implication(s): Electric shock

Location: Exterior & kitchen

16. No GFCI/GFI (Ground Fault Circuit...)

Task: Upgrade

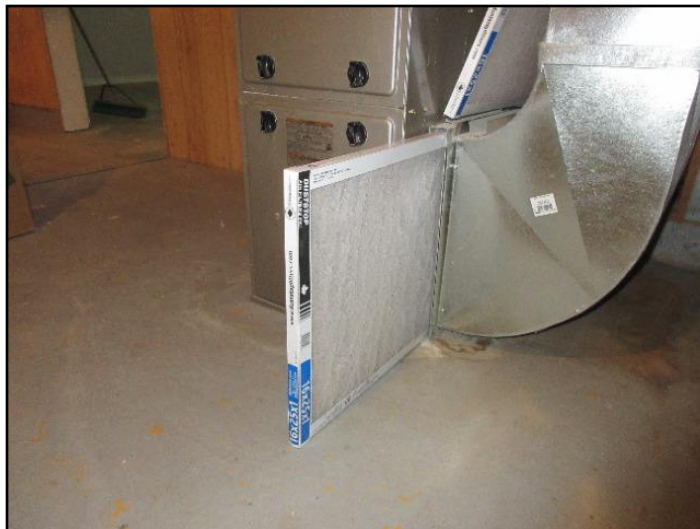
9. Condition: • Replace - regular maintenance

Implication(s): Increased heating & maintenance costs, Reduced comfort

Location: Cold air return

24. *Replace - regular maintenance*

Task: Replace

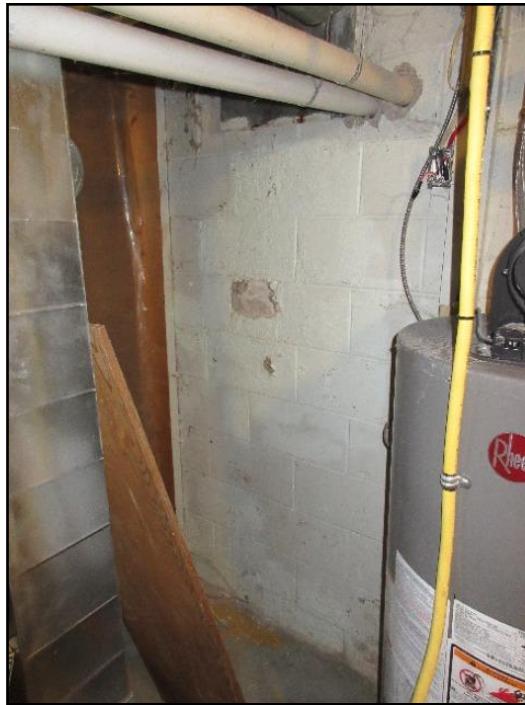
13. Condition: • Crumbling plaster, dry wall or concrete walls

Damage may be indicative of the poor exterior grading seen at this location

Implication(s): Chance of water damage to structure, finishes and contents | Material deterioration

31. Crumbling plaster, dry wall or concrete walls

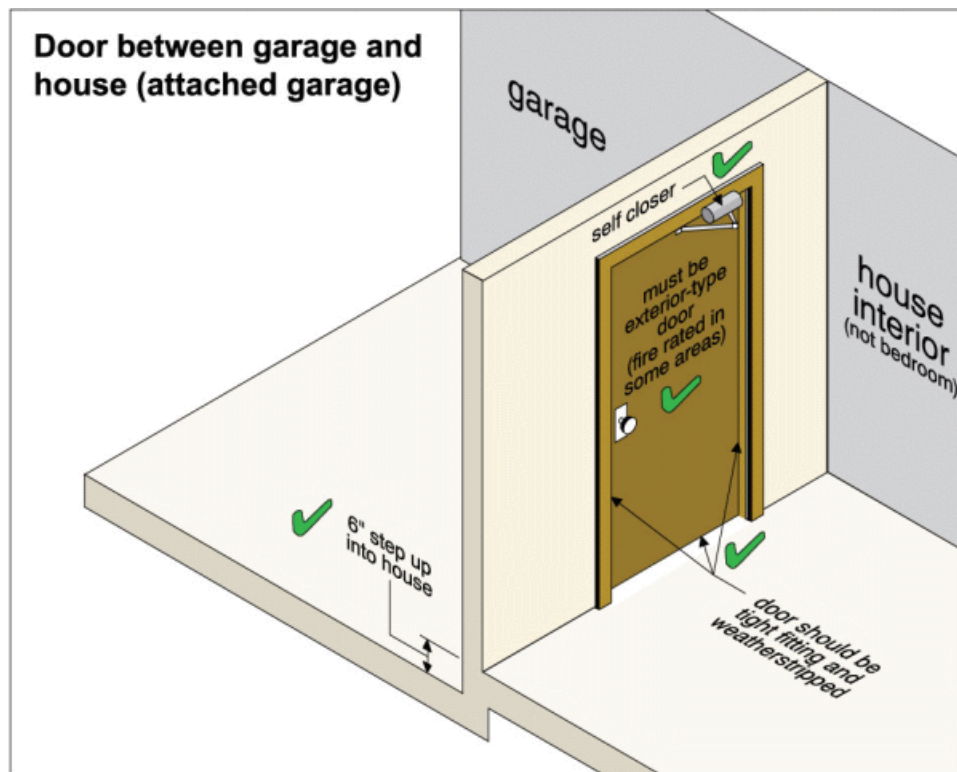
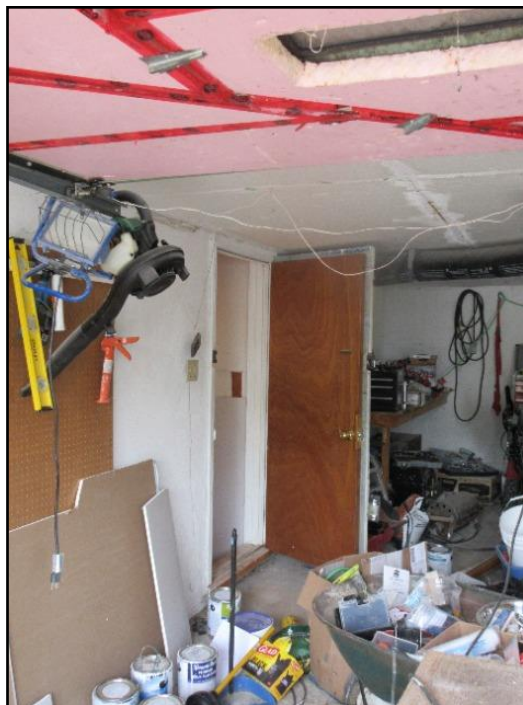
14. Condition: • No self closer

Implication(s): Hazardous combustion products entering home

32. No self closer
