INSPECTION REPORT

For the Property at:
42B SPRINGBROOK DRIVE
PETERBOROUGH, ON

Prepared for: TEAM VANRAHAN
Inspection Date: Saturday, May 1, 2021
Prepared by: David Sharman

RE: Report No. 3442
42B Springbrook Drive
Peterborough, ON

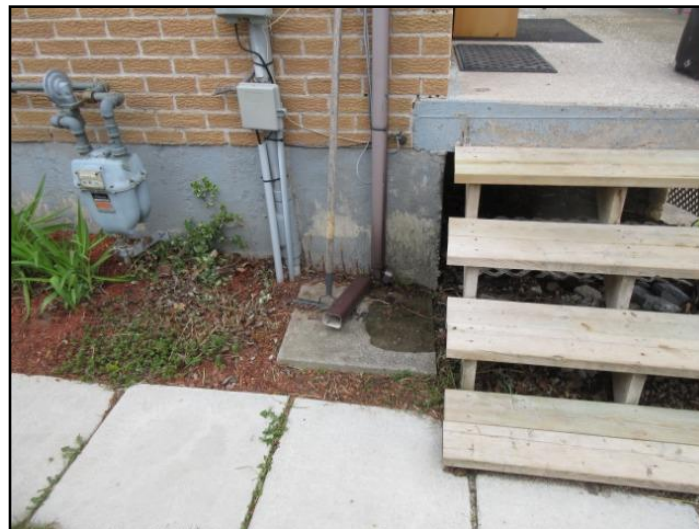
2. Condition: • Discharge too close to building

Implication(s): Chance of water damage to structure, finishes and contents

Location: Front left corner

3. Discharge too close to building

Task: Improve

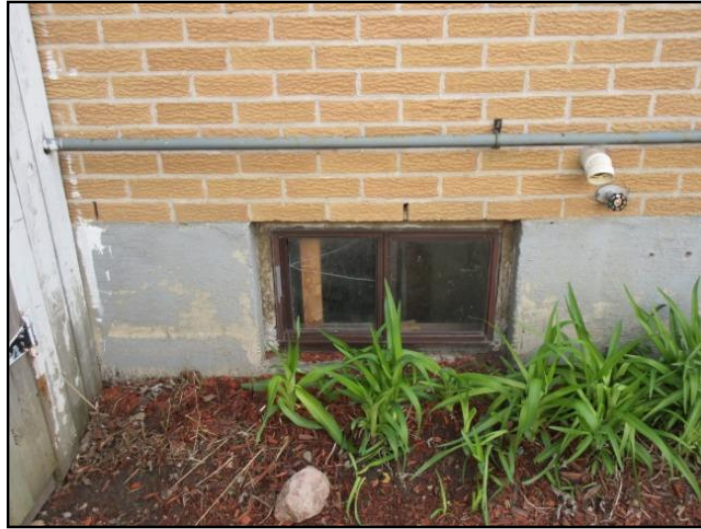
3. Condition: • Cracked

Location: Left elevation

4. Cracked

Task: Replace

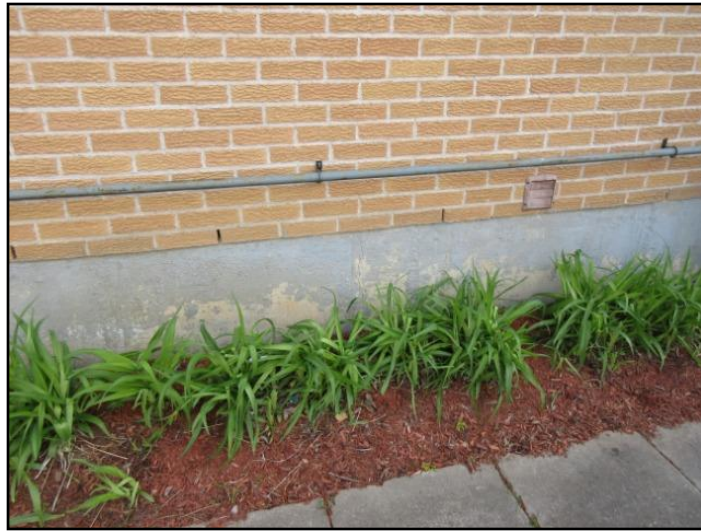
4. Condition: • Typical minor cracks

Implication(s): Chance of water entering building

Location: Left elevation

6. *Typical minor cracks*

Task: Seal & monitor

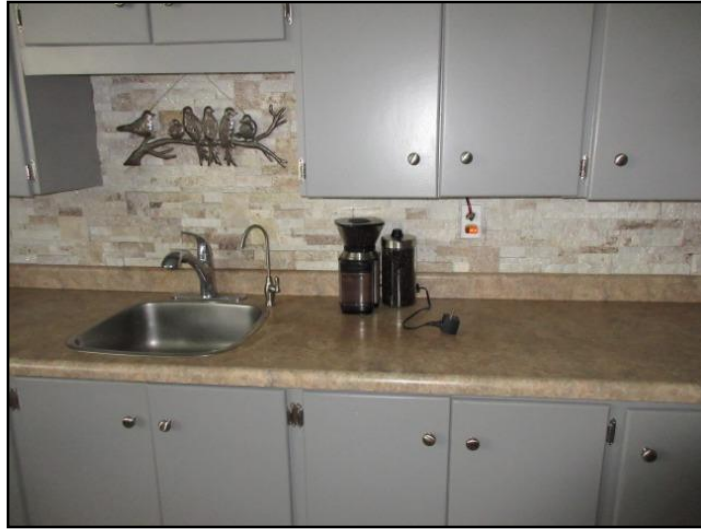
6. Condition: • No GFCI/GFI (Ground Fault Circuit Interrupter)

Implication(s): Electric shock

Location: Kitchen

10. No GFCI/GFI (Ground Fault Circuit...

Task: Upgrade

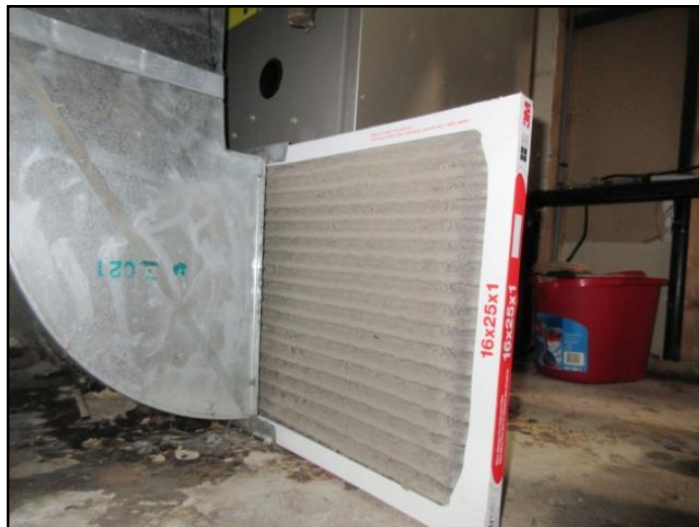
8. Condition: • Dirty

Implication(s): Increased heating costs | Reduced comfort

Location: Cold air return

14. Dirty

Task: Replace

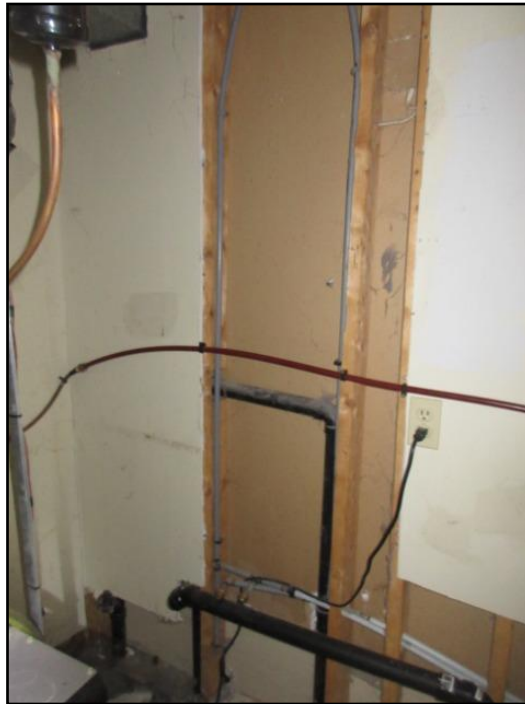
11. Condition: • Polybutylene

Implication(s): Chance of water damage to structure, finishes and contents | Leakage

Location: Basement

23. Polybutylene

Task: Monitor

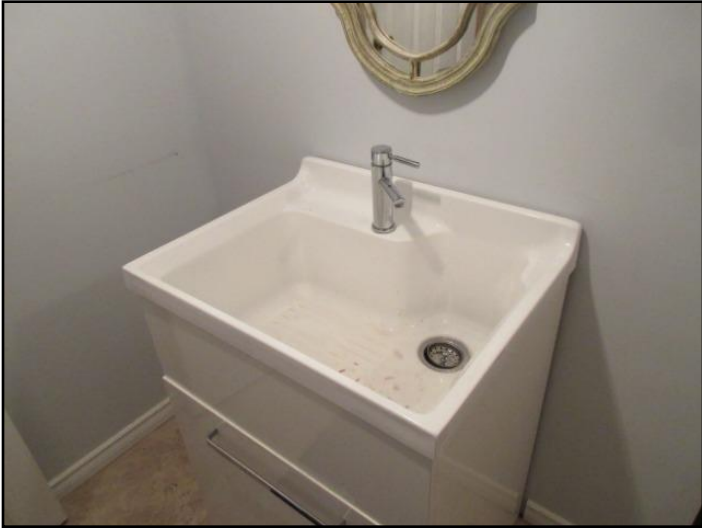
12. Condition: • Hot and cold reversed

Implication(s): Scalding

Location: Basement

24. Hot and cold reversed

Task: Correct

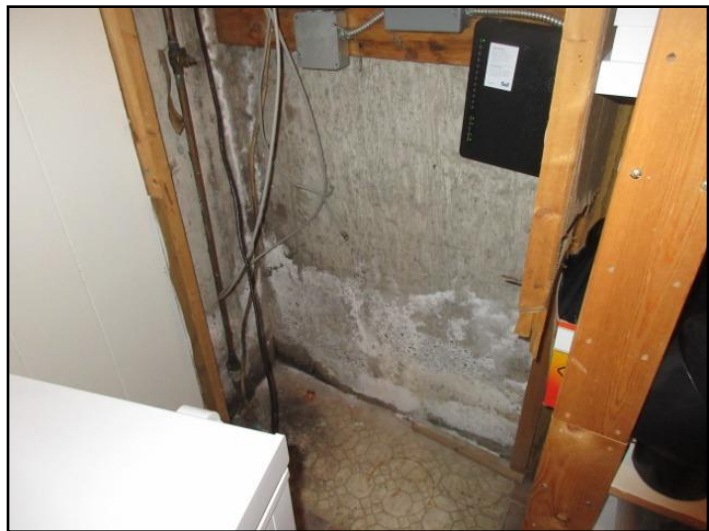
Efflorescence may be indicative of a poor downspout discharge at this location

13. Condition: • Efflorescence

Implication(s): Chance of water damage to structure, finishes and contents

25. Efflorescence

Task: Monitor
