INSPECTION REPORT

For the Property at:
607 LUDGATE STREET
PETERBOROUGH, ON K9H 2B9

Prepared for: TEAM VANRAHAN
Inspection Date: Thursday, March 24, 2022
Prepared by: David Sharman

RE: Report No. 3791
607 Ludgate Street
Peterborough, ON
K9H 2B9

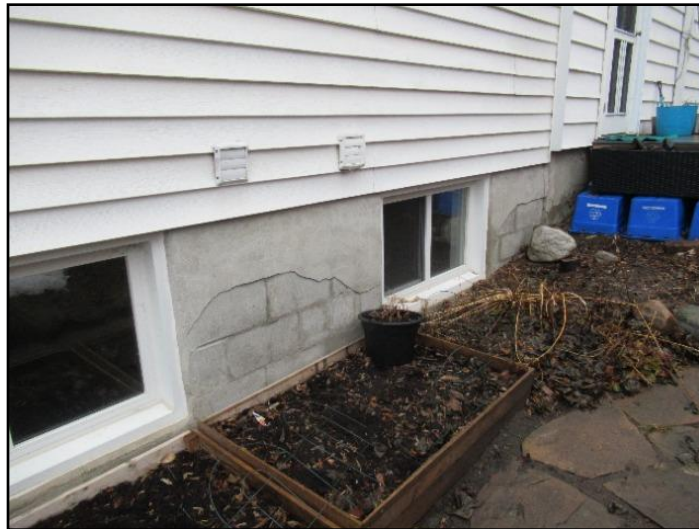
3. Condition: • Parging damaged or missing

Implication(s): Chance of damage to structure | Shortened life expectancy of material

Location: Left elevation

4. Parging damaged or missing

Task: Repair

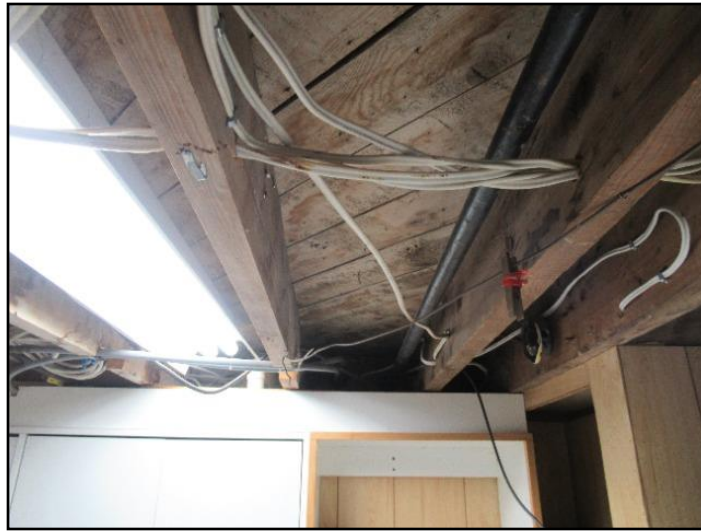
5. Condition: • Split or damaged

Implication(s): Weakened structure | Chance of structural movement

Location: Utility room

5. Split or damaged

Task: Repair

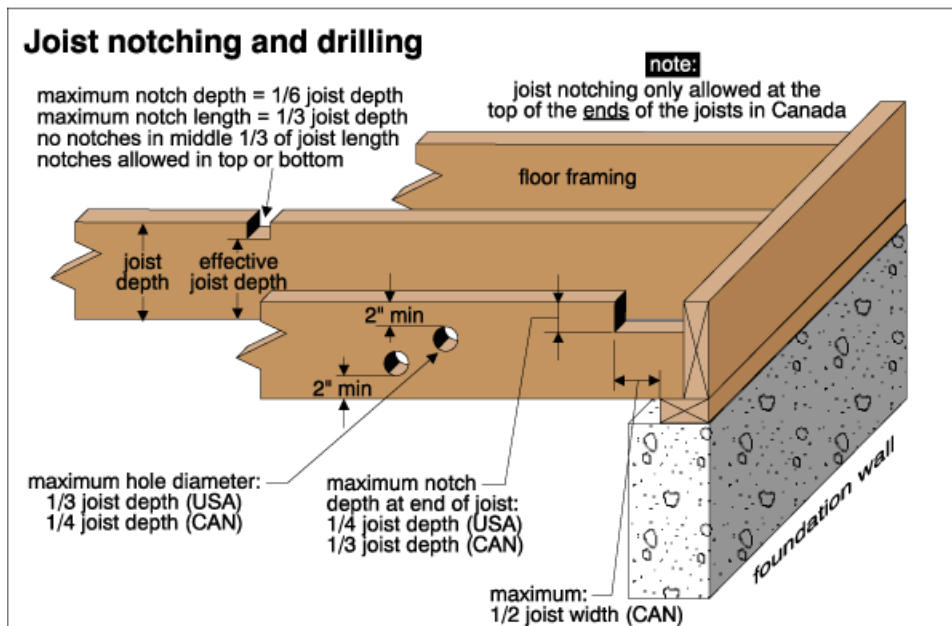
6. Condition: • Notches or holes

Implication(s): Weakened structure

Location: Utility room

Task: Monitor

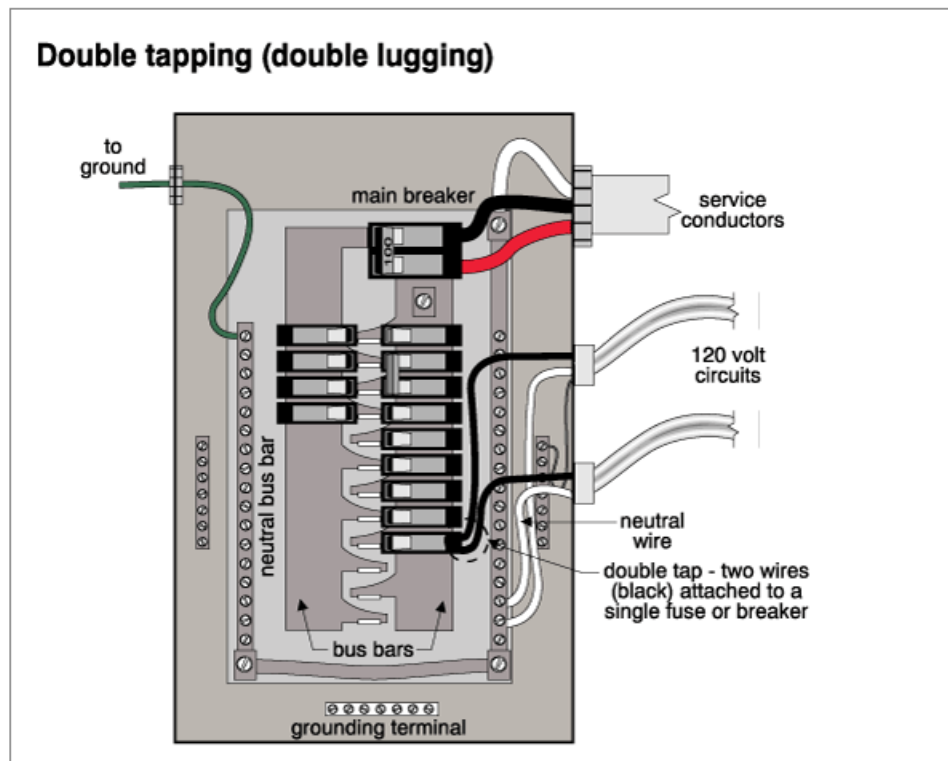
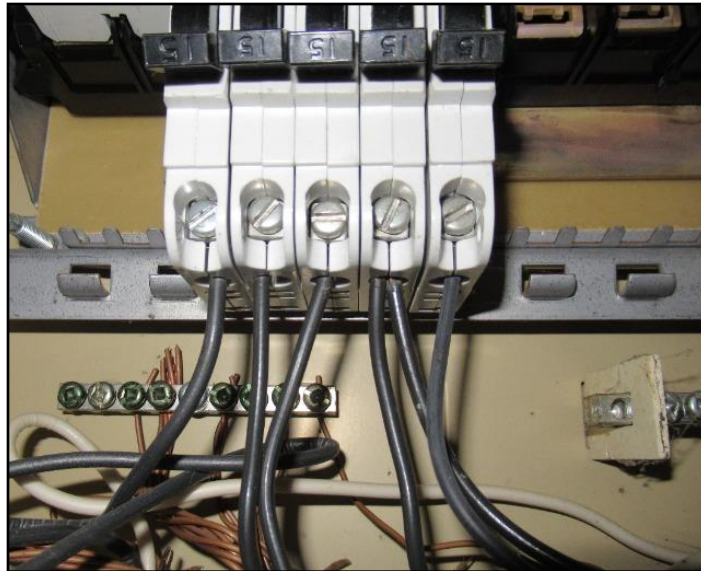
7. Condition: • Double taps

Implication(s): Fire hazard

Location: Distribution panel

10. Double taps

Task: Correct

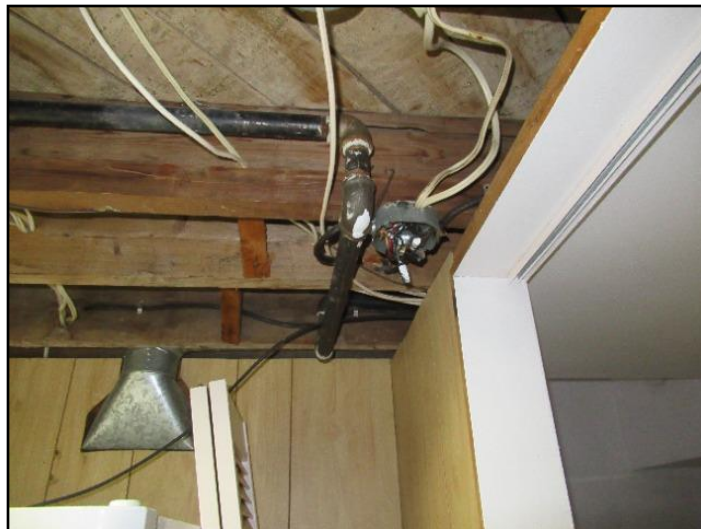
8. Condition: • Cover loose or missing

Implication(s): Electric shock | Fire hazard

Location: Utility room

11. Cover missing

Task: Replace

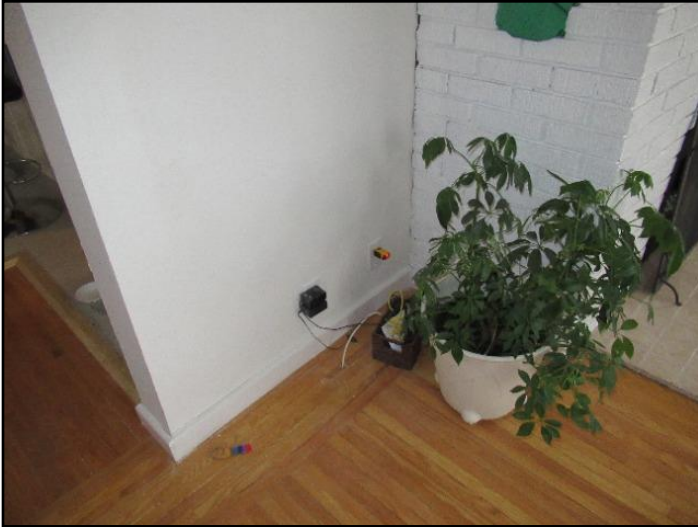
9. Condition: • Ungrounded

Implication(s): Electric shock

Location: Living room

12. Ungrounded

Task: Upgrade

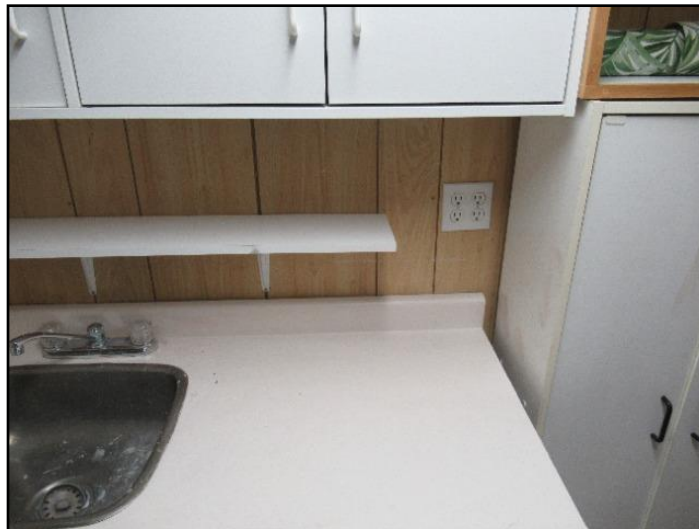
10. Condition: • No GFCI/GFI (Ground Fault Circuit Interrupter)

Although not a deficiency in a home of this age, safety may be improved by upgrading this receptacle

Implication(s): Electric shock

Location: Utility room

16. No GFCI/GFI (Ground Fault Circuit...

Task: Upgrade

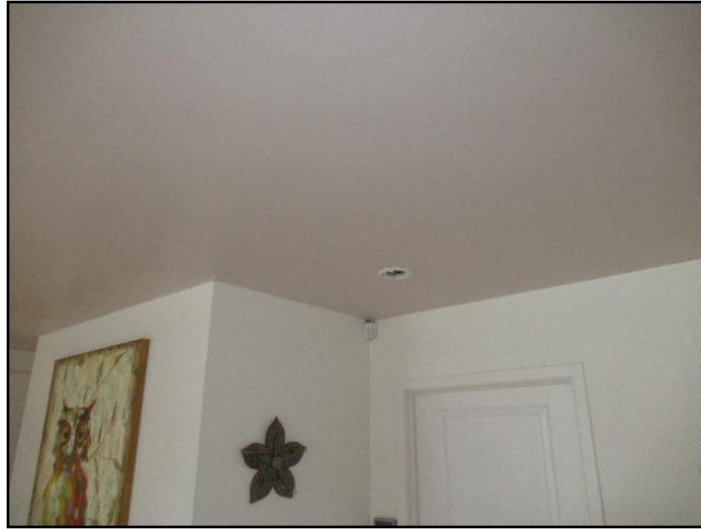
11. Condition: • Missing

Implication(s): Safety issue

Location: Family room

17. Missing

Task: Replace

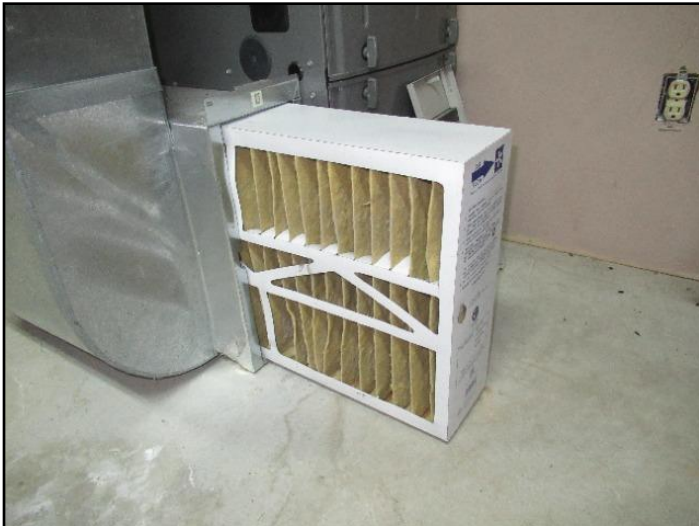
12. Condition: • Replace - regular maintenance

Implication(s): Increased heating & maintenance costs, Reduced comfort

Location: Cold air returns

29. Replace - regular maintenance

Task: Replace

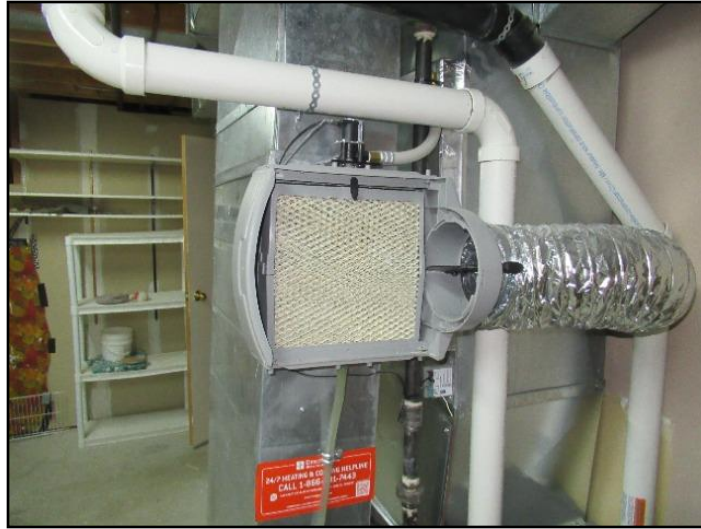
13. Condition: • Clean pad/mesh - regular maintenance

Implication(s): Equipment not operating properly

Location: Unit interior

31. Clean pad/mesh - regular maintenance

Task: Clean

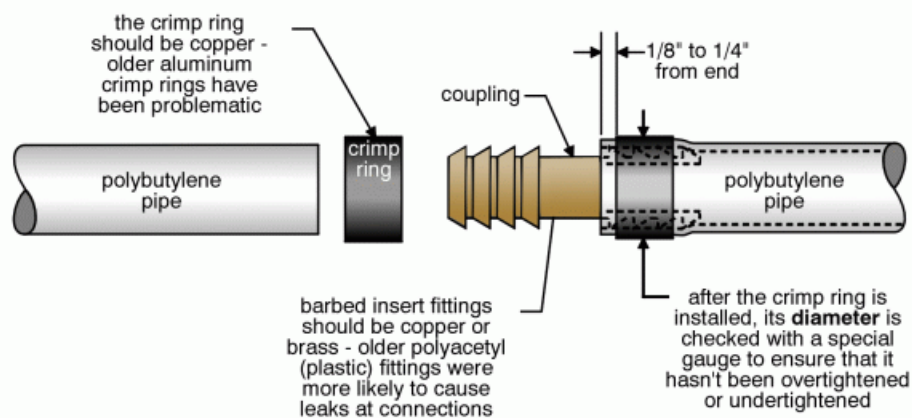
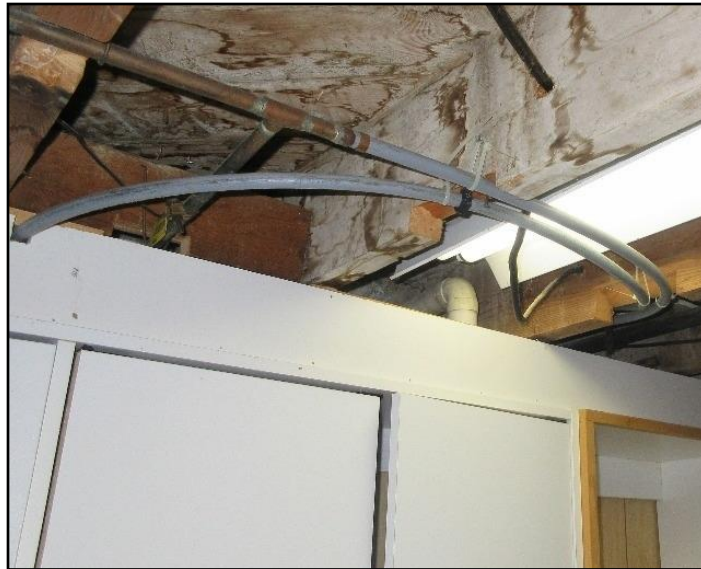
16. Condition: • Polybutylene

Implication(s): Chance of water damage to structure, finishes and contents | Leakage

Polybutylene pipe - crimp fitting

39. Polybutylene

Time: Ongoing
