Key Home Inspections, Inc.
5000 Yonge Street Suite 1901
North York, Ontario M2N 7E9
Inspector: Enio Ferri RHI

Property Condition Report

43 Garden Market Mews
Toronto, Ontario

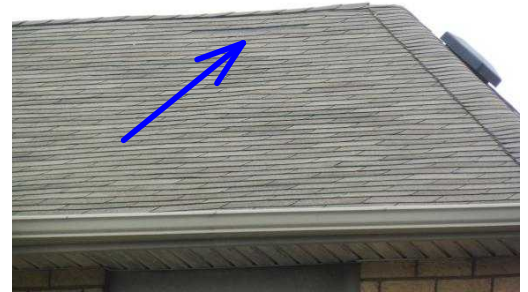
1. Main Roof Surface Material: Fiberglass shingle - Missing shingle is noted at the front area of the roof, repairs are needed.

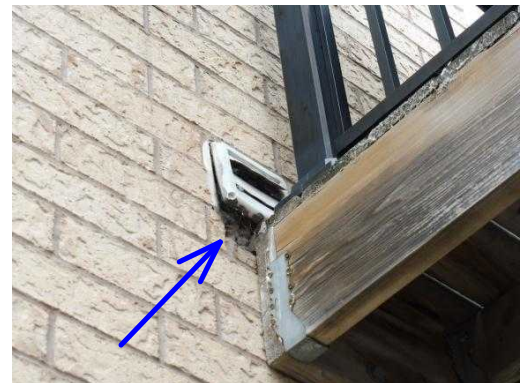
2. Wall Flashing Preformed Metal - Dryer vent cover is loose, repair the vent is recommended.

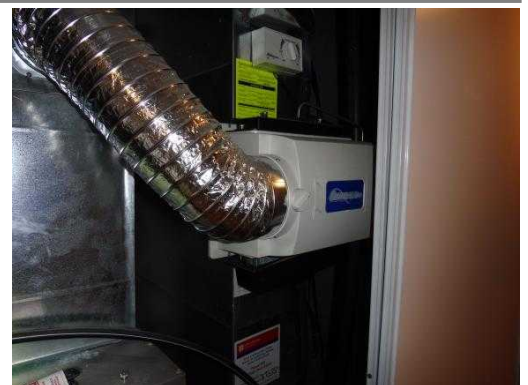
3. Basement Heating System Humidifier: Cascading duct by pass
- - Motor inoperative, repairs or replacement is recommended.

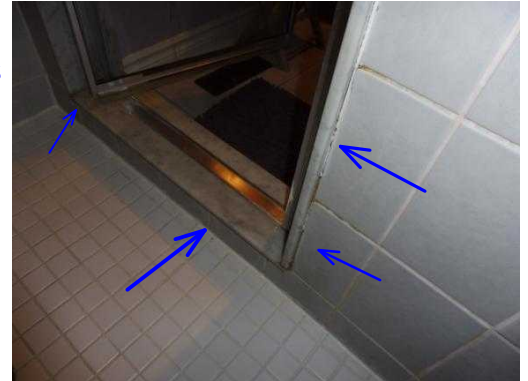
4. Master Ensuite Bathroom Shower/Surround: Tile surround - High moisture was detected in the lower section of the shower stall, this appears to be related to poor grouting and caulking. Re grout & caulk the area is recommended to prolong the life of the shower stall, however underlining damage may exist.

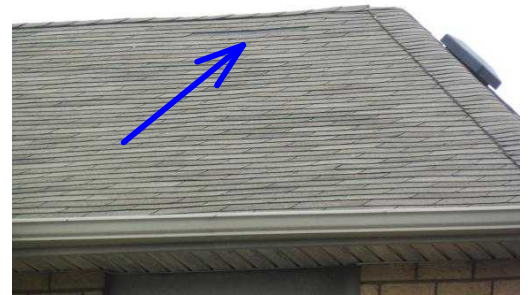
1. ☐☐☒☐ Material: Fiberglass shingle - Missing shingle is noted at the front area of the roof, repairs are needed.

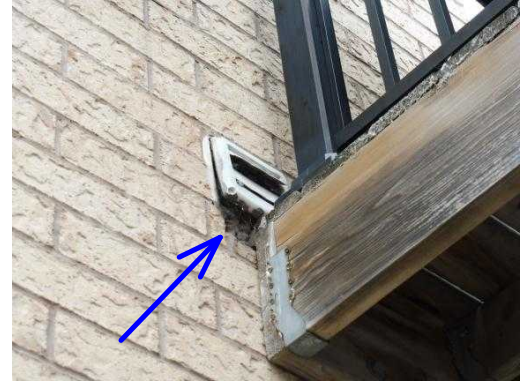
4. ☐☐☒☐ Wall Flashing Preformed Metal - Dryer vent cover is loose, repair the vent is recommended.

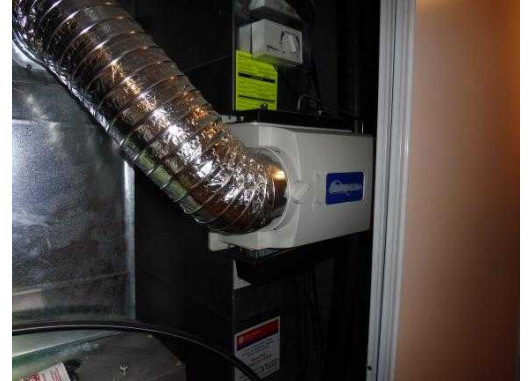
18. ☐☐☒☐ Humidifier: Cascading duct by pass - - Motor
inoperative, repairs or replacement is recommended.

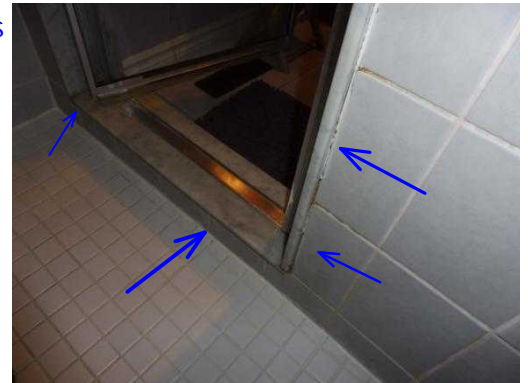
14. ☒ ☐ ☐ ☐ Ceiling: Drywall/Plaster
15. ☒ ☐ ☐ ☐ Walls: Drywall/Plaster
16. ☒ ☐ ☐ ☐ Floor: Tile
17. ☒ ☐ ☐ ☐ Doors: Hollow wood
18. ☒ ☐ ☐ ☐ Windows: Good condition
19. ☒ ☐ ☐ ☐ Electrical: 110 VAC GFCI
20. ☒ ☐ ☐ ☐ Counter/Cabinet: Good Condition
21. ☒ ☐ ☐ ☐ Sink/Basin: Good Condition
22. ☒ ☐ ☐ ☐ Faucets/Traps: Fair Condition
23. ☐ ☐ ☒ ☐ Shower/Surround: Tile surround - High moisture was detected in the lower section of the shower stall, this appears to be related to poor grouting and caulking. Re grout & caulk the area is recommended to prolong the life of the shower stall, however underlining damage may exist.
