Detecting and Diagnosing a Rotor Design Weakness on New Hydrogenerators

Machine Data

Commissioning: 1999 Nominal Air Gap: 11 mm/0.433 in. Turbine Type: Bulb / Kaplan Bearing Layout: Generator Guide
 Power: 42 MW Stator Bore Dia.: 6.45 m/253.94 in. Nbr Blades: 4 Turbine Guide
 Speed: 112.5 rpm

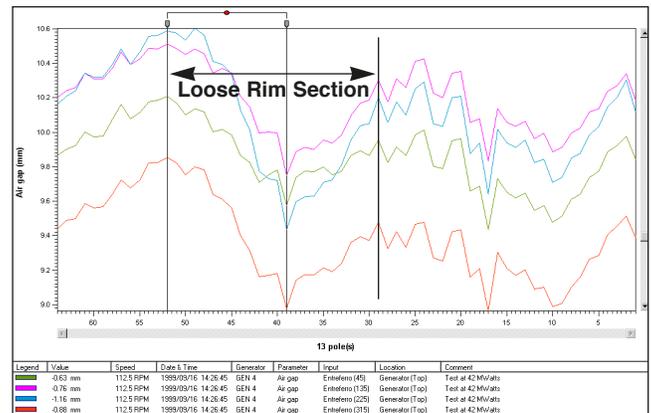
While at site to complete installation and commissioning of the ZOOM system, VibroSystM technician and the plant supervising engineer reviewed data acquired by the system on the other machines. They found an irregularity in the air gap results of one unit. At Full Load, the air gap sensors were measuring different rotor shapes (Figure 1). Sensor at 225° angle (bottom) was providing the most dramatic result. Comparison of each sensor at different operating conditions, ranging from Speed No Load (SNL) to Full Load (FL) demonstrated a transient bump between poles #29 and #52 resulting from a loose section of the rotor rim (Figure 2).

Figure 1: Signature graph of generator at Full Load showing a significant variation for the sensor at 225° (blue curve) between poles #29 and #52.

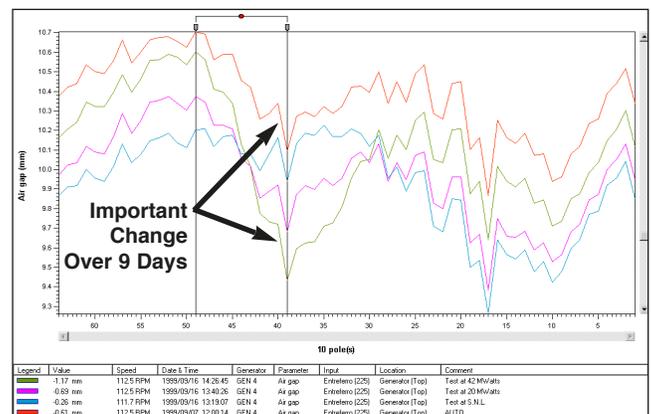
Figure 2: Signature graph of rotor profile at various operating conditions facing sensor at 225° and comparison with result 9 days earlier.

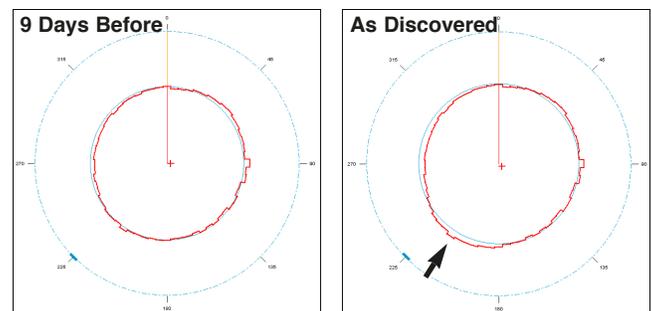
With gravity helping, the loose rim section protruded into the air gap when rotating towards the bottom, then returned to its position when passing at the top (Figure 3). This cyclic flexing was imposing stress on the rotor rim components. The maximum bump amplitude (most critical air gap) occurred when rotor pole #39 passed in front of the sensor at 225° angle. Comparing these results with data recorded at Full Load nine days before clearly showed that the situation was deteriorating very quickly and that a failure could potentially occur at any time.

Figure 3: Polar graphs of rotor profile 9 days apart measured by sensor at 225° (right) angle. Note the bump protrusion in the area between poles #29 and #52.

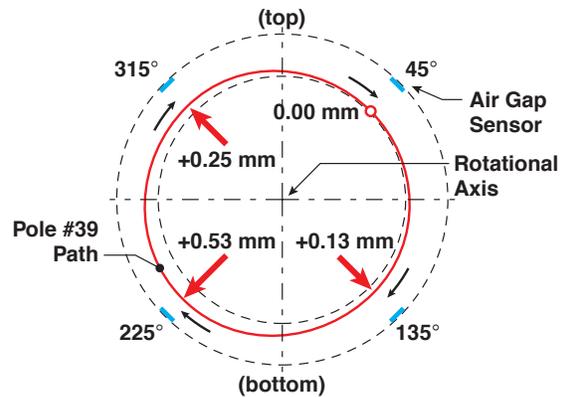
The engineers found the rotor rim and rotor-to-spider attachments in much worse condition than the unit that sustained the first incident. Several bolts broke during percussion tests. The cyclic imbalance overstressed the bolts, thus further loosening the rim.

Figure 4: Illustration of pole #39 (most critical of the loose section) path over one rotation relative to its position facing sensor at 45°.

A detailed generator design review was performed and modifications were implemented on all five machines. The compression bolts were replaced by ones with higher elasticity and the rotor rim-to-spider interface strengthened. Rotor performance is now systematically monitored and air gap alarms have been fine-tuned to effectively warn of air gap loss. No abnormal changes have been detected since and the machines behave within set guidelines.
