Concrete Expansion – R.H. Saunders GS Innovative Structural Rehabilitation & Mitigation Effectiveness

*Keith T. Eastman, Ontario Power Generation, Cornwall, ON, Canada
John Deans, Kinectrics, Toronto, ON, Canada, and
Edward S. Li, Ontario Power Generation, Cornwall, ON, Canada*

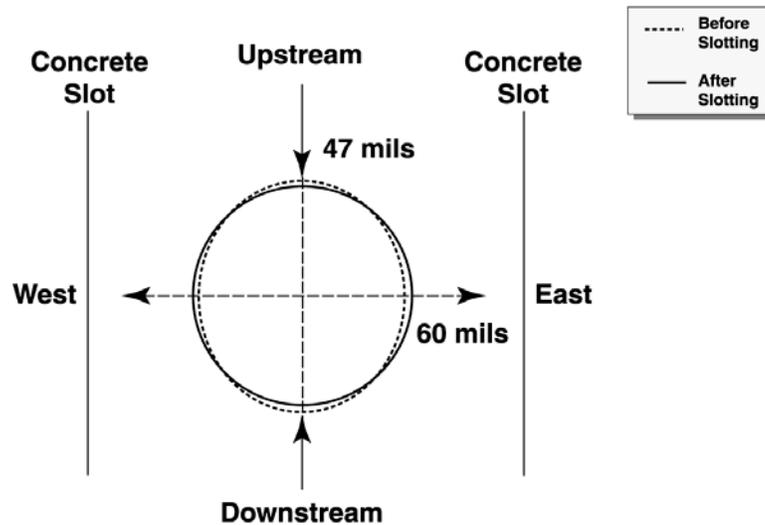
Figure 3 - Diametrical change in runner clearance

The immediate response of concrete slotting was beneficial. Re-establishment of the expansion/contraction joints resulted in reduced longitudinal compressive stresses in the concrete and partial rounding of the throat ring liners. The average diametrical runner clearance decreased 47 mils in the transverse direction and increased 60 mils longitudinally as predicted by the analytical model. See Figure 3.

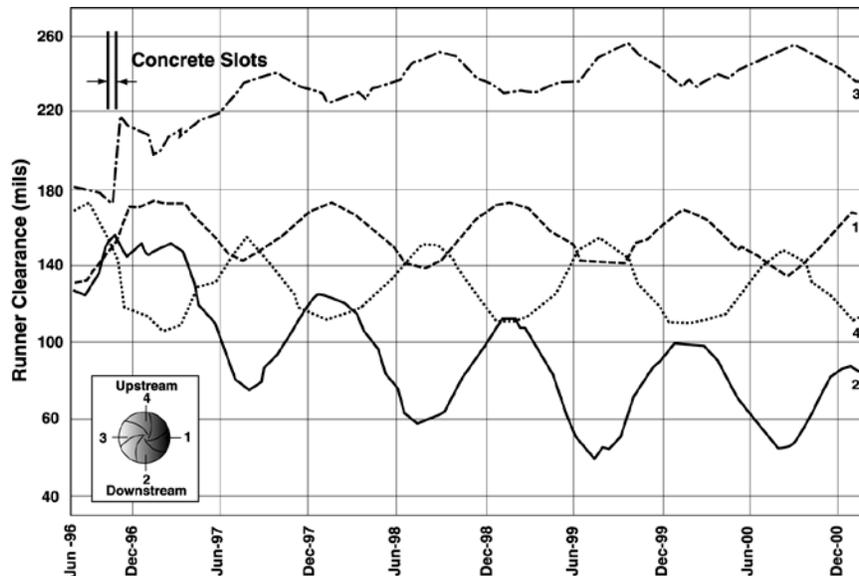
Subsequent to the slotting program, however, the runner clearances have decreased, in the vicinity of the downstream proximity probes, at a rate of 10 mils/year. See Figure 4. This is due to the continued relief of longitudinal compressive stresses. It is expected that this trend will reverse once the compressive stresses due to continued concrete expansion overcome the temporary relief provided by the contraction joint slots.

Figure 4 – Runner clearance – 10 mils/year decrease (downstream)

Since concrete expansion continues at R.H. Saunders GS, the slots were designed to accommodate future concrete expansion without the need to re-slot the joints for at least ten years.

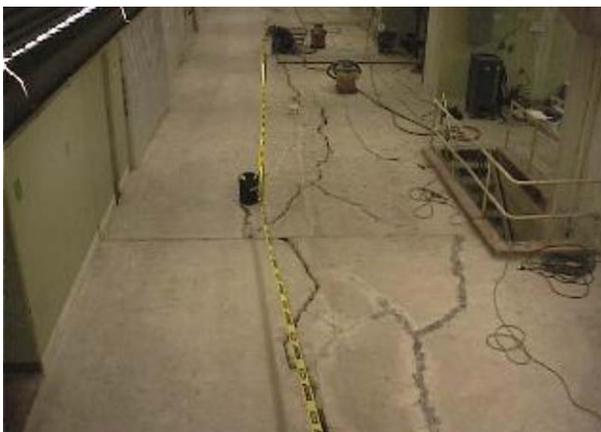
Figure 5 - Tile and mortar bed removed exposing extensive cracking of underlying concrete

An assessment of the generator floor condition revealed that over 60% of the ceramic tiles had debonded from the underlying mortar bed and many tiles were damaged. In addition, 60% of the mortar bed had debonded from the underlying concrete and was found to be friable and damaged. Separation of the suspended slab along the mass concrete interface (i.e. bearing area) resulted in extensive cracking of the concrete, which contributed to failure of the tile floor system as illustrated in Figure 5. As a result, it was decided to replace the ceramic tiles and mortar bed.

Analysis of the failure mechanisms identified the need to isolate the new flooring system from the main concrete structure to allow for future concrete expansion.

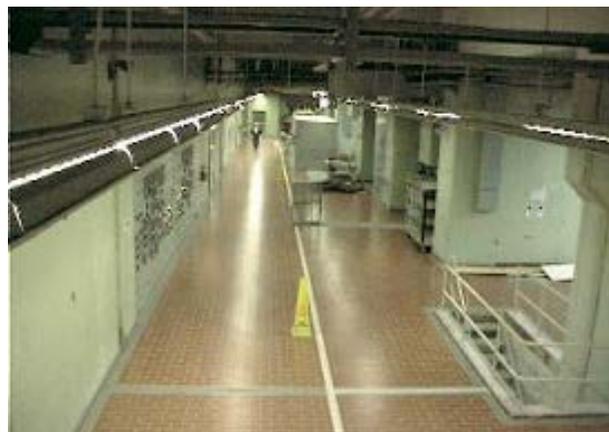
Figure 6 - New generator floor

After assessing each system and experimenting with the epoxy-based systems, the existing floor was replaced with a new mortar bed and ceramic tiles. This was the most practical and cost effective option. The new floor is shown in Figure 6.

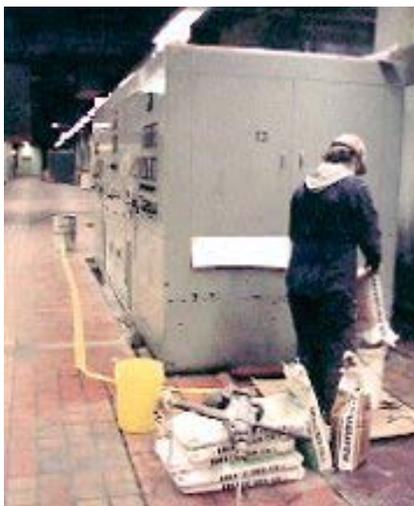
The governor cabinet concrete supports had been severely damaged due to concrete movement. Lateral movement (up to $\frac{3}{4}$ in.) caused severe cracking and spalling of the concrete. Repairs entailed the removal and replacement of the damaged concrete, addition of new steel column supports with sliding Teflon pads to accommodate future movement and extensive structural grouting of numerous fractures in the concrete. See Figures 7 and 8. Post tensioning of the existing reinforced concrete columns was undertaken. These solutions were implemented based on ease of construction, space restrictions and operating requirements

Figure 7 - Preparing to grout around a governor cabinet

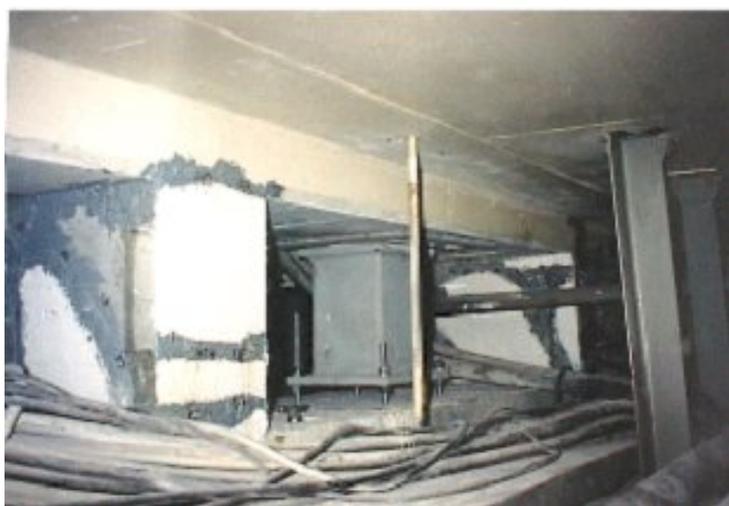
Figure 8 - Structural grouting of columns and new steel column support

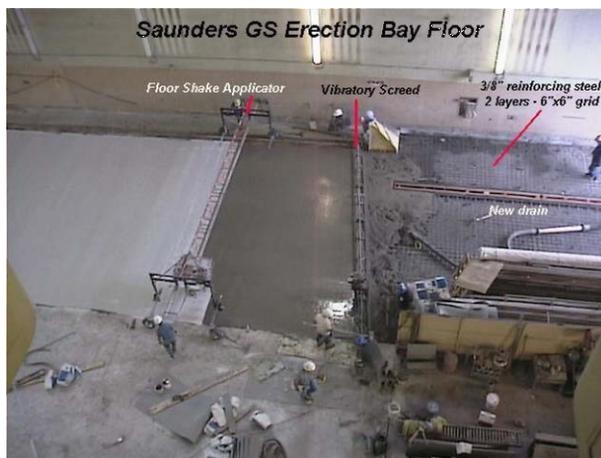
Over 90% of the ceramic floor tiles had debonded from the underlying mortar and numerous tiles had been damaged. The mortar bed had also been damaged and the topping slab was found to be intact.

Figure 9 - Erection bay floor replacement

Since the floor area is exposed to heavy traffic a new reinforced concrete slab and coloured floor shake hardener were installed. Expansion/isolation joints were installed around the perimeter of the floor area to create isolation and accommodate future movements in the floor. A 4,000 psi non-air entrained concrete containing water reducing and super plasticizing admixtures was used to increase workability during placement. Control joints were installed along both directions of the floor slab and where obstructions existed along the floor area. Both the control joints and existing expansion/contraction joints were filled with flexible epoxy and polyurethane sealant. See Figures 9 and 10.

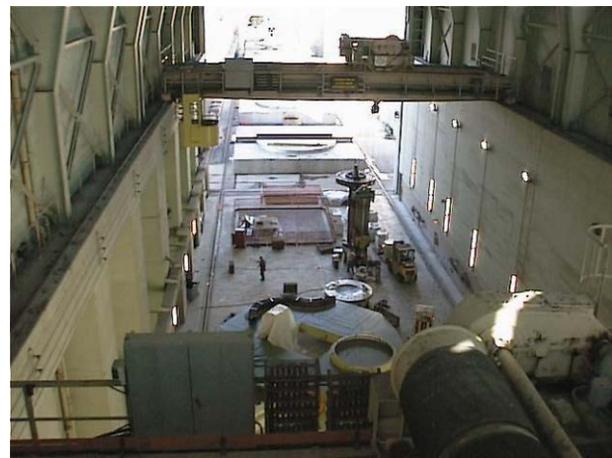
Figure 10 - New erection bay floor

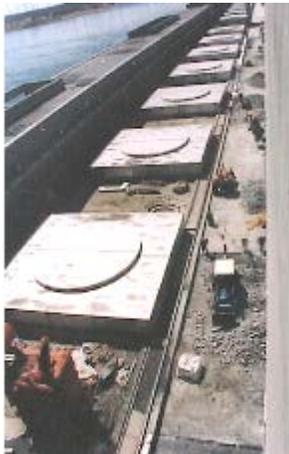
Concrete deterioration was most extensive along the generator roof deck roadway. Thus, the entire topping slab required removal. See Figure 11. The condition of the existing topping slab along the walkway and laydown areas varied necessitating different rehabilitation methods. In areas of significant deterioration, the topping slabs were removed and replaced. Where localized damage and cracking were evident, the topping slabs were repaired. New waterproofing membranes were installed along the entire generator roof deck. New concrete topping slabs were placed along the entire roadway and several laydown areas. The new topping slabs consist of 4,000 psi fibre-reinforced designed concrete. See Figure 12.

Figure 11 - Generator roof deck roadway and laydown area concrete removal

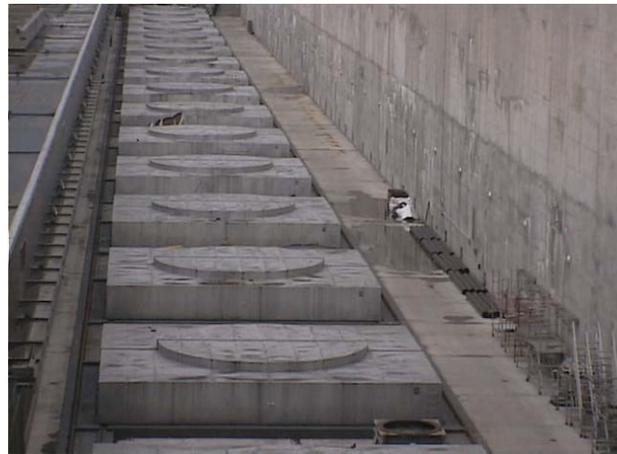
Figure 12 - New generator roof deck roadway, laydown areas and walkway

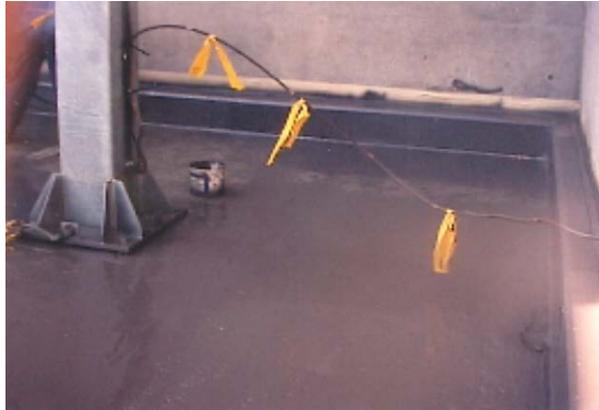
Previous inspections of the bays indicated that the liners were no longer completely water tight due to local cracking and deterioration of the concrete and joint sealant.

Figure 13 - Transformer bay oil containment liner

The repair consisted of local patching of the concrete, replacement of the existing deteriorated joint sealant, surface preparation of the concrete by sandblasting methods and application of a two-component polysulphide base coating. This material was selected as a result of its chemical and UV resistance, and flame retardant and crack bridging characteristics. It provides oil resistance and a leak-proof barrier to transformer oil in the event of a transformer oil spill. The coating also provides a protective layer over the concrete reducing the rate of deterioration and extends the life of the concrete structure. See Figure 13.

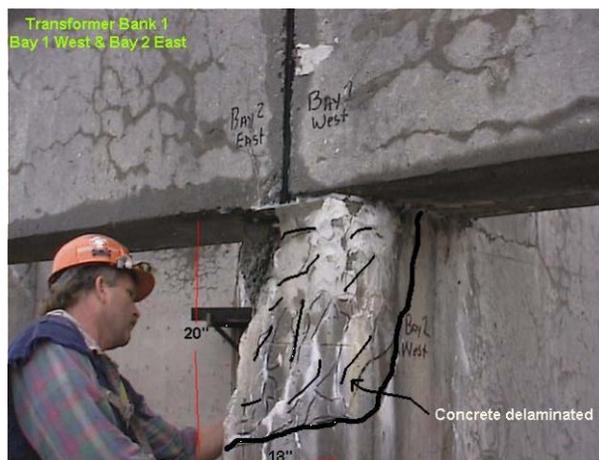
Reinforced concrete beams span the front of each transformer bay supported by fire separation walls. The sections of the beams within the wall bearing support area had sustained damage due to concrete movement and freeze-thaw action. The damage consisted of reduced beam bearing area, loss of reinforcing steel concrete cover, spalled and delaminated concrete, and fractures in the concrete accelerated by water infiltration. See Figure 14.

Figure 14 - Beam bearing area delaminated concrete

- Removal and replacement of all deteriorated concrete and joint sealant,
- Installation of steel knee brackets and post-tensioned anchors to provide additional bearing support for the transformer bay beams,
- Structural repair of major fractures in the concrete by epoxy grouting.

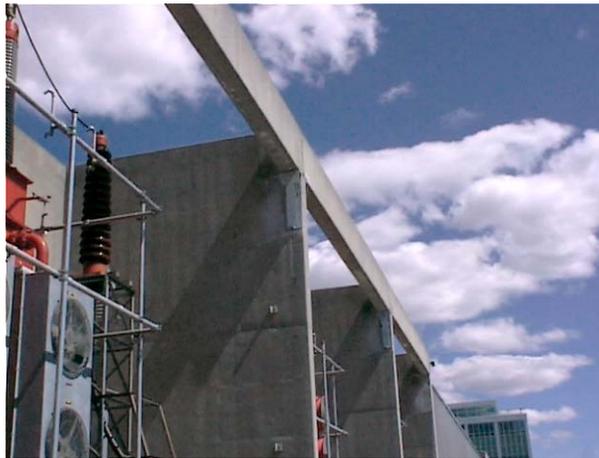
Figure 15 - Transformer bay beams and new steel brackets

A silane-based water proofing sealer was also applied to the beams to extend their life. See Figure 15.
