# The Safety Aspects of The Highland Council's Practice of Placing Small Wind Turbines in School Playgrounds

## A Review by Stuart Young Consulting on behalf of Caithness Windfarm Information Forum

Stuart Young Consulting has been asked to review THC's risk assessment and mitigation measures for Castletown Primary School, being a representative sample of the installations.

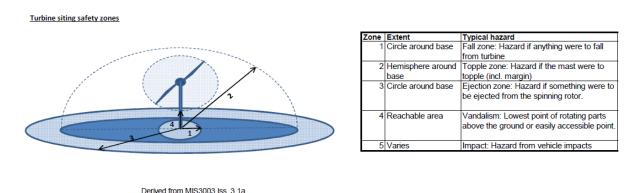
### **Turbine site safety zones**

Five zones have been identified around the wind turbines, the first three of which are relevant to this review:

- 1. A Fall Zone. It is difficult to imagine when a falling object might create a hazard other than when maintenance is being carried out, and that risk will be managed by the contractor carrying out the maintenance.
- 2. A Topple Zone. This zone has a radius equal to the height of the turbine. The risk to persons is very slight indeed because the wind conditions which might cause a turbine to topple unexpectedly will be such that no person is likely to be around. There could be a situation where toppling occurred at the end of a period of instability, but that condition would be obvious and one could expect exclusion zones to be established before there was an immediate safety risk.
- 3. An Ejection Zone. The extent of this zone is variable. The worst case scenario of a small part or component being ejected under differing wind speed conditions can be calculated.

In fact, it is not a decision which needs to be made nor indeed should be made. The solution is simple. Calculate and apply exclusion zones. The risk to be assessed becomes:

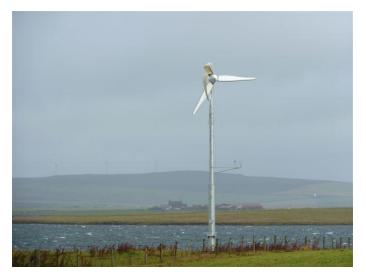
Photograph of a severely damaged turbine taken at Finstown, Orkney on 14<sup>th</sup> September 2012

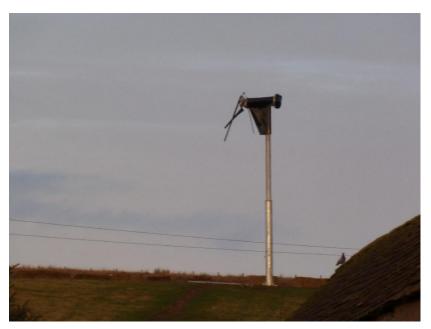
Photograph of a severely damaged turbine taken at Oust in Caithness in January 2013

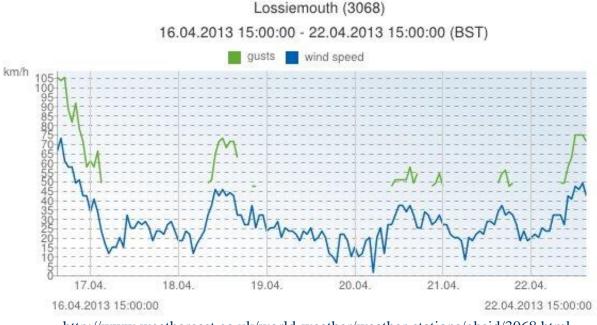
No consideration has been given to gusting. A review has been carried out of the wind speed record at Lossiemouth on 16<sup>th</sup> April 2013, the day the turbine in Aberdeenshire was severely damaged. This is reproduced below.

This shows that gusts can be 50% and more above underlying wind speeds, which suggests that an action trigger wind speed of 50mph would be more appropriate at Castletown Primary, particularly as gusts cause most damage, compared to constant wind speeds.
