STAFF REPORT

NEW BEDFORD HISTORICAL COMMISSION MEETING

CASE # 2018.28: CERTIFICATE OF APPROPRIATENESS

22 Hamilton Street (Map 53 Lot 183D)

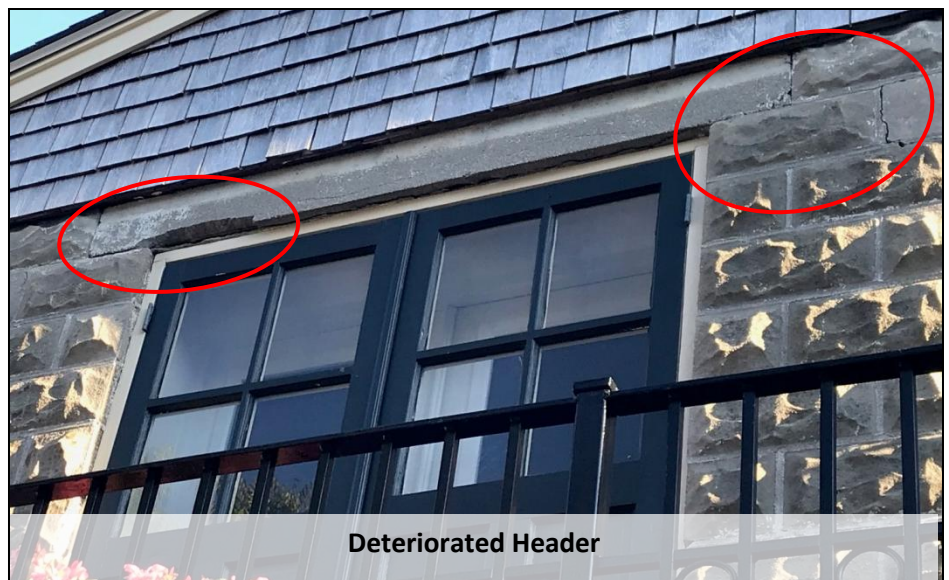
Deteriorated Header

PROPOSAL: The applicant is proposing to make repairs to the existing masonry to address deterioration and cracking. Paul Choquette, a historic masonry specialist, has proposed repointing all of the mortar joints; repair the broken header over the second floor windows/patio door, with the addition of a new angle iron above the patio door. To address water infiltration, caulking will be applied where the brick meets the concrete block and at the lower entry step. A water seal (*Silex Water Proofer*) will be applied to the entirety of the concrete block to prevent further water infiltration.

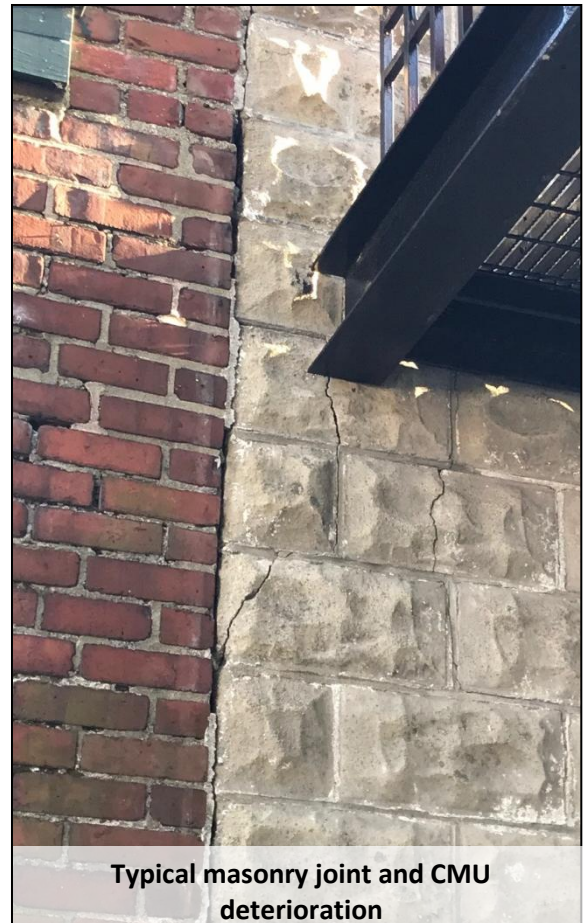
Typical masonry joint and CMU deterioration
