**Tartan 4100 (#6) Triforce**

## Raymarine Electronics' Upgrade (June 2023)

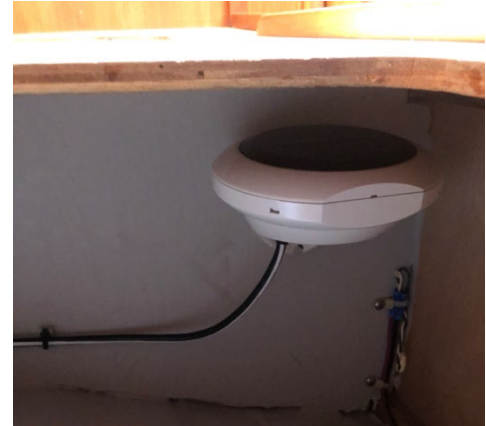
### EV-1 (S/N 1021659)

The EV-1 was installed on the aft partition of the forward access in the starboard settee berth. Installed a 1 m spur cable (A06039) from the attitude sensor aft into the aft access of the starboard settee berth into a SeaTalkNG tee connector (A06028). The tee connector is mounted on the outboard vertical side of the access. A 120 ohm resistor (blue terminal connector A06031) was installed on one side of the tee. On the other side, a 1 m back bone cable (A06034) was installed and led aft up into the vertical access (just below the TV/Radio compartment and terminates in the iTC-5 Converter.

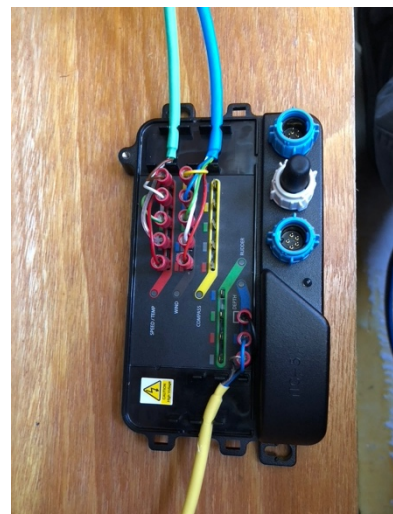
Carefully strip back 3.5 inches of insulation and remove the foil shielding. Carefully separate the wires (red, screen, green, white and brown). Install shrink tubing for the main cable (green in this case). Dry fit the cable into the converter such that the cable insulation terminates in the middle of the two cable routing supports for that particular cable. Red wire – strip back 0.5 in (22 AWG), twist and bend back so that you have 0.25 in inserted into the female spade connector and crimp. Next, route the screen wire and install shrink wrap back to the insulation. Measure 1.25 inches beyond the screen male connector in the iTC-5 unit and cut wire. Strip back 0.5 in, twist and bend back for 0.25 in that is inserted into the next female spade connector and crimp. Green wire – route the wire and measure 1.25 in beyond the green male connector and cut wire. Strip back 0.5 in, twist and bend back for 0.25 in that is inserted in the next female spade connector and crimp. Continue the process with the white wire and then the brown wire. Position shrink wrap and heat. Perform the exact same process for wind (I used blue shrink wrap). For depth, because there are only 3 wires instead of five, I initially

stripped back 3.25 in rather than the 3.5 in for wind and speed. The rest of the process was the same.

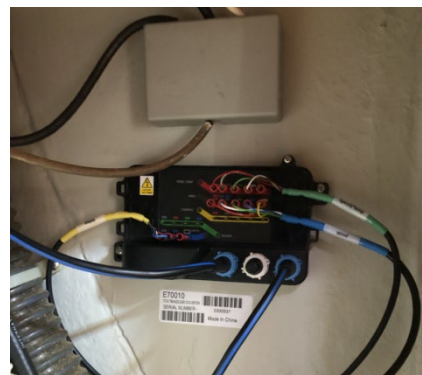
### iTC-5 Converter (S/N 0330537)

The iTC-5 converter was installed in the access below the TV/Radio on the aft partition, just below the converter box for the TV streaming device. The 1 m back bone cable from the EV-1 was installed in one of the back bone connectors and a 3 m back bone cable (A06035) was installed in the other back bone connector on the iTC-5. A blanking plug (A06032) was installed in the center spur connection on the iTC-5. The 3 m back bone cable was led up behind the TV and into the nav station side access and follows the VHF antenna cable into a 5 way back bone connector (A06064).

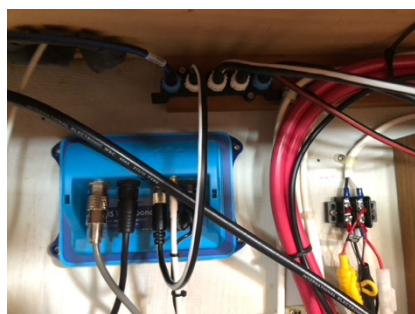
### Navigation Station Side Access Panel

Due to the size of the spur cable (A06045) leading from the Vesper Marine XB-8000 AIS device to the 5-way back bone connector, I had to relocate the AIS device. I took the opportunity to install a 3A in-line fuse to the AIS splitter and do some cable management for the power going into and out of a 2-way junction block so that all three fuses were in the same location. The in-line fuses from left to right are: 3A – AIS splitter; 3A – AIS power and 10A – VHF power.

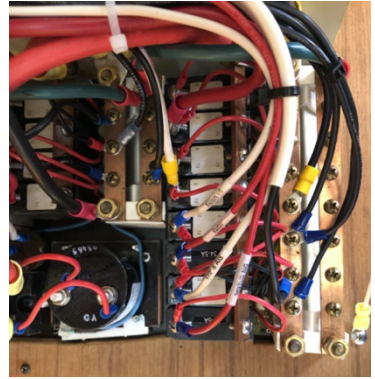
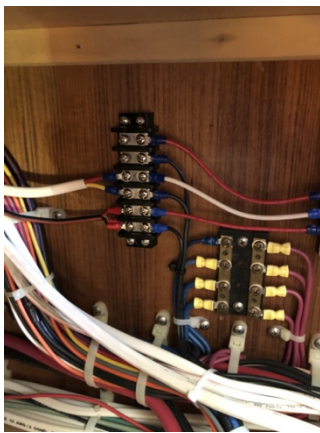
Note: In order to do this installation, some thermal breaker management needed to be done on the distribution panel.

- The DC Outlet wiring was moved from the SSB breaker to the DC Outlet breaker (not sure why it was installed this way) but now it is correct.
- A 20A breaker from the Blower breaker was relocated to the Auto Pilot breaker for use with the ACU 200. The Blower breaker is now a 30A breaker and is not used.
- Two 5A breakers were purchased and installed for the Navigation breaker and the Radar breaker.
- A 10A breaker was relocated for the Axiom +9.
- A 15A breaker was relocated for the VHF breaker (10A for the VHF and 3A for the AIS).

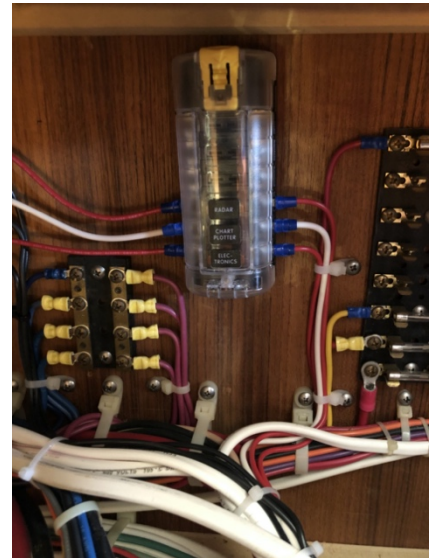
A 14 AWG 2-wire safety marine cable was installed for the Axiom +9. The cable terminates in the 6-way junction block above the SeaTalkNG power cable. 14 AWG black wire (DC -) was led to the negative bus on the distribution panel and 14 AWG white wire (DC +) was led to a 7.5A ATC fuse and then to a 10A thermal breaker on the distribution panel.

A 16 AWG red wire (DC +) was run from the Radar breaker on the distribution panel to a 5A ATC fuse and then to the 6-way junction block above the Axiom +9 cable. A 16 AWG black wire (DC -) was run from the negative bus on the distribution panel to the 6-way junction block. The radar is pre-wired. The radar has not been installed yet due to the Scanstrut LMP-1 being on back order.

The pictures show the 6-way junction block and the ATC fuse panel.

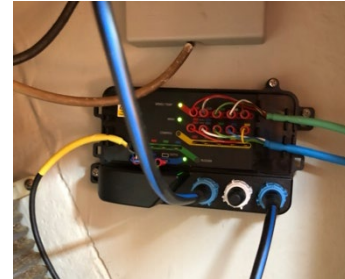
At this point, with the EV-1, iTC-5 converter with depth, speed and wind installed, the 5-way back bone connector, and I70s installed; a systems check was warranted to test the installation for errors. Before plugging in the power cable to the backbone, another 120 ohm blue terminal blank was installed into the 5-way connector and then the resistance was tested between Can A and Can B on the spur connector leading to the I70s. The reading was 59.9 ohms. Before installing the power connector into the 5-way backbone connector, DC voltage was tested between DC+ and DC- and DC+ and RF-. The readings were 13.45 volts (on shore power). I then turned on

the breaker for Navigation on the distribution panel and powered up the i70s MID. The main goal here was to ensure the installation was done properly up to this point before proceeding aft with the remainder of the installation and to check the iTC-5 converter and EV-1 installation. All had green solid indicator lights.

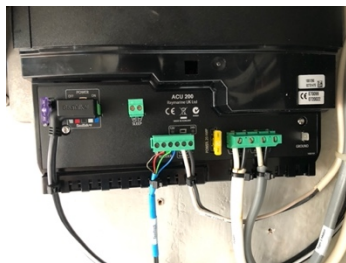
### **ACU 200 (S/N 0720022)**

The ACU 200 was mounted vertically on the forward bulkhead of the starboard lazarette, just outside of one of the two installed galvanic isolators. This was the location of the original ACU 100. On the ACU 200, connections were made for SeaTalkNG (SeaTalk set to Power Off), rudder feedback, Type 1 linear drive clutch (switch set to 12 V), Type-1 linear drive motor power, and ACU 200 power. All cabling existed except for the SeaTalkNG spur cable.

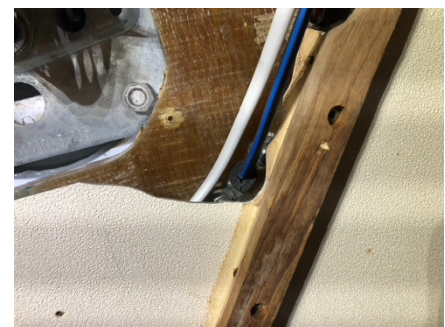
### **Nav Pod (GP1040-16)**

Before installing the nav pod, the 5 m back bone cable (A06036) coming from the tee connector at the ACU 200 was led to the helm through the starboard pedestal guard into the final 5-way back bone connector (A06064) located in the nav pod. A 0.5 in hole was drilled on the starboard side to access the starboard pedestal guard. Previously only one SeaTalk 1 wire ran through the starboard pedestal guard.

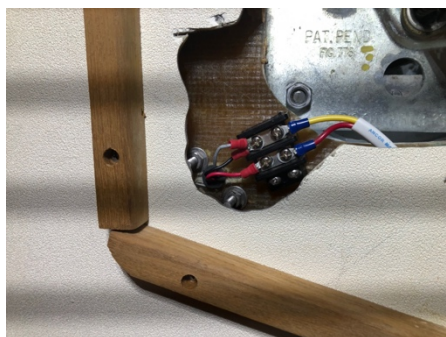
The nav pod was being installed in the same location as the previous instrument pod for the old ST50 instruments. However, I had to grind out and make the holes bigger in the pedestal guard to accommodate the SeaTalkNG connectors.

For the nav pod installation, four #7 holes were drilled and then a ¼-20 tap was used for the mounting screws. The nav pod was installed as per the manufacturers instructions.

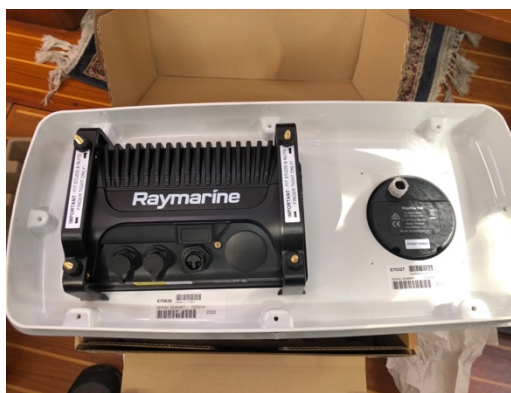
#### **Axiom +9 (S/N 1220214) and I70s (S/N 1222404)**

The Axiom +9 and second I70s were installed in the Nav Pod which had been pre-cut for both instruments. Only the mounting screw holes for the I70s had to be drilled. Pilot holes were drilled prior to drilling the correct size holes and all holes were drilled using the slowest speed possible. A Dremel tool (slowest speed setting) was used to initially mark the location of the holes for the I70s. A cable ferrite was installed 3.5 in (max is 3.94 in) from the I70s on a 0.4 m spur cable (A06038) that connected the I70s to the 5-way back bone connector. The Axiom +9 was connected to the back bone using the provided SeaTalkNG to DeviceNet adaptor cable.

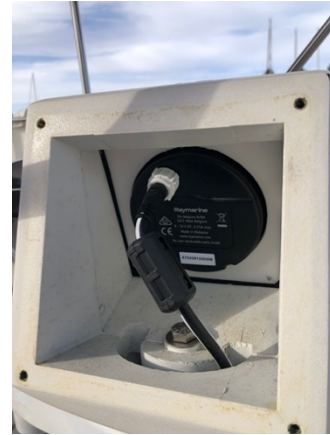
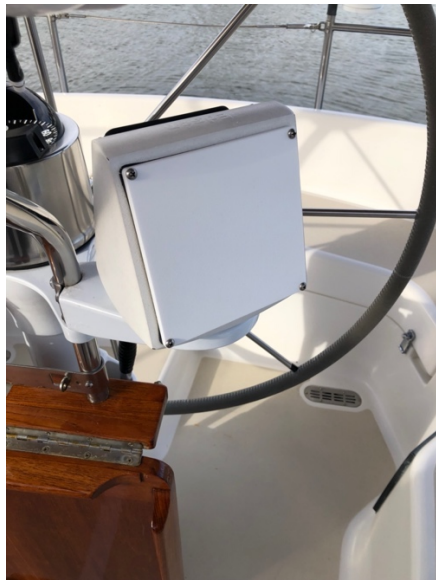
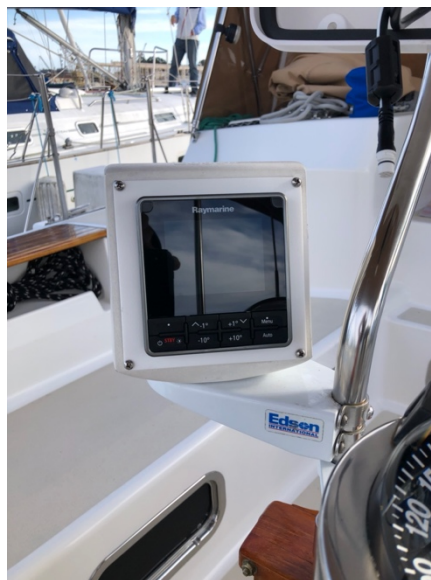
#### **P70s (S/N 1220208)**

The P70s was installed in the same location as the old ST6000+ auto pilot controller. The old plastic mounting surfaces were cracked and beyond repair. Two 5.5 in square x ¼ in white King Starboard plastic sheets were pre-cut and shipped from Boat Outfitters. Once received, the 4

mounting screws for the back surface and the four mounting screws, center hole and P70s mounting screws all had to be drilled and cut. A Dremel tool using the hole cutting device was used to cut the mounting hole for the P70s. Gaskets were made using left over gasket material from the Axiom +9 installation and the P70s was mounted on the Edson mounting bracket. A cable ferrite was installed 3.5 in (max is 3.94 in) from the P70s on the 1 m spur cable that was already led up to the nav pod into the 5-way back bone connector. The last connection was a 120 ohm blue terminal connector (A06031) in the 5-way connector to properly terminate the backbone installation.
