**NATIONAL REGISTER OF HISTORIC PLACES
INVENTORY -- NOMINATION FORM**

Jenkins, (Belle Ainsworth) Estate

20950 S. W. Farmington Road

Beaverton

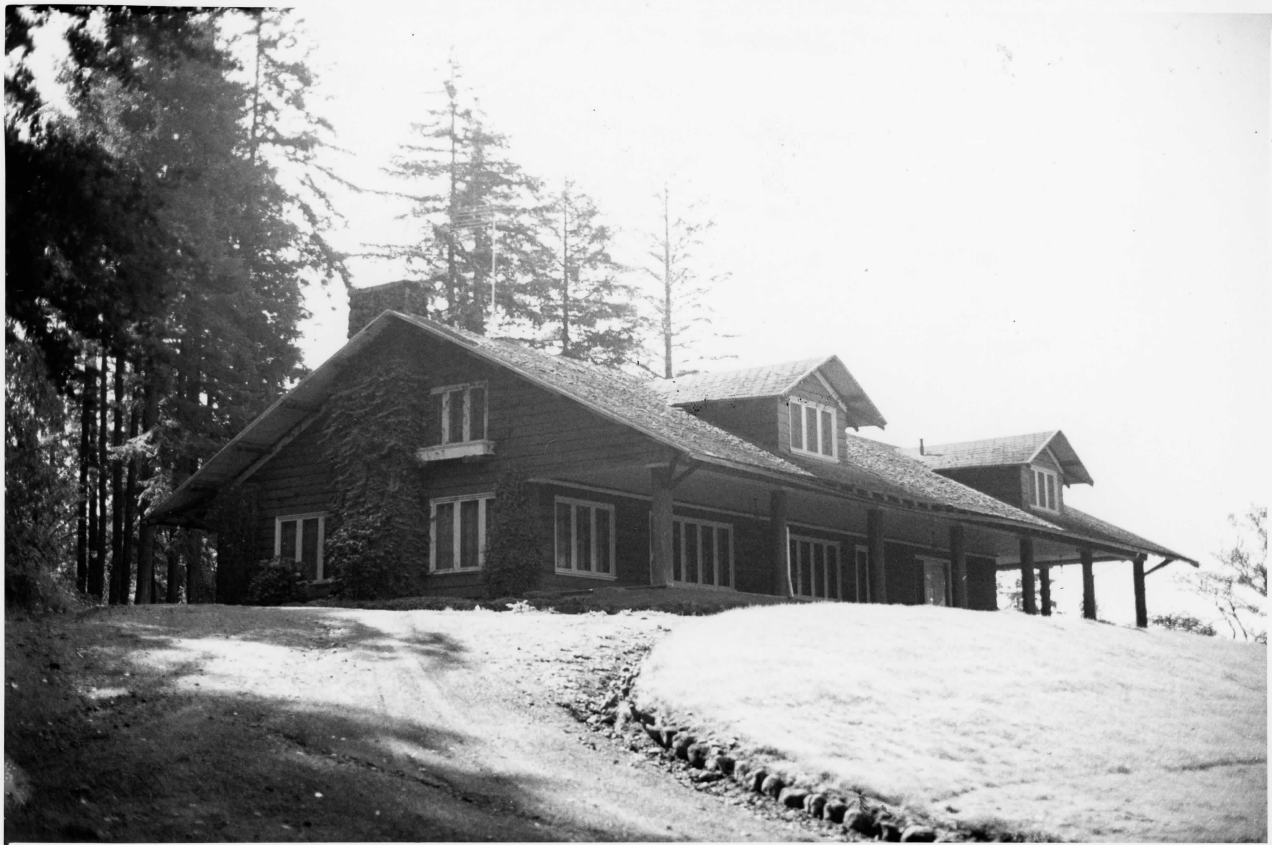
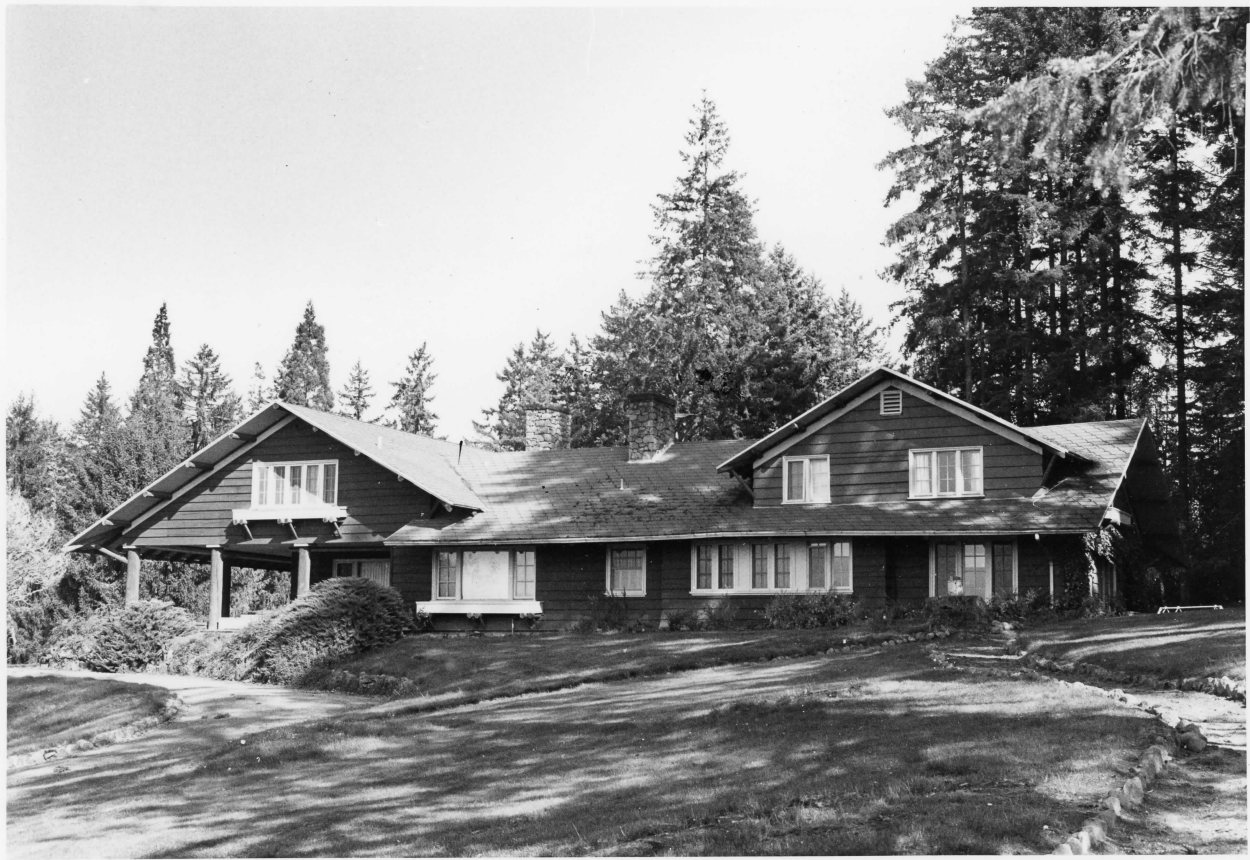
Basic floor and wall construction is in good condition. Siding is in good condition except at the lowest course where some rot has occurred due to ground contact. Some re-nailing is needed. Windows are generally in good operating condition.

Roofing is in fair condition. The eave along the west elevation sags, apparently due to dislocation of pole outlookers. There is some rot at ends of a few outlookers. Some gutters need repair and/or replacement.

All interior surfaces are in good condition though some refinishing is necessary.

Electrical wiring is substandard and will need replacement to meet current codes.

Main House, Jenkins Estate
Near Beaverton, Oregon
Photo by George A. McMath
Photo taken September 1977
Negative at Allen, McMath, Hawkins
Main House looking Southwest
Photo No. 1

Main House, Jenkins Estate
Near Beaverton, Oregon
Photo by George A. McMath
Photo taken September 1977
Negative at Allen, McMath, Hawkins
Main House looking East
Photo No. 2

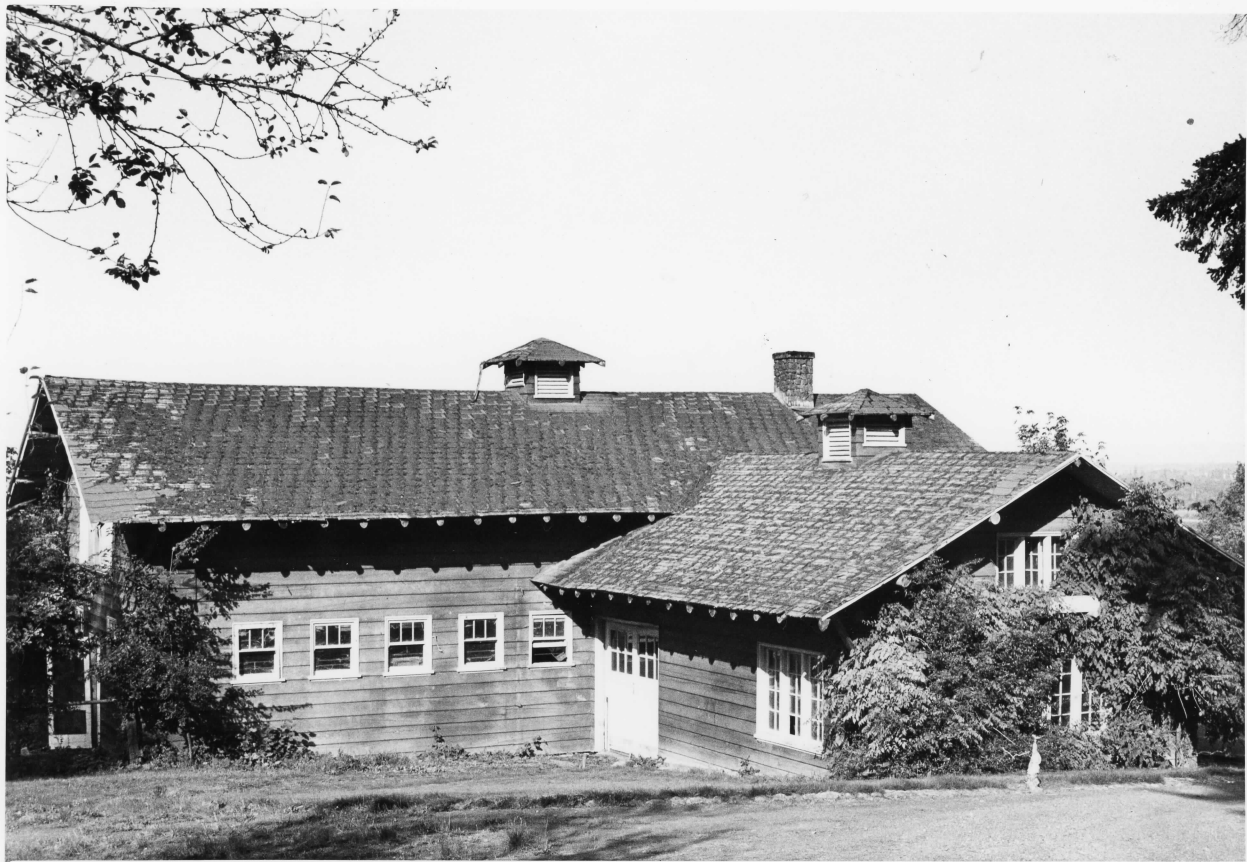
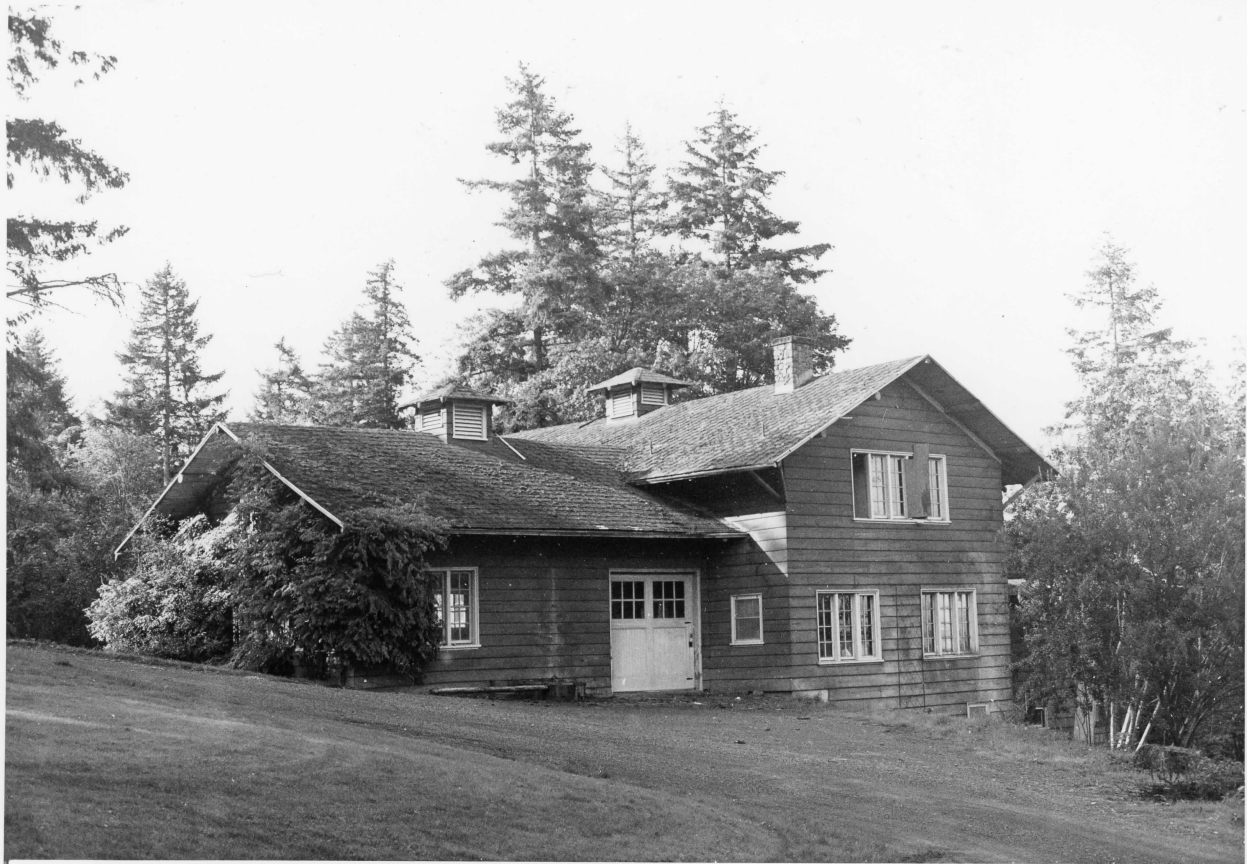
A substantial amount of rot damage has occurred due to moisture contact with wood members. Structural damage includes: complete collapse of the wood floor structure in the easterly 12' of the ground floor of the east wing - rot at stud ends; rot at east beam ends at the ground floor of the center wing; rot in plates and flooring at second floor; extensive rot in roof sheathing; and rot in the floor structure of the lower level dairy.

Siding is in good condition with the exception of rot in the lower courses, particularly along the east walls, a few open mitered corner joints, and a few boards with excessive splits and some loose nails. Some windows are in need of repair. Roofing is in very poor condition and leaks have caused considerable damage (see above).

The roof is presently covered with temporary sheet material. Several pole outlookers are partially rotted. Gutters are in poor condition.

Except for a few damaged boards, interior finishes are in good-fair condition. Some water damage to floors on the second floor has resulted from the roof leaks.

Stable, Jenkins Estate
Near Beaverton, Oregon
Photo by George A. McMath
Photo taken September 1977
Negative at Allen, McMath, Hawkins
Stable looking West
Photo No. 3

Stable, Jenkins Estate
Near Beaverton, Oregon
Photo by George A. McMath
Photo taken September 1977
Negative at Allen, McMath Hawkins
Stable looking Southwest
Photo No. 4

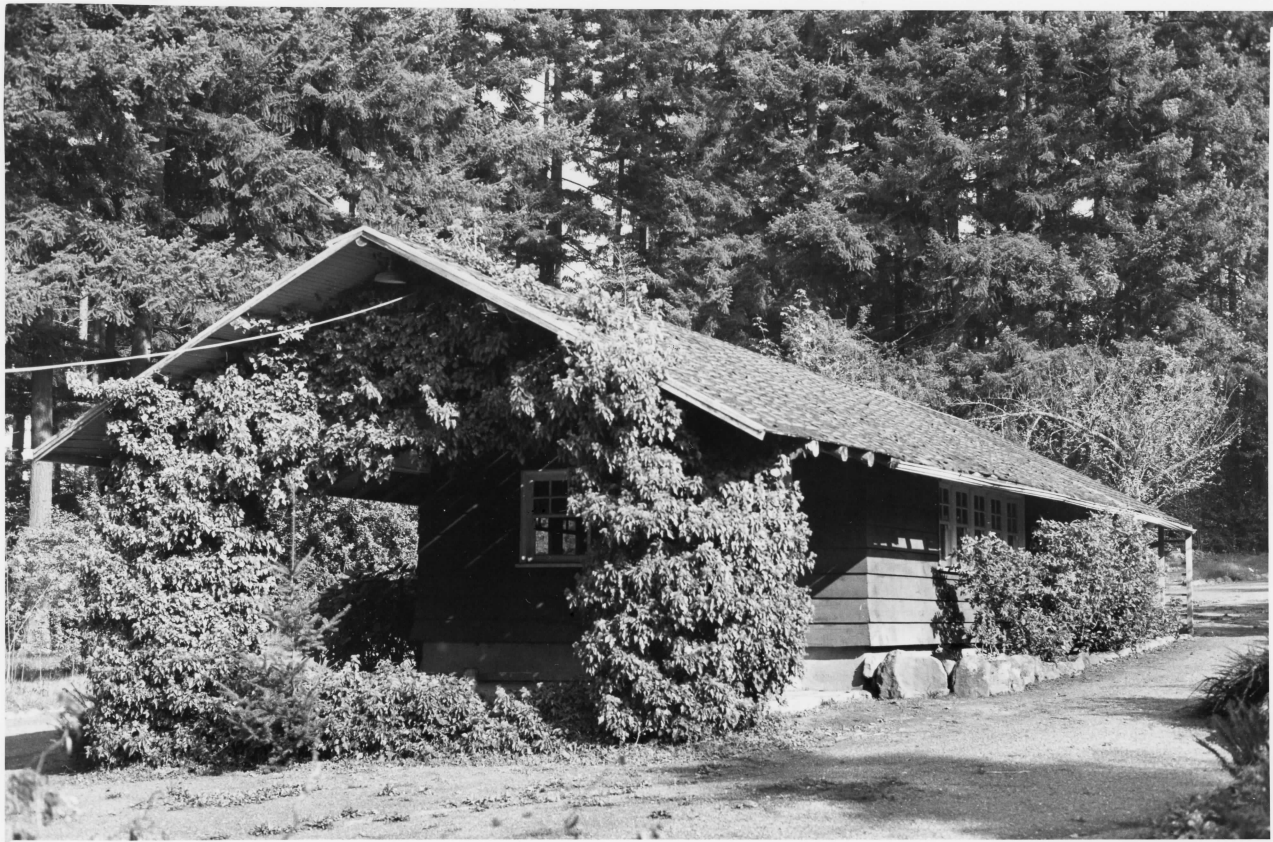
Except for some loose nails, siding is in good condition. Windows are in good condition. Roofing is in poor condition and is presently covered with temporary sheet material. Water leakage caused some rot in some roof sheathing and pole rafters. Gutters are in poor condition. Except for rot in some ceiling boards, finish woodwork is in good condition.

Pump House, Jenkins Estate
Near Beaverton, Oregon
Photo by George A. McMath
Photo taken September 1977
Negative at Allen, McMath, Hawkins
Pump House looking East
Photo No. 5

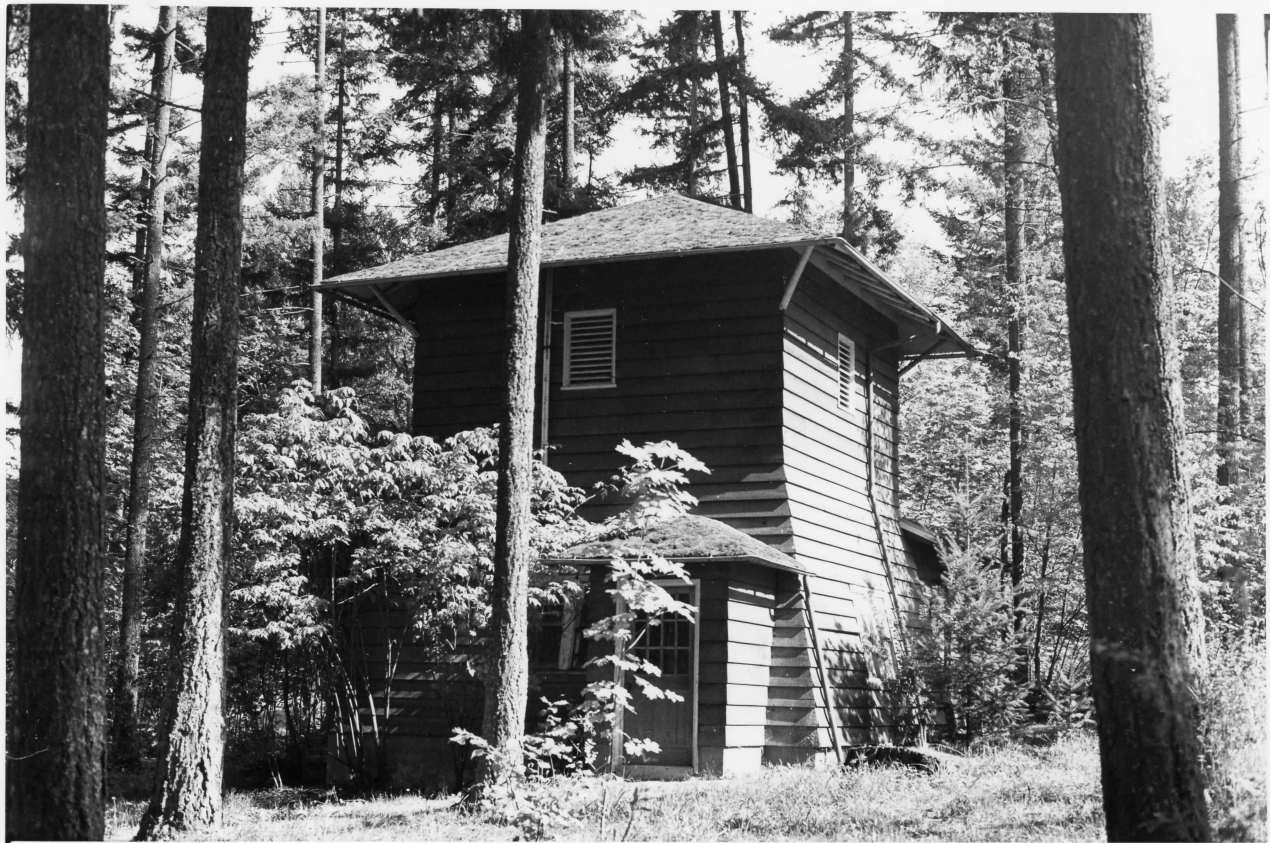
The basic structure is in good condition except for a rotted sill at the southeast corner. The tank support members are in good condition.

Siding is in good condition with the exception of rot on the lower courses, loose nails, and a few open corner joints. Roofing is in poor condition. Gutters are in fair condition.

Water Tower, Jenkins Estate
Near Beaverton, Oregon
Photo by George A. McMath
Photo taken September 1977
Negative at Allen, McMath, Hawkins
Water Tower looking Northeast
Photo No. 6

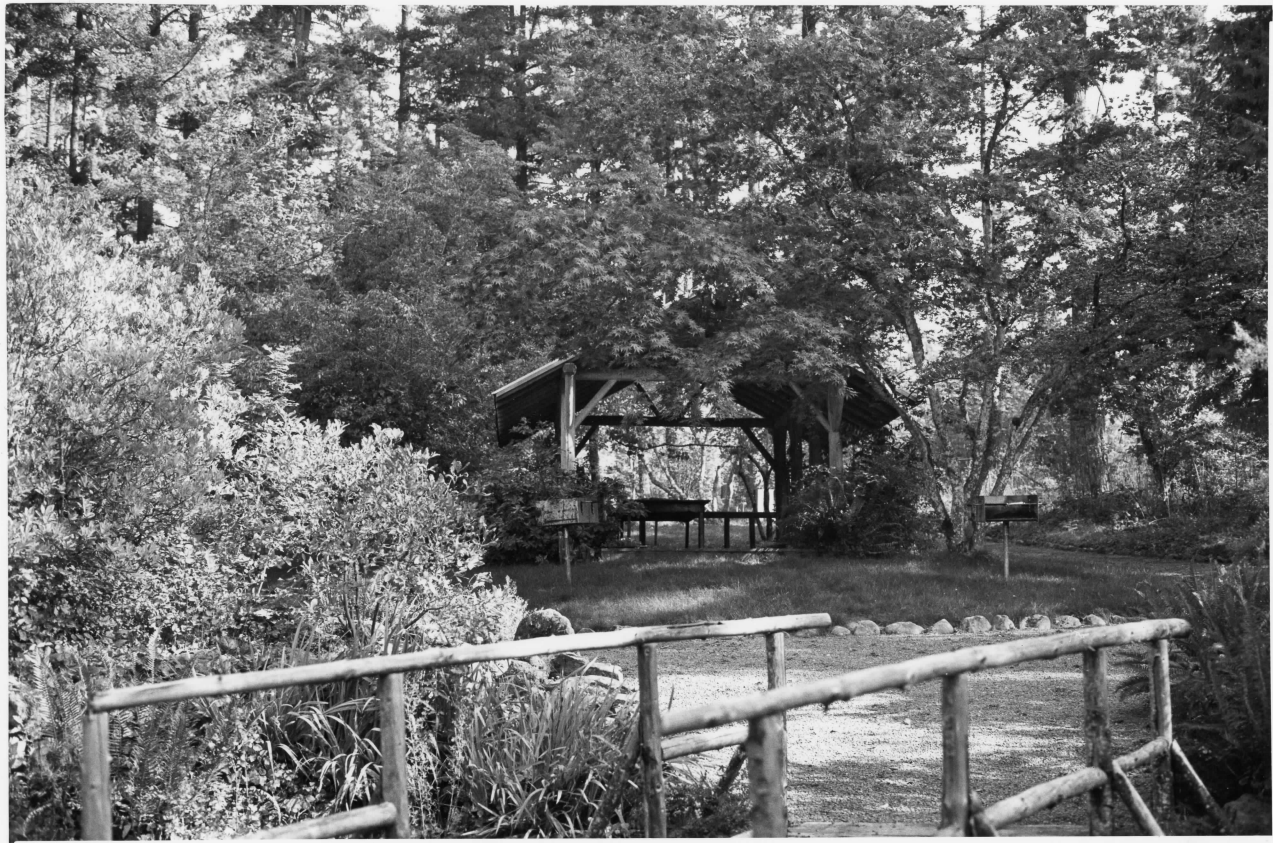
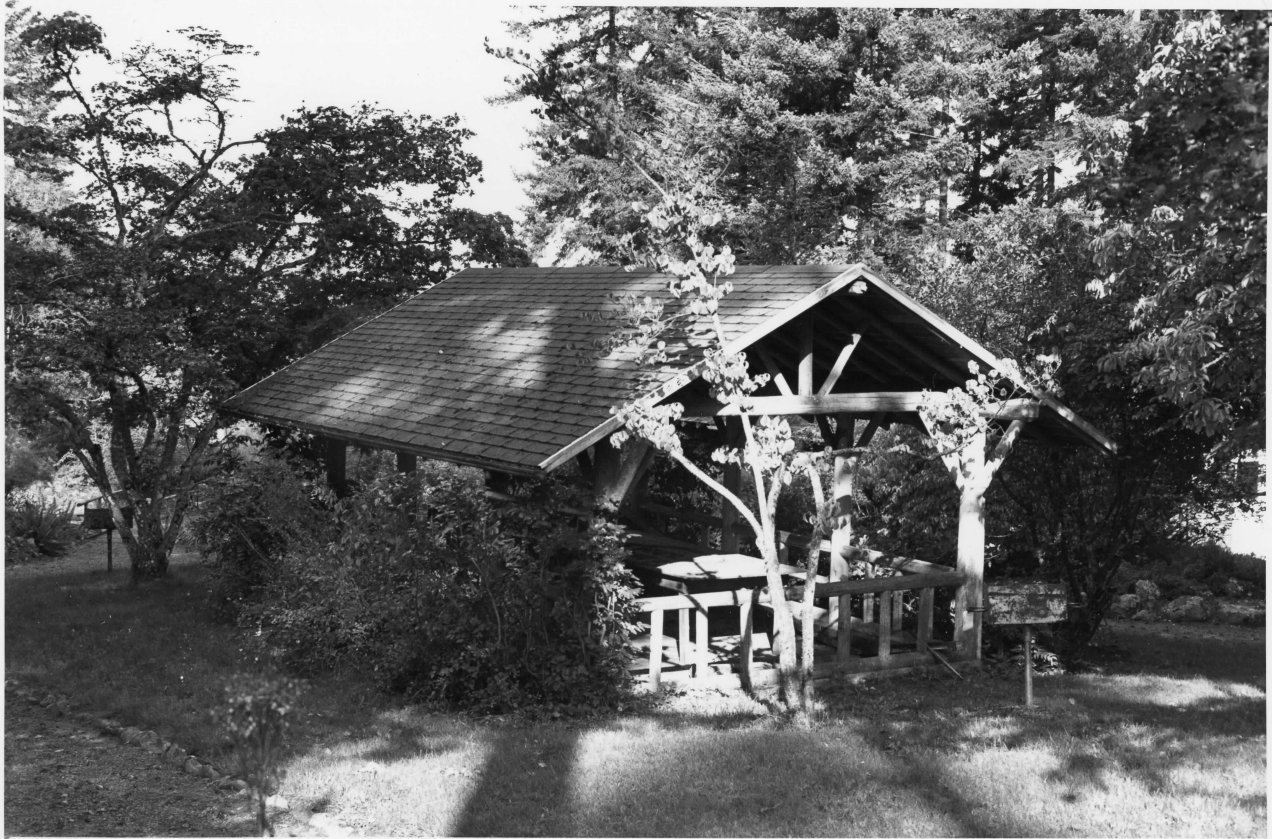
The wood members are generally in good condition - some rot is evident at post bases and in the railing.

Roofing is in fair condition. A wood gutter in fair condition is on the south eave: The north eave gutter is missing.

Tea House and Bridge, Jenkins Estate
Near Beaverton, Oregon
Photo by George A. McMath
Photo taken September 1977
Negative at Allen, McMath, Hawkins
Tea House and Bridge looking East
Photo No. 7

Tea House, Jenkins Estate
Near Beaverton, Oregon
Photo by George A. McMath
Photo taken September 1977
Negative at Allen, McMath, Hawkins
Tea House looking Southeast
Photo No. 8

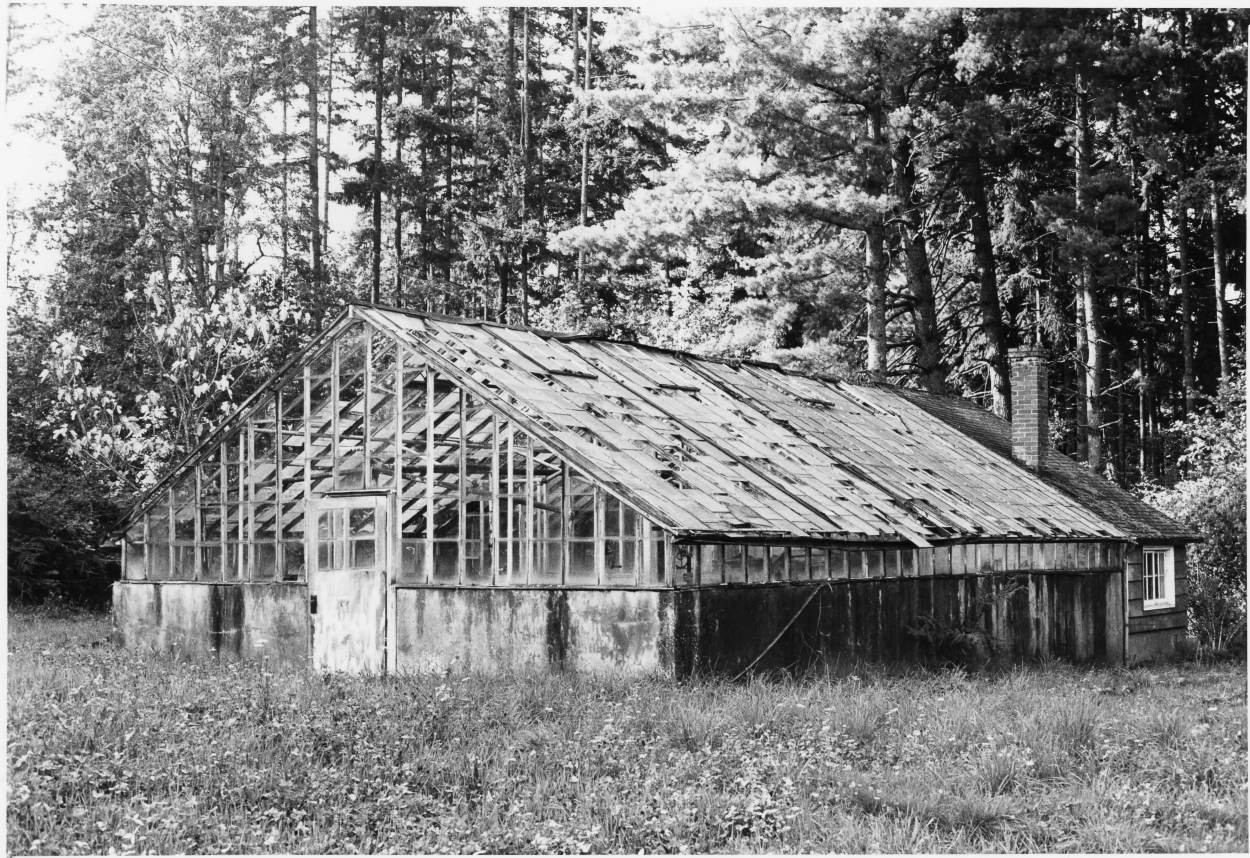
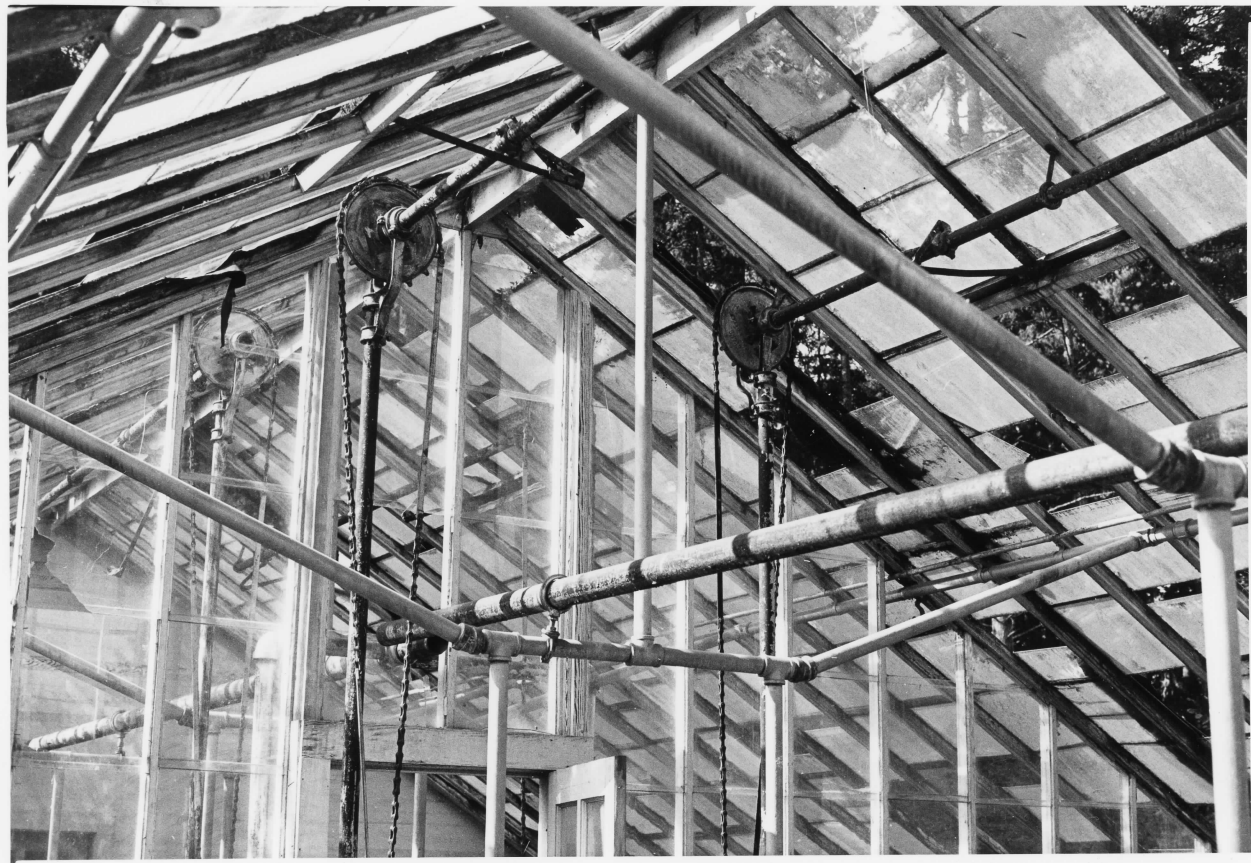
The westerly portion of the building is in good condition except the roof which is in poor condition.

In the easterly glazed portion of the building, most wood ribs have rotted ends, and approximately 30% of the glass is missing. The steel pipe structure is in good condition. Wood planting tables are in poor condition and some aisle floor planking is rotted.

Wheels, gears, pulleys and chains used to operate ventilation panels are intact but are badly rusted, and do not function.

Green House, Jenkins Estate
Near Beaverton, Oregon
Photo by George A. McMath
Photo taken September 1977
Negative at Allen, McMath, Hawkins
Green House looking Southwest
Photo No. 9

Green House, Jenkins Estate
Near Beaverton, Oregon
Photo by George A. McMath
Photo taken September 1977
Negative at Allen, McMath, Hawkins
GreenHouse Interior
Photo No. 10

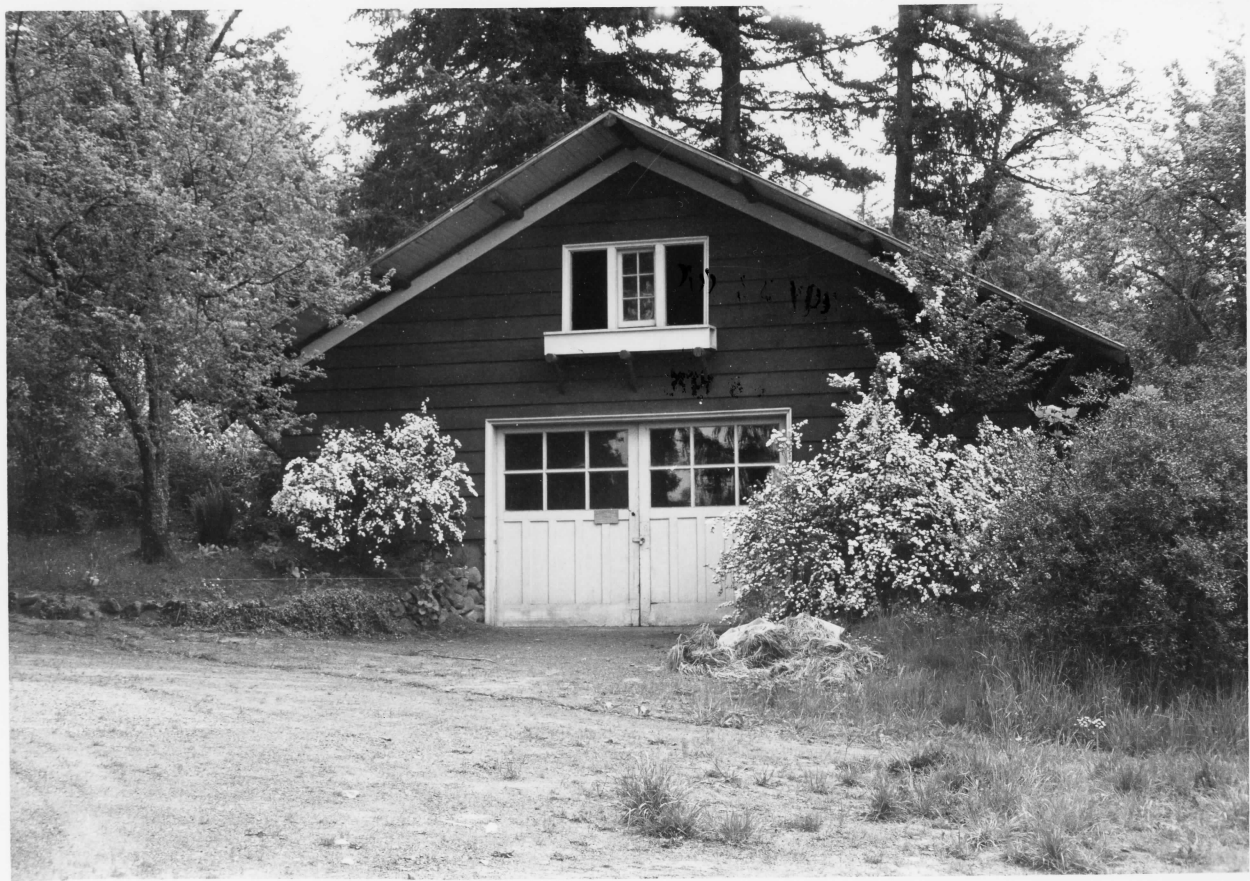
Carriage House, Jenkins Estate

The basic wall structure is in good condition. Siding is in good condition with the exception of rot on the lower courses where it is contact with earth. Some nails are

loose and some mitered corners are open. Roofing is in poor condition and is presently covered with temporary sheet material. Water leakage has caused rot in some roof members and at the ends of some pole outlookers. Gutters are in fair-poor condition.

Windows and doors are in good condition.

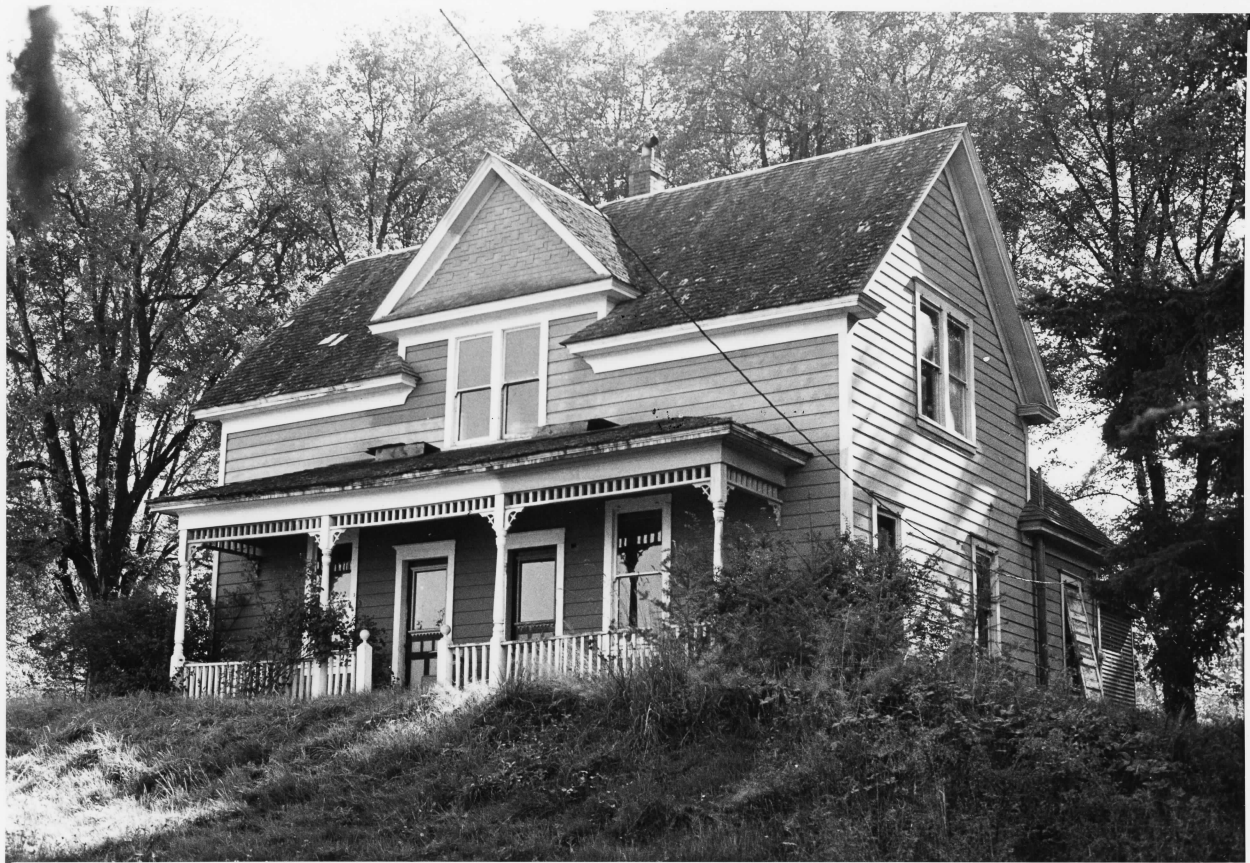
ORIGINAL FARM HOUSE

Original floor joist and wall structure are in good condition. The posts and beams of the under structure are not original and are in good condition. Porch flooring is 1" x 4" T & G fir and is in poor condition as are several balusters. Post bases show some rot. Other porch woodwork is in good-fair condition.

Vertical skirt boards have some rotted ends when in contact with the ground. Other exterior wall surfaces are in good condition. Windows are in good-fair condition. Shingle roof is in poor condition.

Interior woodwork is in good-fair condition.

Original Farm House, Jenkins Estate
Near Beaverton, Oregon
Photo by George A. McMath
Photo taken September 1977
Negative at Allen, McMath, Hawkins
Original Farmhouse looking southwest
Photo No. 12
