OPERATIONAL & MANAGEMENT ASSESSMENT BALTIMORE CITY FIRE DEPARTMENT

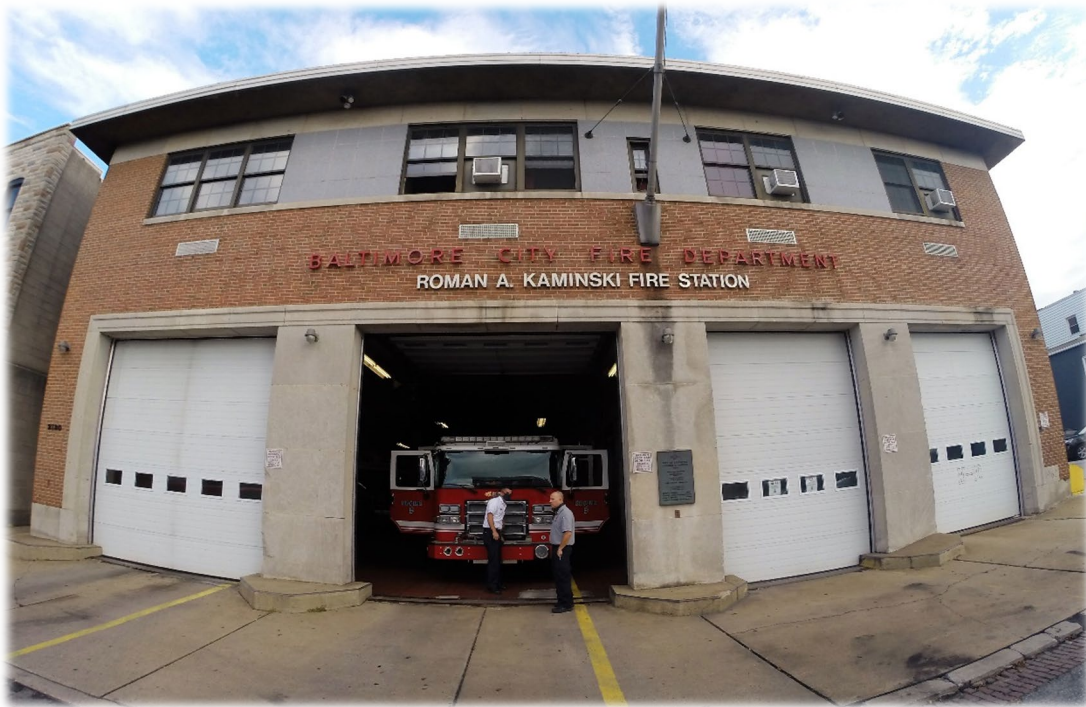
The first floor is the apparatus bays and ancillary spaces like turnout storage, the weight room, and utility spaces. The 2nd floor is the living spaces. This station has many qualities in its original construction: glazed block, Terra Cotta tile bay floors, and interior masonry partitions. The exterior is relatively low maintenance with red brick and stone trim. It lacks a fire sprinkler system as well as a fire alarm system. HVAC, plumbing, and electrical systems could be updated.

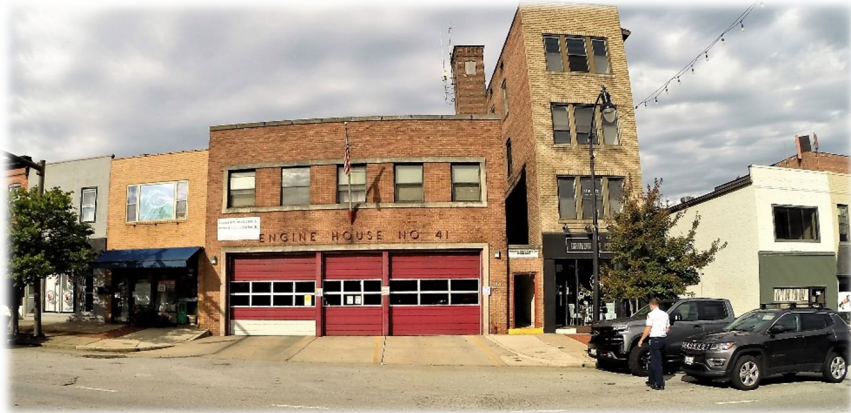
This station does not have the typical ornamentation common in firehouse construction in the late 19th century. The station has had the entire 2nd floor remodeled and it has been architecturally updated. The remodeling has definitely extended this station's functionality and useful life. It lacks a fire sprinkler system as well as a fire alarm system. HVAC, plumbing, and electrical systems could be updated.

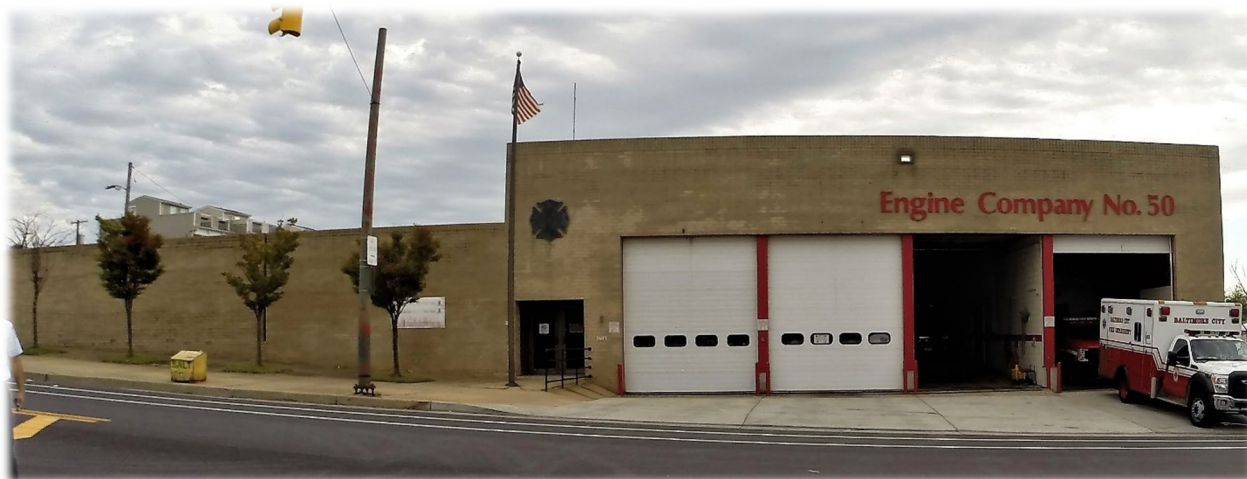
It lacks a fire sprinkler system as well as a fire alarm system. HVAC, plumbing, and electrical systems could be updated.

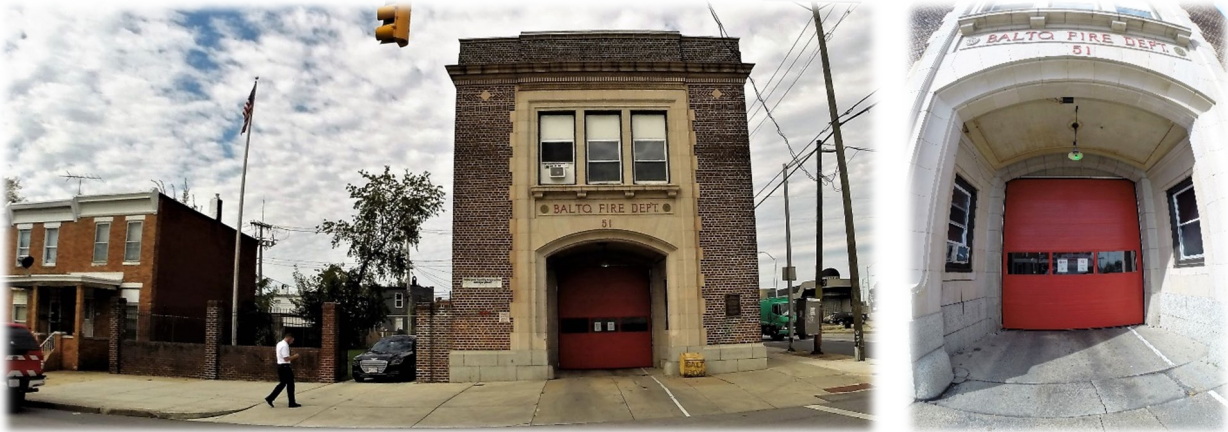
Station 51 is a historic, red brick firehouse. This station features stone masonry core with arched bay door and frames the windows above. It lacks a fire sprinkler system as well as a fire alarm system. HVAC, plumbing, and electrical systems could be updated.

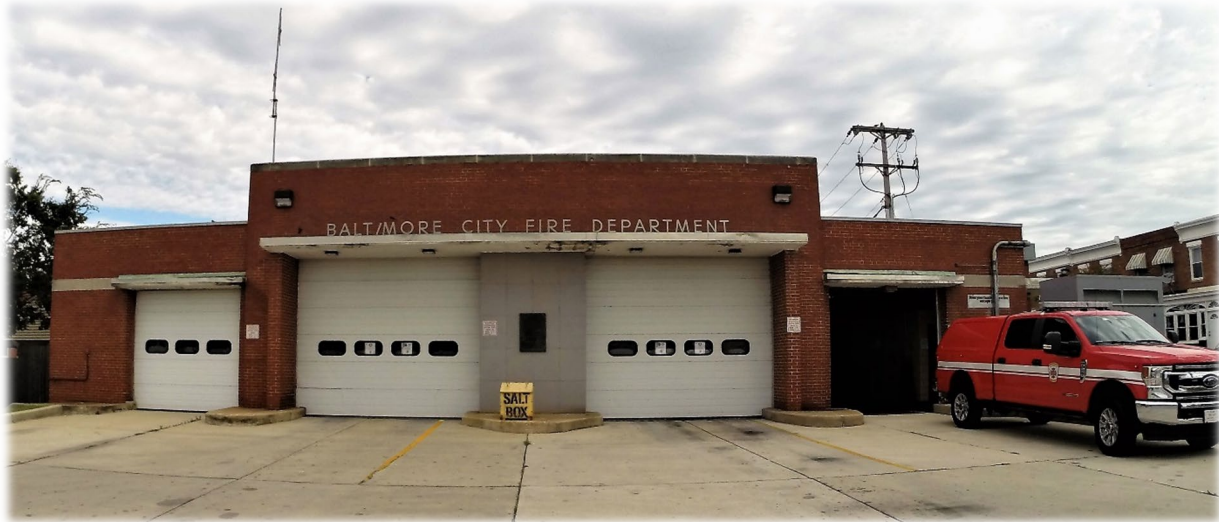
The two middle bays are “pull-through” and the station quarters flank the two middle bays, behind the two side bays. It lacks a fire sprinkler system as well as a fire alarm system. HVAC, plumbing, and electrical systems could be updated.

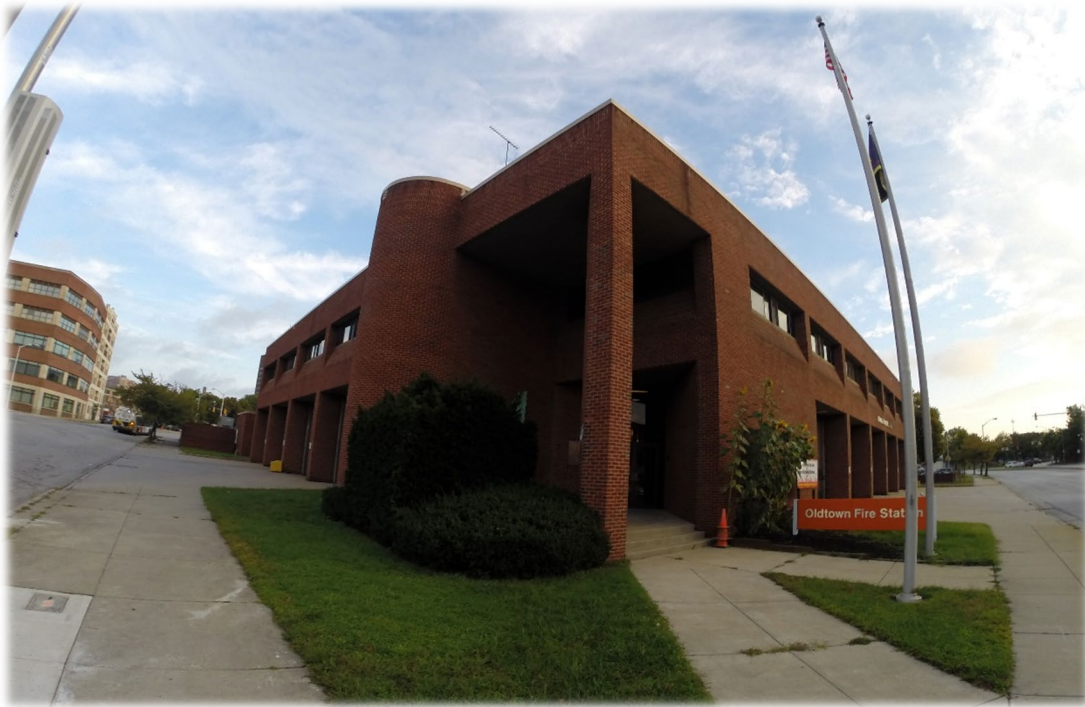
The first floor is the apparatus bays and ancillary spaces like turnout storage, the weight room, and utility spaces. The 2nd floor is the living quarters. This station also houses some BCFD IT functions and the Emergency Operations Center (EOC). The exterior is relatively low maintenance red brick. It lacks a fire sprinkler system as well as a fire alarm system. HVAC, plumbing, and electrical systems could be updated.

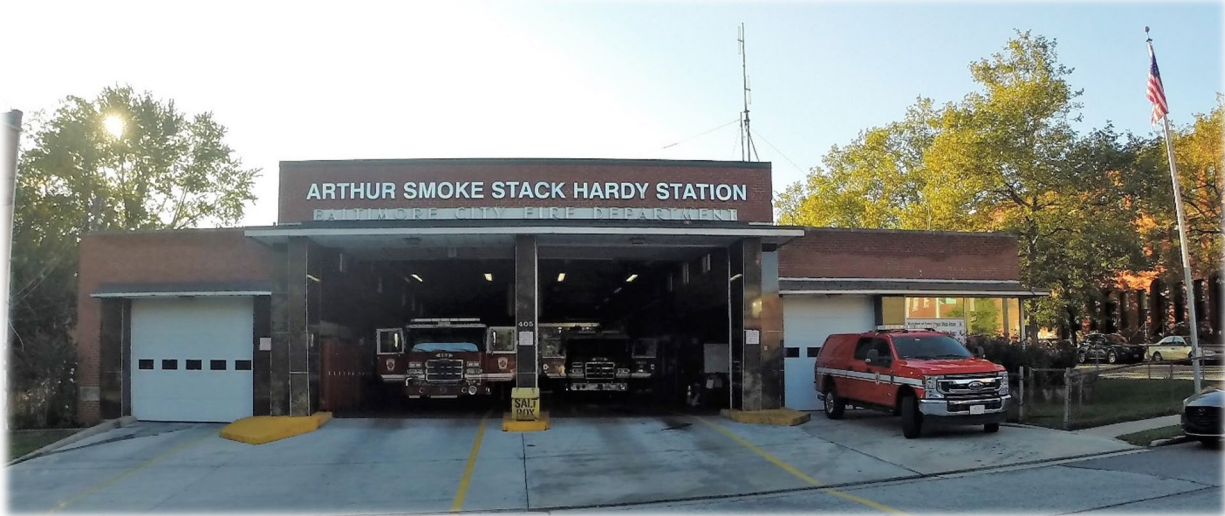
The station quarters flank the bays. It lacks a fire sprinkler system as well as a fire alarm system. HVAC, plumbing, and electrical systems could be updated.

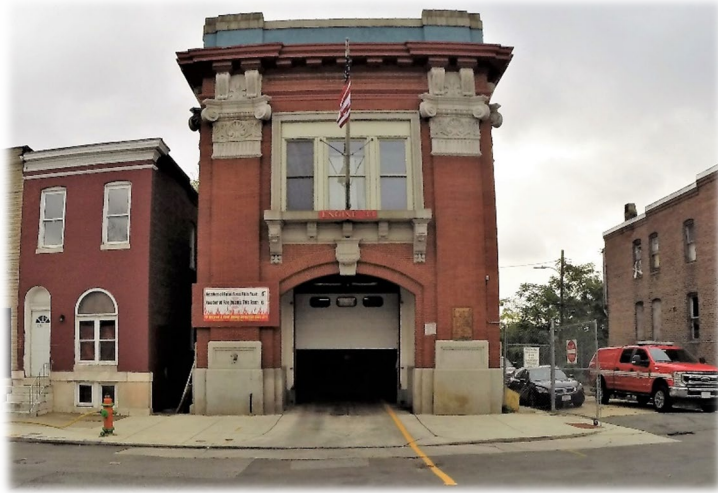
Station 33 is a historic, red brick firehouse. The BCFD has managed to keep this iconic station viable even in today's operational and deployment model requirements. It lacks a fire sprinkler system as well as a fire alarm system. HVAC, plumbing, and electrical systems could be updated.

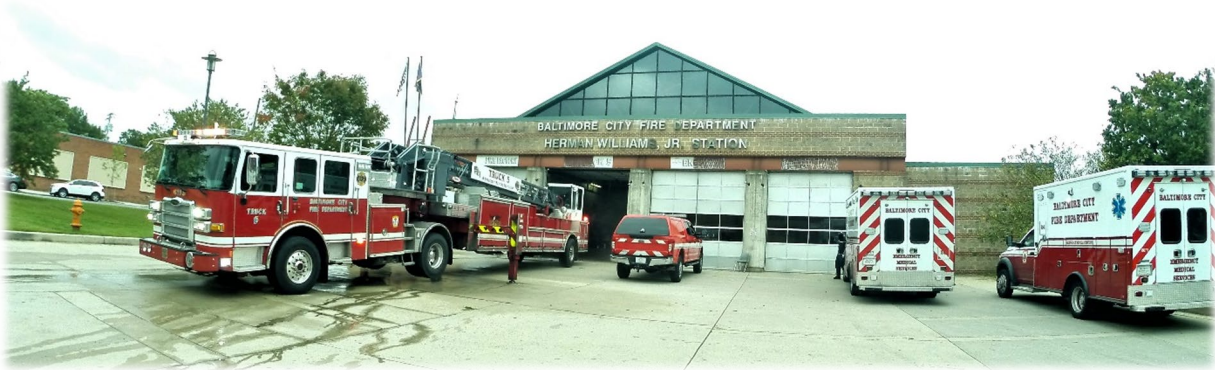
Station 5T is BCFD's 2nd newest station. It lacks a fire sprinkler system as well as a fire alarm system. HVAC, plumbing, and electrical systems could be updated.

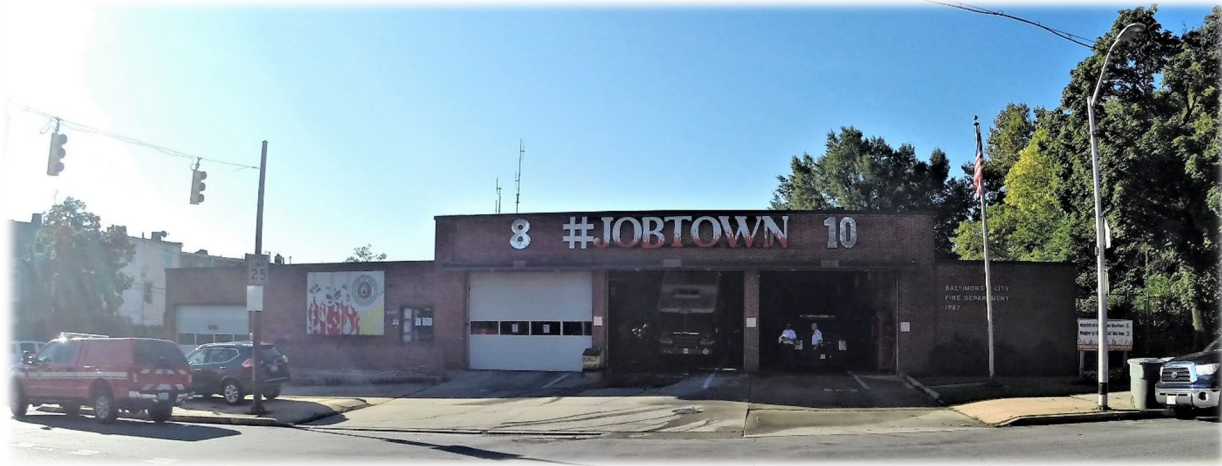
The station quarters flank the bays. It lacks a fire sprinkler system as well as a fire alarm system. HVAC, plumbing, and electrical systems could be updated.

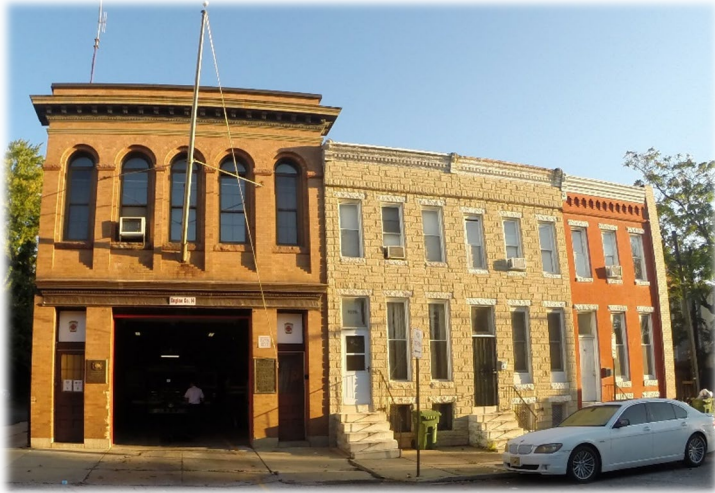
Station 14 is a historic, red brick firehouse. It lacks a fire sprinkler system as well as a fire alarm system. HVAC, plumbing, and electrical systems could be updated.

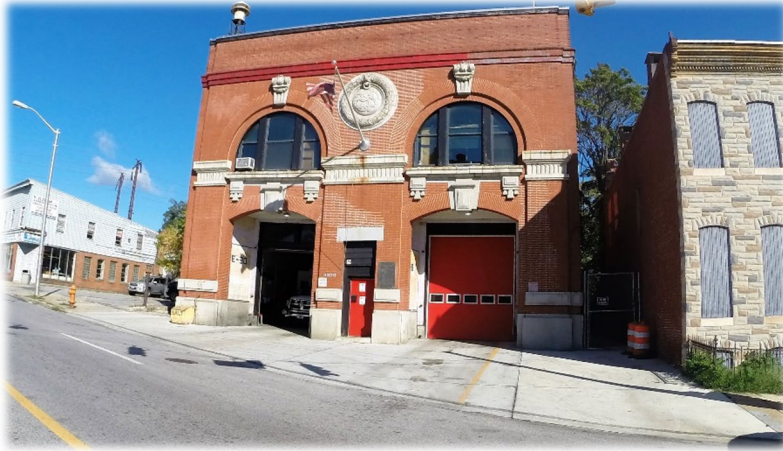
Station 30 is an ornate, historic, red brick firehouse. This station features stone accents in the masonry with arched windows and bay doors. It lacks a fire sprinkler system as well as a fire alarm system. HVAC, plumbing, and electrical systems could be updated.

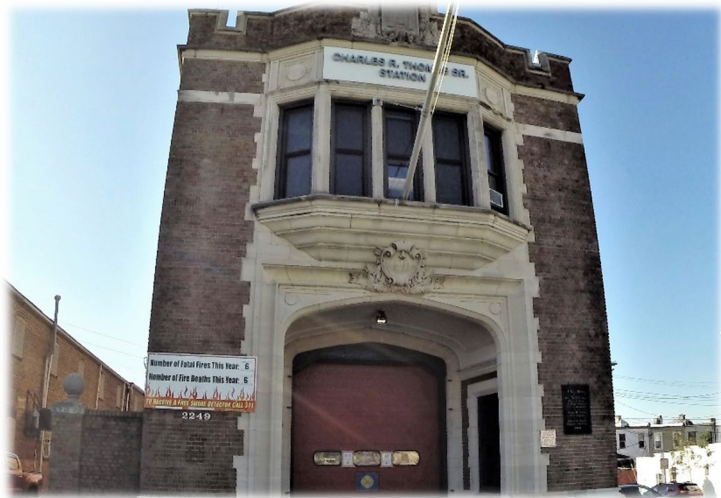
Station 36 is a historic, red brick firehouse. This station was once the training academy site. It lacks a fire sprinkler system as well as a fire alarm system. HVAC, plumbing, and electrical systems could be updated.

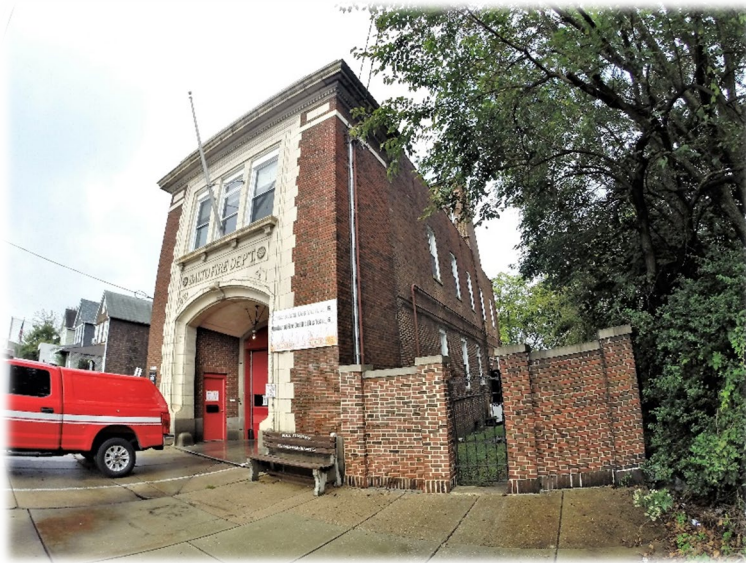
Station 47 is a historic, red brick firehouse. This station features stone masonry core with arched bay door and frames the windows above. It lacks a fire sprinkler system as well as a fire alarm system. HVAC, plumbing, and electrical systems could be updated.

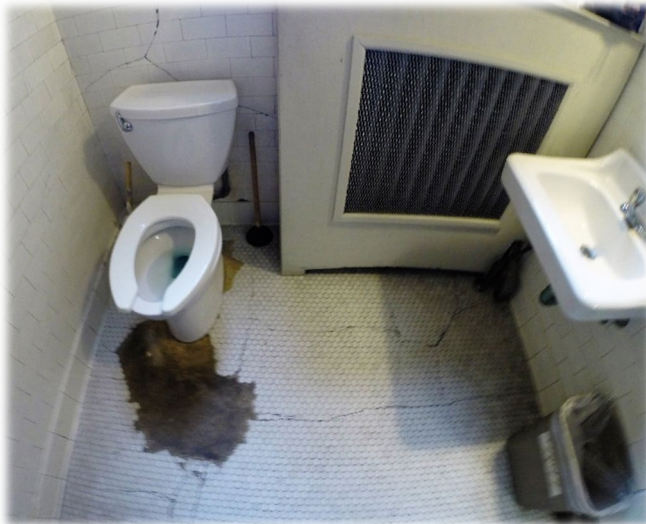
Cracks in floor and wall

Captain's private restroom – floor and wall cracks

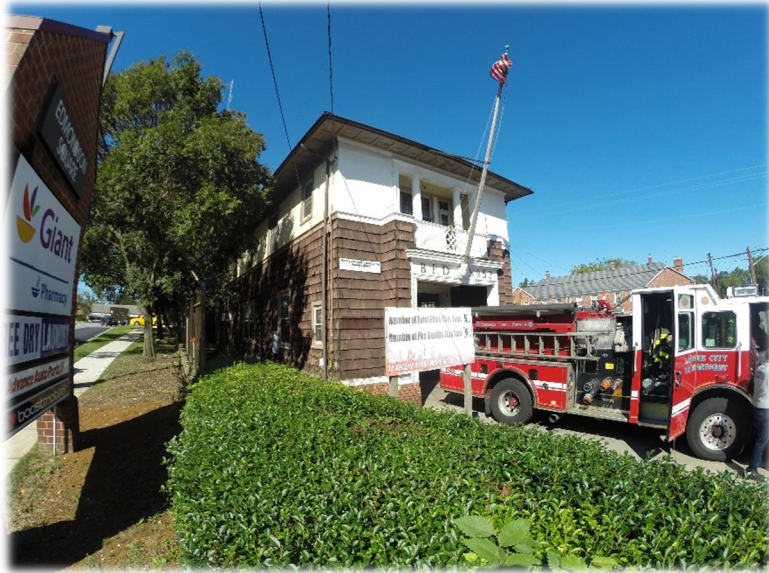
Station 53 is a historic, cedar shingle and stucco firehouse. This station features stone masonry core with arched bay door and frames the windows above. It lacks a fire sprinkler system as well as a fire alarm system. HVAC, plumbing, and electrical systems could be updated.

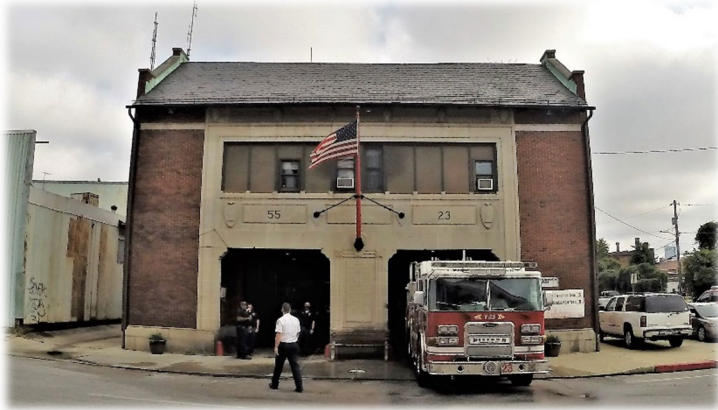
Station 55 is another historic, red brick firehouse. This station features stone masonry that included the engraved dedication plaque. It lacks a fire sprinkler system as well as a fire alarm system. HVAC, plumbing, and electrical systems could be updated.

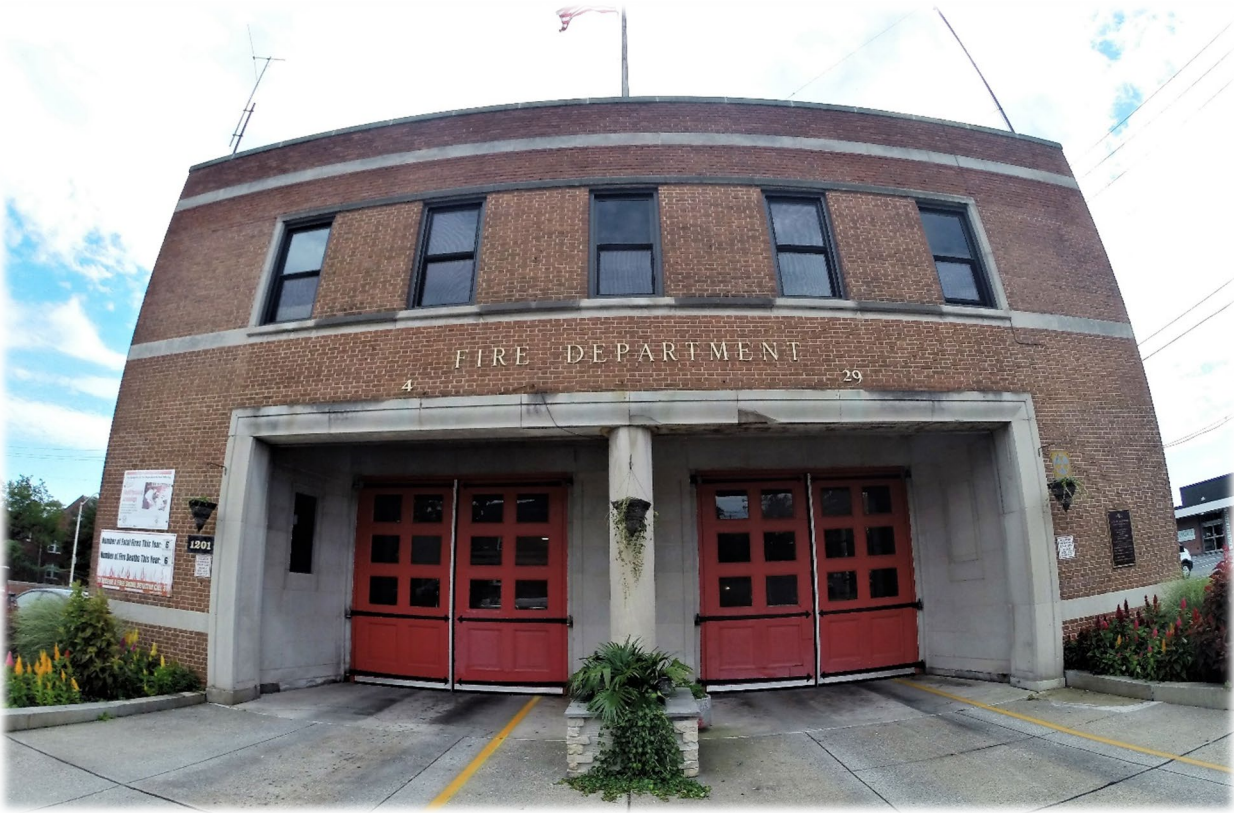
Station 4 is a traditional, red brick firehouse. It lacks a fire sprinkler system as well as a fire alarm system. HVAC, plumbing, and electrical systems could be updated.

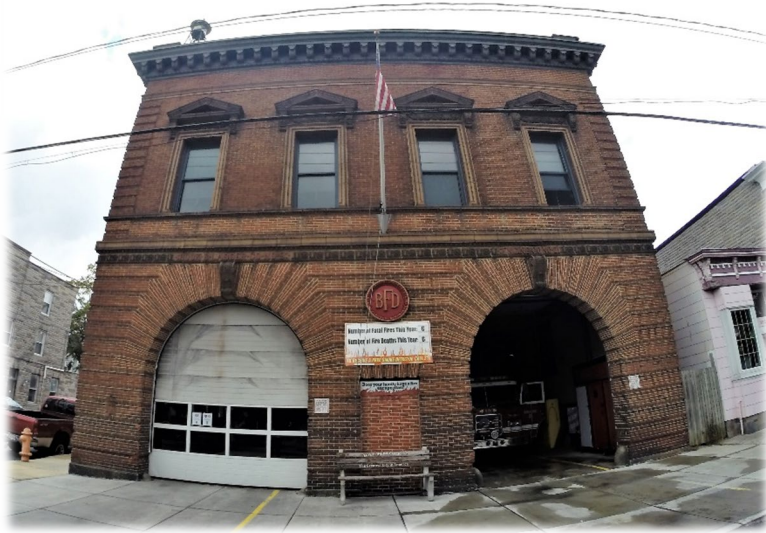
Station 21 is an ornate, historic, red brick firehouse. It lacks a fire sprinkler system as well as a fire alarm system. HVAC, plumbing, and electrical systems could be updated.

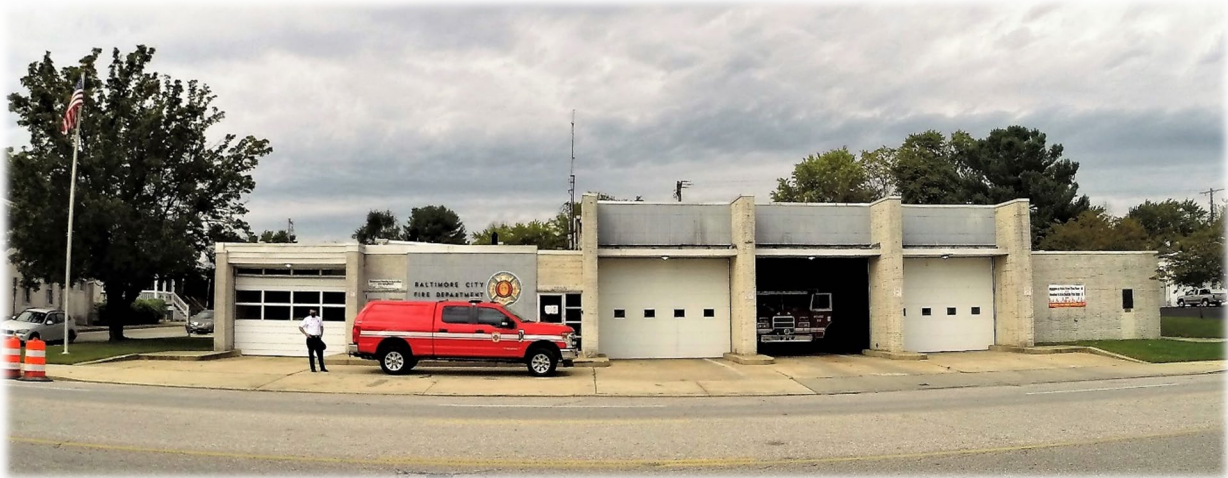
The station quarters flank the bays. It lacks a fire sprinkler system as well as a fire alarm system. HVAC, plumbing, and electrical systems could be updated.

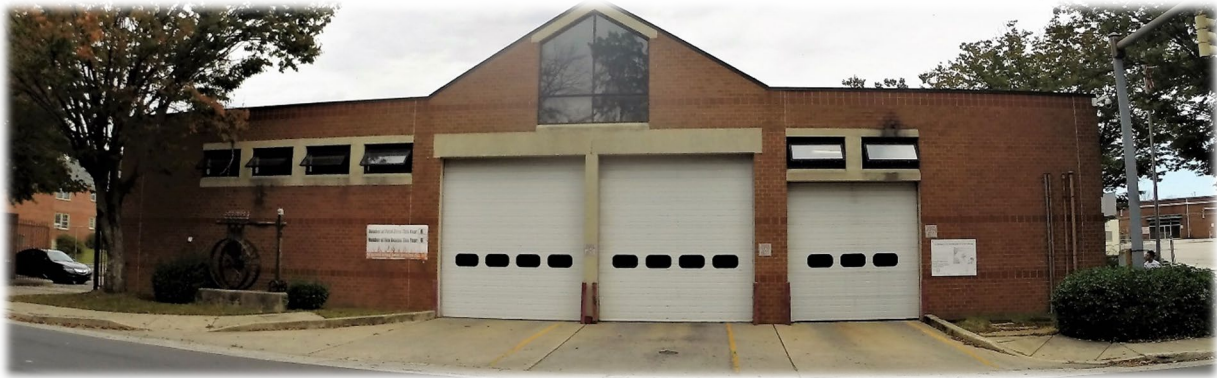
It lacks a fire sprinkler system as well as a fire alarm system. HVAC, plumbing, and electrical systems could be updated.

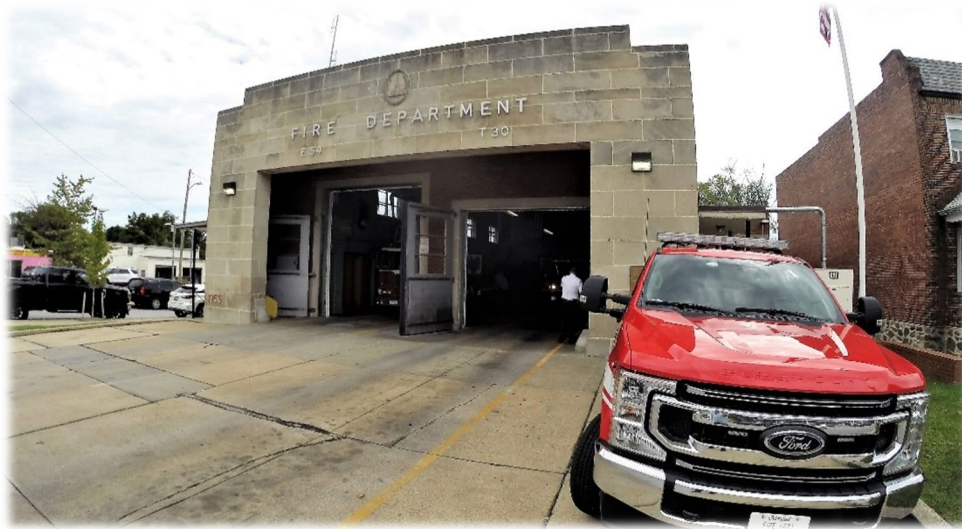
The station quarters flank the two middle bays. It lacks a fire sprinkler system as well as a fire alarm system. HVAC, plumbing, and electrical systems could be updated.

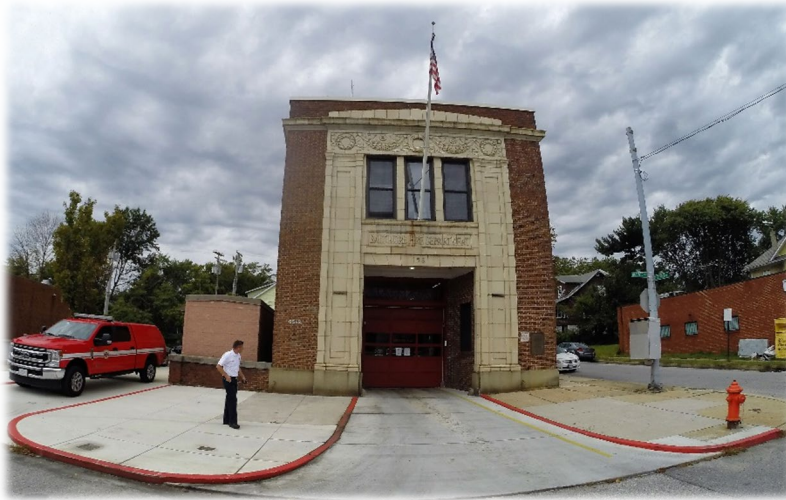
Station 56 is a historic, red brick firehouse. This station features stone masonry core with very detailed fenestration. It lacks a fire sprinkler system as well as a fire alarm system. HVAC, plumbing, and electrical systems could be updated.

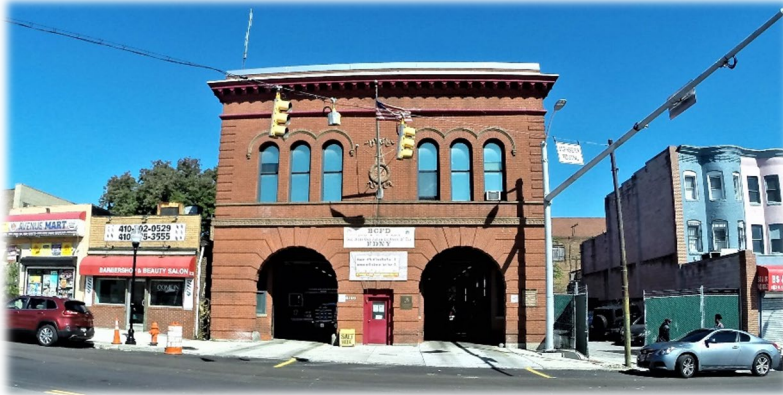
Station 20 is a historic, red brick firehouse. It lacks a fire sprinkler system as well as a fire alarm system. HVAC, plumbing, and electrical systems could be updated.

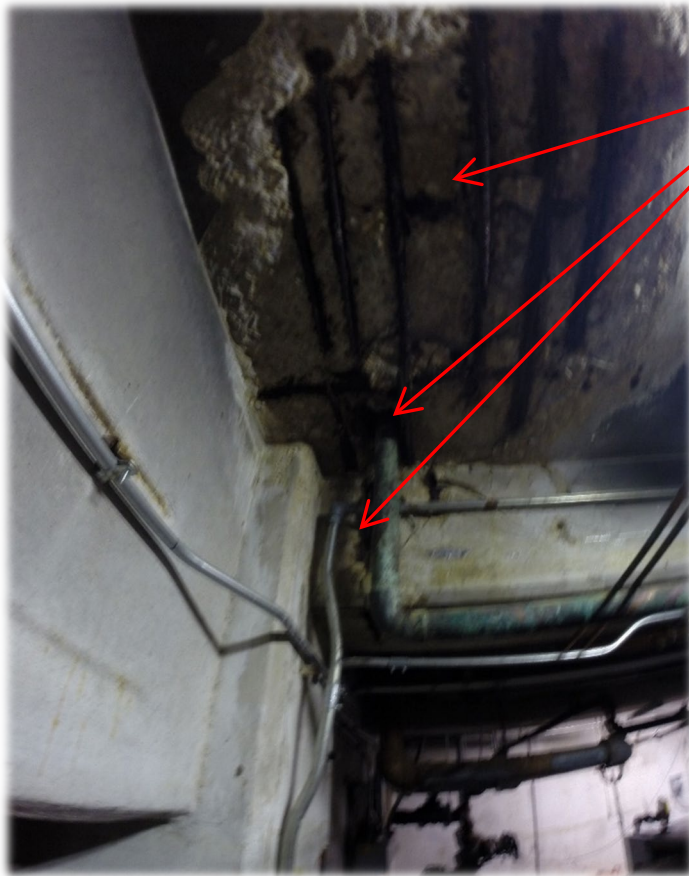
It lacks a fire sprinkler system as well as a fire alarm system. HVAC, plumbing, and electrical systems could be updated. One obvious structural condition was noted (below).
