Broadcast Electronics Inc.

STX Software Update Application Guide

597-4101-002
10/20/09
Rev.B

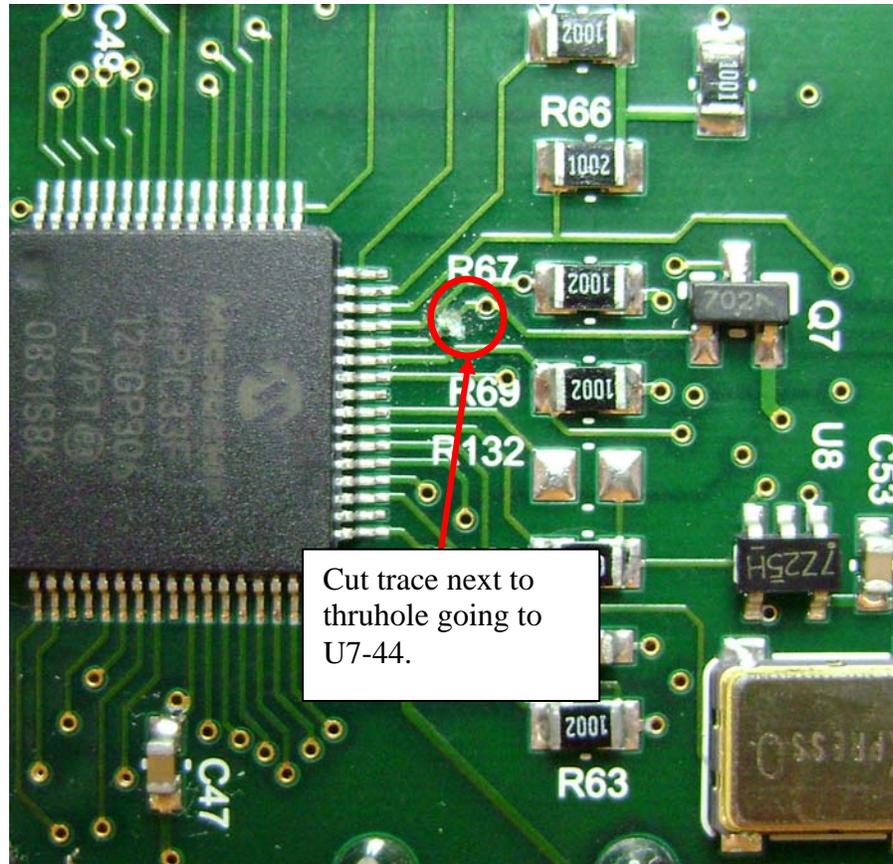
If the exciter download is unsuccessful, a minor board modification may be necessary to allow the software update to successfully complete. This board modification may be required on units, that are not already at exciter software version 1.6 or greater, to allow the transmitter to return to an on-air status after a failed software download. For reference, this board modification will allow a microprocessor reset line to properly operate and not be unduly influenced (held low) by part tolerance issues.

However, if the exciter software is not already at version 1.6 or greater and the unit refuses to accept the download, the TX will be off the air as the controller will continue to try to send the new code to the exciter. In that case, locate the internal exciter board (part number 919-4000) and cut the trace between U7-44 and a thru hole via. The trace should be cut on the pin 44 side of the via. See photograph.

Cut trace next to thruhole going to U7-44.
