THIRD GENERATION SUSPENSION UPGRADES: PART THREE

by Doug Leno

LET'S GET STARTED: PART THREE

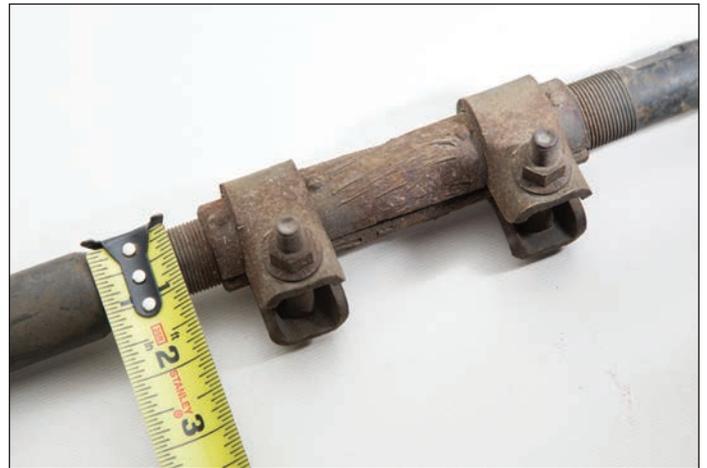
After 10 years and 150,000 miles, my factory steering system tie rod ends were showing the expected signs of deterioration and the wear produced some sloppy steering performance. To determine the repair, I first looked to see if there were any steering system recalls. I discovered "Safety Recall H46" which affected a small number of vehicles requiring a new drag link inner joint and/or pitman arm, but it turned out that this recall did not affect my vehicle. I was on my own for parts replacement.

Beyond the geometry differences themselves, the new T-type steering system provides additional stiffness and stability via larger diameter tubes, 1.5" versus 1.25", compared to the older Y-type system (see figures 6 and 7). This made the decision to upgrade easy. Because the job would be a simple one, I decided to perform the upgrade myself.

Figure 6: My tape measure shows the 1.25" diameter steering linkage tubes used on the 2003-2008 "Y-type" steering system that I replaced. The newer "T-type" system uses larger 1.5" diameter tubes.

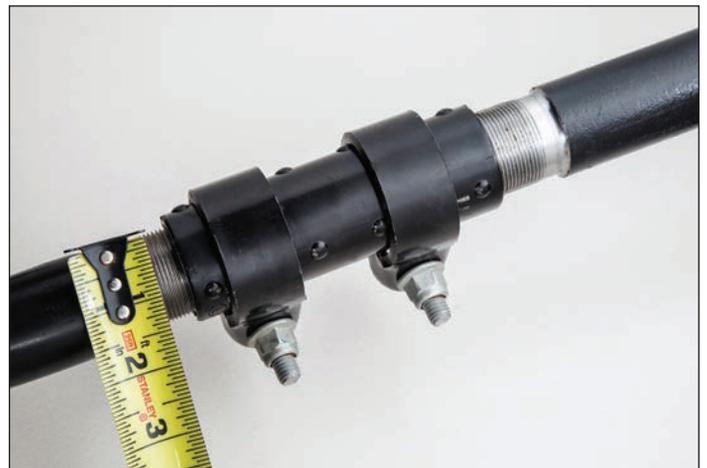
Figure 7: T-type steering system is made with 1.5" diameter tubing, and is considerably more robust than the older, Y-type steering system. The new system is over five pounds heavier.

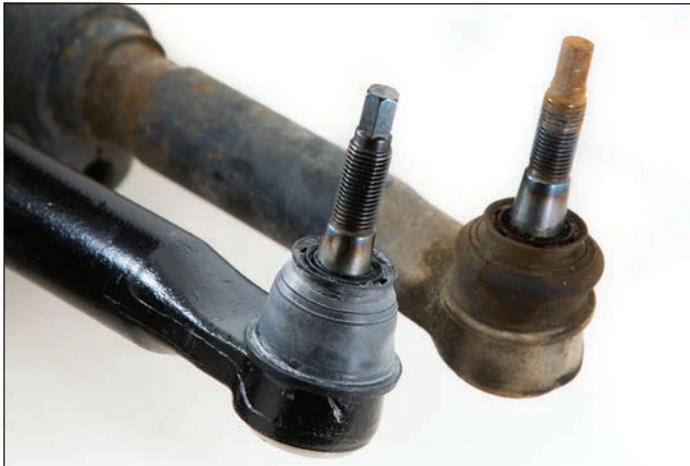
The left tie rod ball stud on about 264,000 of the above vehicles may fracture under certain driving conditions. This could cause loss of directional control and/or crash without warning.

Unsatisfied with this lack of detail, I requested permission to inspect a few steering linkages which my dealer had already replaced under the recall. I started by inspecting the left tie rod ball stud of both "new" and "recalled" systems, as shown in Figure 10. Do you see any difference? I didn't either!

Figure 10: I found no difference between "good" and "recalled" tie rod ball studs, the subject of N49. On the left is a verified "good" part which I installed on my truck. On the right is a recalled part from my dealer's boneyard.

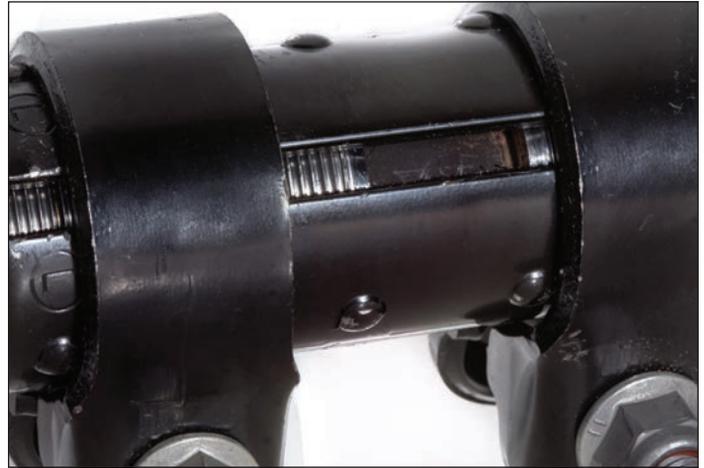
After further investigation I found what I believe to be the real reason for the recall: The recall does not appear to address the ball stud itself; it addresses the probability that a careless alignment technician might pre-stress the left-side ball stud during toe adjustment! If you carefully inspect figure 11, you will see the update: The newest tie rod has an internal mechanism to prevent the right-hand tube from rotating along with the toe adjustment collar. The older (recalled) tie rod has no such mechanism, as you can see in figure 12.

Figure 11: The adjustment collar on the newest T-style steering system. Note the inner mechanism in between the two threaded halves. This prevents the right hand tube from rotating along with the adjustment collar.

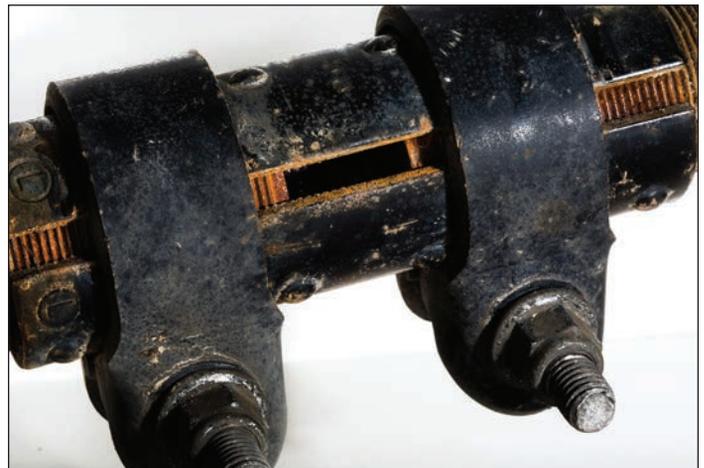
Figure 12: The older (recalled) system allowed the right hand tube to rotate along with the adjustment collar, allowing a careless technician to pre-stress the ball stud inside the steering knuckle.

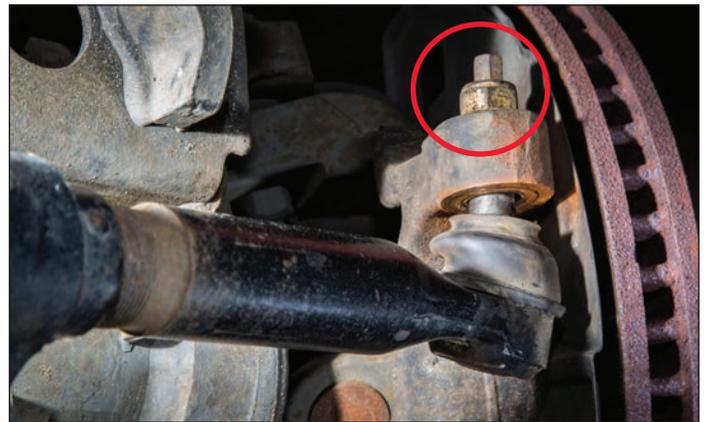
Figure 8: Dropping the old Y-type tie rod from the driver-side steering knuckle. The nut in this photograph (circled) is only partially removed.

After removing the Pitman arm from the steering box, the entire system can be removed by loosening the nuts on the left and right ball studs (see Figure 8).

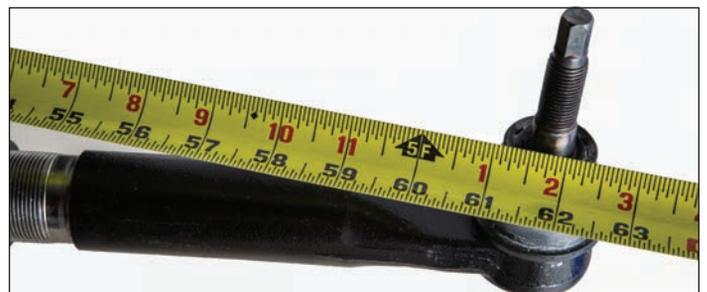
Figure 9: pre-adjusting the length of the new tie rod before installation.

Although most of us rely on alignment shops to check or perform the adjustment, our Turbo Diesels are easy to align, even in a home garage. "Total Toe" is the only adjustable alignment parameter, determined by the length of the tie rod set via the adjustment collar. This meant I had to set "Total Toe" myself, at least initially. Rather than measure the parameter directly on the vehicle, I decided to pre-adjust the length of the new tie rod to match the length of the old one (see figure 9), and then go to an alignment shop for final adjustment. It turned out my pre-adjustment was only 1/32" off!

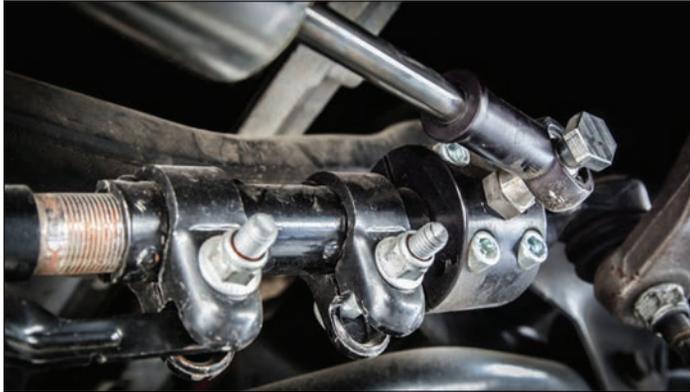
Figure 12: Installation of the Carli Suspension "High mount stabilizer" required a new clamp to accommodate the new tube diameter.

Carli Suspension's dual stabilizer system is compatible with either "Y-type" or "T-type" steering systems. As is the focus of this article, the newer steering system is manufactured with larger diameter tubes, which means that a different Carli suspension clamp is required for the upper stabilizer (see figure 12). Carli's low-mount stabilizer utilizes the factory supplied clamp, shown in figure 13. Note that for these photographs, I decided to break with tradition and show the installation after several hundred miles of road use. You won't see shiny new parts in these photos, but you will see how road grime accumulates, and how the axle tube itself protects the lower stabilizer (figure 13).

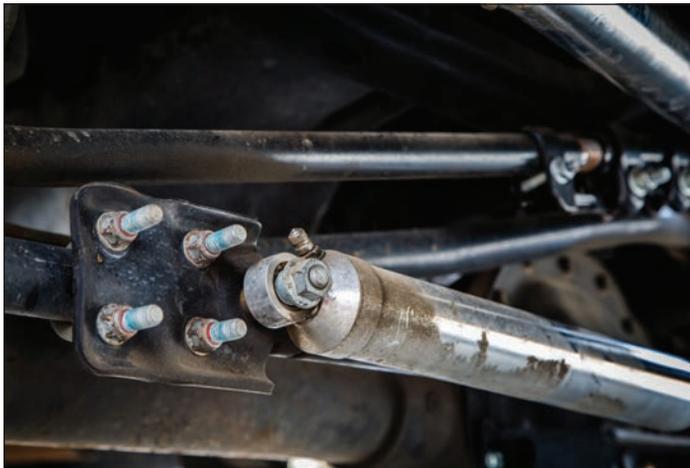
Figure 13: The Carli Suspension Low-mount stabilizer utilizes the factory supplied clamp, repositioned to the correct location per instructions from Carli Suspension.
