Subject: Fwd: ECO Insulating Glass - PROBLEMS  
Date: 12 January 2017 at 18:35  
To: [REDACTED]

**From:** "Glenn MacEachern" <[glenn@ecoglass.ca](mailto:glenn@ecoglass.ca)>  
**Subject:** RE: ECO Insulating Glass - PROBLEMS  
**Date:** 12 January 2017 at 18:15:41 GMT+1  
**To:** [REDACTED]  
**Reply-To:** <[glenn@ecoglass.ca](mailto:glenn@ecoglass.ca)>

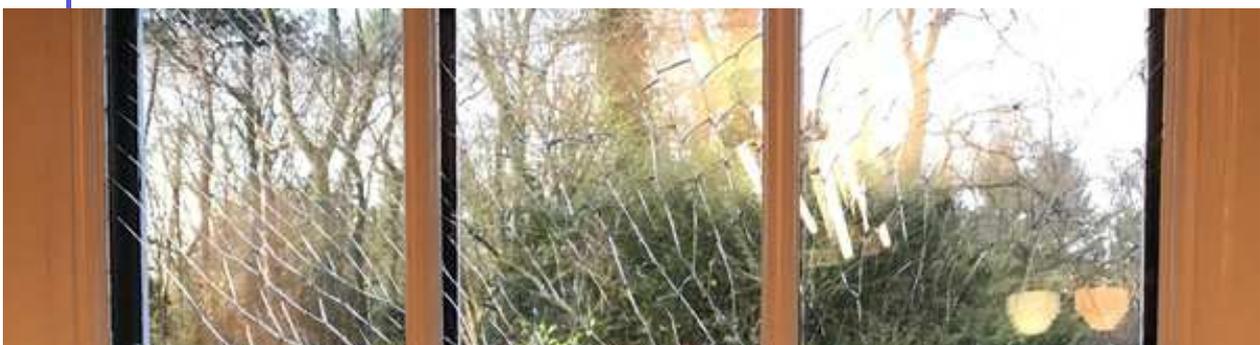
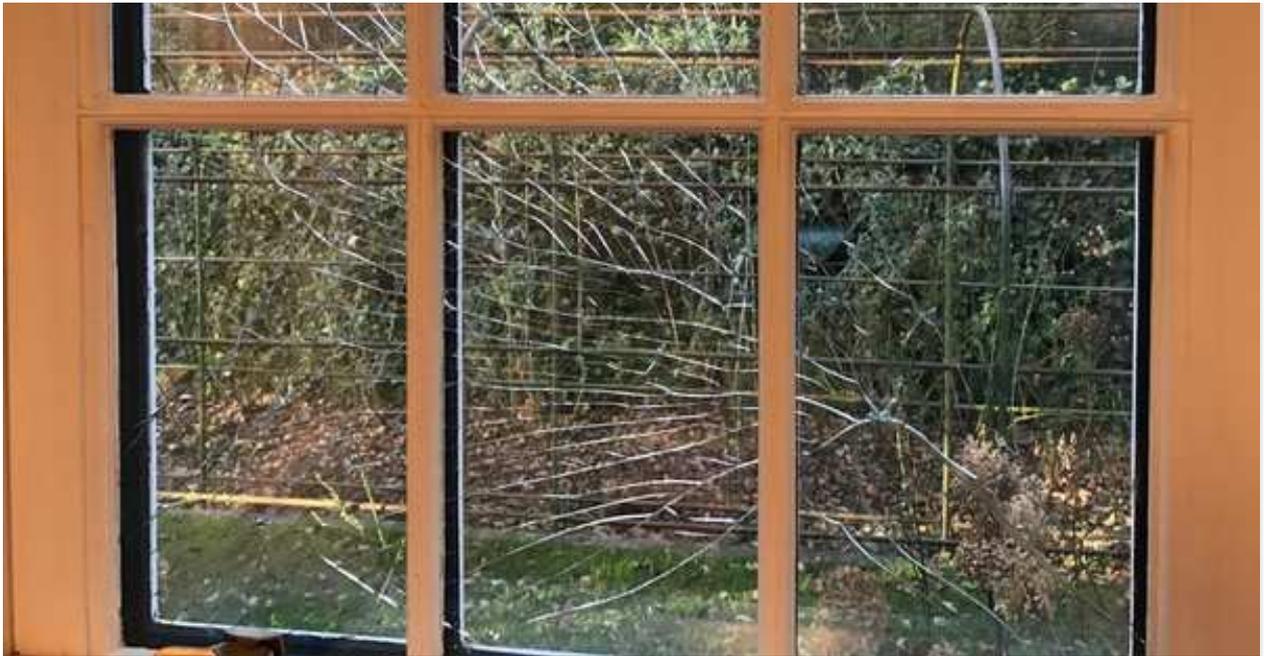
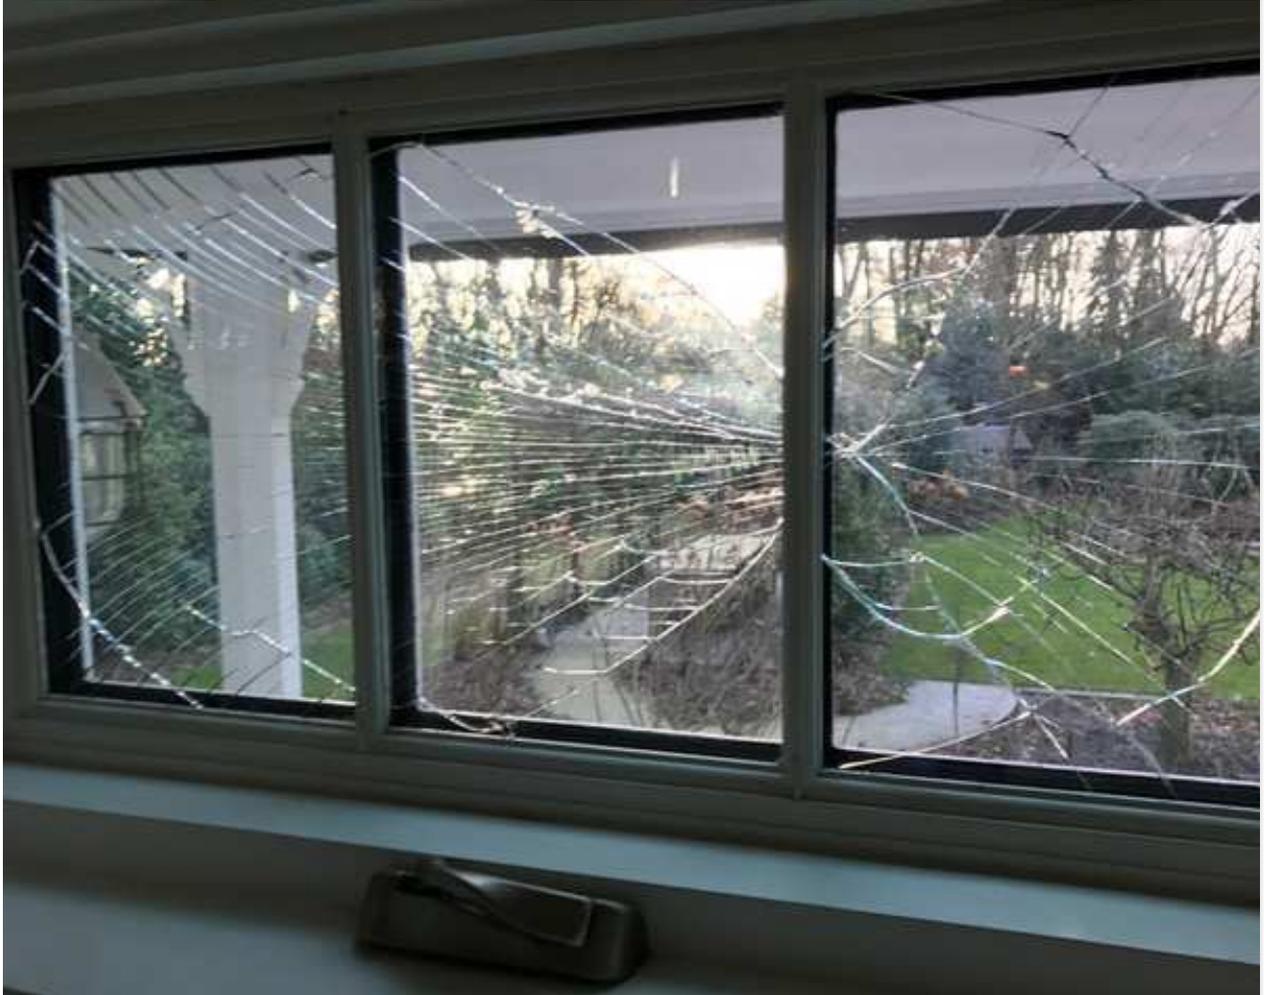
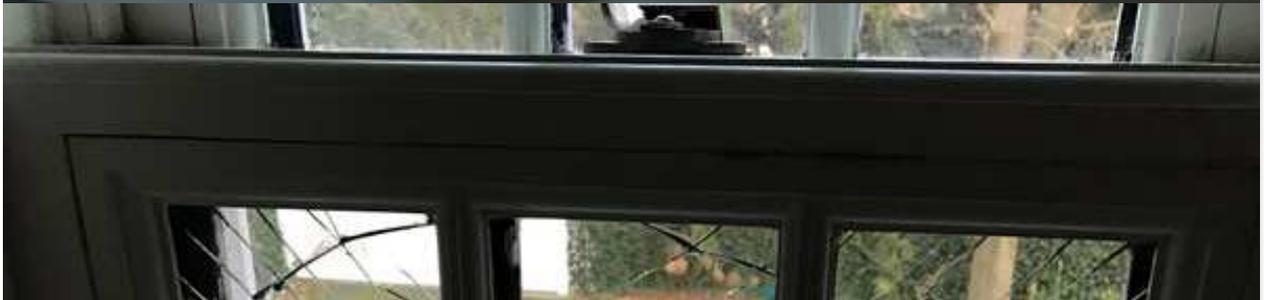
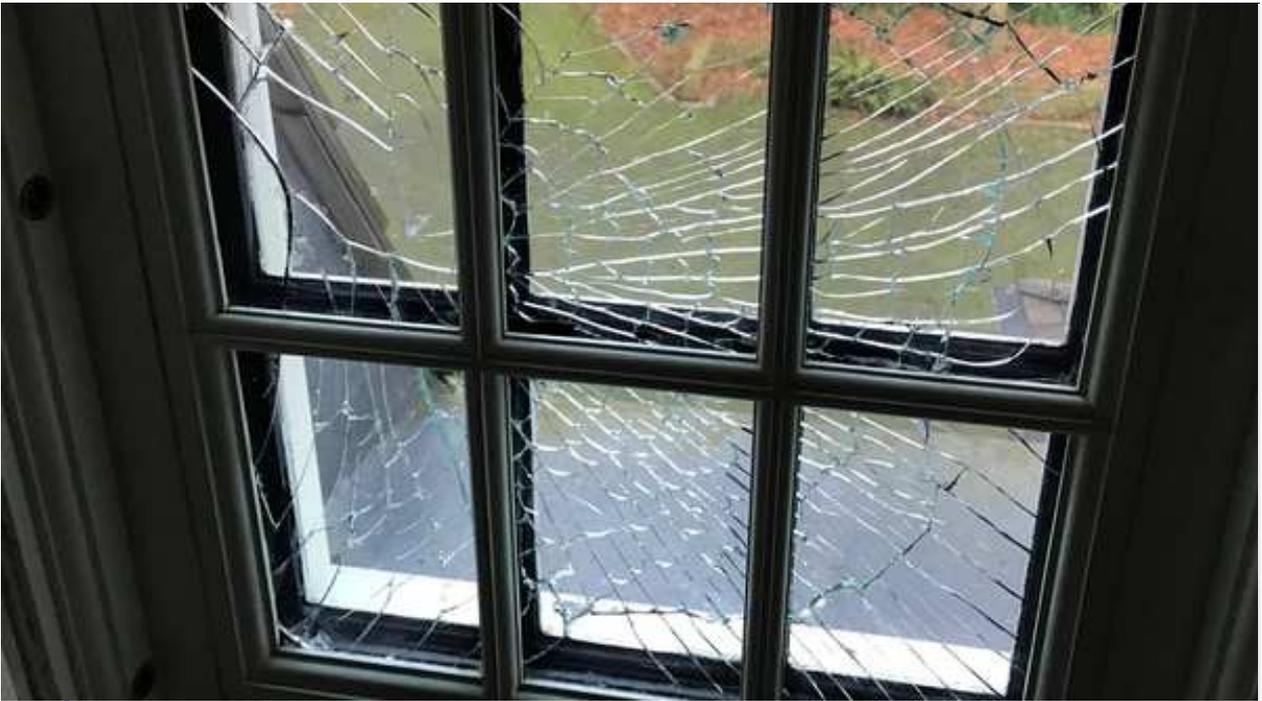
The two main "suspects" in this are thought to be that the units are too tight in the framing systems or the stops on the windows are not sufficient enough ( wide enough ) to completely cover the black sealant ( leading to UV exposure on the sealant causing the sealant to break down and enabling the gas molecules to evacuate from the interior cavity - which in turn causes the glass to be concave and ....with the right atmospheric conditions .....implode ) . From the exterior of your house is the black sealant – around the perimeter of the insulated unit itself - visible ?

I the mean time there are 3 more panes that imploded see photo's attached.
