June 29, 2016  
File No. 116066-000

Subject: Blasting Impacts on Nyanza Cap and Groundwater Flow  
Proposed Ashland Rail Transit Apartments  
Ashland, MA

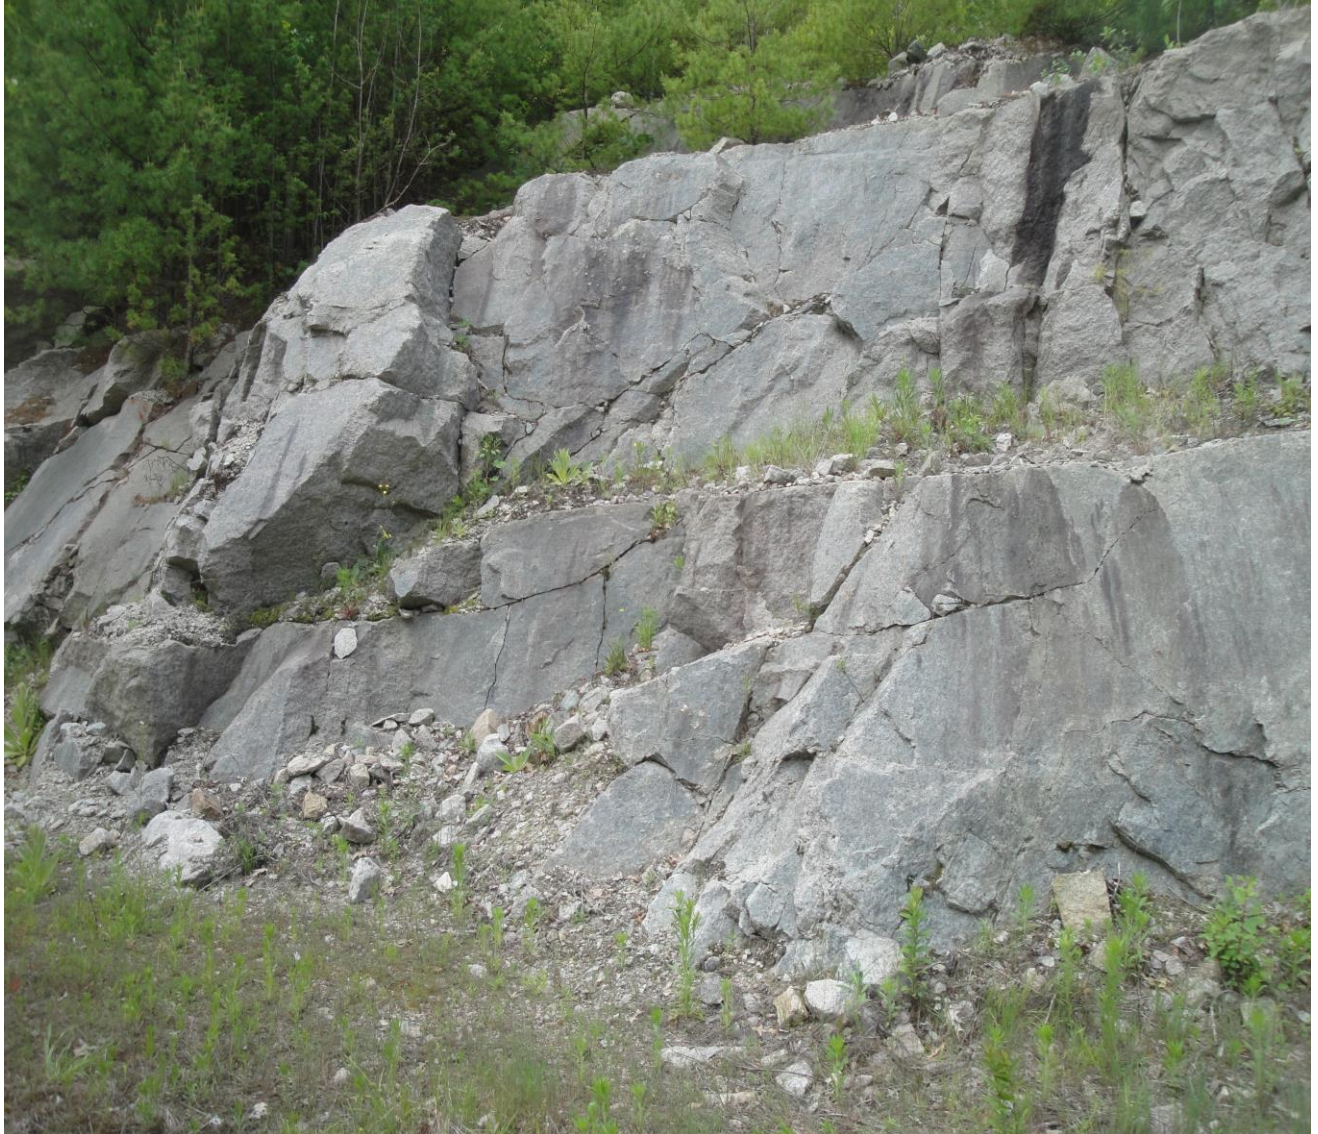
In this case, the rock is massive granitic bedrock, containing steeply dipping, relatively continuous joints and shallow dipping, relatively continuous joints. (See Photos 1 and 2 attached). If multiple hole delay blasting is utilized, the extent of fracturing around the limits of excavation would be a maximum of about 8 to 10 ft. If perimeter control measures are utilized at the limits of excavation, which would require close spacing of holes and lighter hole loading at the perimeter of the rock excavation, that damage zone is significantly reduced, to a few feet or less.

Photo 1, Granitic Bedrock in drainage swale near the southwest corner of the Nyanza site, looking northeast.

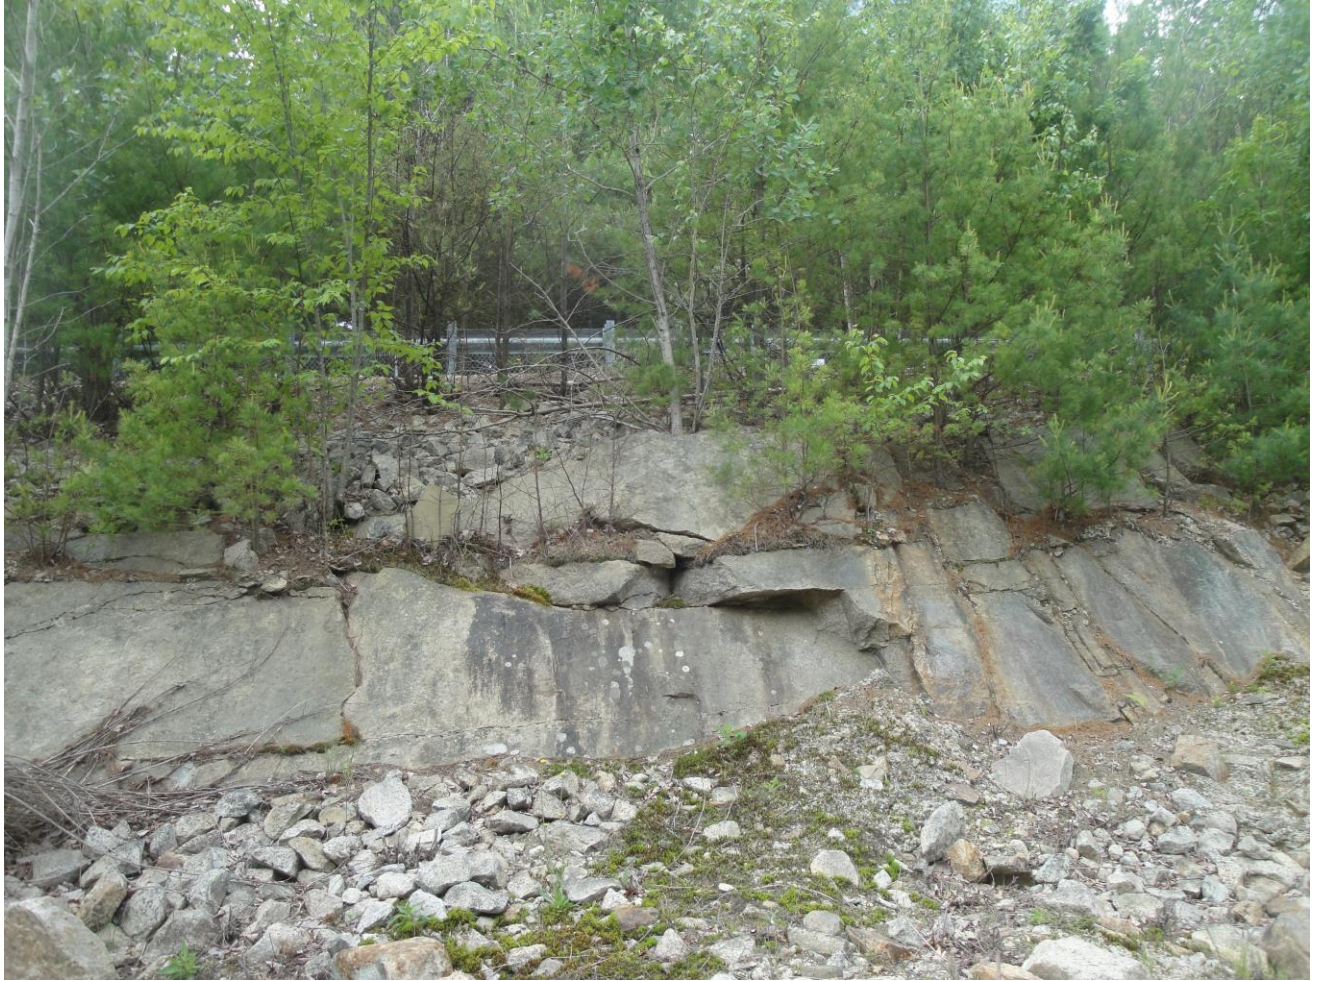
PHOTO 2 Looking west toward bedrock at southwest corner of Nyanza site, with access road behind.
