Mould & Moisture Assessment Gulf Shore Consolidated School

Project No. 12620

May 17, 2011

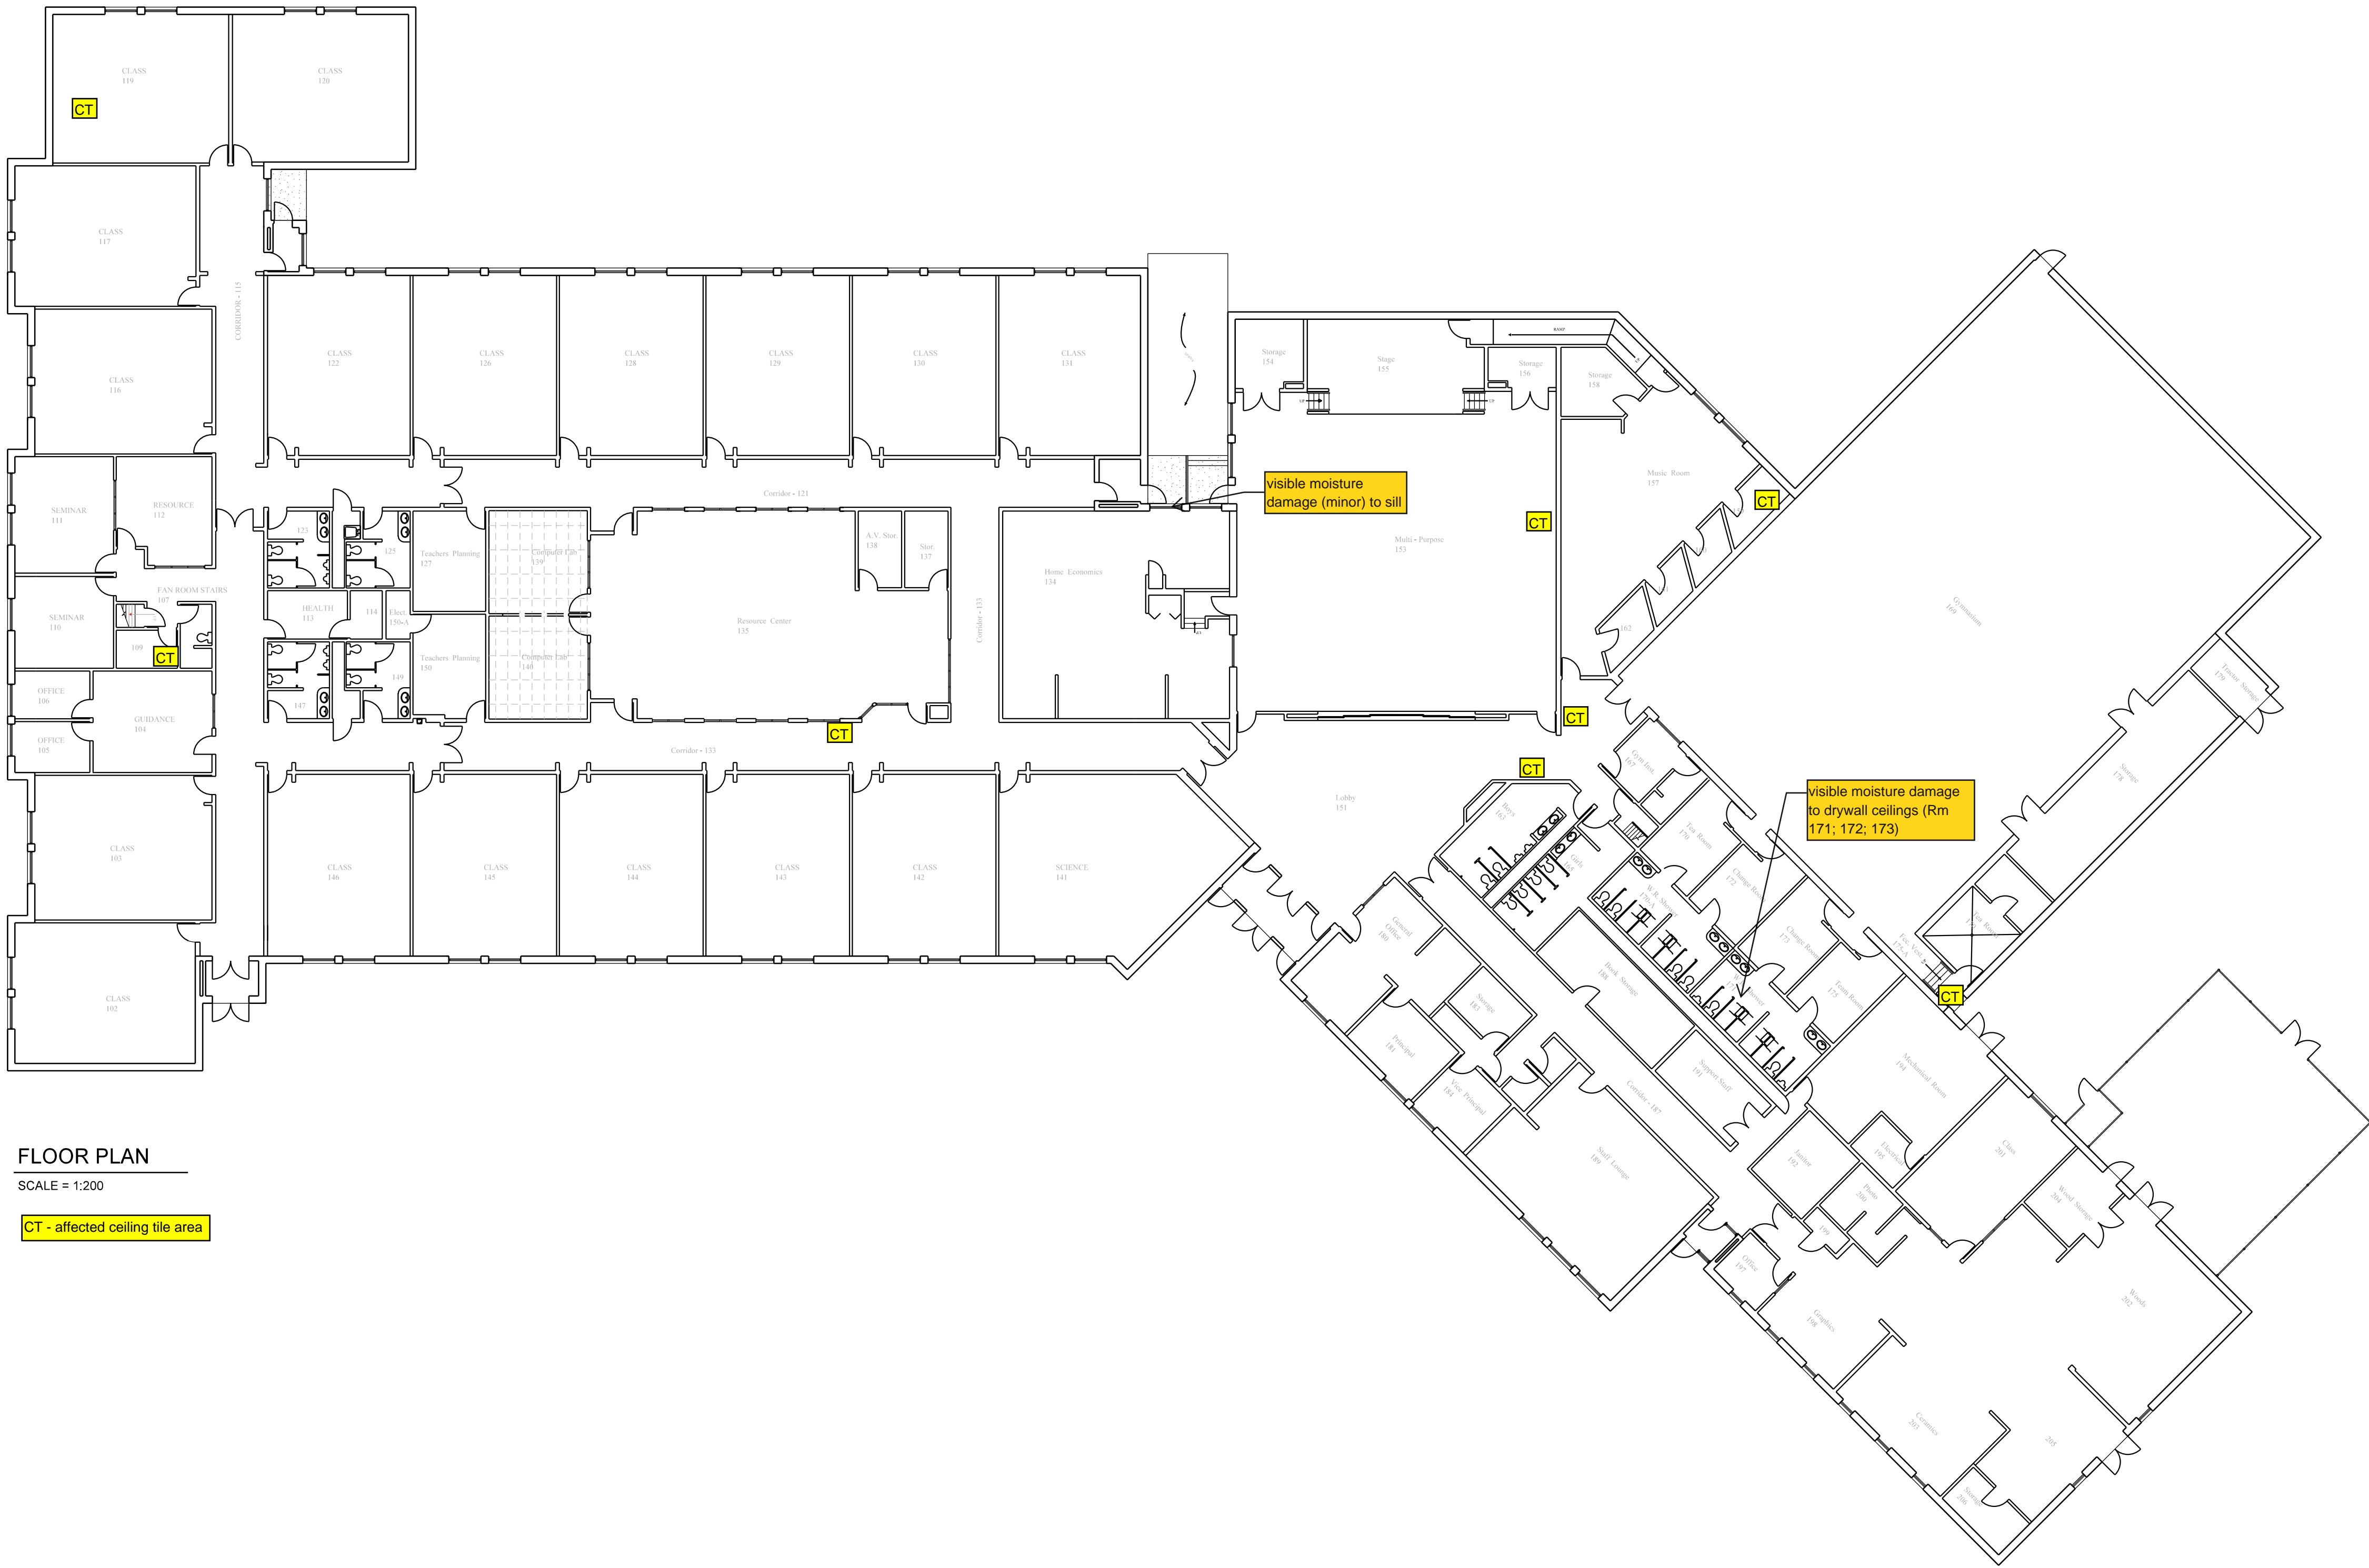
FLOOR PLAN

Table II Summary of Moisture affected areas		
Room No. / Description	Comments / Observations	Action required
Rms 109; 119; 133 corridor; 151 (lobby); 153; 159; 175A	Stained ceiling tiles observed and reported in noted areas (see site floor plan - Appendix I for location markings).	Replace ceiling tiles as precautionary measure and to assist in detecting further water leaks. Some mechanical leaks were reported at the time of assessment.
Rm 134	Visible water damage to windows. No current water leaks or condensation observed at the time of the assessment. No moisture detected. Window exhibits evidence of past water intrusion around windows without visible mould.	Report and repair any further water leaks promptly to detect source(s) and prevent subsequent mould growth.
Room 171, 172, 173	Visible moisture damage to drywall ceilings. No current water leaks or condensation observed or reported at the time of the assessment. No moisture detected.	Before repairs are made to these areas, conduct further investigation above ceiling by opening small section to assess for potential hidden moisture and / or mould growth.

CT - affected ceiling tile area
