CITY OF SOMERVILLE, MASSACHUSETTS
OFFICE OF STRATEGIC PLANNING & COMMUNITY DEVELOPMENT
JOSEPH A. CURTATONE
MAYOR

ALTERATION TO A HISTORIC PROPERTY STAFF REPORT

Site: 178 Central Street c.1840 Adams-Locke House
Case: HPC 2019.026 Single Building Local Historic District

Date of Application: April 19, 2019
Legal Notice: *Replace windows*
Staff Recommendation:
Date of Public Hearing: May 21, 2019

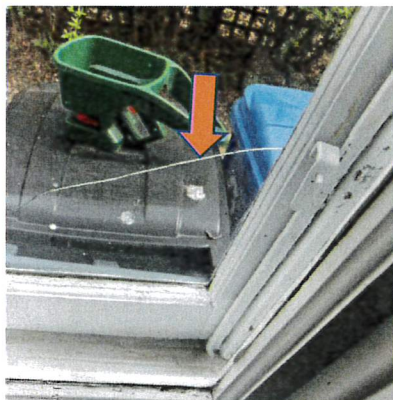
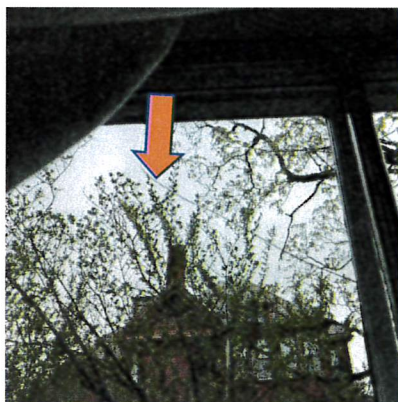
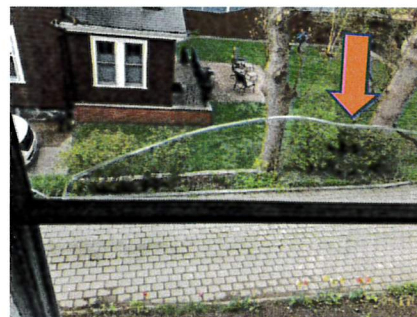
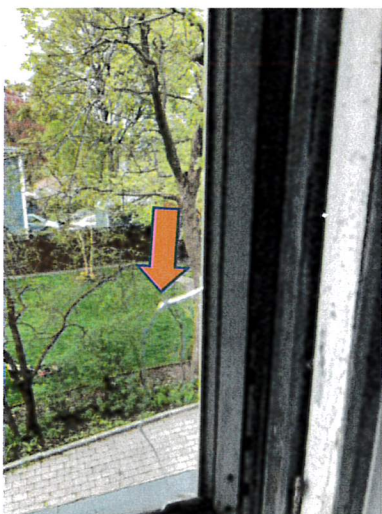
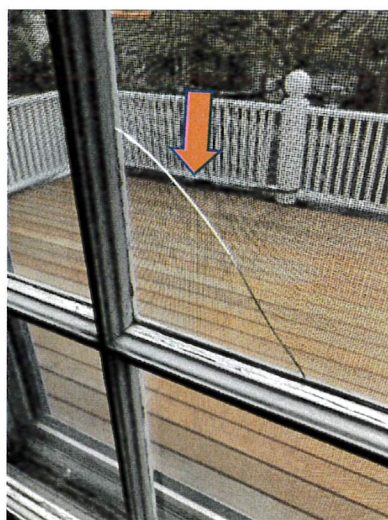
Below are examples of storms (from 1st and 2nd floors) that have cracked glass (sorry, some are hard to see) from ice melting in winter. Replacing glass and trying to caulk and insulate were ineffective, resulting in repeat icing and breakage. I currently have 6 of these 19 windows with broken glass. I do not have a photo from winter but all windows completely iced over and can barely see out of them. When the weather gets warmer, the melting ice cracks the glass. I stopped replacing the glass as it is a chronic problem. The upper right example is a very large shard of glass which is on the second floor and just barely hanging. This is a clear and present danger which worries me.

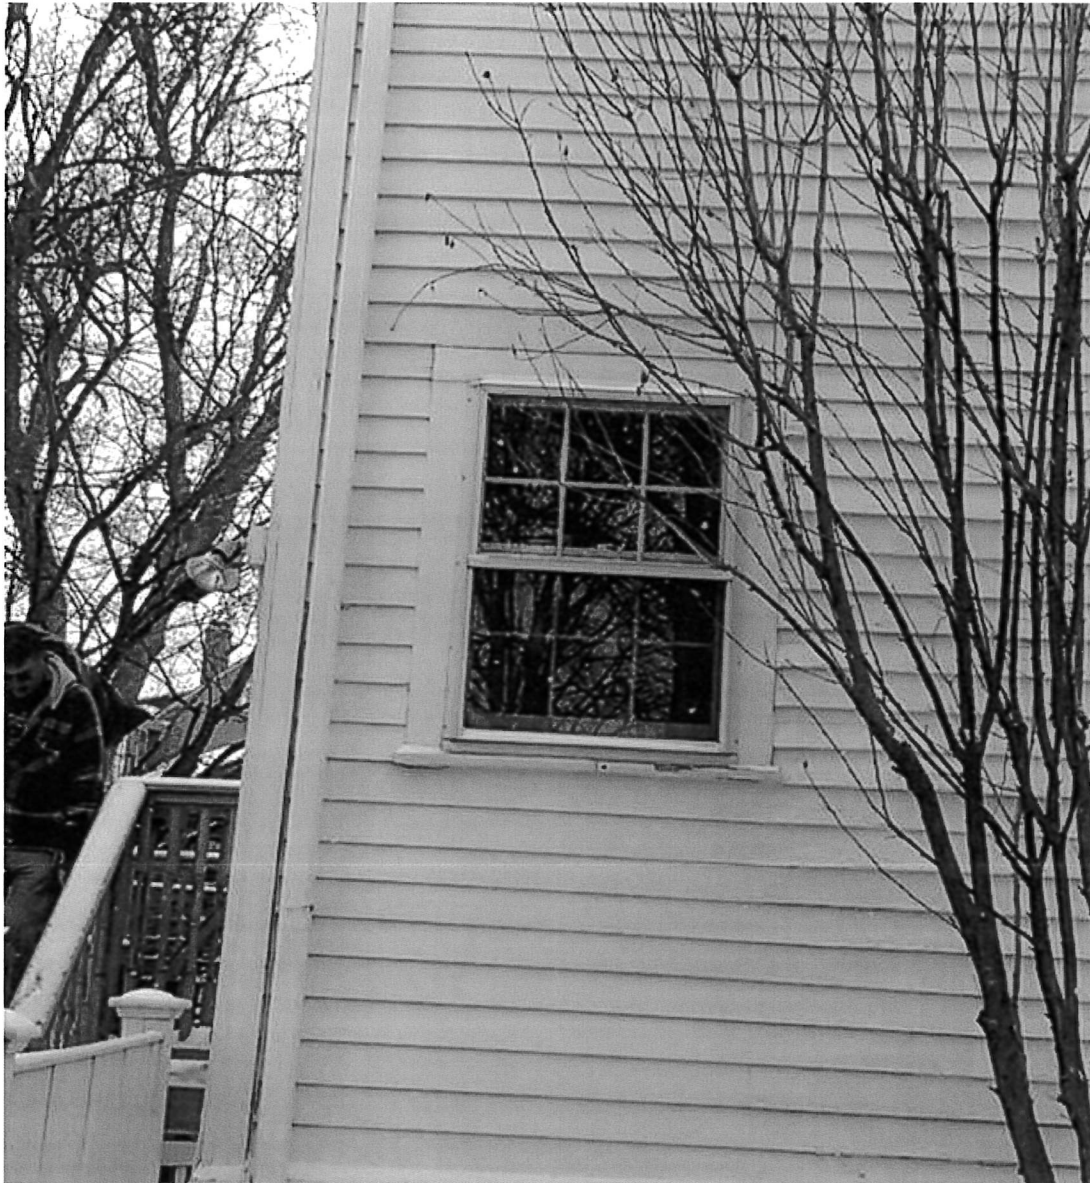
Close-up of window requiring replacement

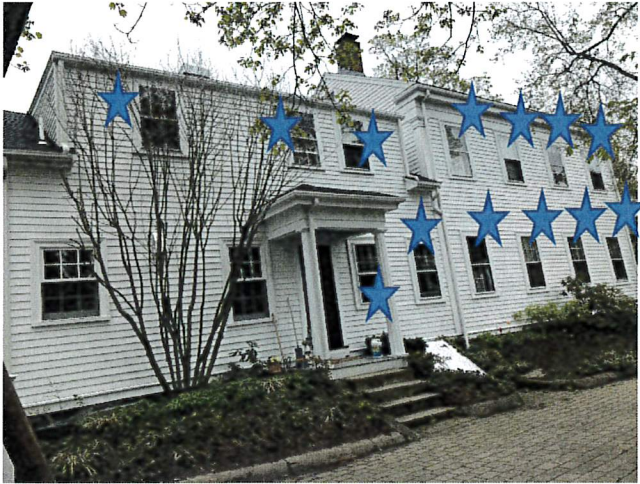
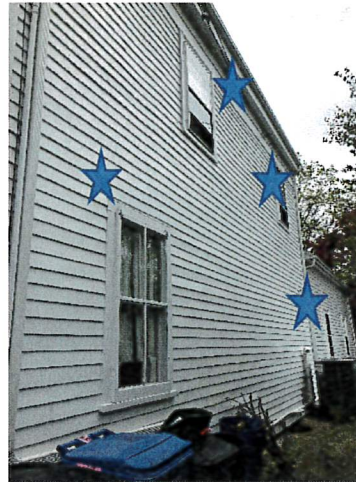
Windows to be replaced
from driveway side of
house (West) and opposite
side of house (East).

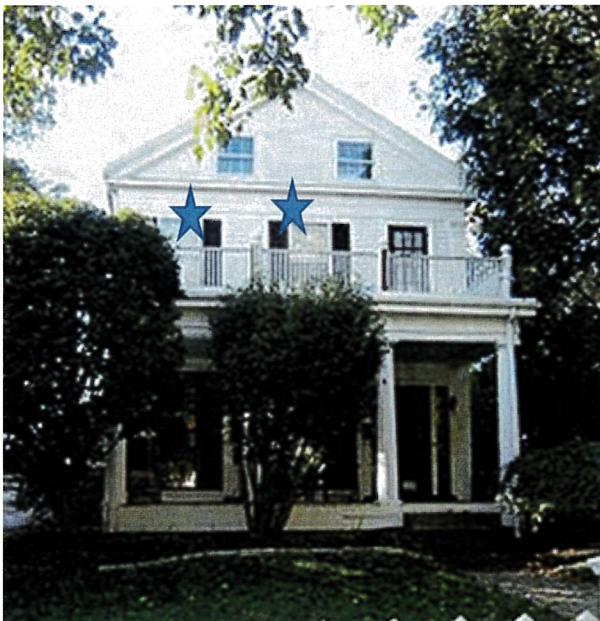
Windows to be replaced from front of house (street view)

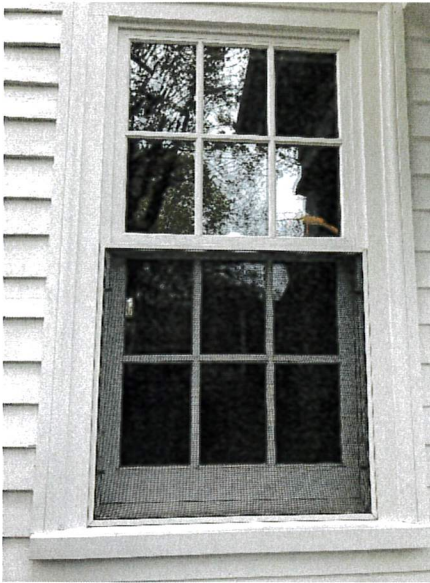
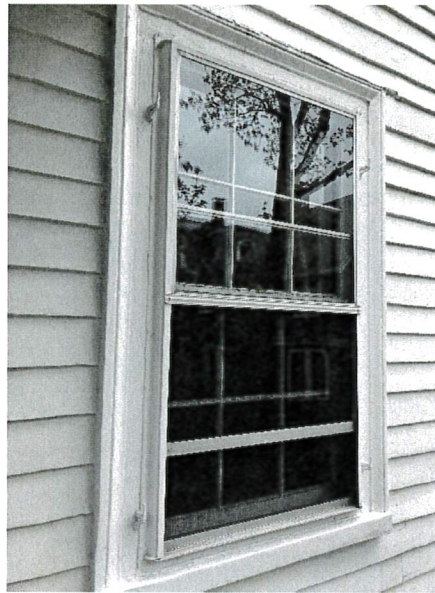
Close up comparison between existing window needing replacement (right) and one that was replaced by Marvin Tilt Pac (left).

The appearance is strikingly different and detracts from the harmony/appearance of the façade from the street

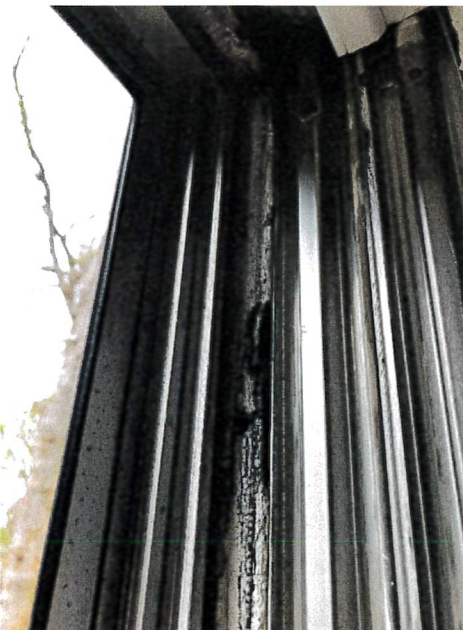
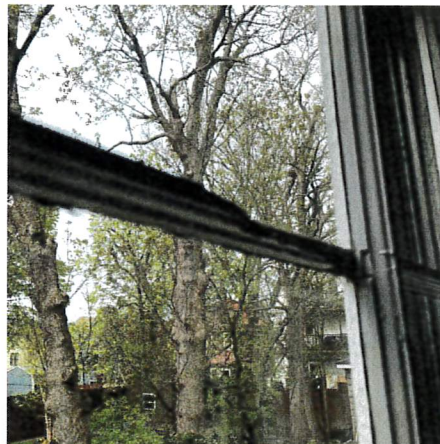
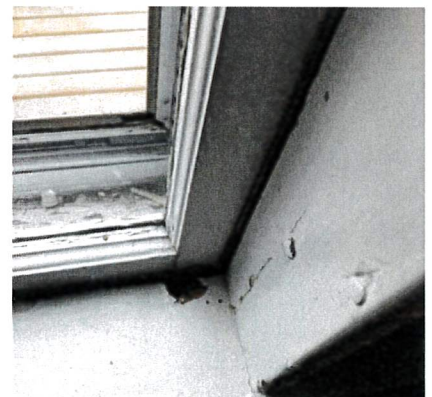
Below are examples of rotten jams and mullions; large gaps around aluminum jam covers allowing water/ice and air to infiltrate causing rotting. These windows are all from 1st Floor LR and parlor.

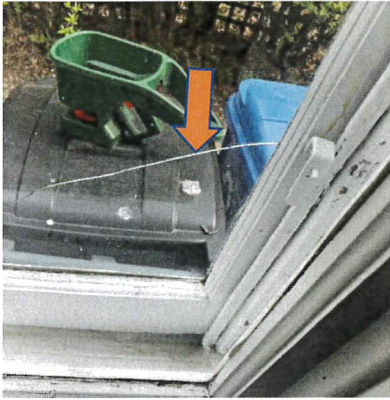
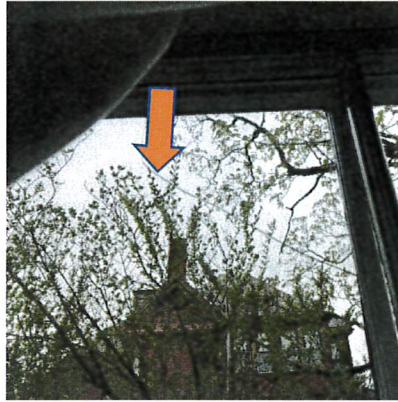
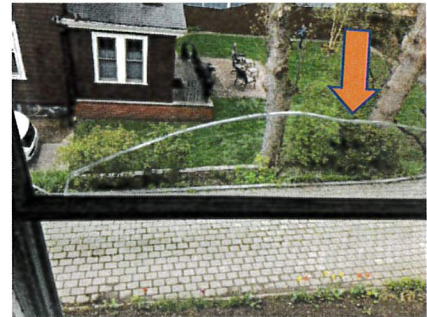
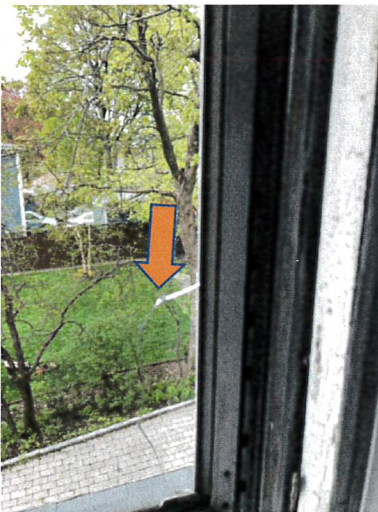
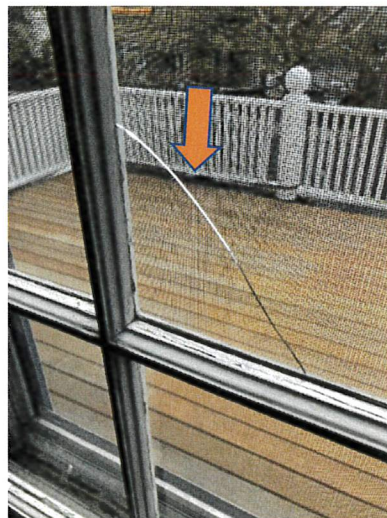
Below are examples of storms (from 1st and 2nd floors) that have cracked glass (sorry, some are hard to see) from ice melting in winter. Replacing glass and trying to caulk and insulate were ineffective, resulting in repeat icing and breakage. I currently have 6 of these 19 windows with broken glass. I do not have a photo from winter but all windows completely iced over and can barely see out of them. When the weather gets warmer, the melting ice cracks the glass. I stopped replacing the glass as it is a chronic problem. The upper right example is a very large shard of glass which is on the second floor and just barely hanging. This is a clear and present danger which worries me.

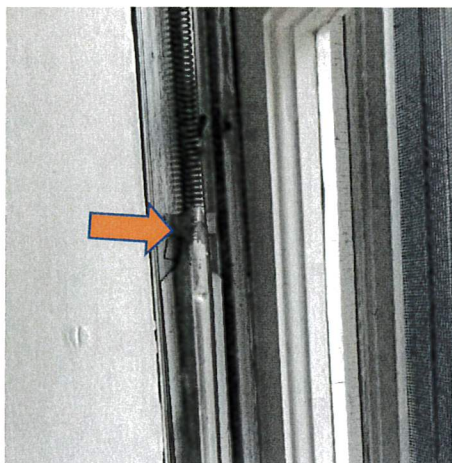
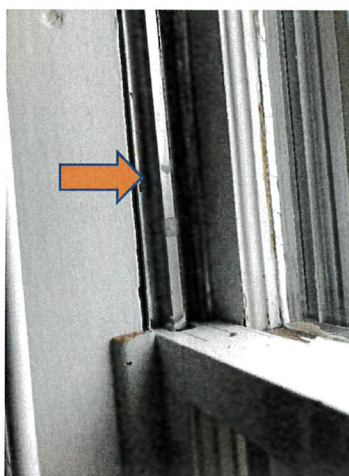
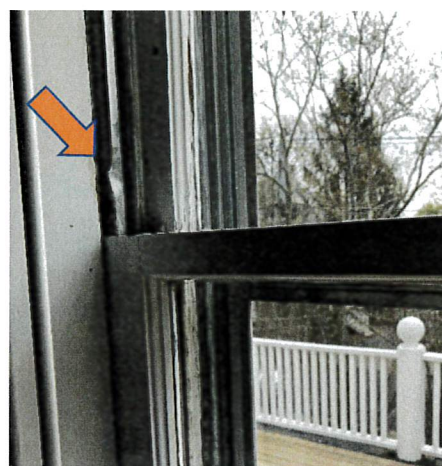
These photos below show aluminum jam replacements that are bent with broken springs and no longer hold the window up unless you lock them closed. I have to propphem open with sticks in summer to get fresh air.
